No. TCD-4667-97

Japan Civil Aviation Bureau

## Airworthiness Directive

1. Applies to: NAMC Model YS-11 and -11A series airplanes

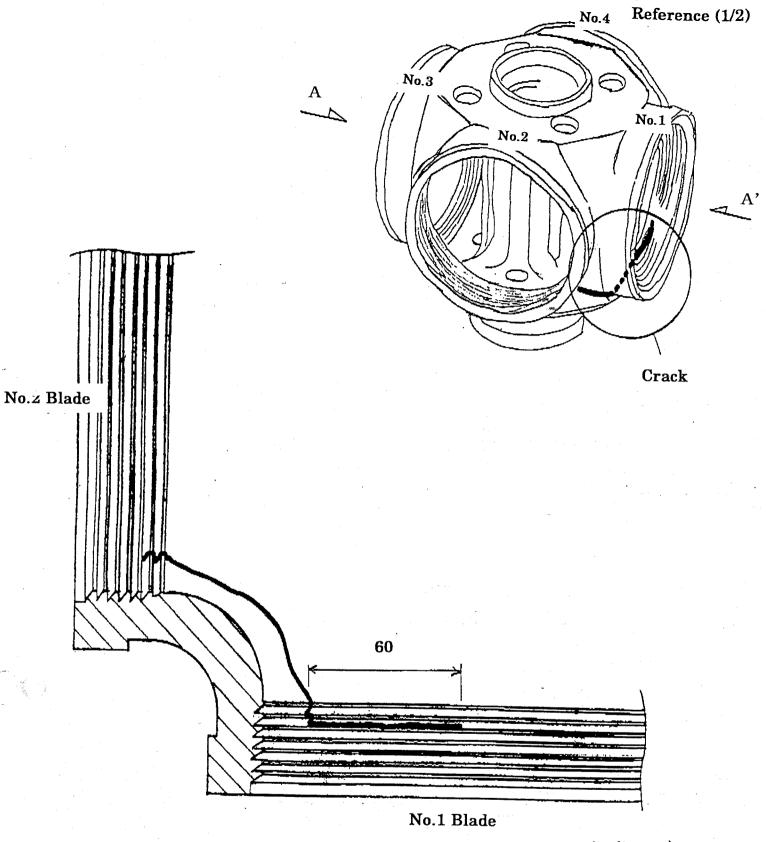
## **HUB CRACK - VIEW FROM TOP**

To prevent cracking of the propeller hub, accomplish the following.

TCF-50-001-2E Japan Civil Aviation Bureau No. TCD=4667-97 basheet 2/2 detailed visual inspection for cracking of the propeller hub. If the crack is detected by the inspection specified in the 2.2 paragraph 2.1, replace the hub with the airworthy one. Report to the Director-General of Civil Aviation Bureau on the crack detected by the inspection together with total time and total cycles from new or latest overhaul of the hub. An alternative means of compliance with this AD may be used, if approved by the Director-General of JCAB and A relativistic 3. Remarks . Note and rest of the control of the Montepage of the state of the control of the co This AD becomes effective on October 13, 1997.
