Accident

Aircraft Type and Registration:	AW139, 5N-BOX
No & Type of Engines:	2 Pratt & Whitney Canada PT6C-67C turboshaft engines
Year of Manufacture:	2012 (Serial no: 31386)
Date & Time (UTC):	13 November 2023 at 0958 hrs
Location:	Norwich Airport
Type of Flight:	Commercial Air Transport (Non-Revenue)
Persons on Board:	Crew – 2 Passengers – None
Injuries:	Crew – None Passengers – N/A
Nature of Damage:	Damage to main rotor blade tips
Commander's Licence:	Airline Transport Pilot's Licence
Commander's Age:	35 years
Commander's Flying Experience:	2,600 hours (of which 2,100 were on type) Last 90 days – 200 hours Last 28 days – 80 hours
Information Source:	Aircraft Accident Report Form submitted by the pilot

Synopsis

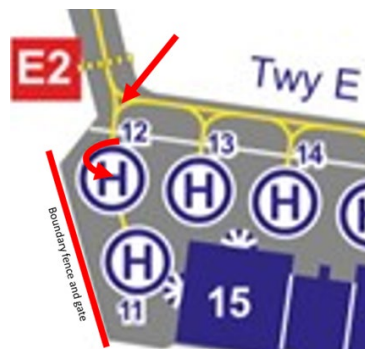
Figure 2
Parking stand positions

The only unoccupied parking stand on the apron was Stand 12 which is the closest stand to the airfield perimeter (Figure 2). Stand 11 is disused. As the helicopter ground taxied toward Stand 12 the commander was PF. He stated that he followed the yellow line off Taxiway Echo into the parking stand and then followed the outer yellow circular line (Figure 3) to the right to allow him to turn left and park facing to the east, in the same direction as the helicopter on the adjacent Stand 13.
