REPORT OF  
THE ROYAL COMMISSION  
to inquire into and report upon the  
CAUSE OF THE ACCIDENT  
which occurred to the  
SCAFFOLDING  
on the  
D.I.C. BUILDING  
on 8 MAY 1957

*Presented to the House of Representatives  
by Command of His Excellency*

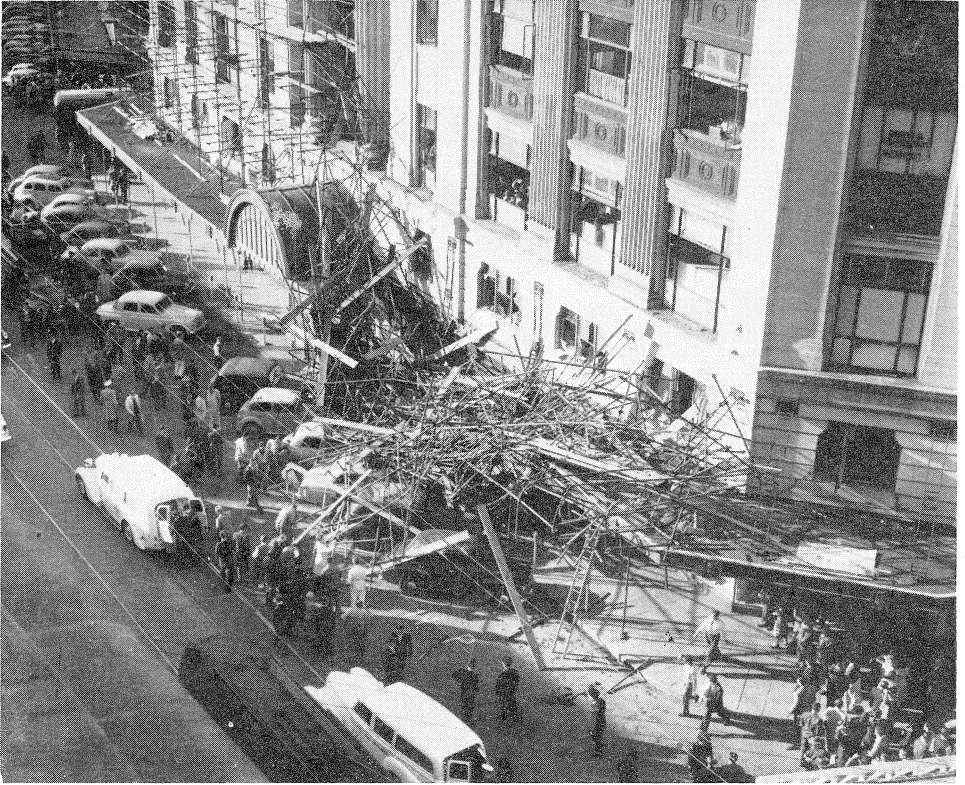
## APPENDIX F: EXHIBIT No. 13

73. Photograph Exhibit No. 13, attached as Appendix F, gives a view of the building after the scaffolding had collapsed and was still lying on top of the damaged verandah.

Earliest photograph taken of collapsed scaffold.

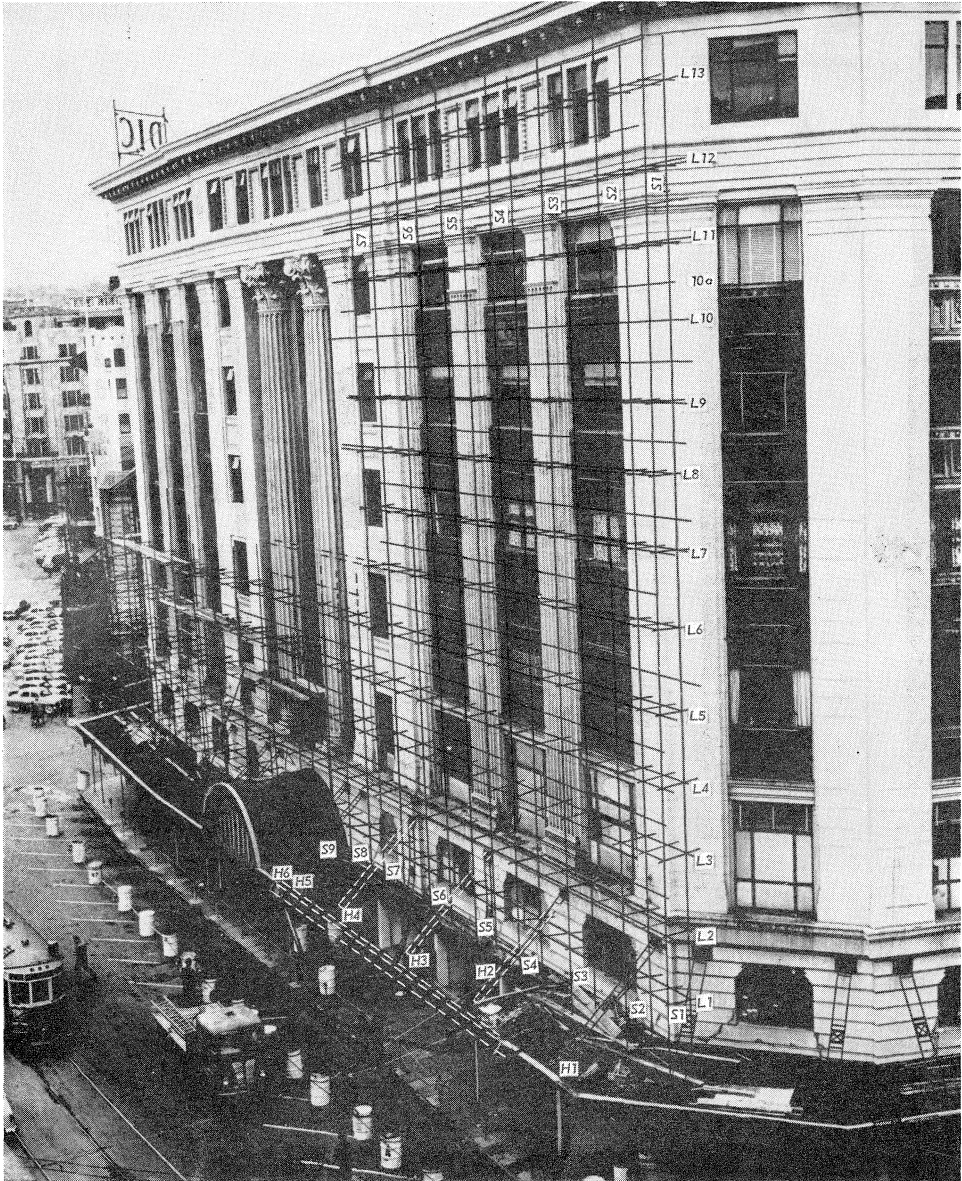
APPENDIX G: EXHIBIT No. 14

75. Photograph Exhibit No. 4, attached as Appendix G, is a view of the frontage of the D.I.C. Building after the damaged scaffolding and verandah had been cleared away, and on it has been drawn the scaffold as it existed just prior to the collapse.

*Prepared in the Ministry of Works District Office, Wellington.  
Scaffold as at time of failure.*

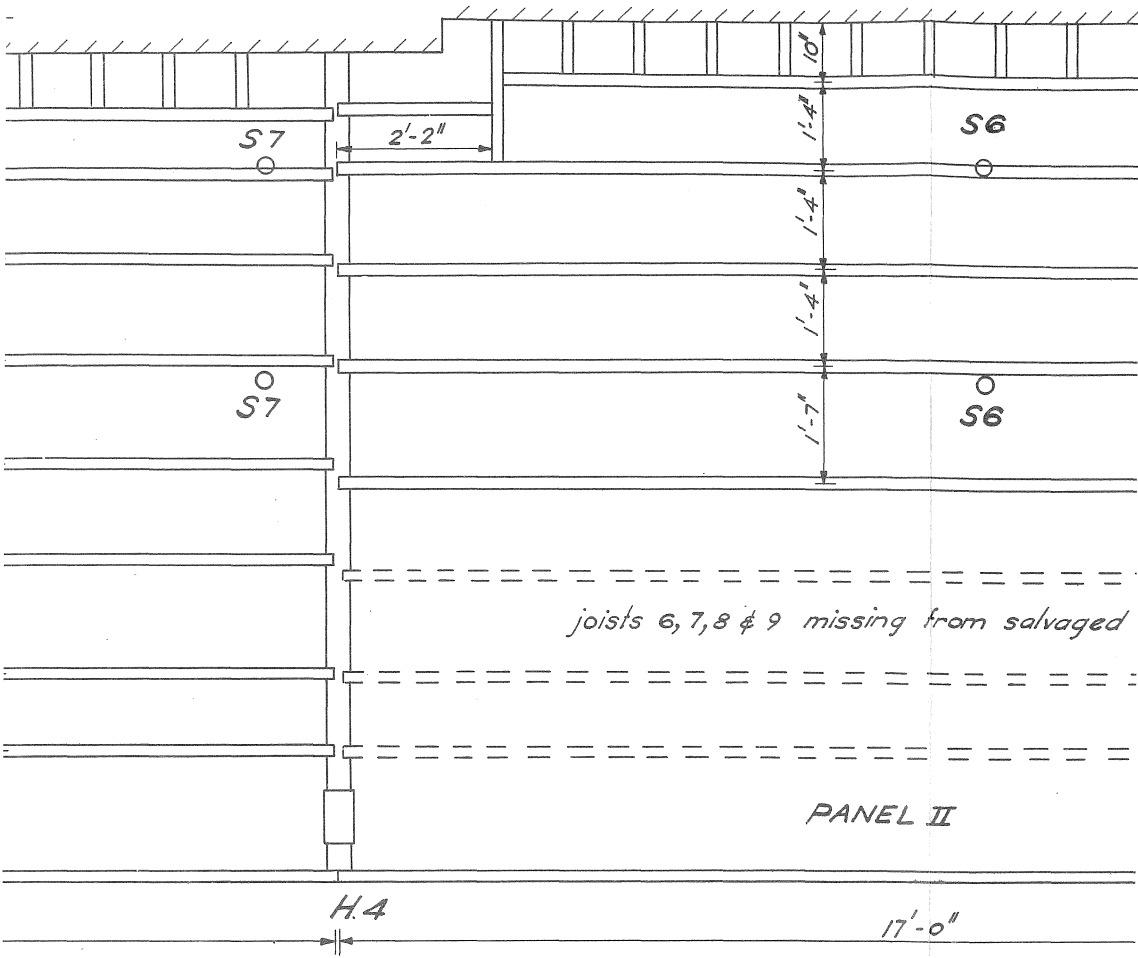
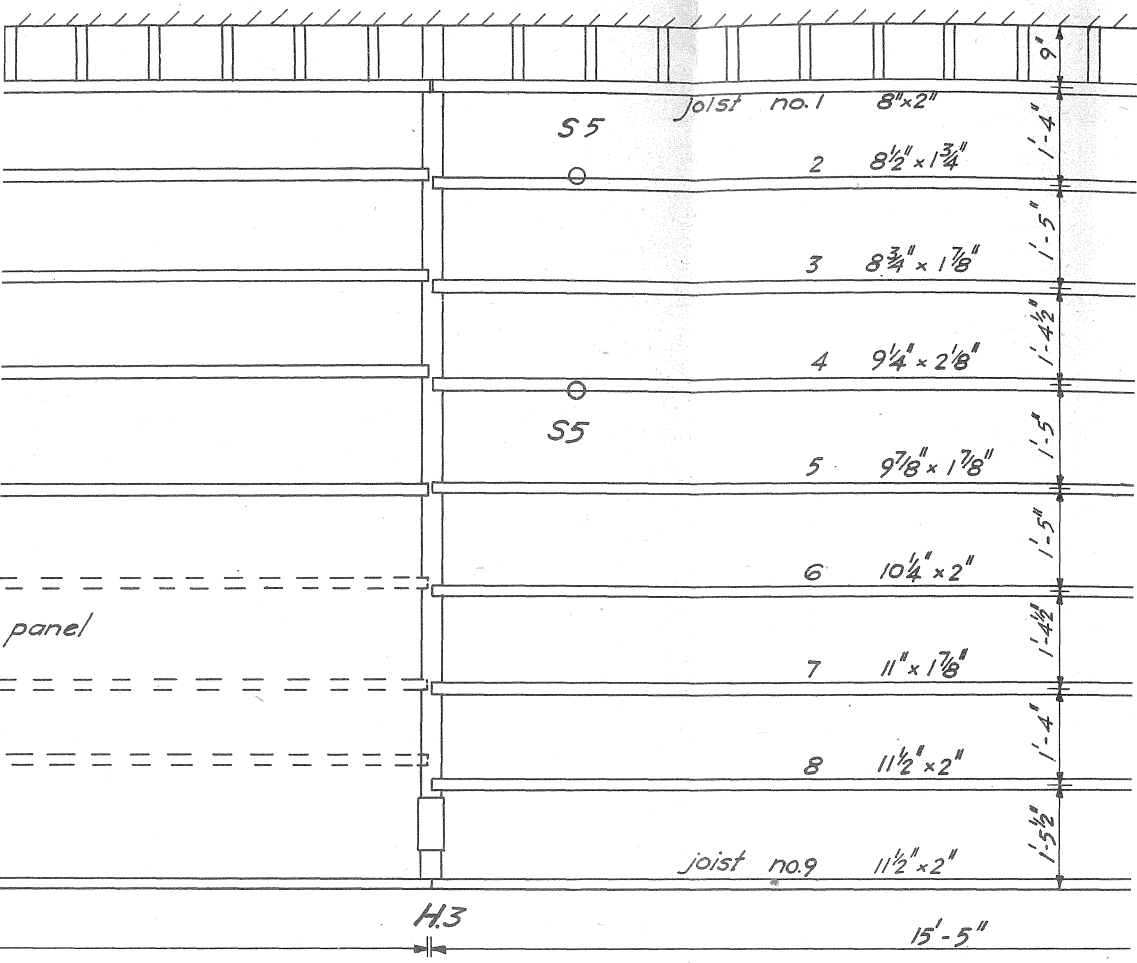
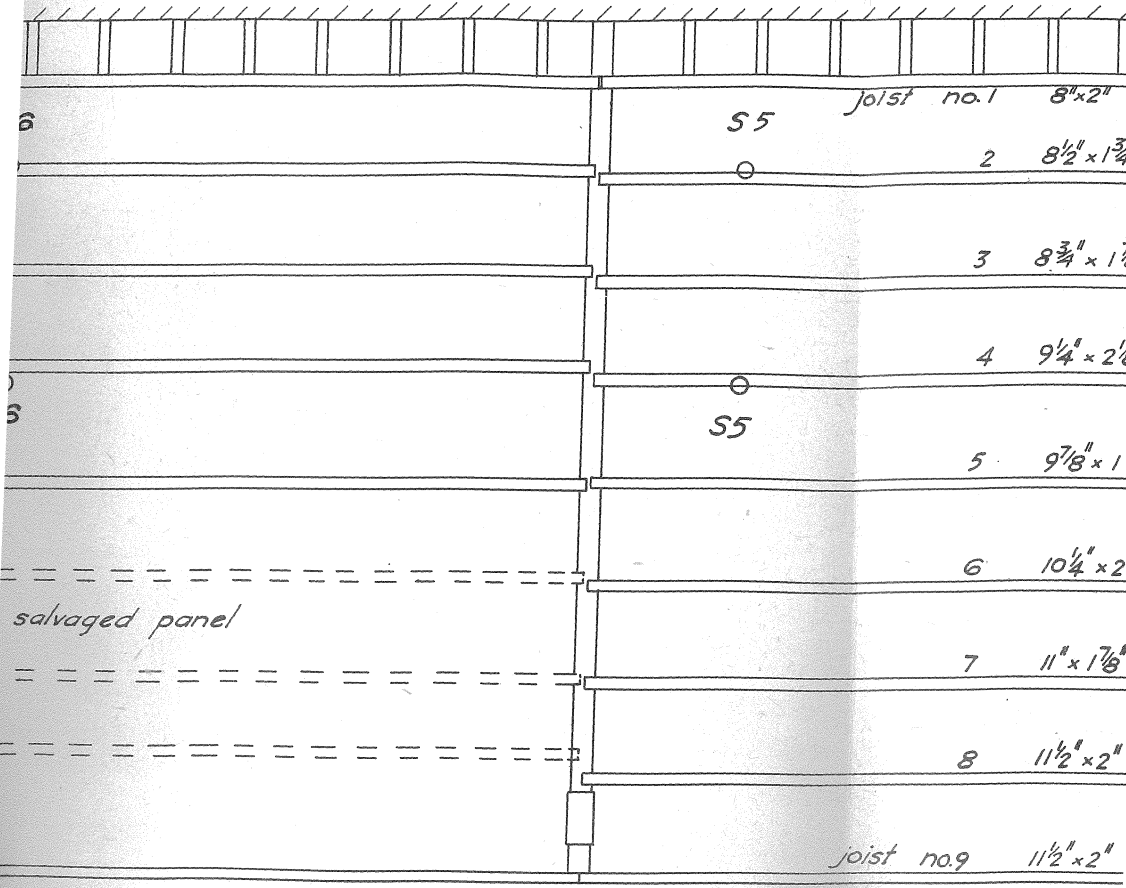
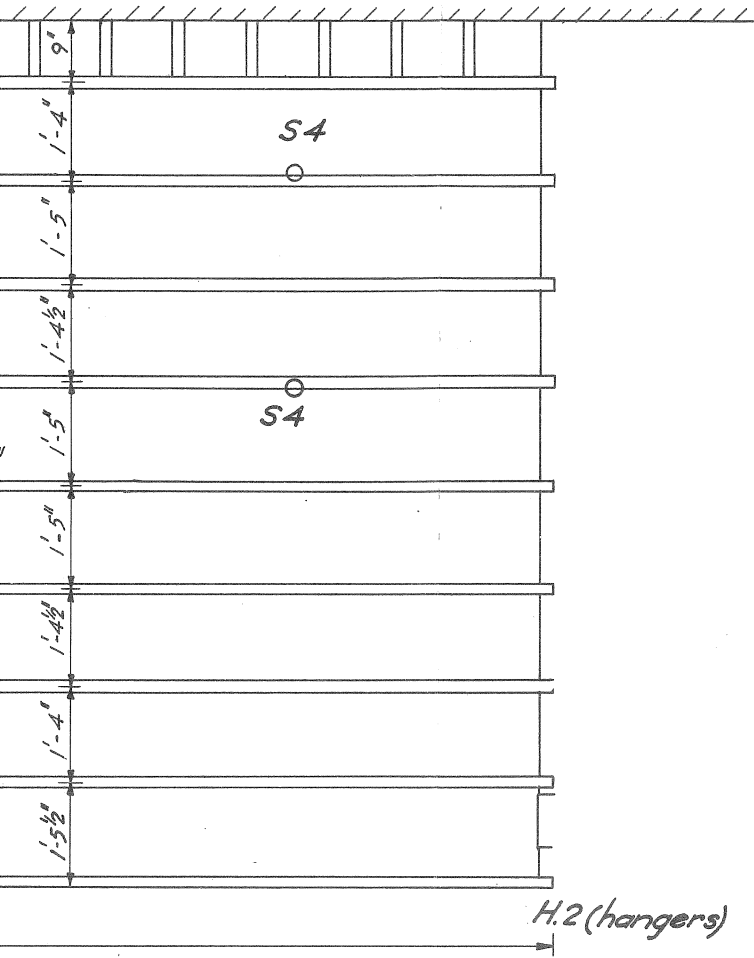
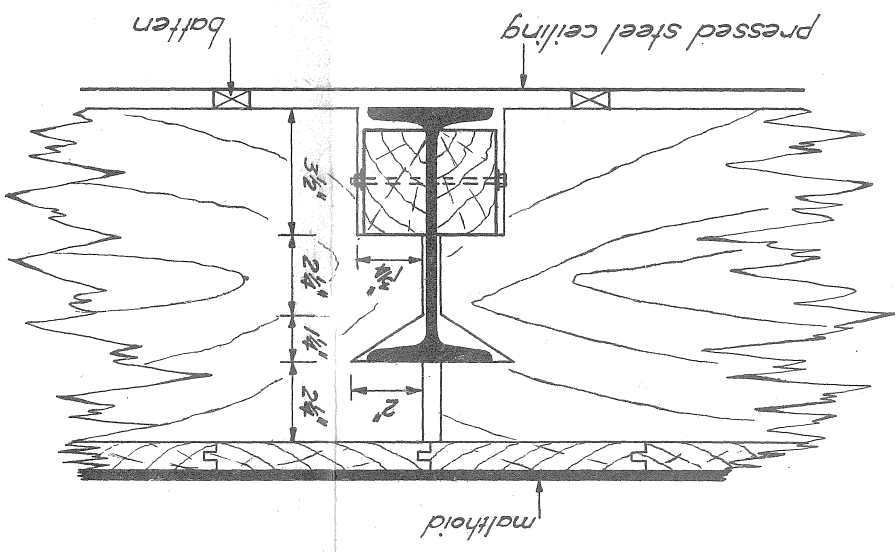
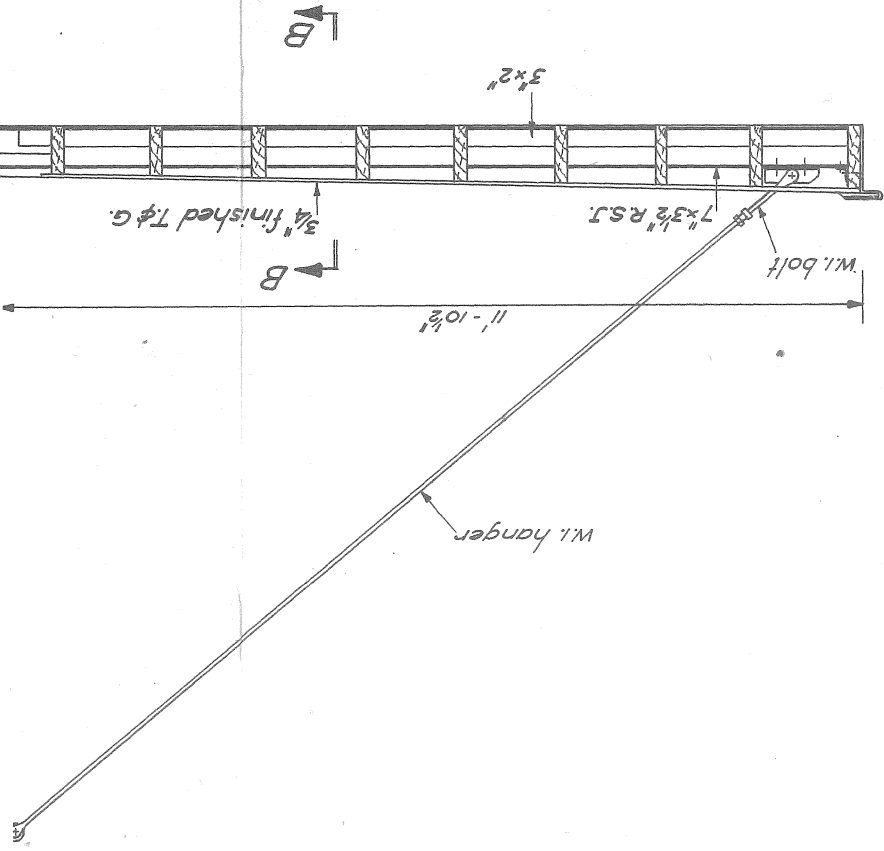
DRAWING No. 3  
APPENDIX H

42. At the same time we cannot escape the conclusion that the overload had caused some elastic deflection or other yielding of the oregon joists of the verandah, and that this movement may have aggravated the conditions which we think led to the collapse. On the other hand we do not accept the theory that the oregon joists carrying the main load of the scaffolding collapsed by being pushed down past the flanges of the rolled steel joists which supported them, or that a standard of the scaffold punctured the verandah. We believe that the scaffolding itself was in a highly unstable condition, and that the first major failure was the buckling of the heavily loaded and poorly restrained standards. This allowed the crumbling framework of the scaffolding to drop down, subjecting the hangers supporting the steel joists of the verandah to impact which in turn caused the wrought-iron bolts connecting the hangers to the verandah joists to fail. Three panels of the verandah then collapsed to the pavement.

43. We find nothing in the behaviour of the verandah which is inconsistent with its original design and construction; in other words it was adequate in strength to carry any loading which it would normally have been expected to carry. Its condition at the time of collapse was, for all reasonable and practical purposes, sound.

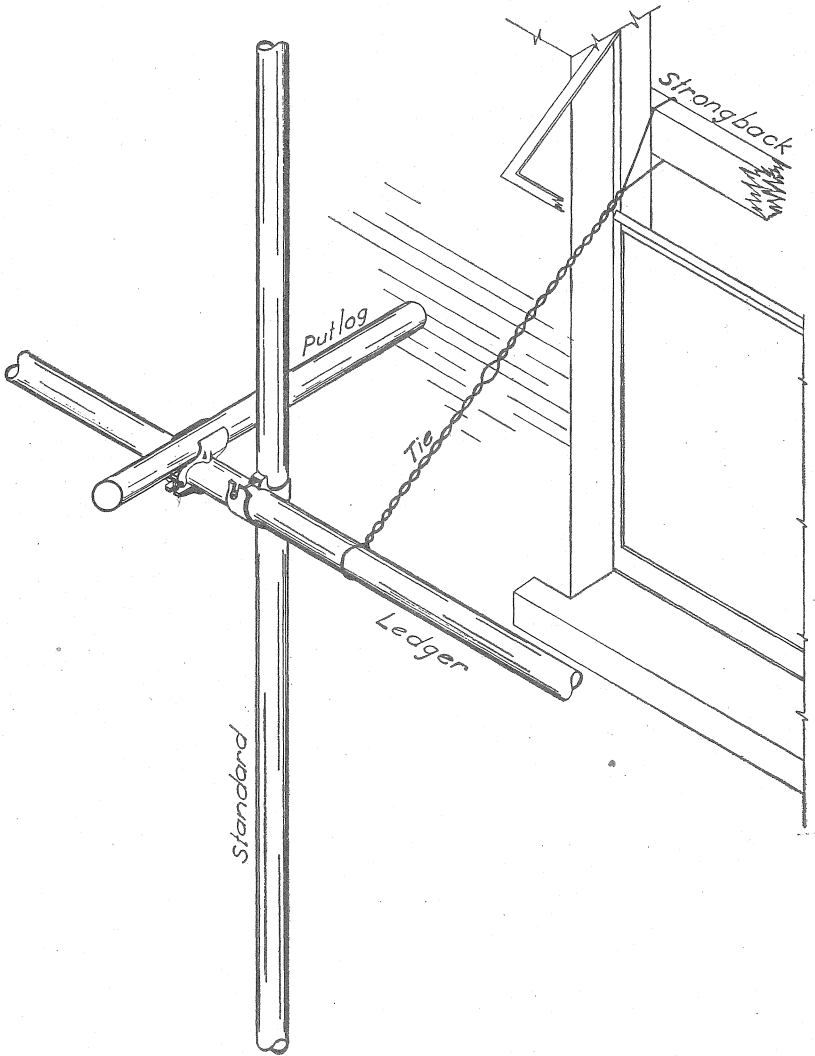
APPENDIX J: DRAWING SHOWING METHOD OF TYING  
SCAFFOLD TO BUILDING

131. Tests carried out by the Railways Department showed that twisted-wire ties taken from the scaffold broke at a load of 1,277lbs. The strongbacks across the windows did not fail and there was not sufficient evidence to warrant a finding that the ties were not adequately secured to the scaffolding. We conclude that the individual ties and the strongbacks were, in themselves, satisfactory.

Method of fixing ties (D.I.C. inquiry).
