AIRCRAFT ACCIDENT REPORT 3/2001

Air Accidents Investigation Branch

**Report on the accident to
HS748-Series 2B, G-OJEM
At London Stansted Airport
On 30 March 1998**

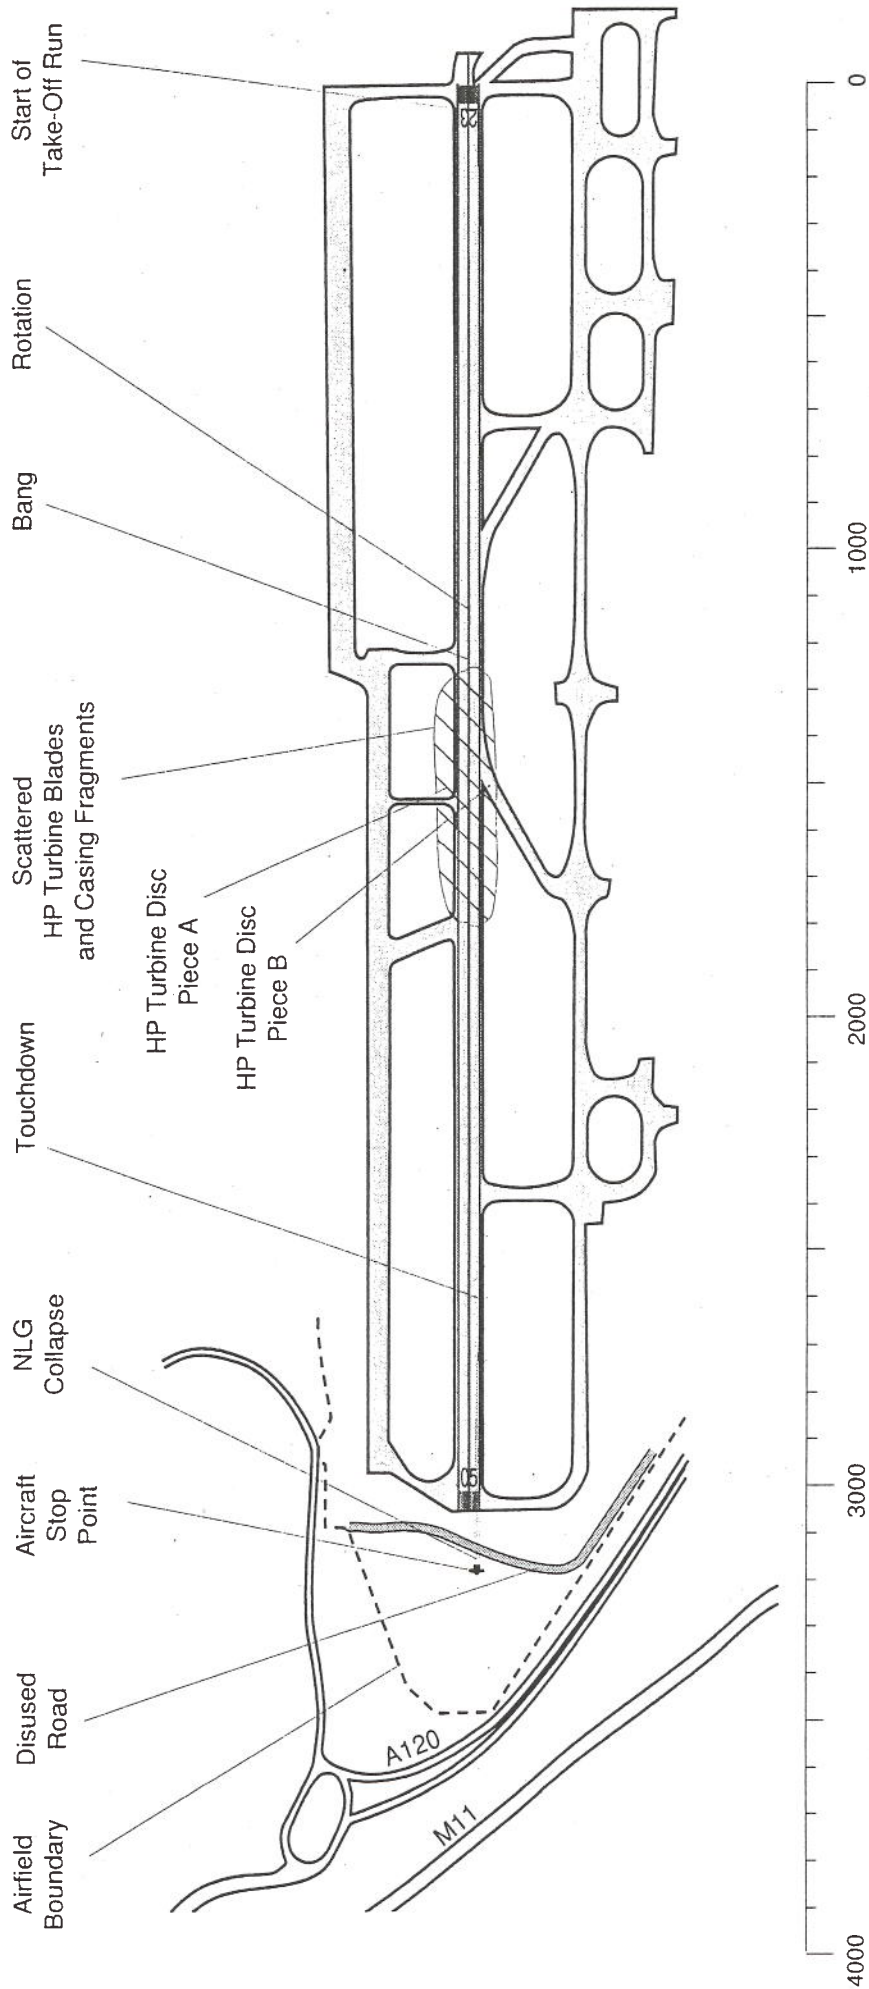
Fig 1

Following the accident, a significant quantity of engine debris was found scattered on the mid section of Runway 23 and its surrounds, over an area extending between 1250-1800 m from the start of the runway (Figure 1). The debris included nacelle cowl and engine casing parts, together with fragments of the NGVs, blades and disc associated with the HP turbine. The HP turbine disc was found in two major pieces, each 35-45 m from the runway centreline, with the larger piece on a runway turn-off south-east of the runway and the smaller on the grass to the north-west.

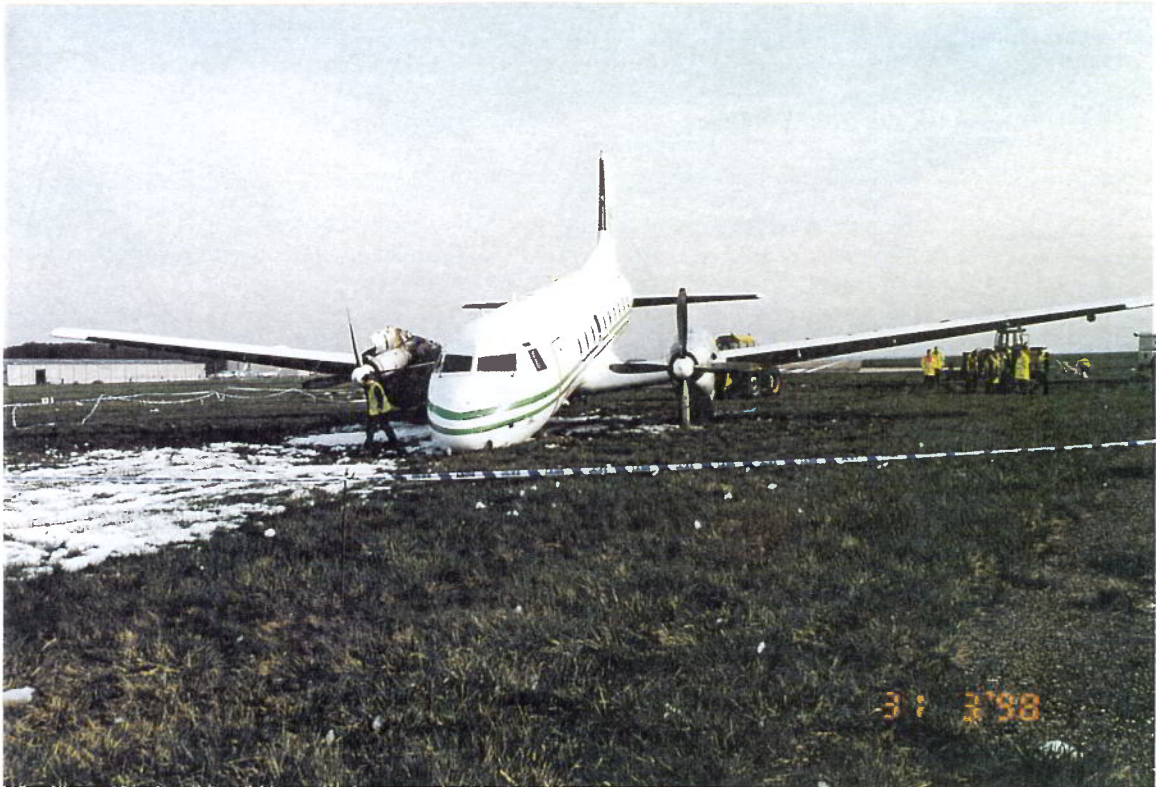
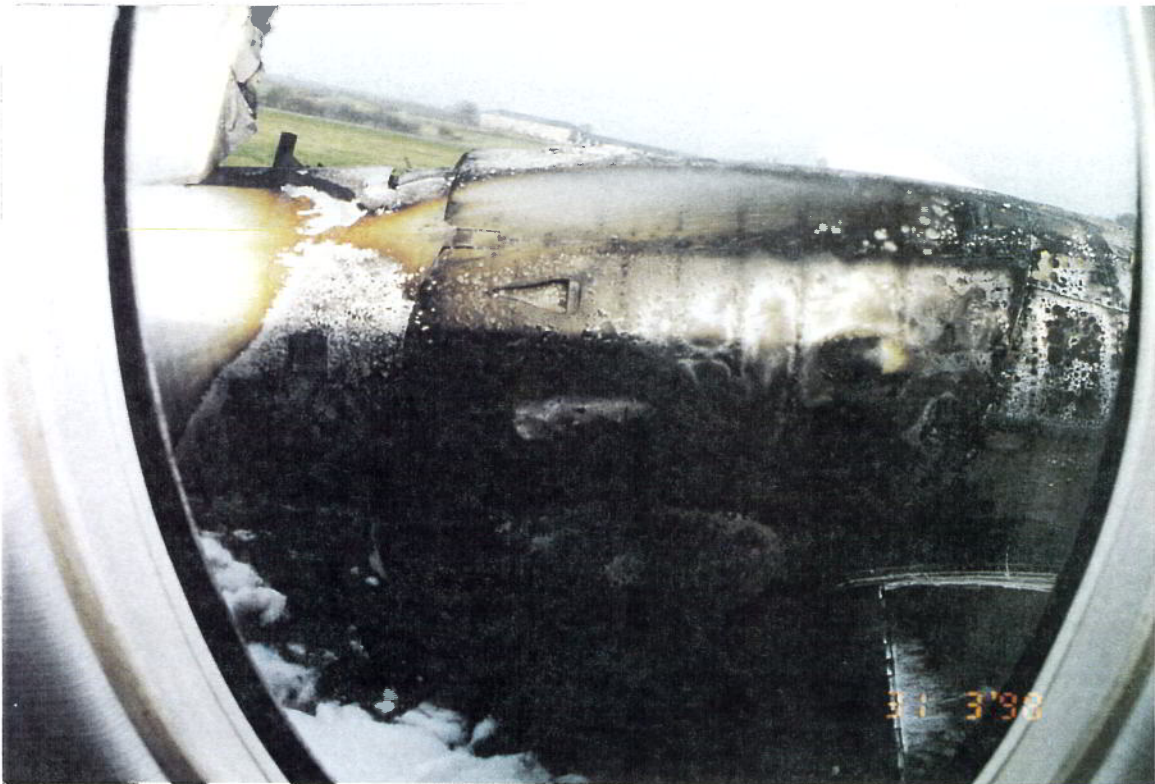
Fig 3

Aircraft damage consisted of severe disruption and fire damage to the No 2 powerplant, detachment of the nose landing gear and localised disruption of the associated fuselage structure and deformation of the forward fuselage undersurface (Figure 3).

The No 2 nacelle cowl panels remained in place but had been holed on the top centreline in the region of the HP turbine and it was clear that this damage had been caused by impact from engine debris. Additionally, most of the cowl panels had been fire damaged, including the lower and aft portions of the engine bay cowls and most parts of the jet pipe and landing gear bay cowls. The fire damage also extended to the wing adjacent to the inboard side of the nacelle, to the inboard wing flap and to the right main landing gear tyres. The damage generally consisted of soot blackening, together with destruction of the paint coating in many areas. It was more extensive and generally more severe on the inboard than the outboard side and on exterior rather than interior surfaces. In some areas the cowl panel material had suffered visible local overtemperature damage, in one case causing loss of material, but the fire damage had not resulted in significant breaching of the cowls. The wing damage consisted of sooting and paint blistering of the external surface of the leading edge fairing, and moderate sooting of parts of the top and bottom exterior surfaces of the wing torque box.

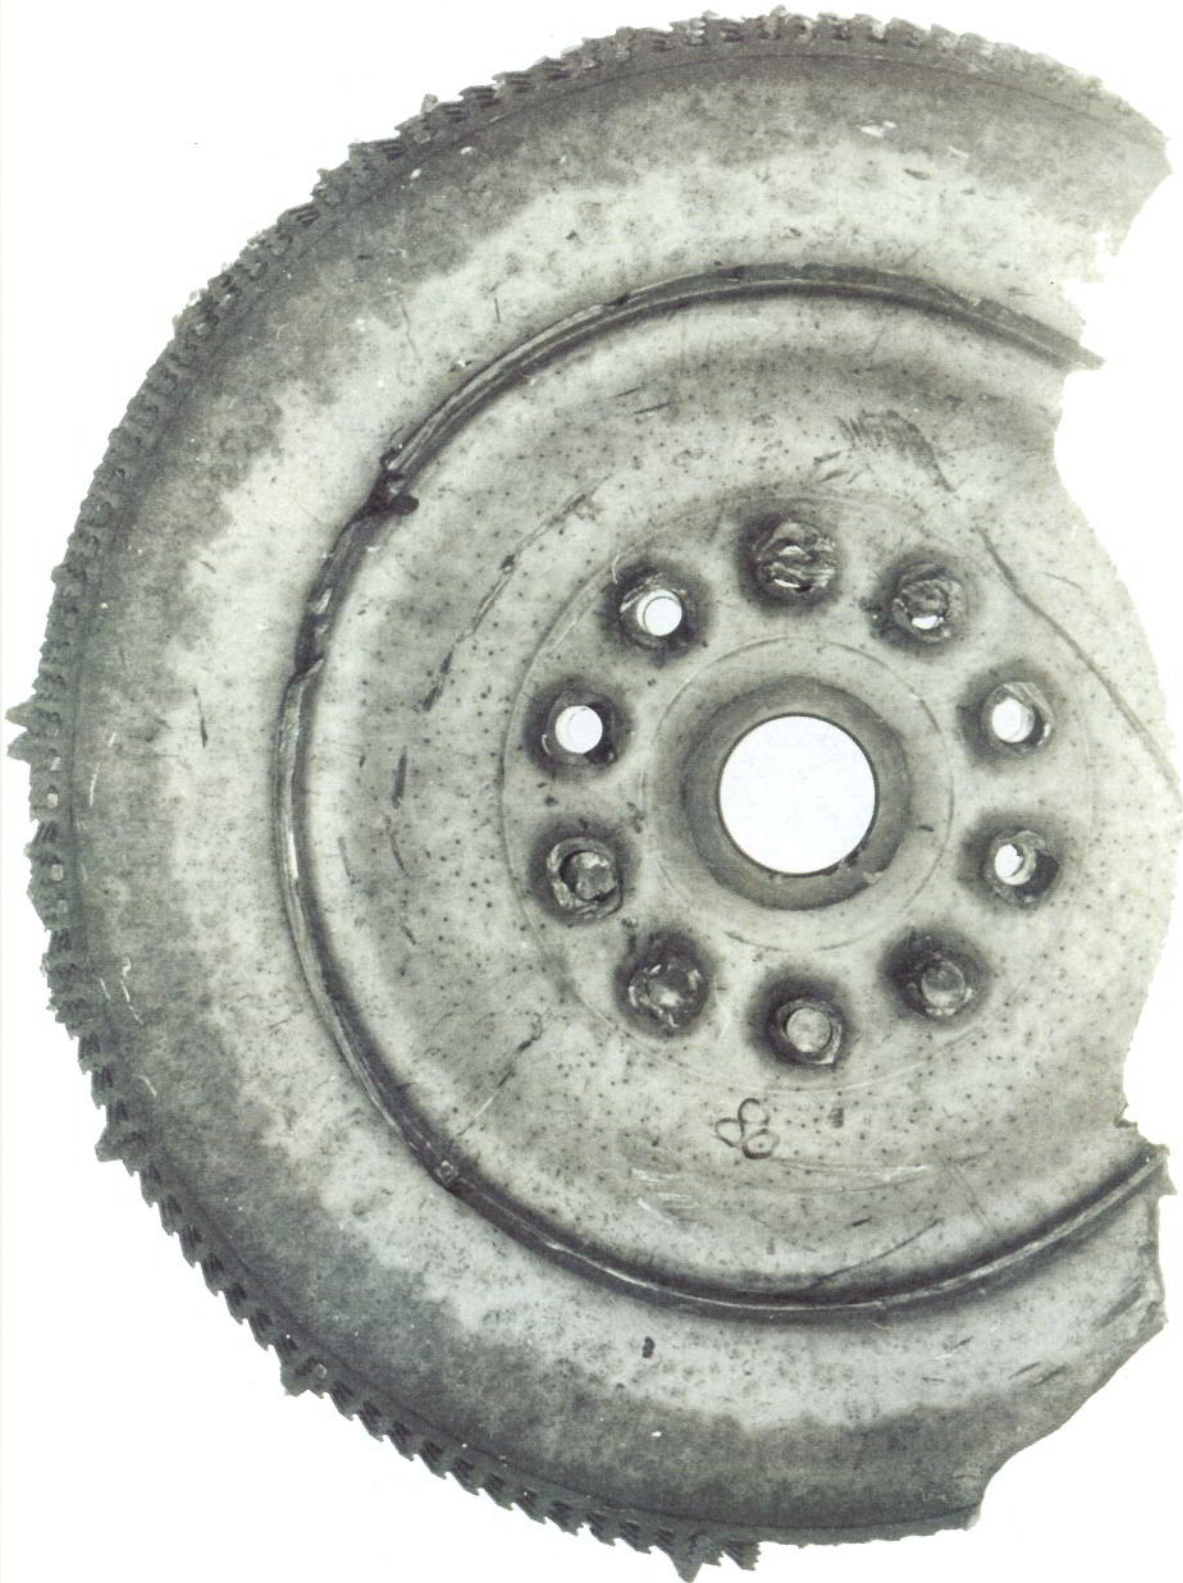
Fig 11

The HP turbine disc (PN RK40726, SN LV450) was recovered from the runway area in two main pieces (Figure 11), together with a few small fragments. The HP turbine blades had all been fractured near to their fir tree attachments. The damage was too severe to allow any estimation of blade platform or shroud gaps, or of seal ring wear and prevented accurate dimensional checking of the disc.

The main disc portions, designated as 'A' and 'B', measured 11.5x3.5 inch and 15.0x11.5 inch overall and weighed 3.5 lb and 17.6 lb respectively. The main part of the disc fracture was circumferential, following the inner radius between the disc aft seal ring and the diaphragm for approximately 40% of the circumference, with an approximately radial fracture at either end.

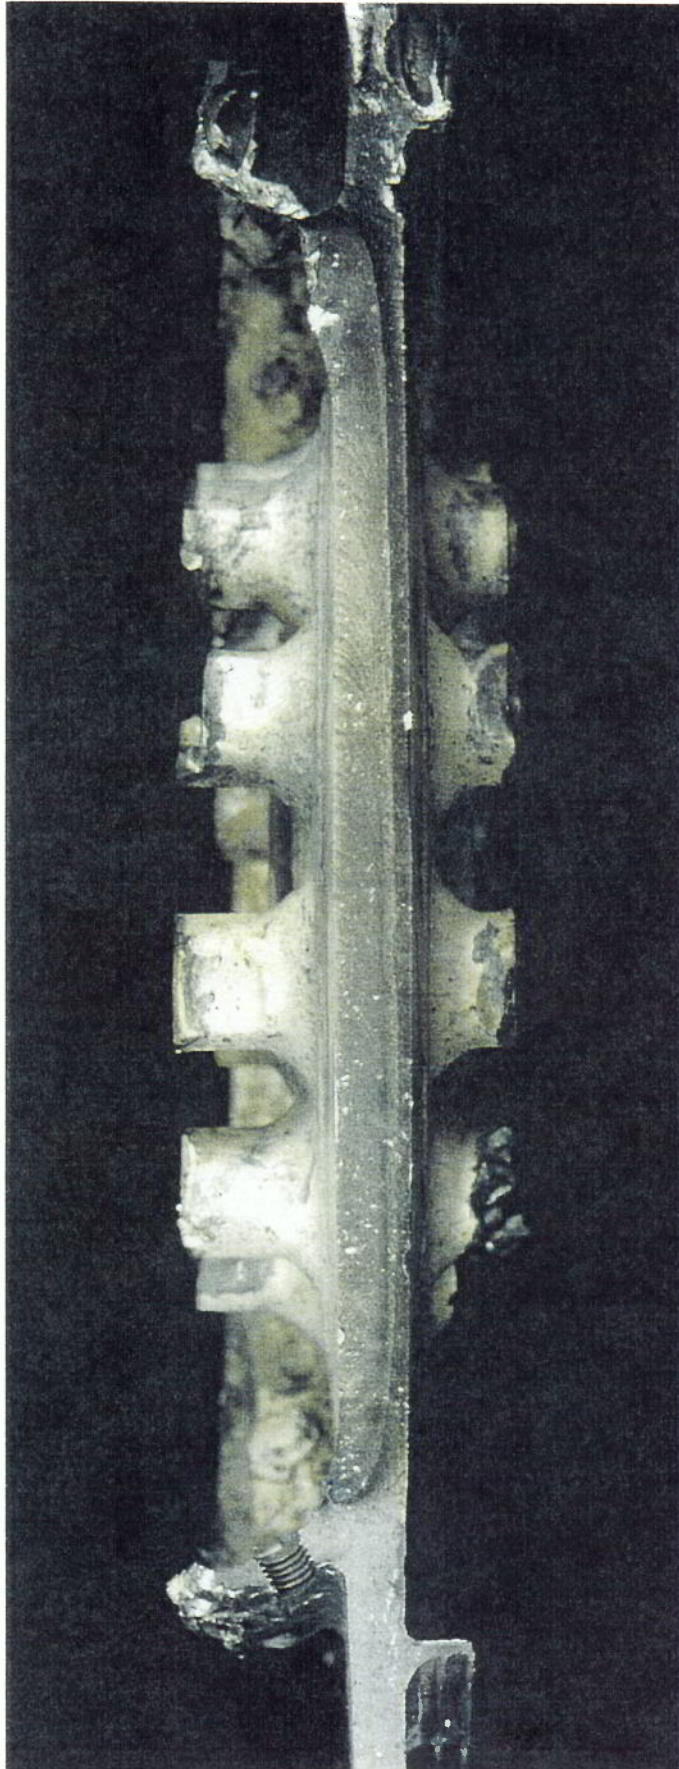
Fig 12

The face of the circumferential fracture was generally flat, and banded with a series of light-coloured conchoidal markings (Figure 12). The fracture face on Piece A

had suffered appreciable impact damage; that on Piece B was little damaged by impact but the features had been degraded by oxidation to a significant extent.

The fatigue fracture surface exhibited approximately 150 lighter coloured narrow bands, with darker regions between. It was concluded that each light region was an arrest band that represented a divider between separate periods of vibration that had been sufficient to cause crack growth in HCF during the propagation stage. It was not possible to correlate the arrest bands to flight cycles. Some indistinct striation features were evident in the HCF areas between the bands, with striation densities in the order of 20,000/mm. The available detail was insufficient to allow an accurate striation count over the fracture surface. The best estimate of the number of HCF load reversal cycles involved in the propagation of the crack was in the order of 1-5 million.
