**PRELIMINARY GEOTECHNICAL EVALUATION
REHABILITATION OF THE
EAST ALISO CREEK EMERGENCY SEWER (REACES)
MOULTON NIGUEL WATER DISTRICT
LAGUNA NIGUEL, CALIFORNIA
MNWD JOB #2002059**

May 9, 2003
Project No. 202426002

Subject: Geotechnical Evaluation
Rehabilitation of the East Aliso Creek Emergency Sewer
Moulton Niguel Water District
Laguna Niguel, California
MNWD Job # 2002059

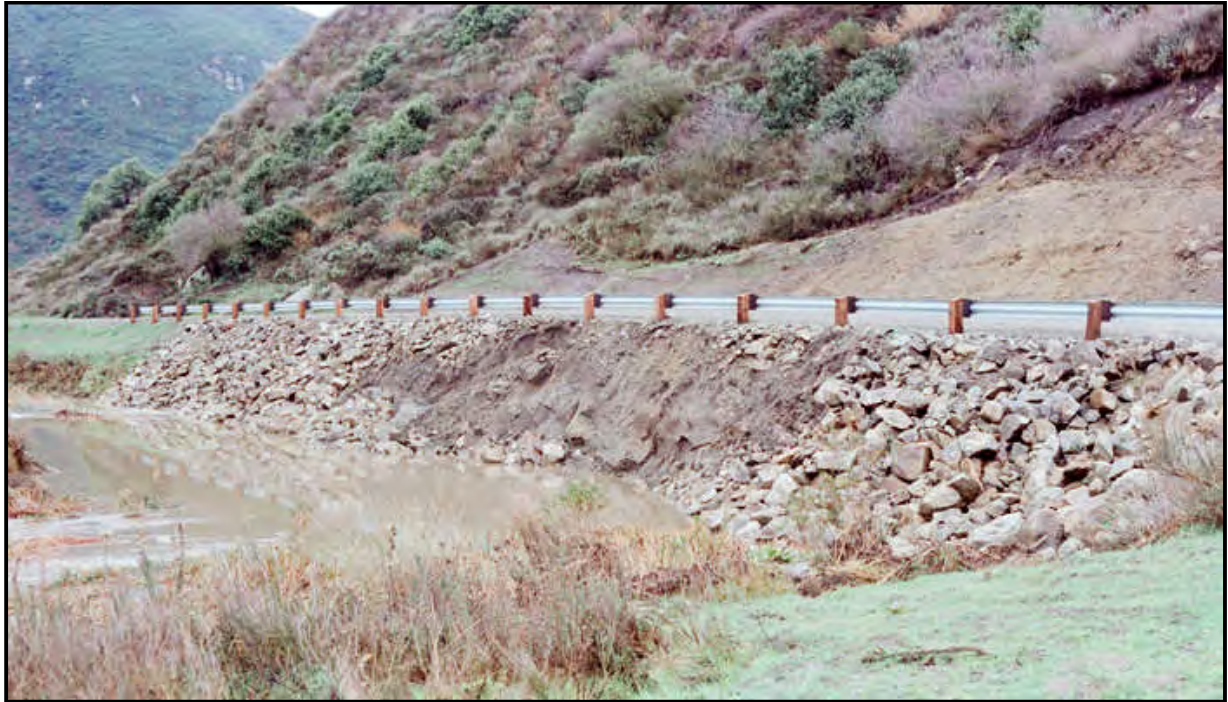
Figure 1-3. East (left) Bank Erosion along Aliso Creek Showing Undermined MNWD Pipeline (photo courtesy of SOCWA, appears to be near RM 1.60)

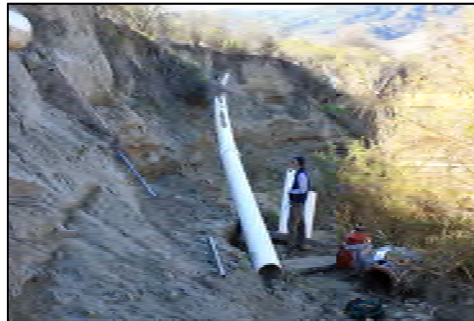
21
Leakage along Abandoned Pipe,
Slumping, Impingement

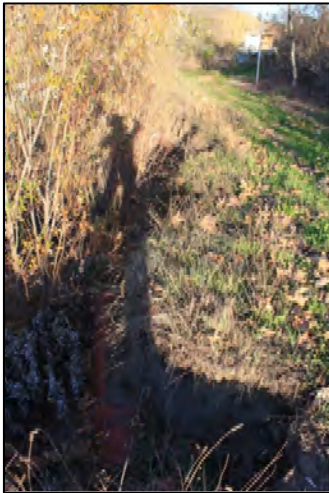
16
VCP Exposed, Slumping
(looking u/s) Slumping due to pipe leakage or geotechnical instability; exposed sewer line.

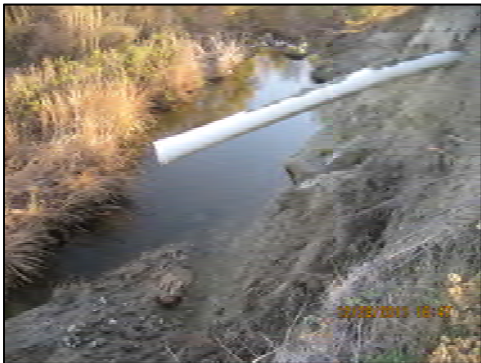
15
Flow Impingement, Slumping
(looking d/s) Direct impingement of flood flows; slumped material at toe.

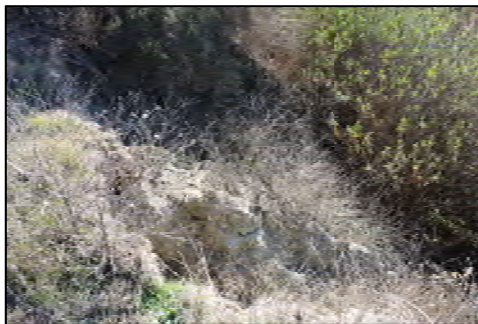
7
Impingement & Concentrated Runoff

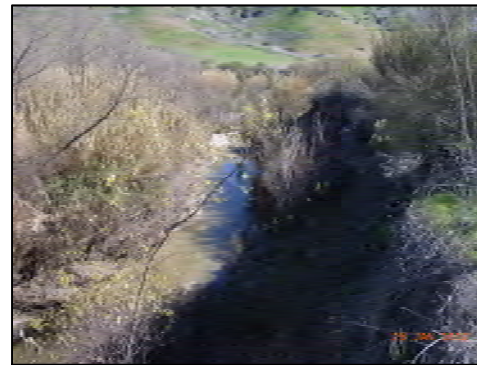
6
Upper Bank Geotechnical Instability

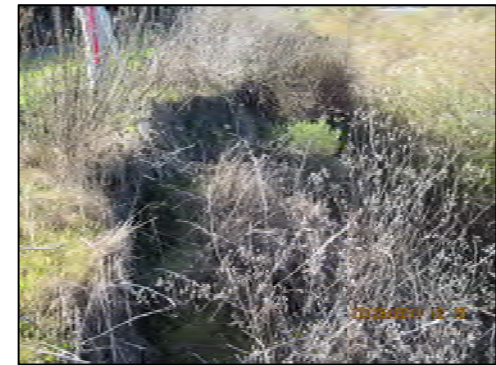
5
Slumping

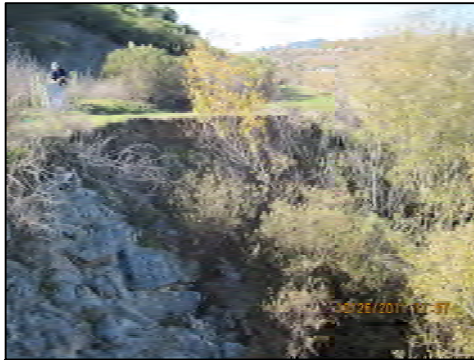
4
Local Scour

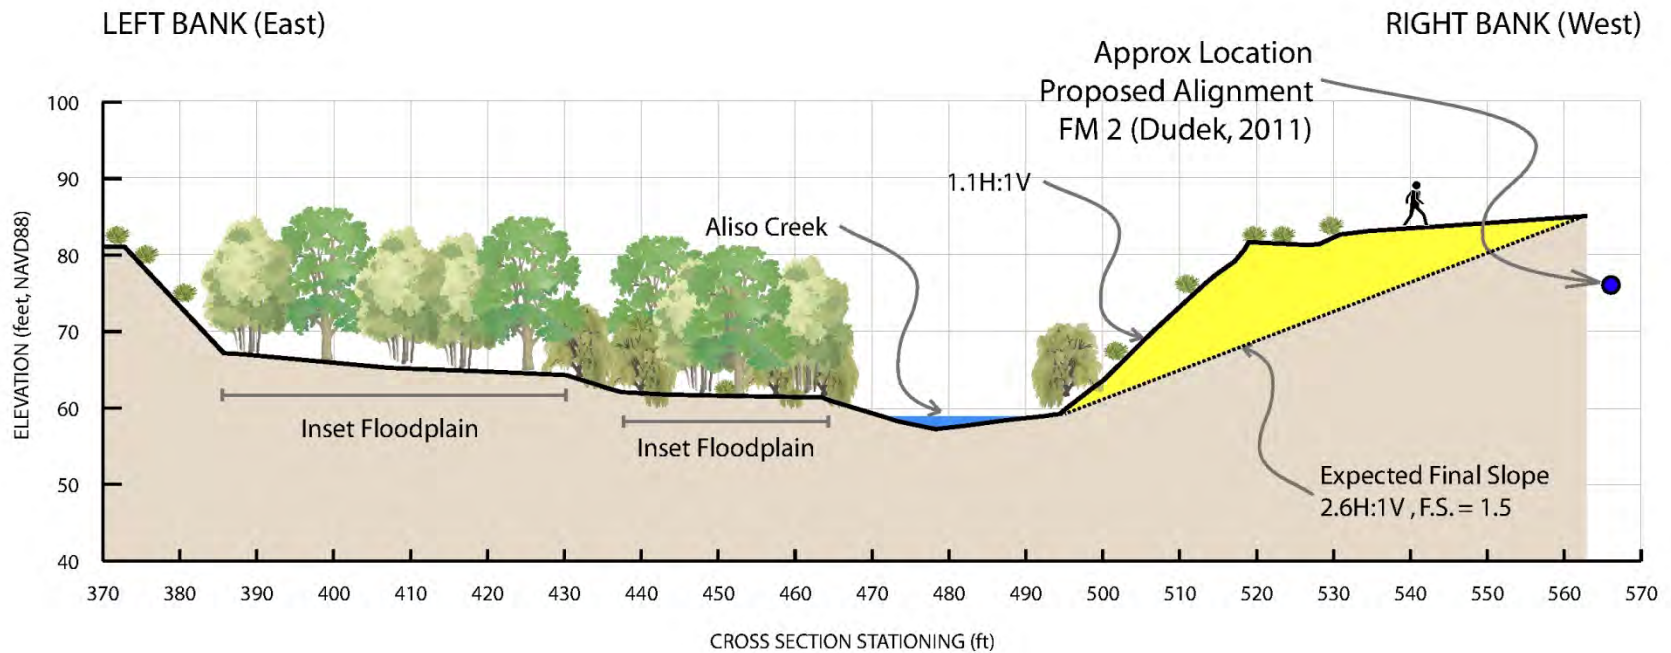
Figure B-5: Bank Instability due to Flow Impingement and Potential Bend Migration

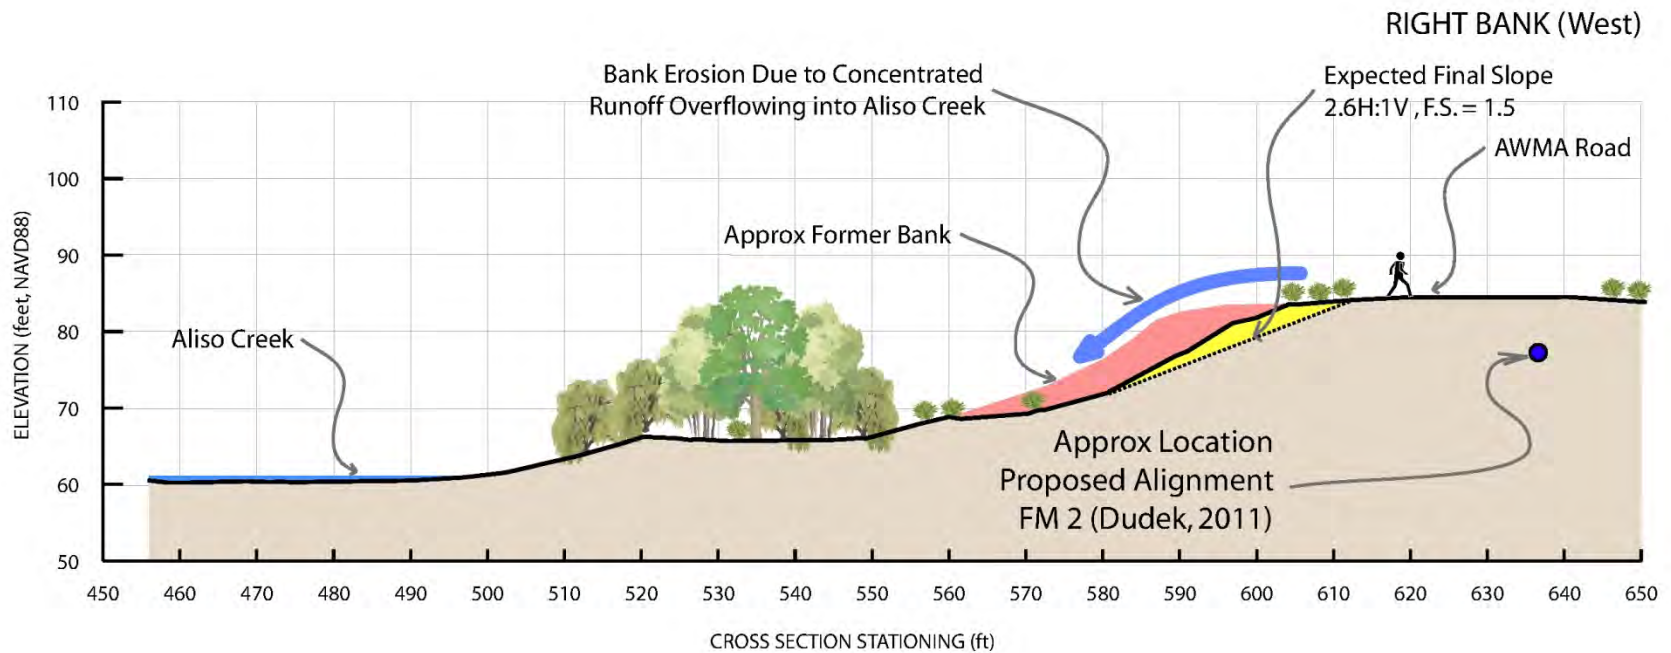
Figure B-6: Bank Erosion due to Concentrated Runoff along AMWA Road

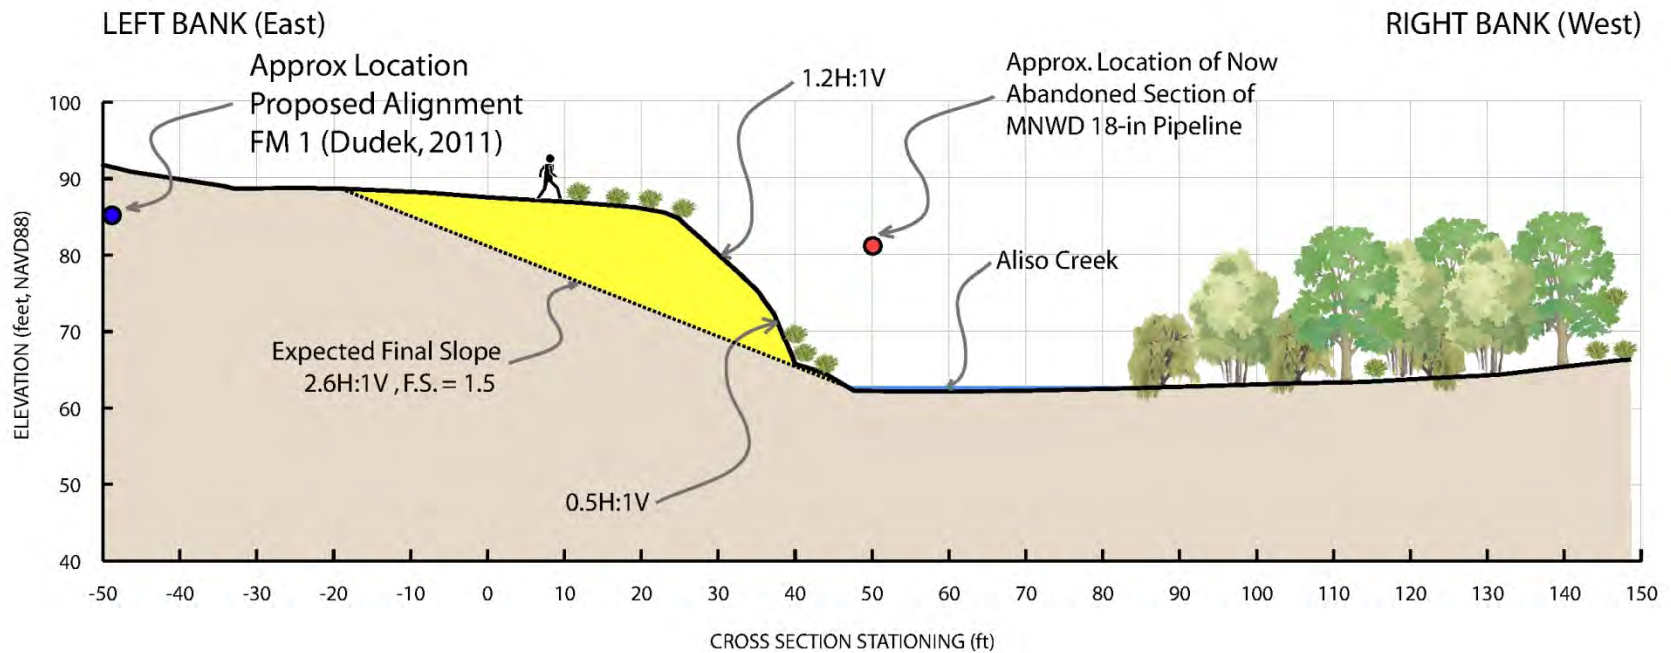
Figure B-7: Existing Exposure of East (Left) Bank Infrastructure

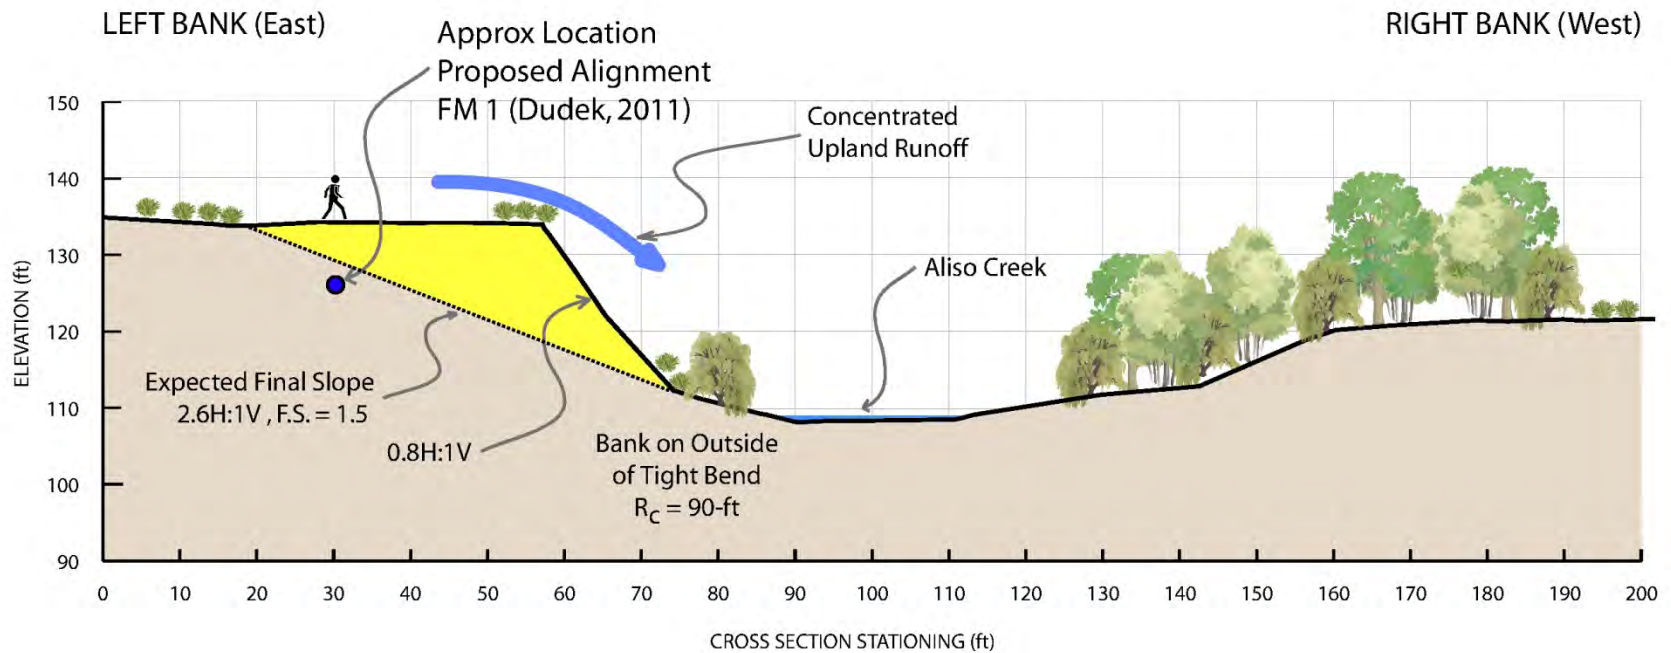
Figure B-8: Bank Erosion Exacerbated by Concentrated Upland Runoff
