South Orange County Wastewater Authority

Lower Aliso Creek Erosion Assessment

County of Orange, California

April 2012

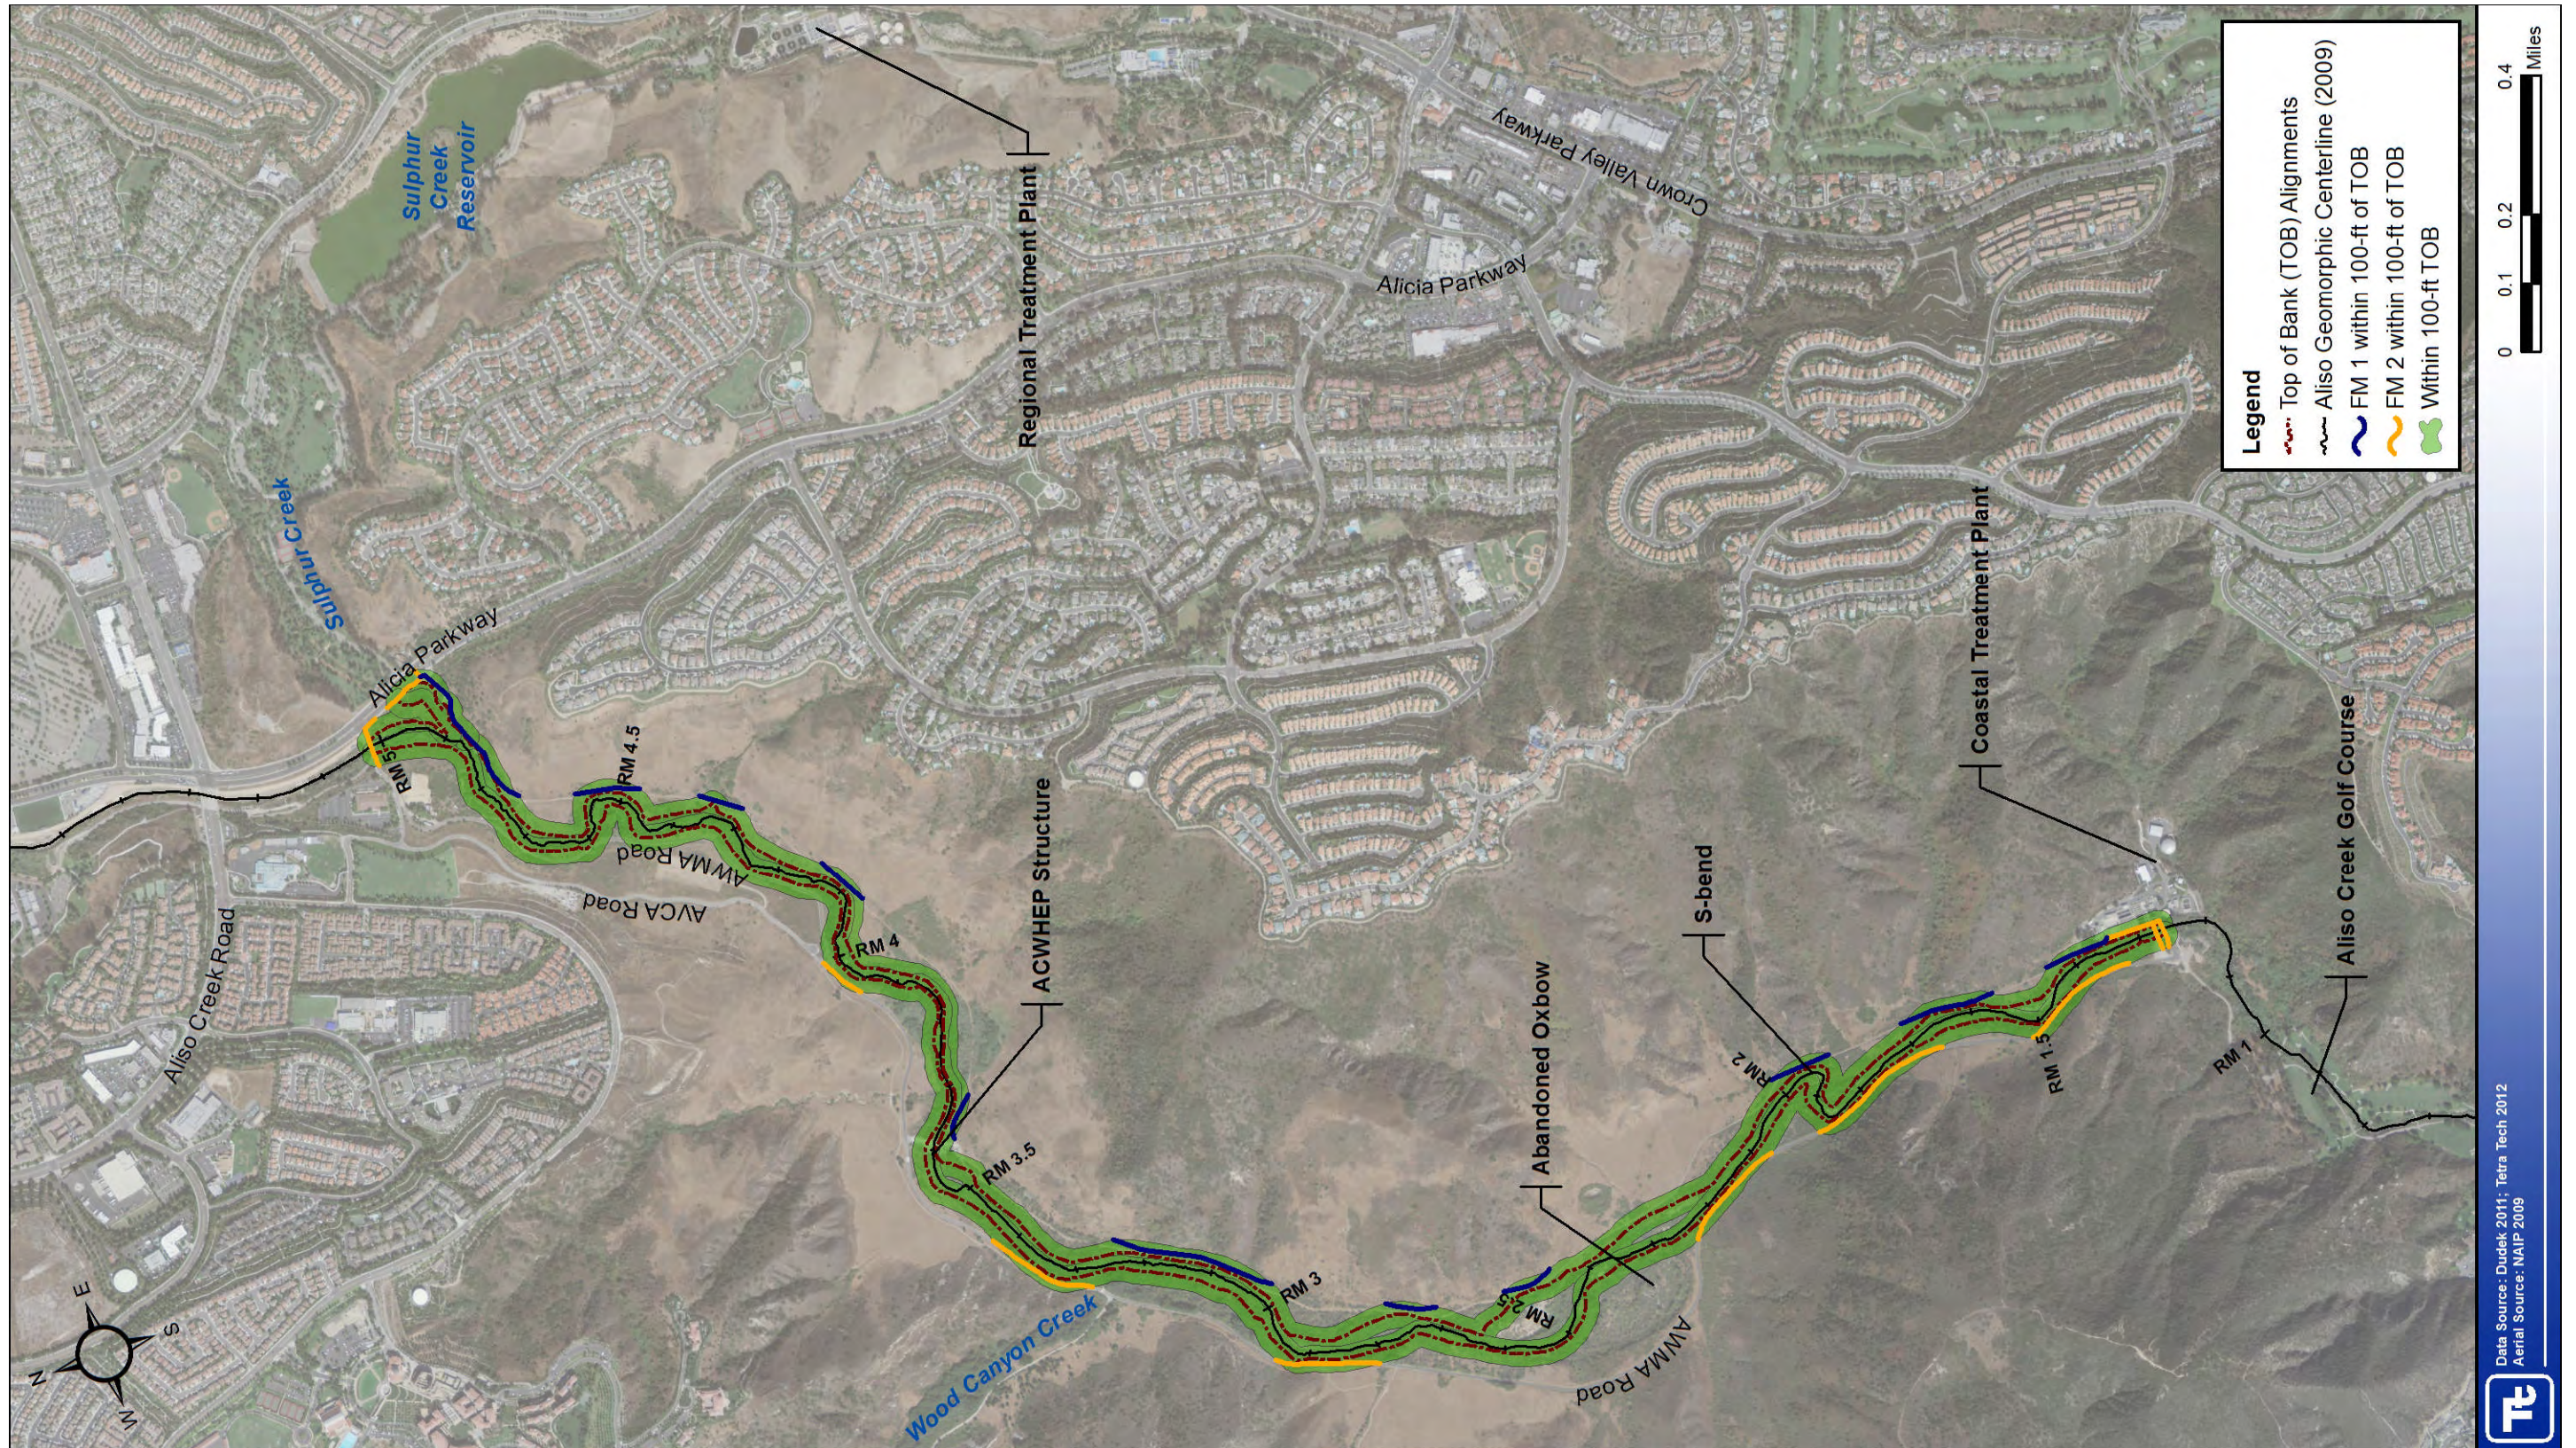
Figure 3-8. Screening of Proposed Pipeline Alignments for Areas Potentially Impacted by Geotechnically Unstable Banks

Despite the frequent observations made during the field reconnaissance of geotechnically unstable banks, the proposed pipeline alignments are generally landward of the stable bank angles (F.S. = 1.5) including the recommended setback distance of one-third the slope height. The geotechnical erosion risk is rated *Low* along both proposed alignments except for a single reach along the east (left) bank (FM 1 pipeline alignment) from approximately RM 4.49 to RM 4.55 that is rated *Moderate*.

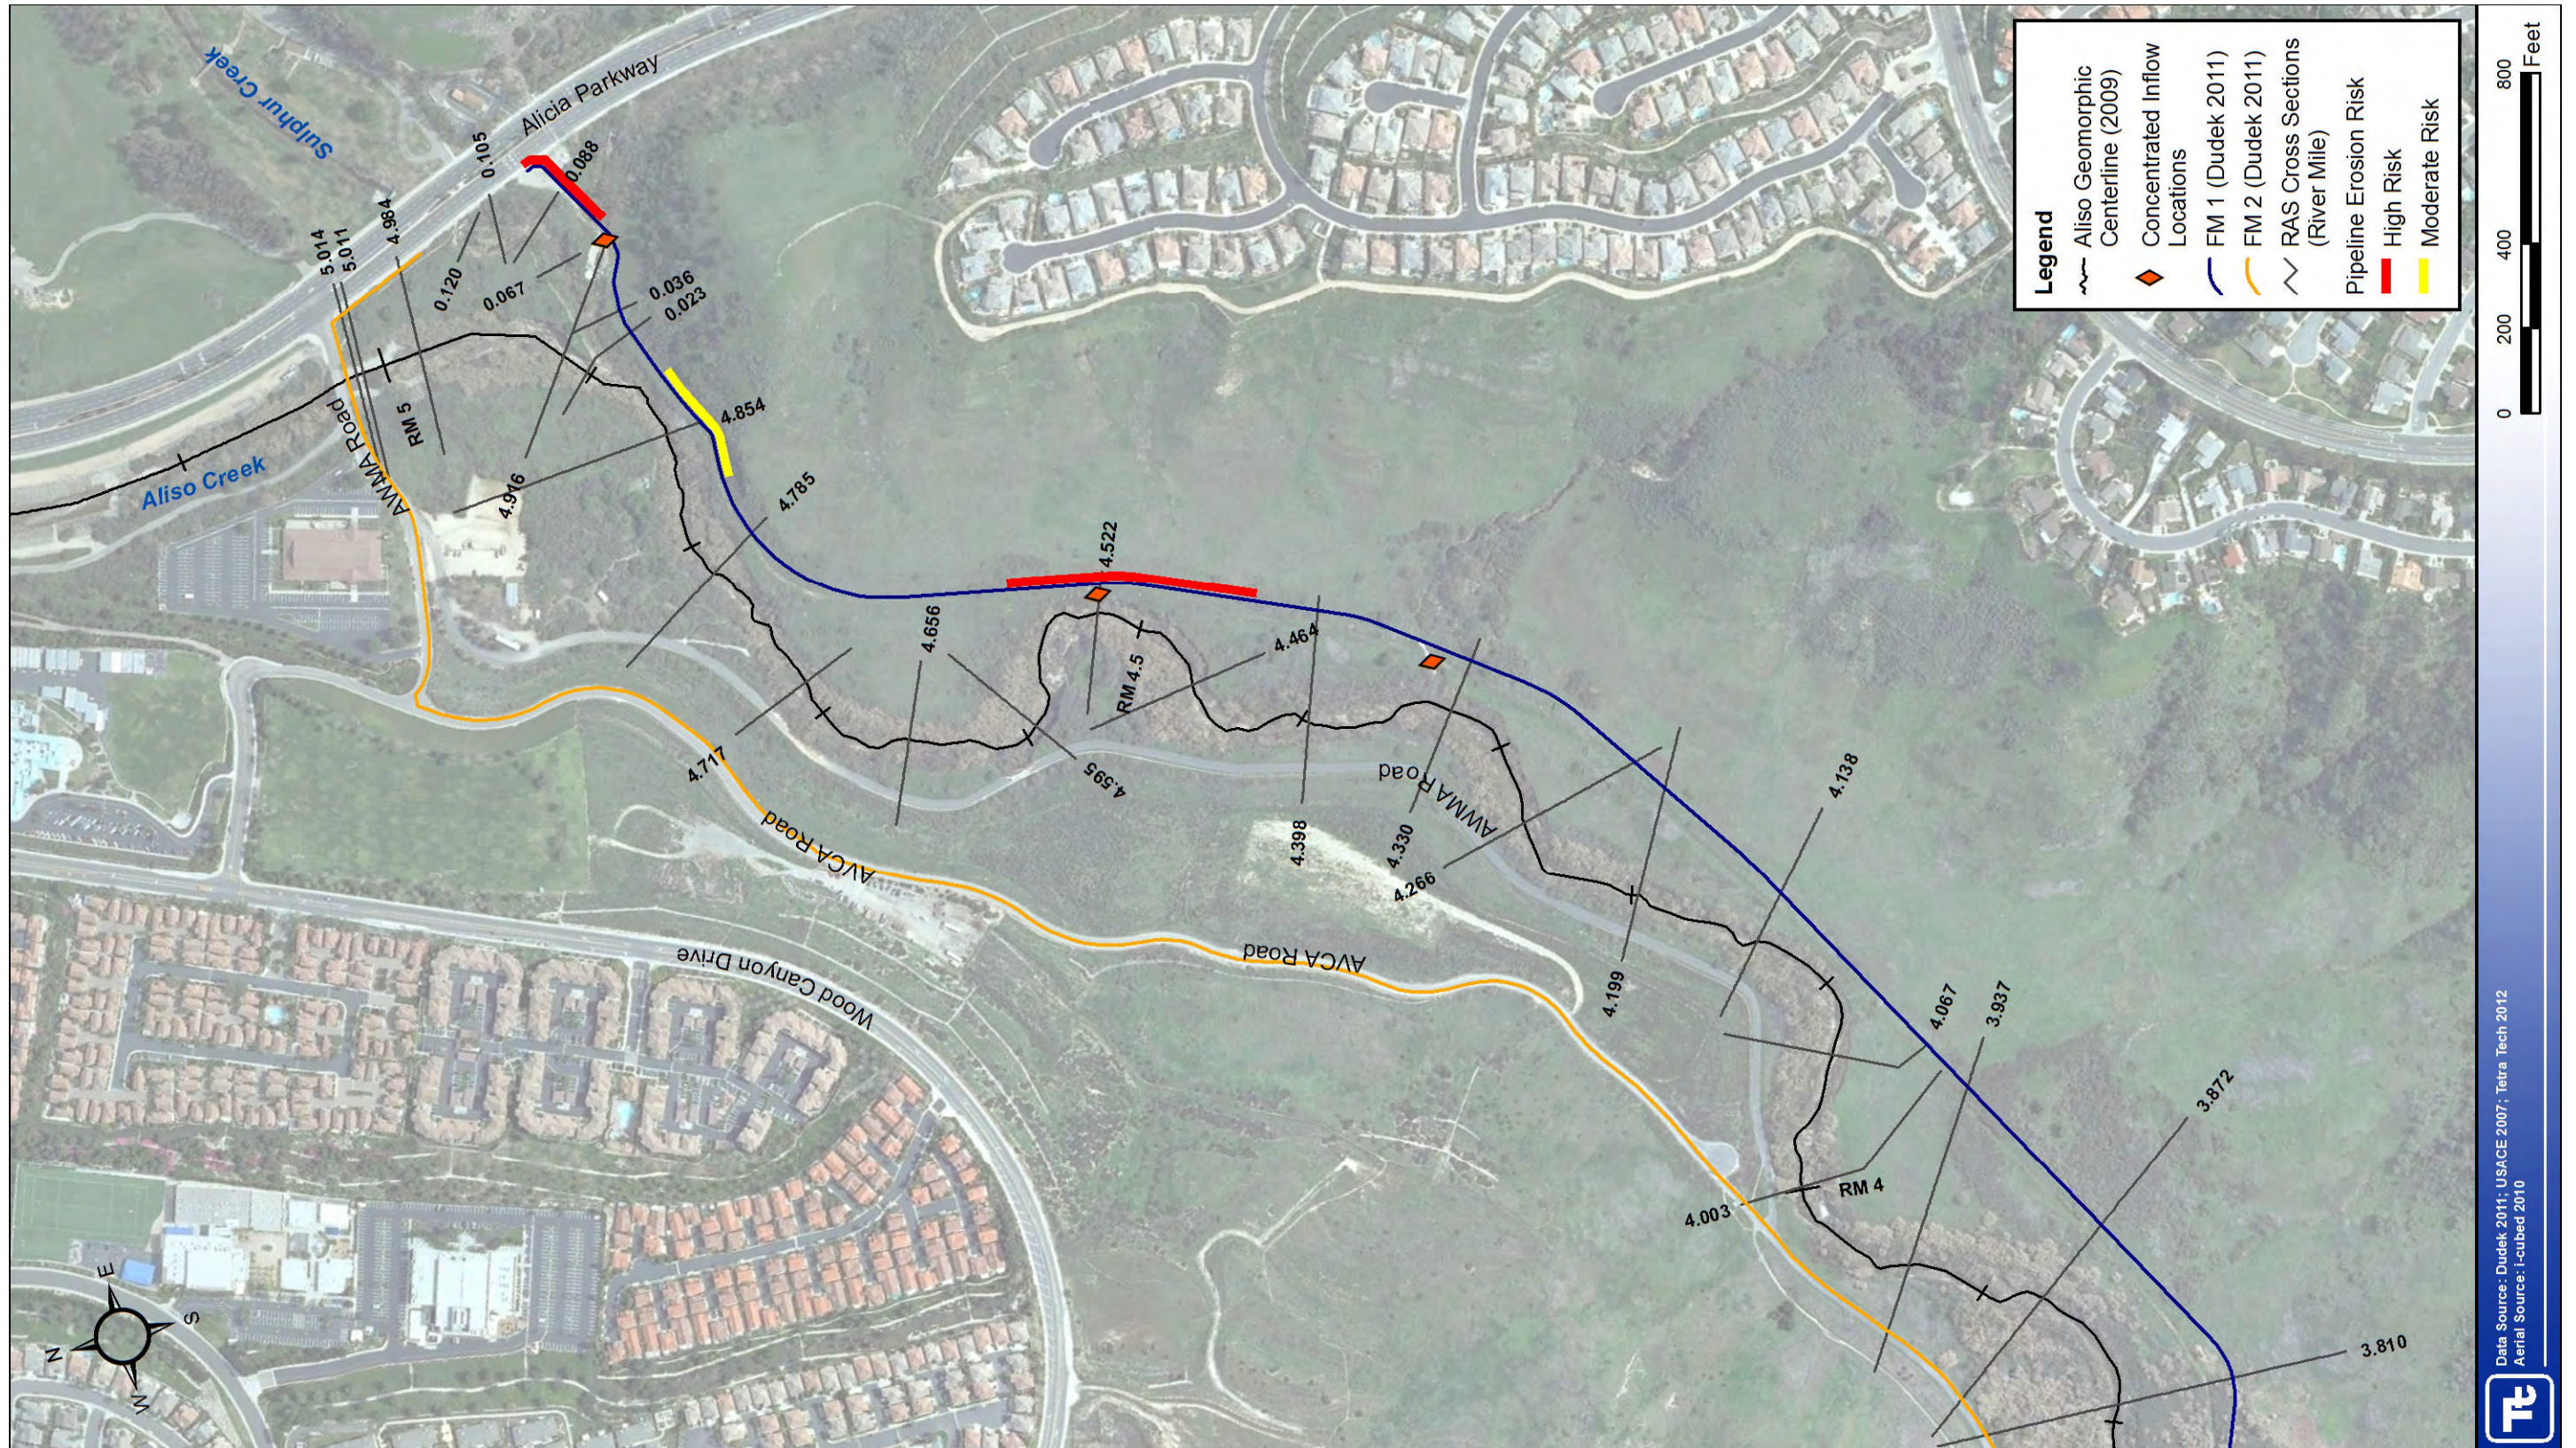
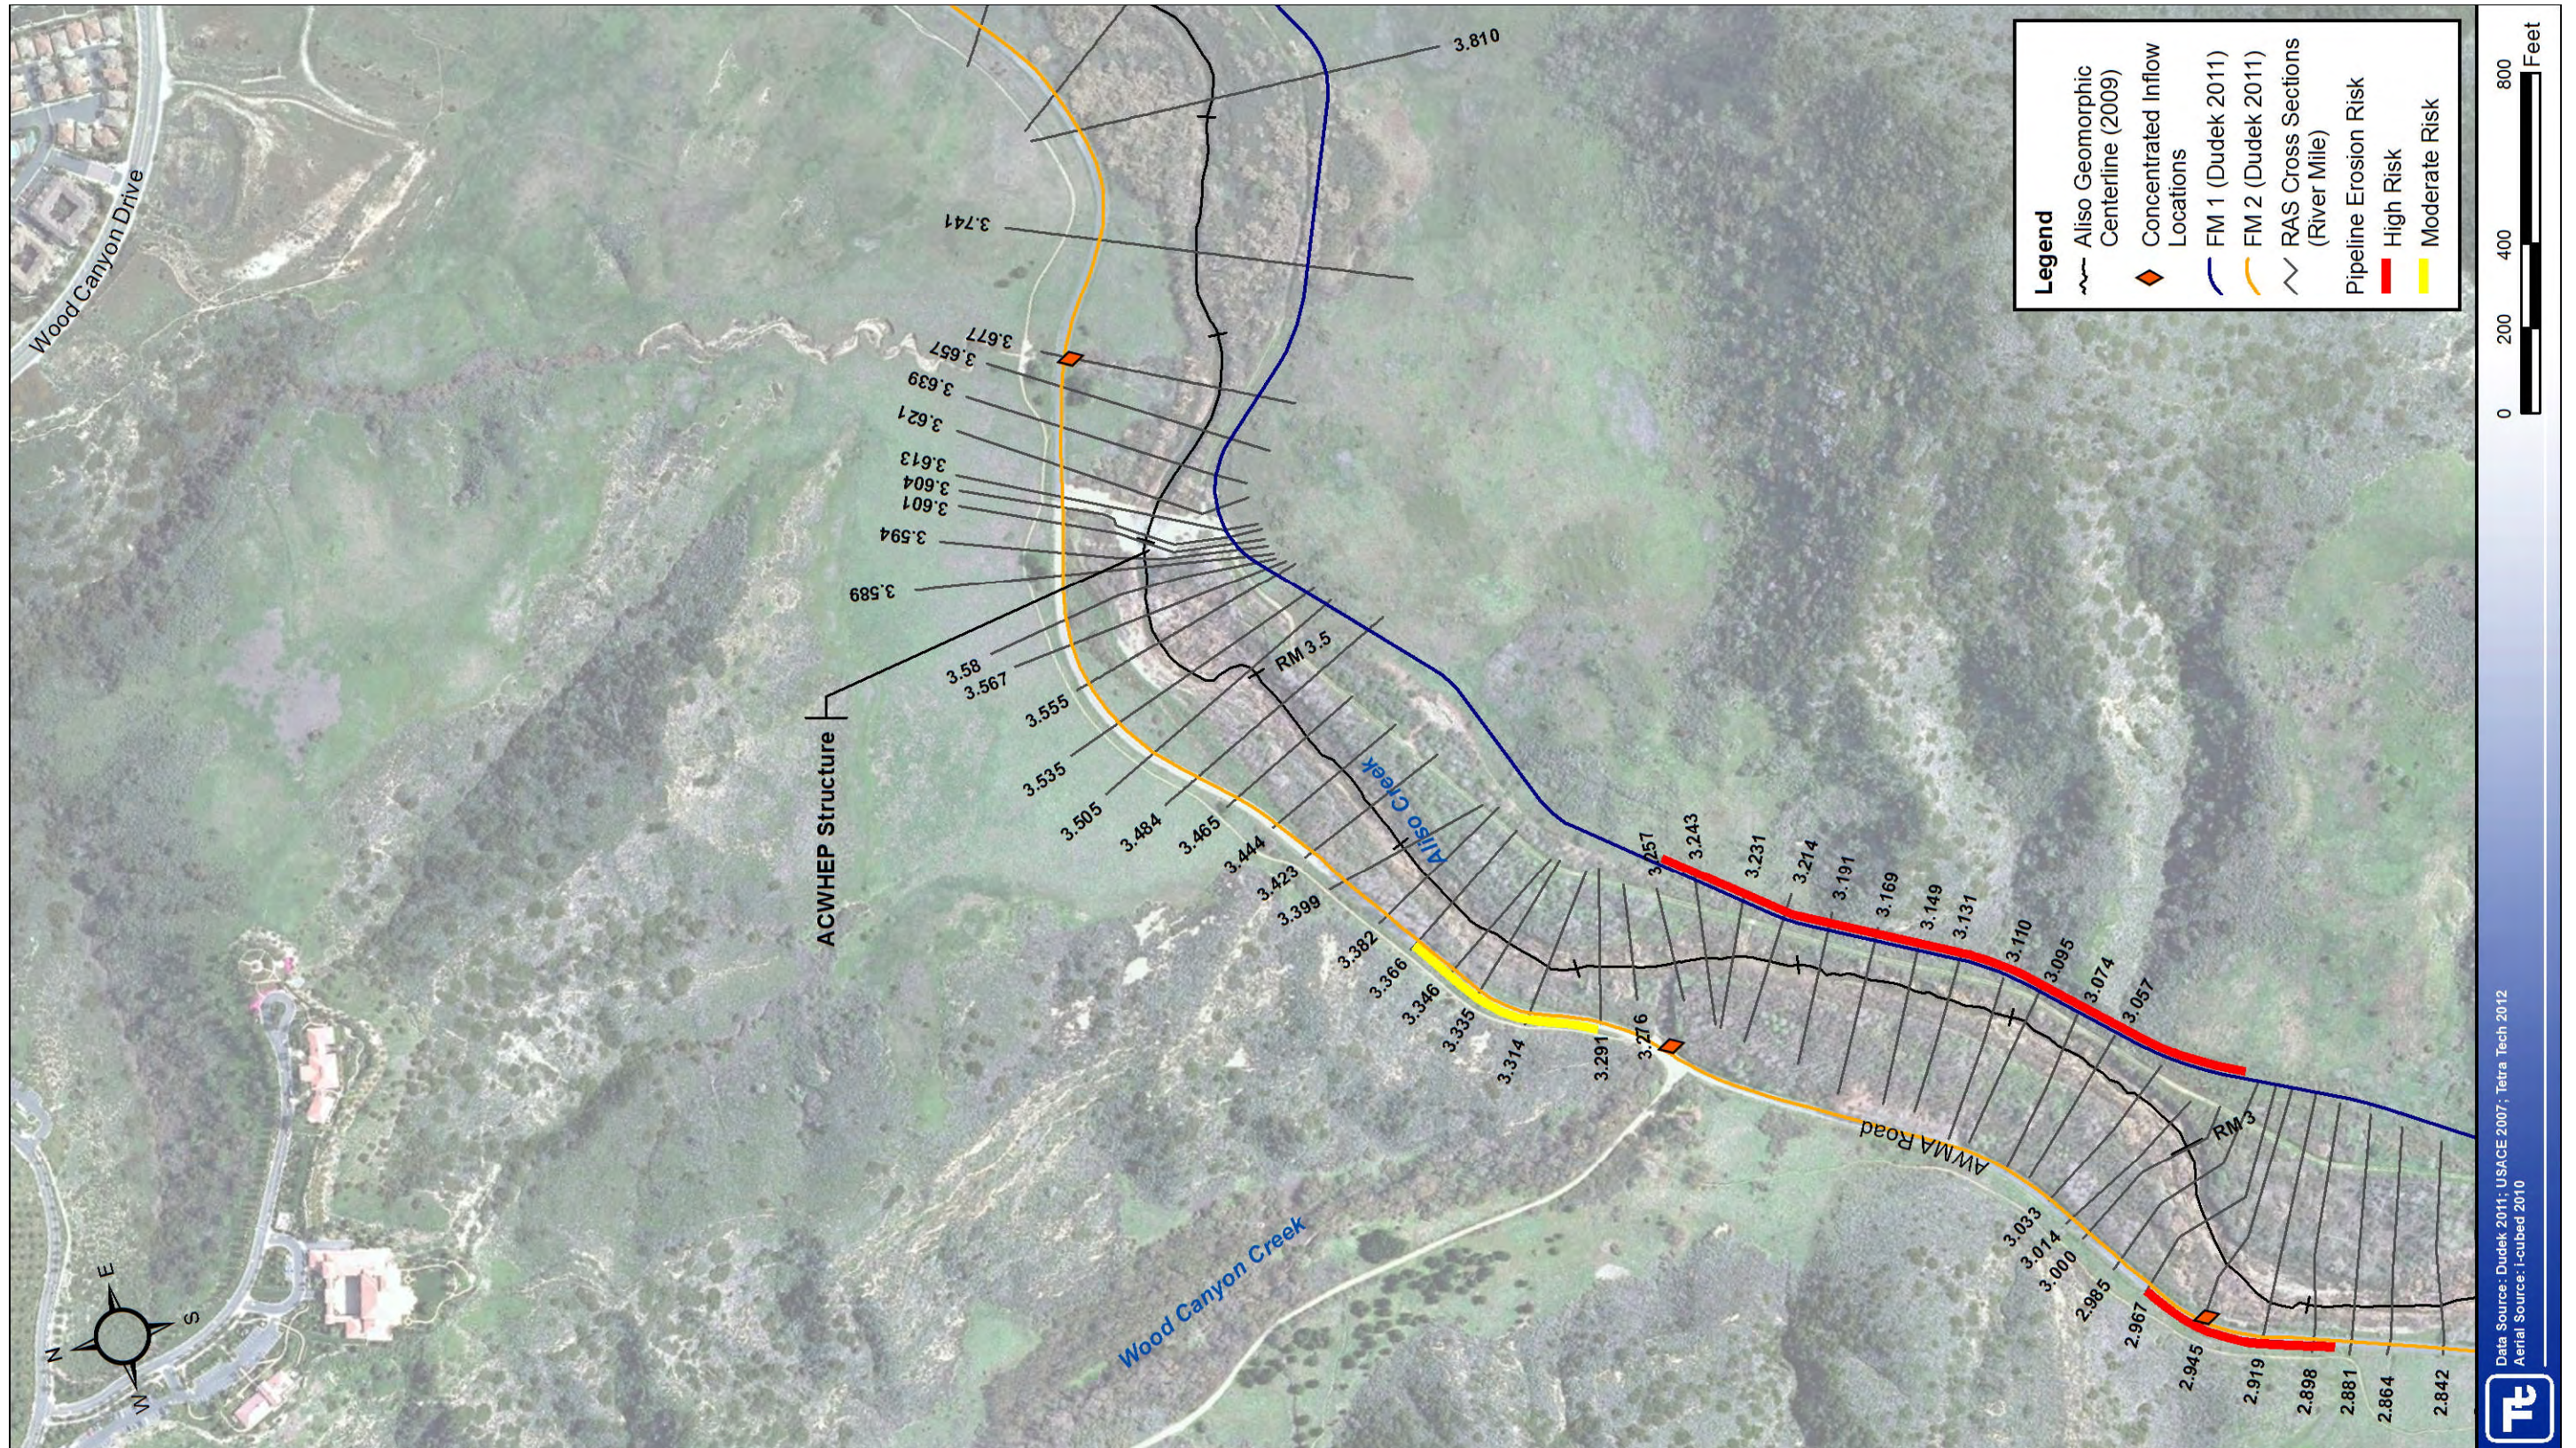
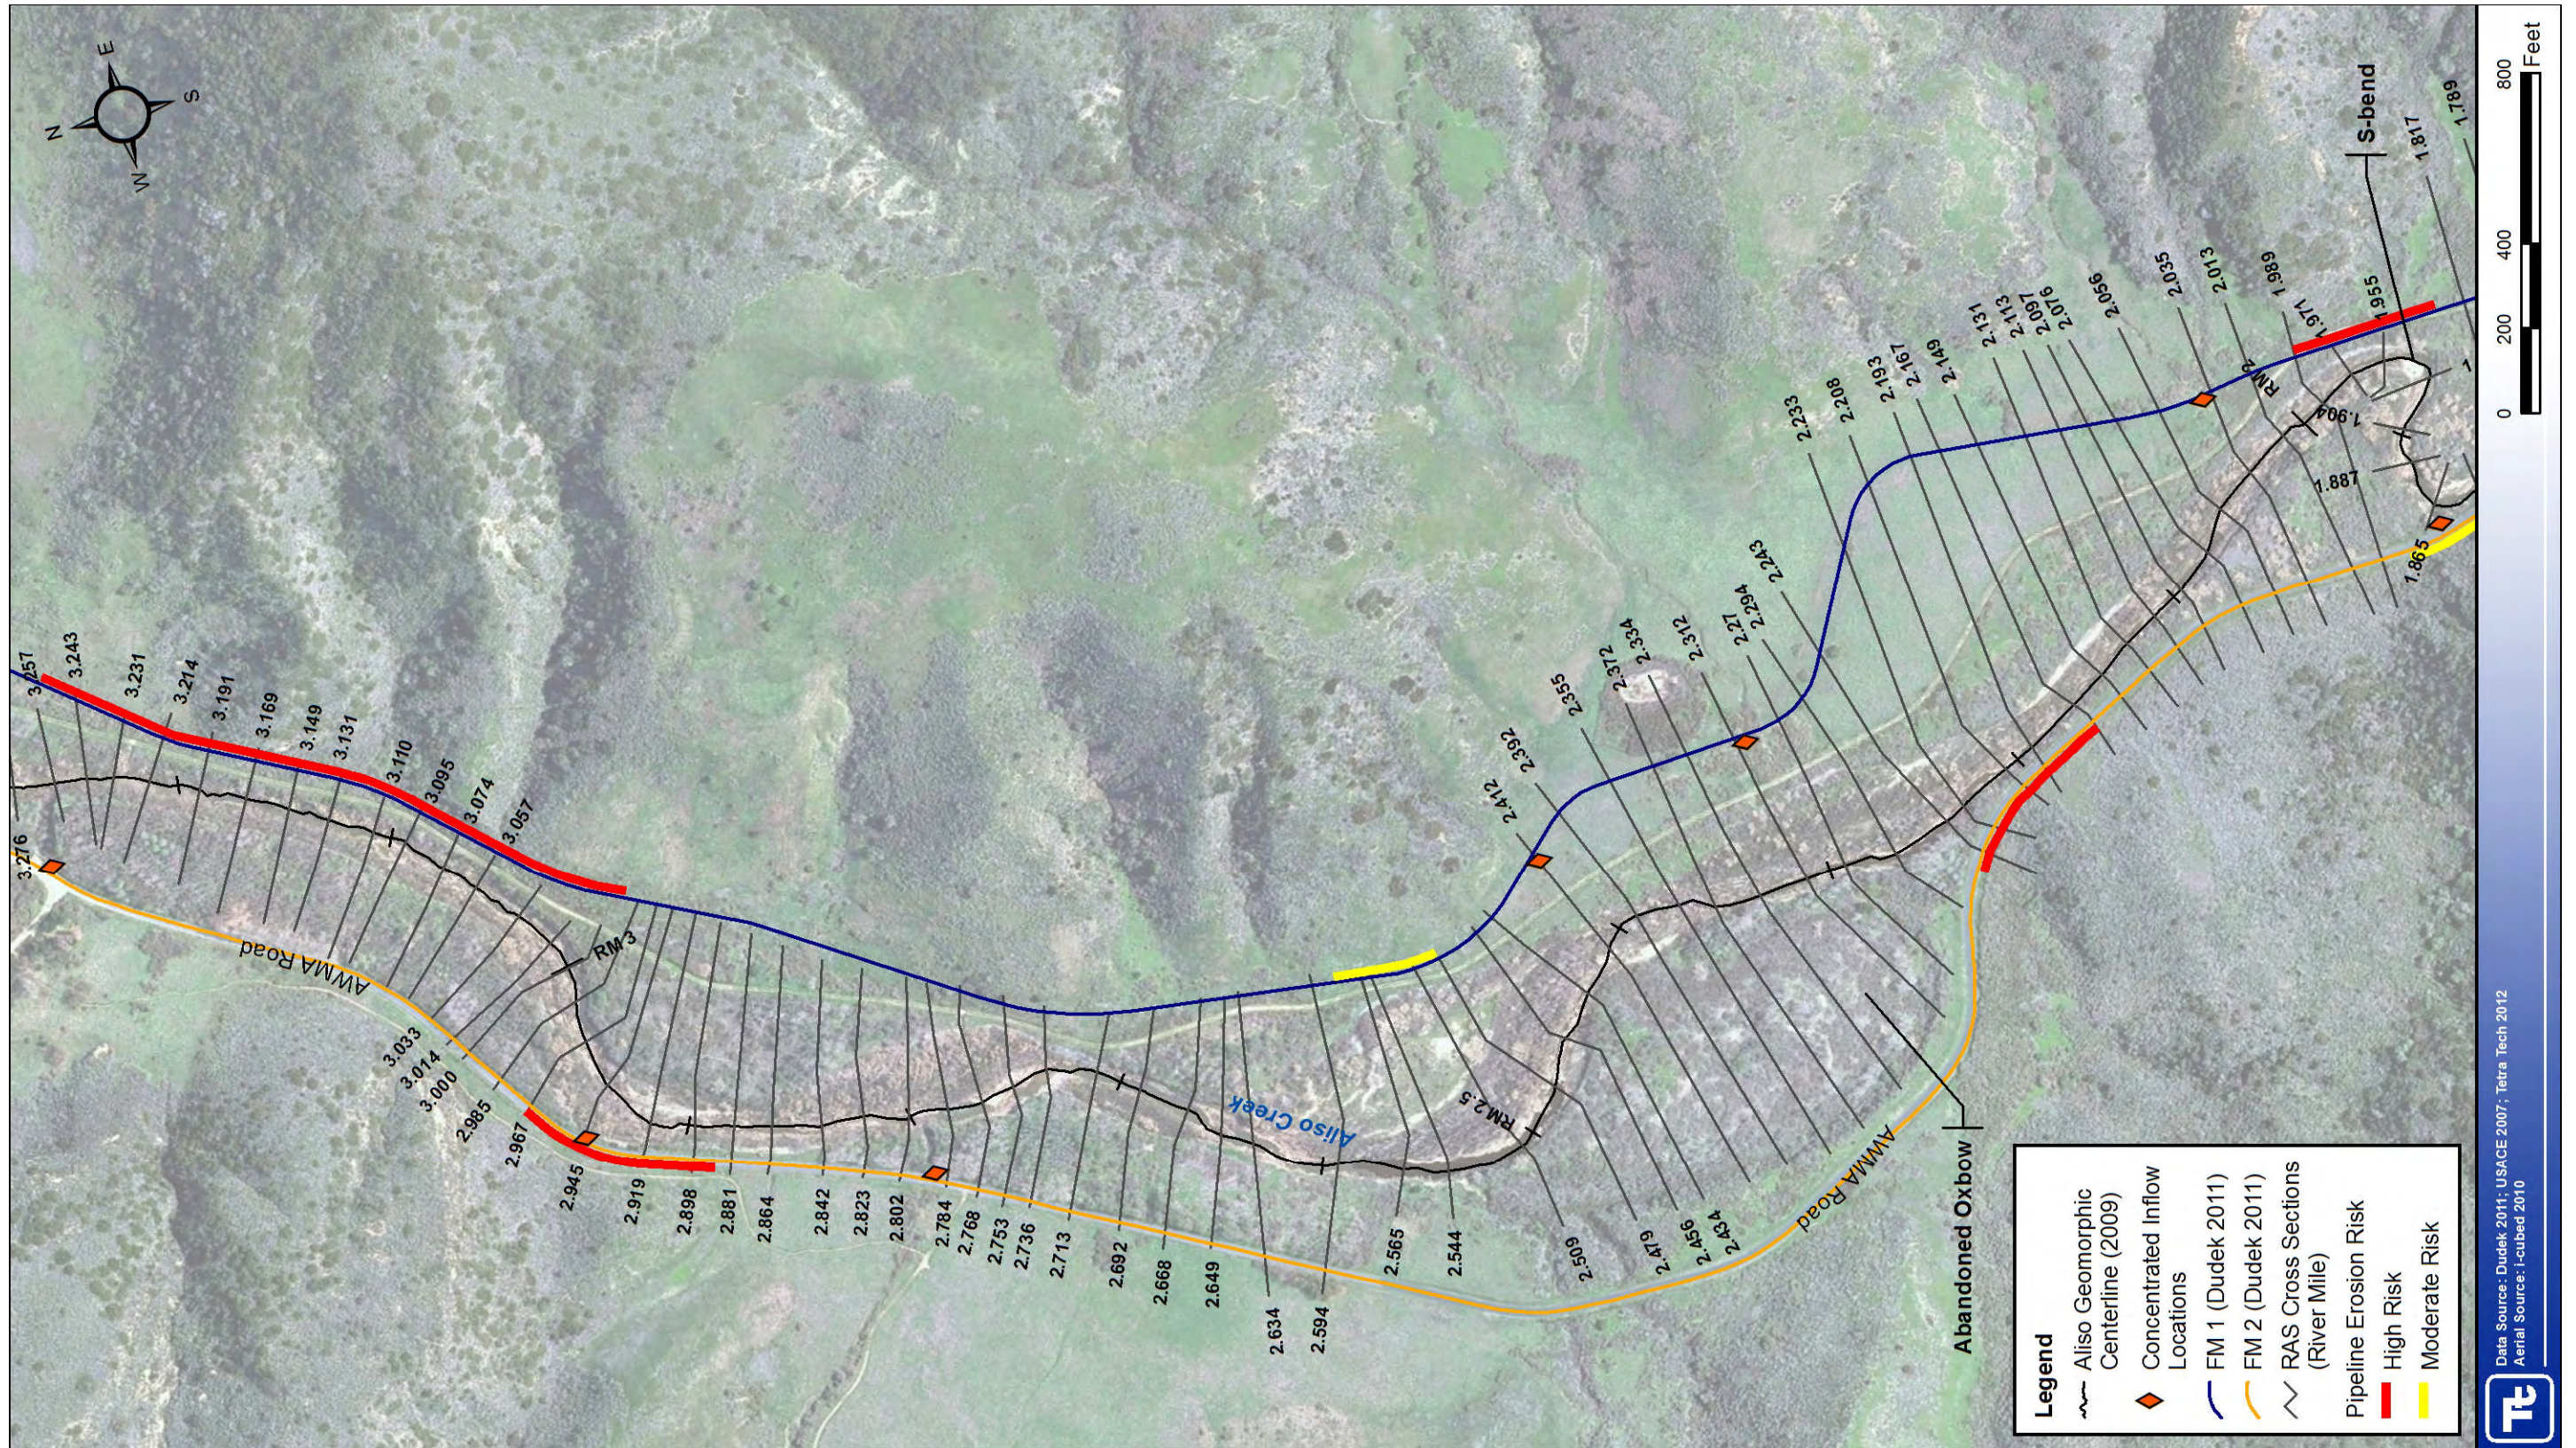
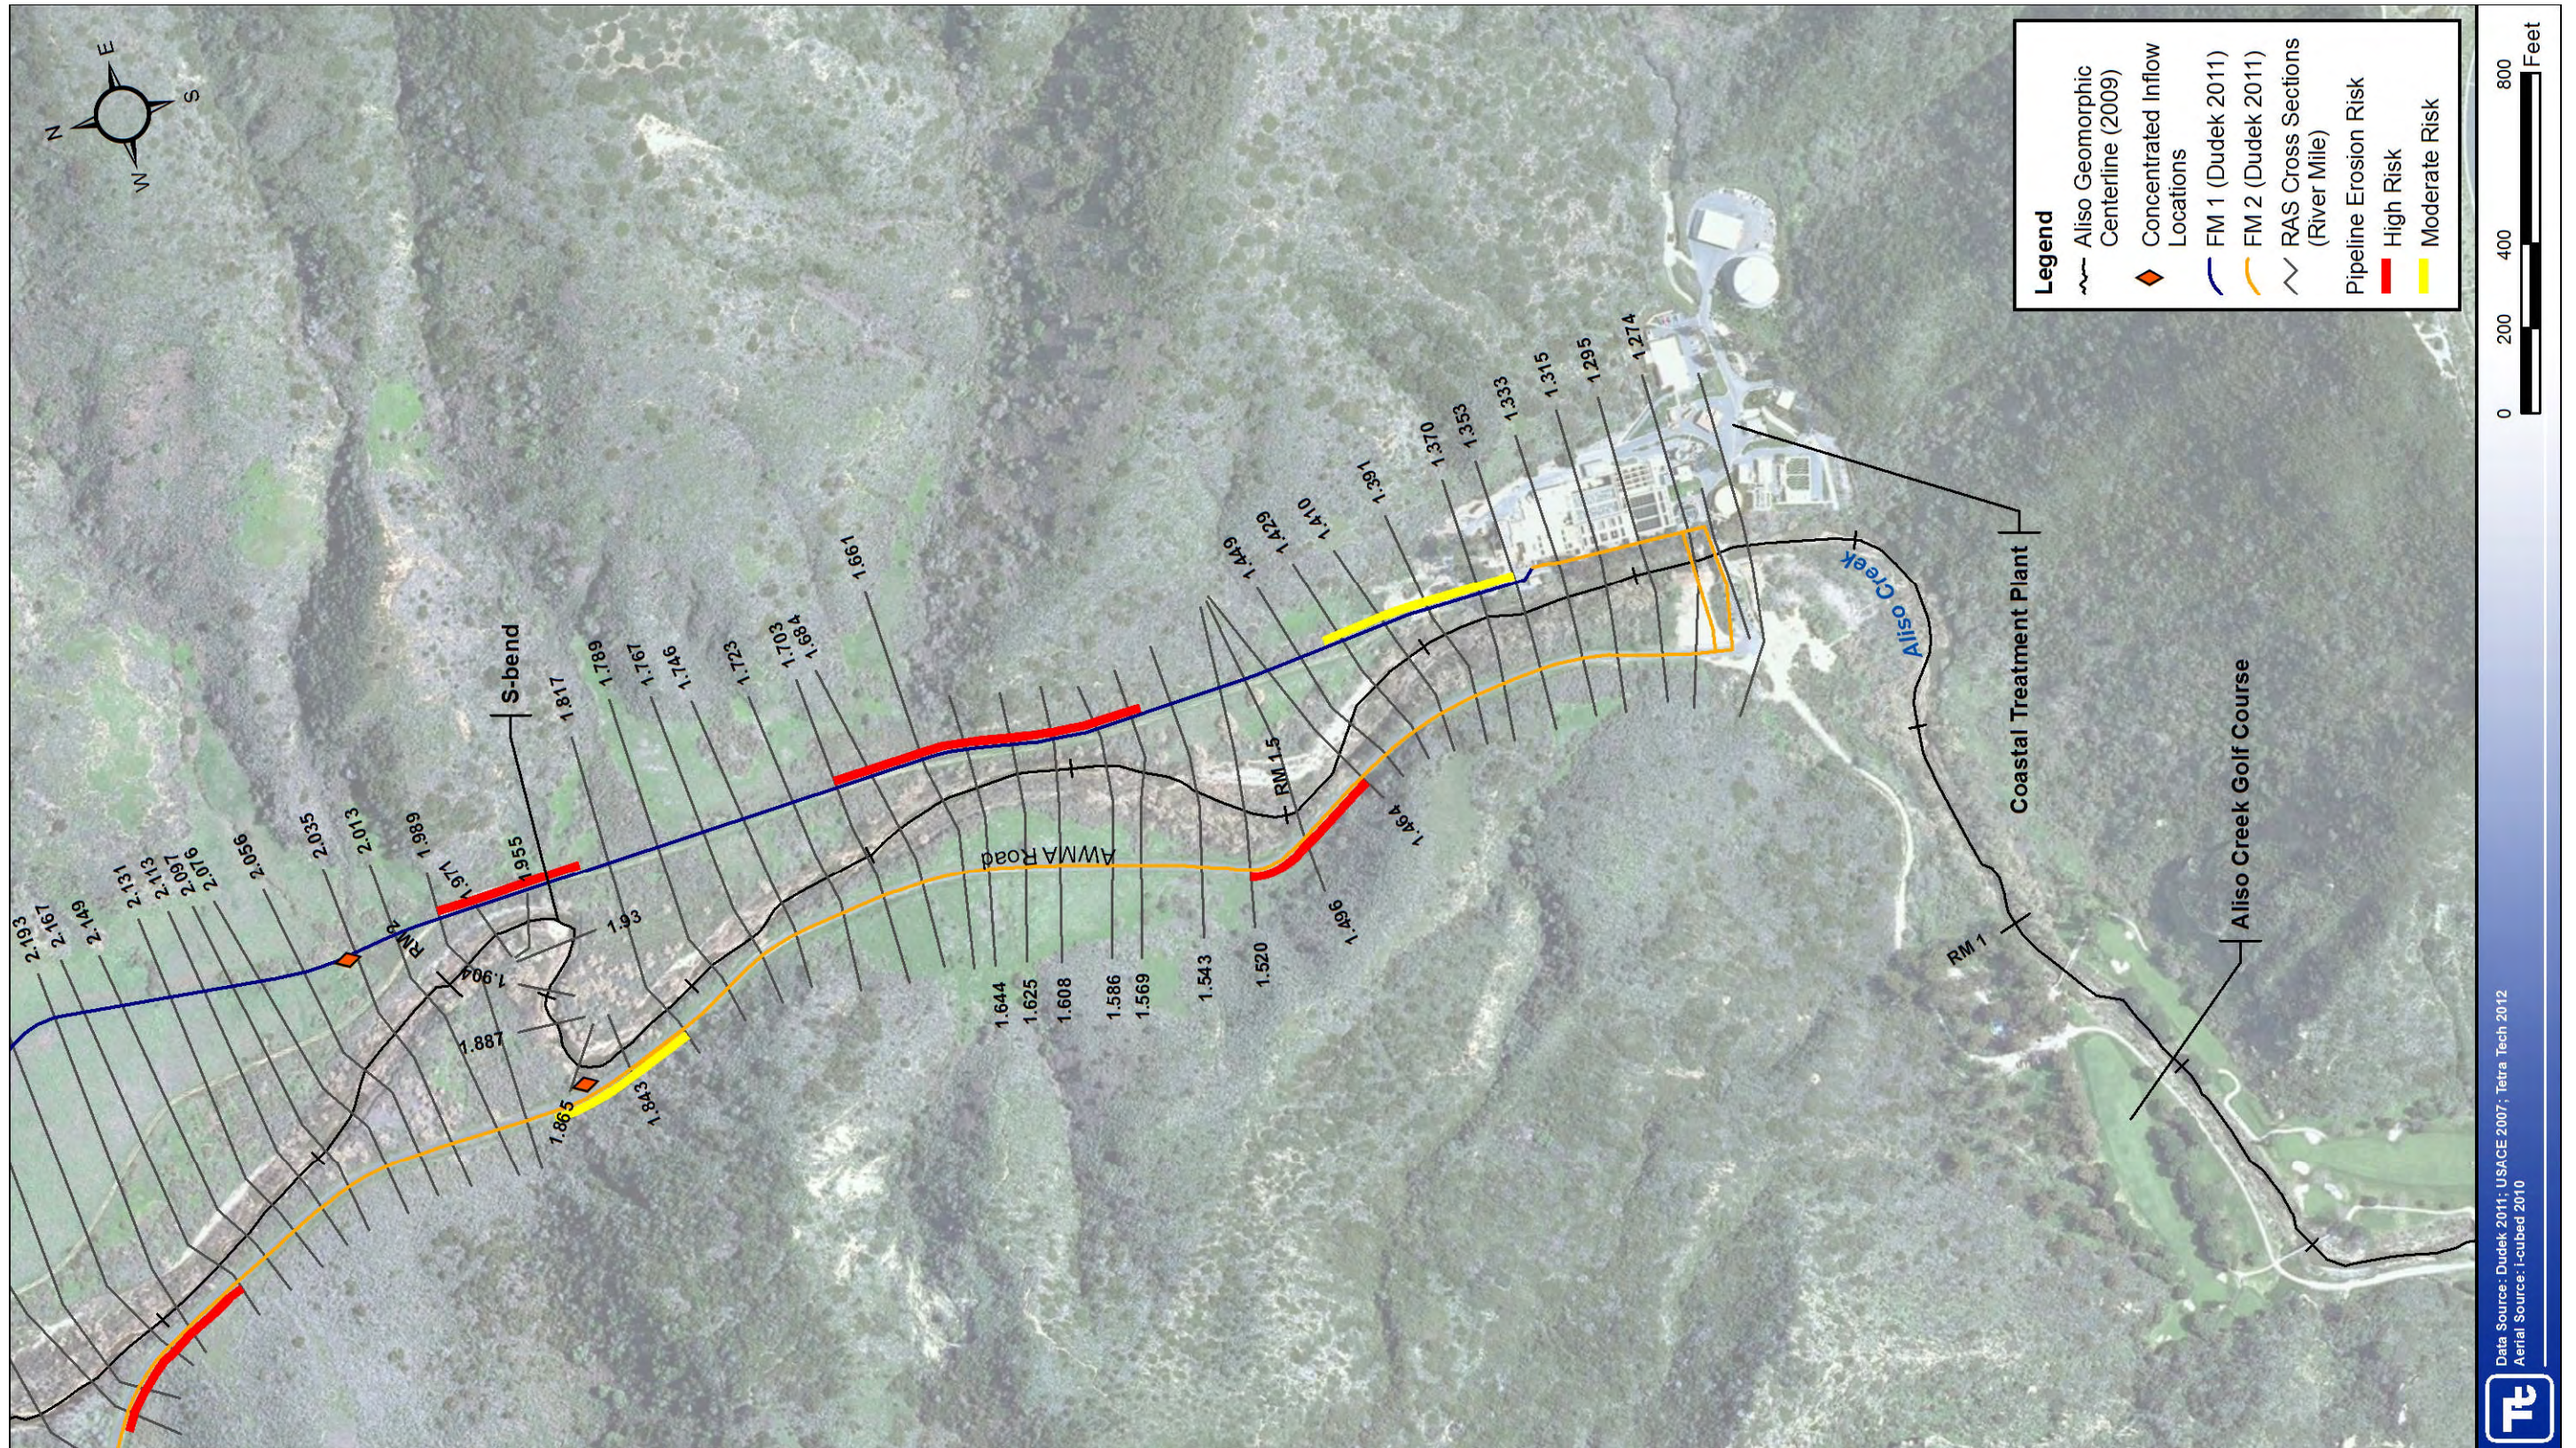
Figure 4-1 (Map 1 of 4). Combined Erosion Risk To Proposed FM 1 and FM 2 Alignments

The proposed FM 1 alignment along the east (left) bank is potentially subject to approximately 3,300 feet of *High* erosion risk and approximately 1,250 feet of *Moderate* erosion risk; the remaining 12,050 feet of the proposed alignment is along banks with erosion risk rated *Low*.
