South Orange County Wastewater Authority

Lower Aliso Creek Erosion Assessment

County of Orange, California

April 2012

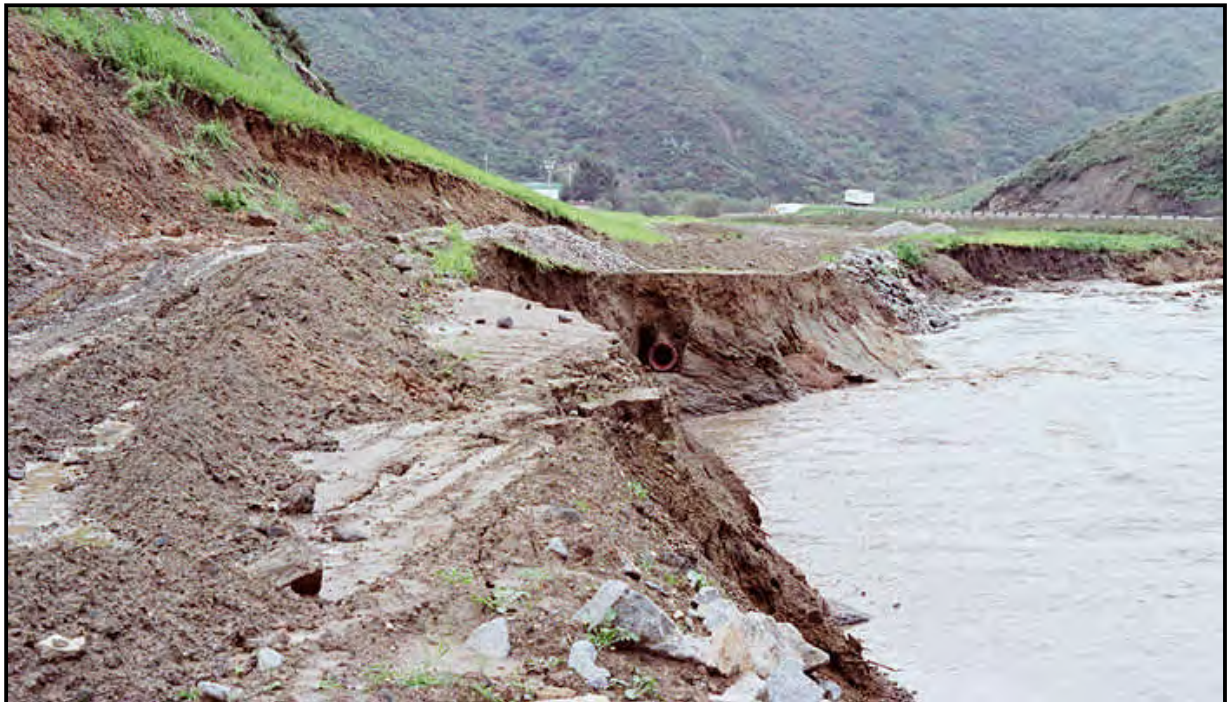
Figure 1-3. East (left) Bank Erosion along Aliso Creek Showing Undermined MNWD Pipeline (photo courtesy of SOCWA, appears to be near RM 1.60)

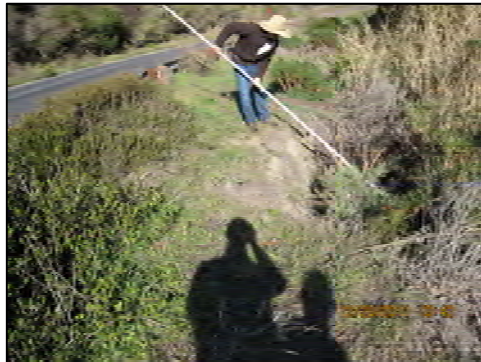
31
Flow Impingement, Narrow Setback
 Active flow impingement above elevation of riprap revetment along bank. Narrow setback. Also concentrated runoff down the bank.

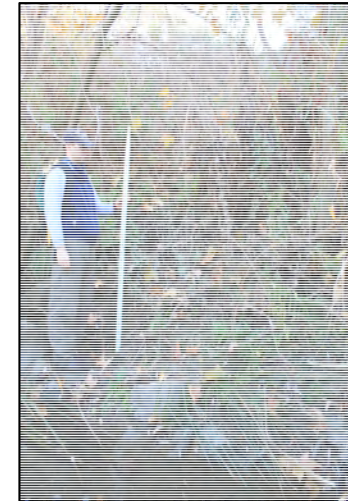
20
Stable Bank

Landward view of depositional berm and vegetation along toe of riprap revetment. Stable bank angle. Sycamore and tree-willows along toe.

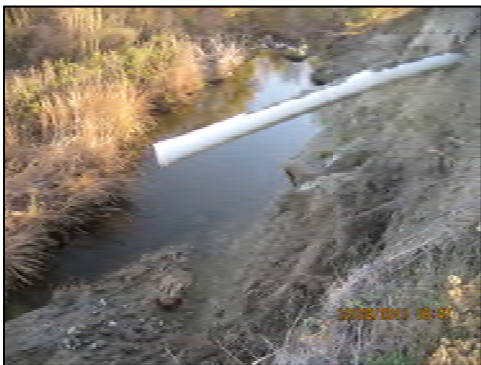
15
Flow Impingement, Slumping
(looking d/s) Direct impingement of flood flows; slumped material at toe.

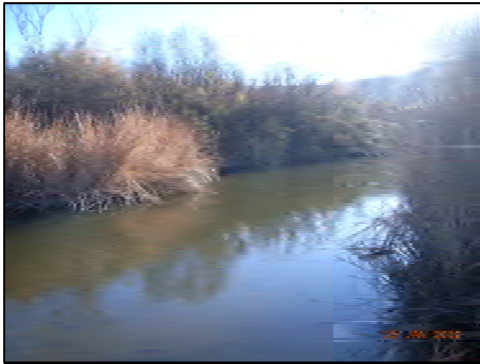
13
Stable Bank
(looking u/s) Low bank height, connected floodplain. Well-vegetated floodplain.

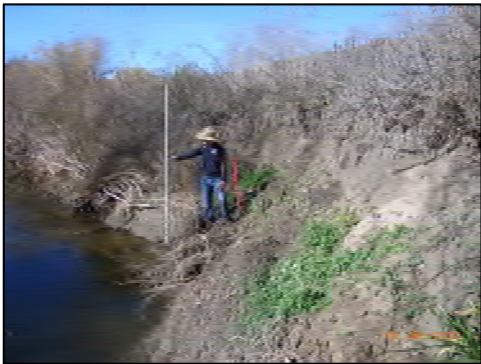
12
Flow Impingement
(looking d/s) Outside bend upstream of ACWHEP backwater influence, unstable bank.

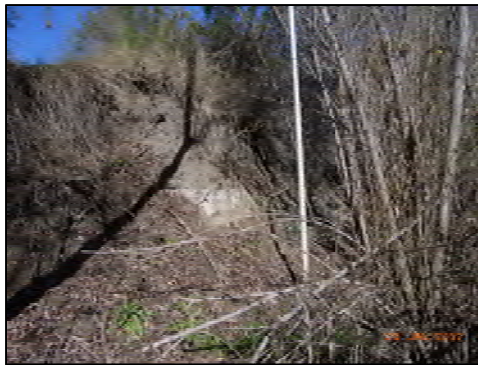
10
Upper Bank Instability
(looking u/s) Close proximity to alignment. Lower bank stable and vegetated, scarp along upper bank.

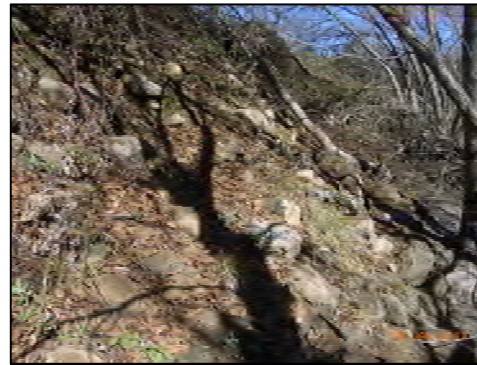
9
Impingement, Weathered Riprap
(looking u/s) Riprap revetment to protect against impingement is breaking down.

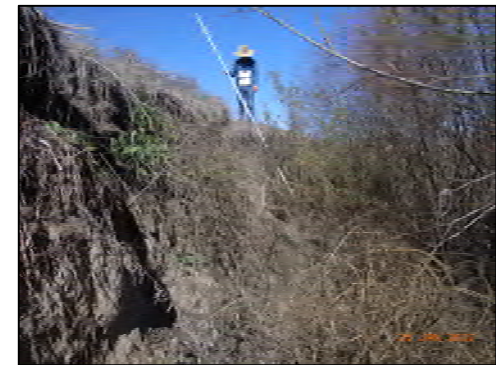
8
Upper Bank Geotechnical Instability
(looking u/s) Close proximity to pipe alignment, further widening as upper bank stabilizes.

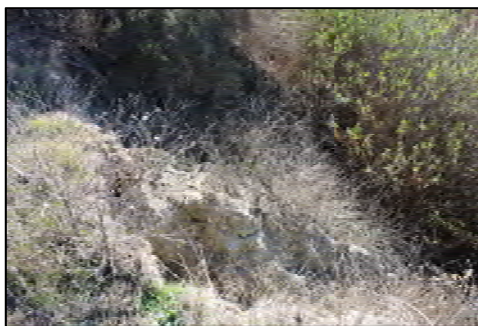
7
Impingement & Concentrated Runoff
(Riverward view) Fluvial energy cutting into toe of alluvial fan; concentrated upland runoff contributes to bank failure. Steep high bank actively failing.

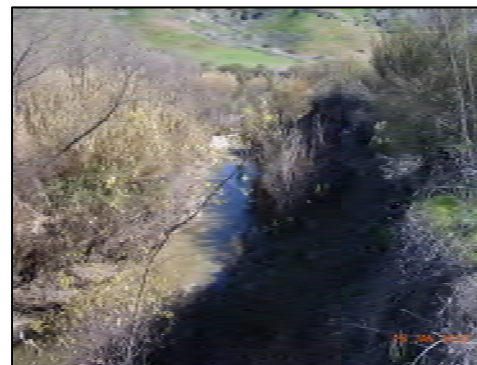
6
Upper Bank Geotechnical Instability
(looking d/s) 30-ft high bank, nearly vertical. Close proximity to AMWA Road.

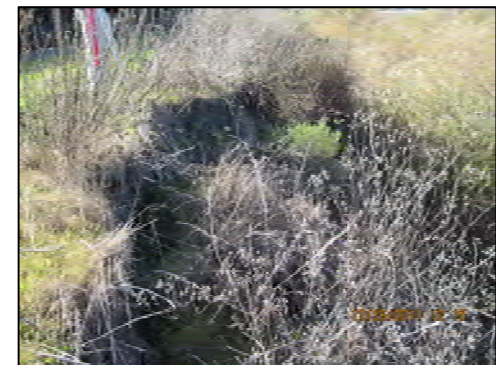
5
Slumping
(looking d/s) No woody vegetation at toe to hold failed material. No room to lay back slope.

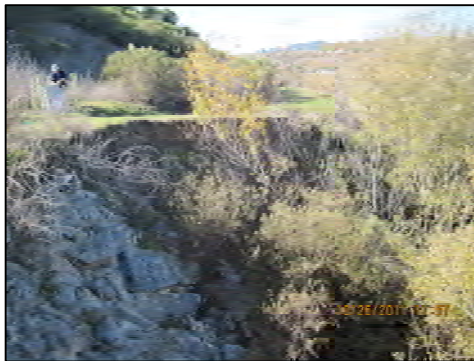
4
Local Scour

(looking d/s) Turbulence from water spilling off grouted rock is locally scouring the bank.

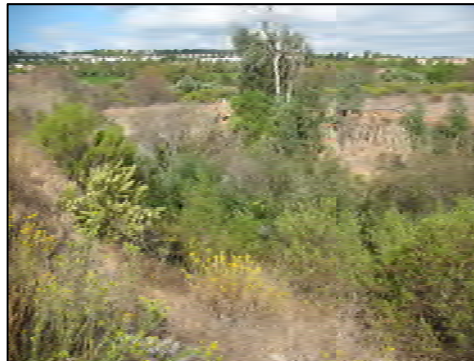
3
Flow Impingement

Riverward view of bend in Sulphur Creek where flood flows directly impinge on bank slope.

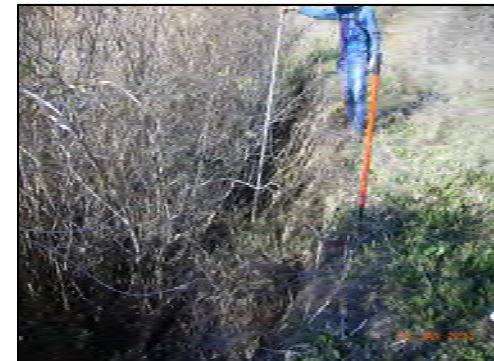
2
Upper Bank Geotechnical Instability

(looking u/s) Lower bank stabilized by dense woody vegetation; upper bank will continue to erode to achieve a stable bank angle.

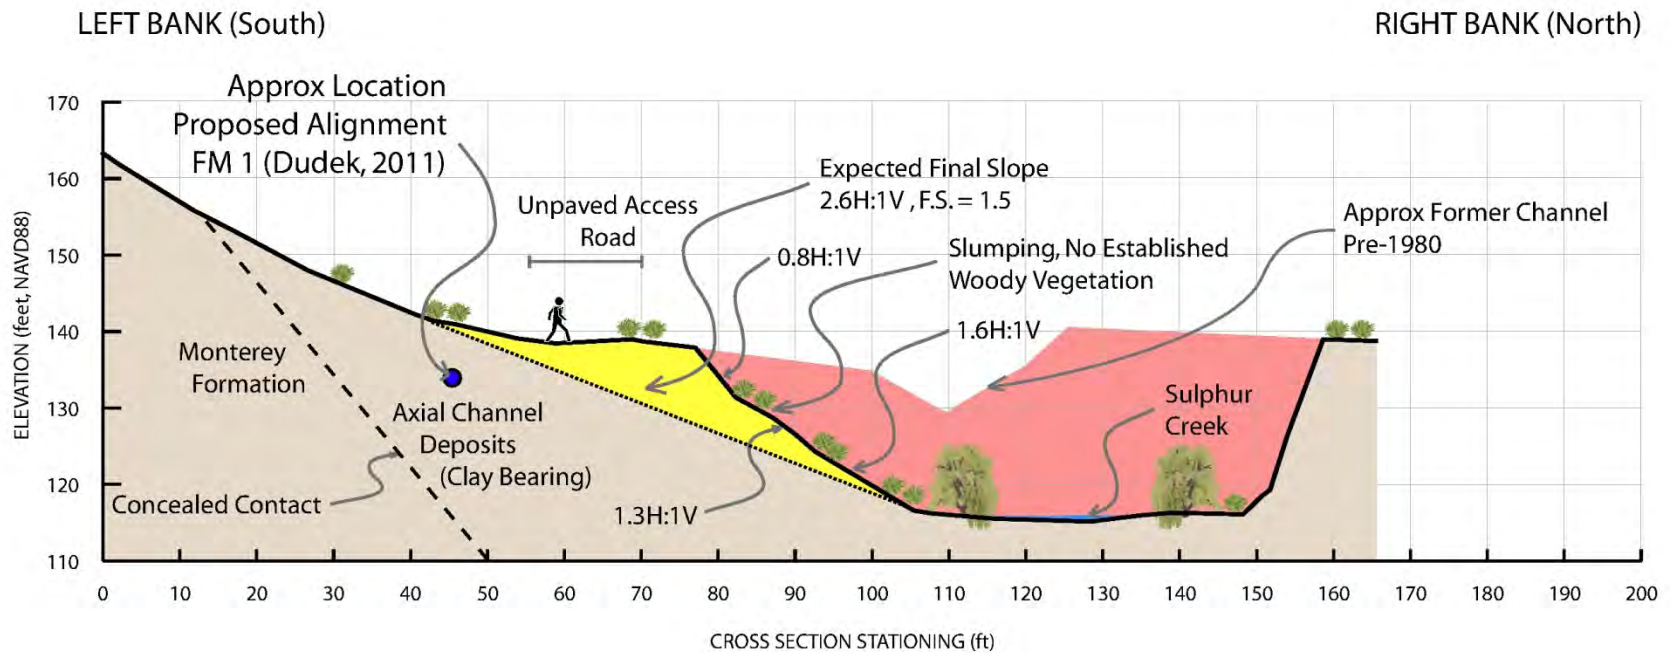
Figure B-1: Bank Slumping due to Geotechnically Unstable Slope

NOTES: Cross Section shown is of Sulphur Creek, 0.023 miles upstream of the Aliso Creek Confluence.

The left (south) bank is slumping due to geotechnical instabilities resulting from channel incision. Factors such as an overly steep bank slope, a slope height of around 20 feet, and a near absence of established woody vegetation along the slope (and particularly along the toe) contribute to the existing unstable bank. It is expected that further erosion of the bank will continue until the slope flattens to approximately 2.6H:1V. Using a factor of safety of 1.5, the stable bank slope is approximately 10 feet from the proposed pipeline alignment, and this distance is further reduced when the recommended setback equal to one-third the bank height is incorporated.

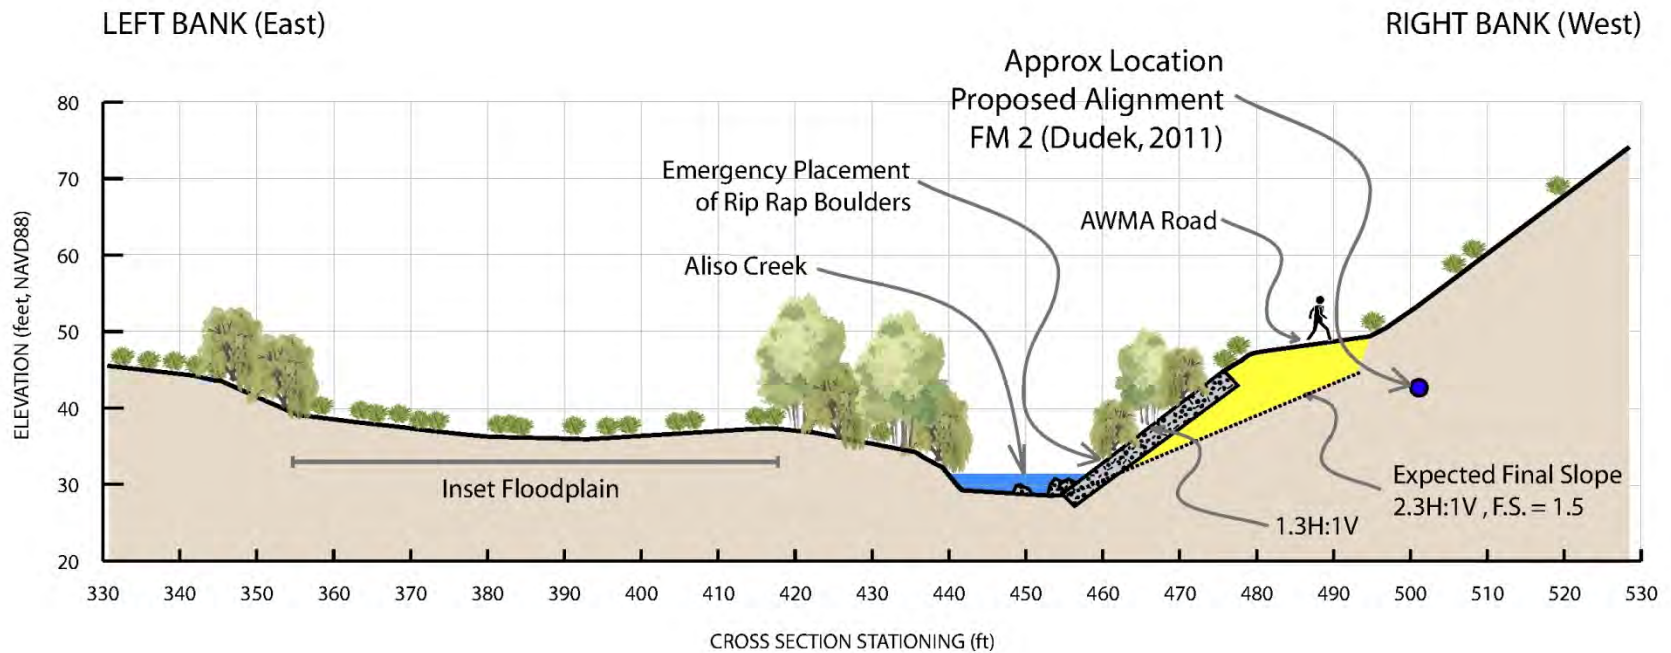
Figure B-2: Over-Steep Existing Riprap Revetment

NOTES: Cross Section shown is of Aliso Creek, 1.449 miles upstream of the Pacific Ocean.

Many of the existing bank protection measures appear to have been installed during emergency situations. For riprap revetments, this means the rock was probably dumped from top of bank, likely without any formal engineering design. As shown here, this can lead to measures that may not provide long-term protection to the bank or the proposed pipelines. Monitoring and maintenance of the protection is recommended as the future pipe alignment could be endangered if bank protection fails. In this example, if the protection was to fail, a stable bank slope would be within approximately 5 feet of the proposed alignment. This situation is representative of conditions at cross sections 1.496 to 1.410 (see **Table 3-3** in the main body of the report).

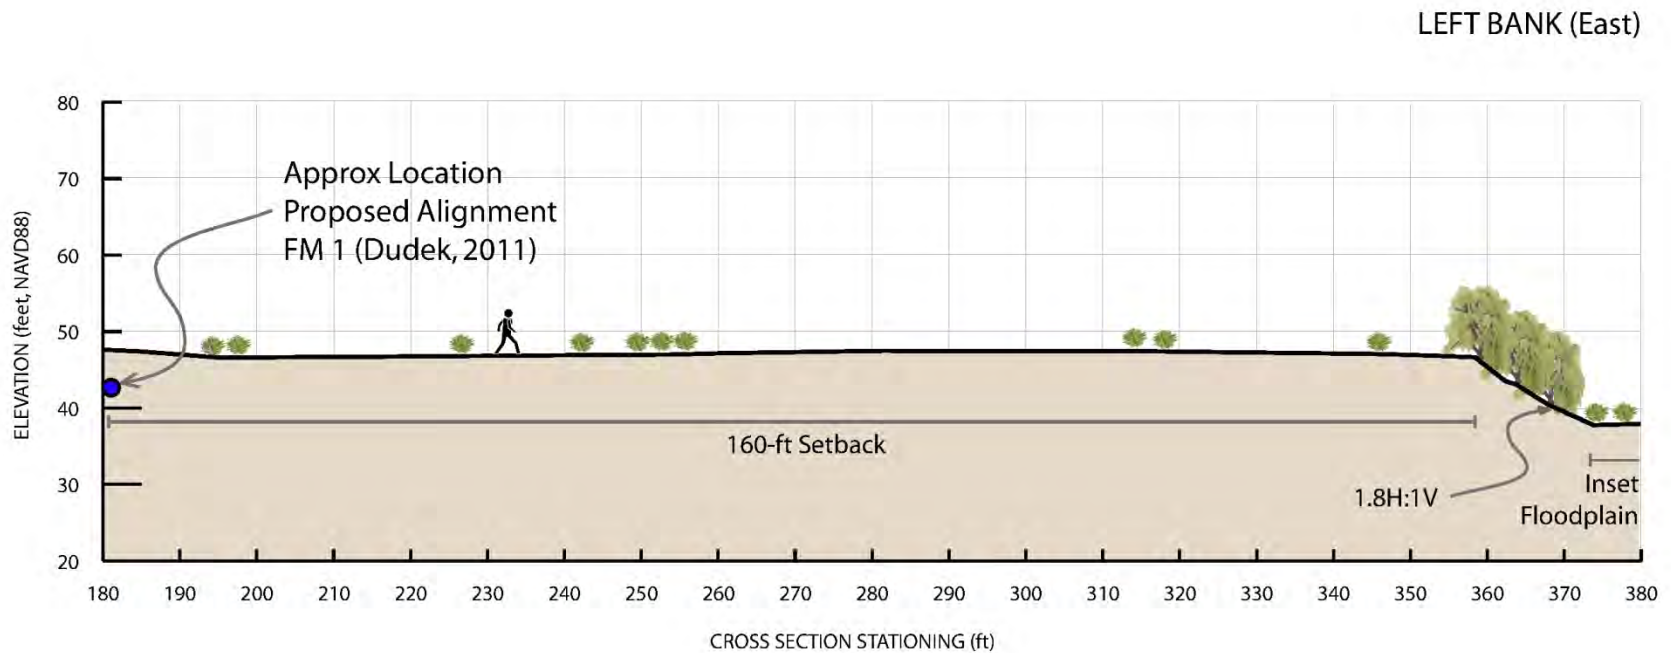
Figure B-3: Stable Bank Angle

NOTES: Cross Section shown is of Aliso Creek, 1.520 miles upstream of the Pacific Ocean.

The proposed FM 1 alignment is setback 160 feet from the relatively stable left bank, as indicated by its low slope height, established woody vegetation, flatter slope angle, and the inset floodplain. Considering historical locations of the channel, there is low potential for the channel to avulse/migrate to a location that would threaten the future integrity of the proposed pipeline. This situation is representative of conditions at cross sections 1.543 to 1.449 (see **Table 3-2** in the main body of the report).

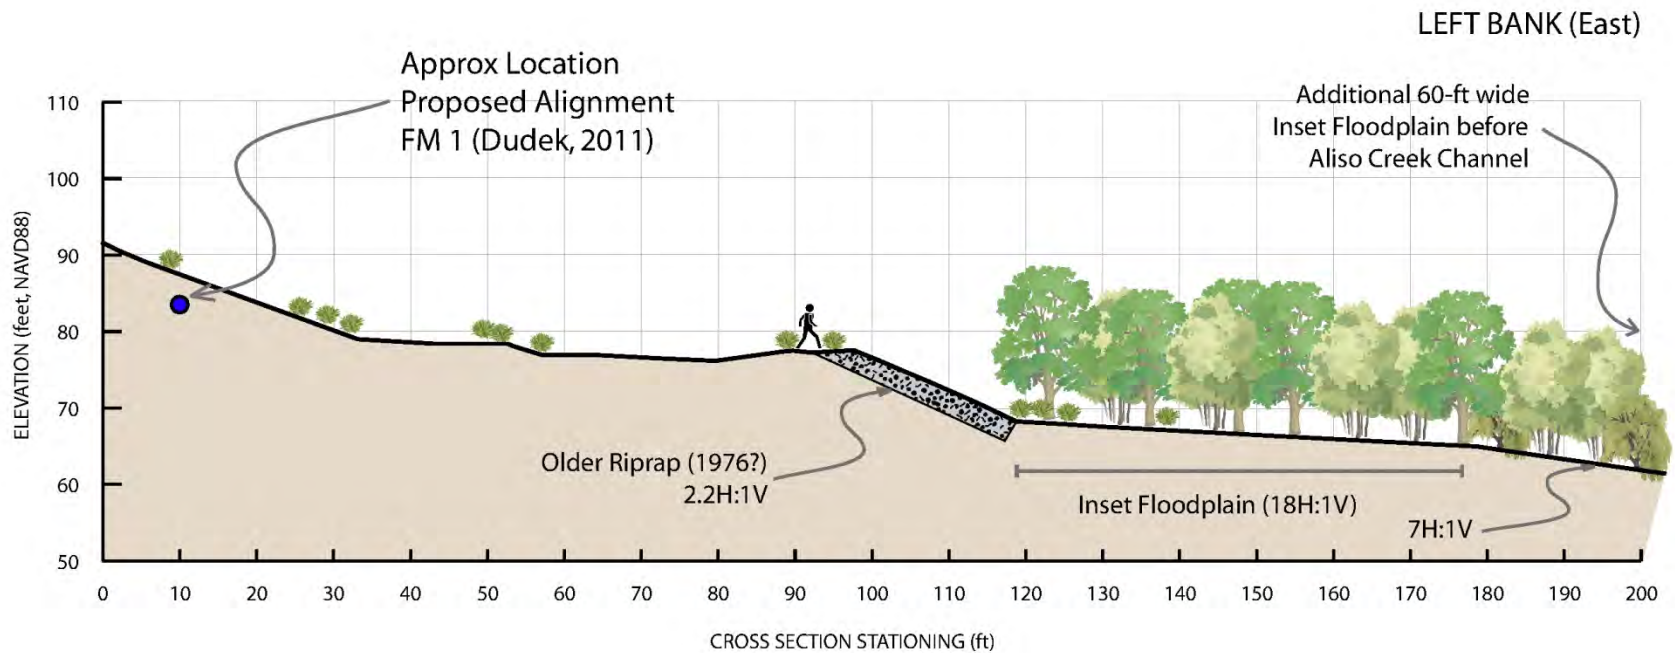
Figure B-4: Establishment of Inset Floodplain

NOTES: Cross Section shown is of Aliso Creek, 2.768 miles upstream of the Pacific Ocean.

Two inset floodplains are have developed between the channel and the toe of the riprap protection. These floodplains support established woody vegetation (e.g., tree willows and sycamore). The riprap was constructed at a stable slope. The proposed pipeline alignment is setback 90 feet from the top of the riprap protection. The potential for channel avulsions and bank erosion is low, so there is low long-term risk of pipeline damage from channel erosion. This situation is representative of conditions at cross sections 2.842 to 2.736 (see **Table 3-2** in the main body of the report).
