M A G A Z I N E
F L I G H T
A I R W O R T H I N E S S
S U P P O R T
T E C H N I C A L
A I R B U S

A320 Family

A practical guide to reducing in-flight interruptions

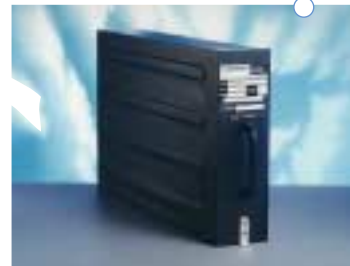
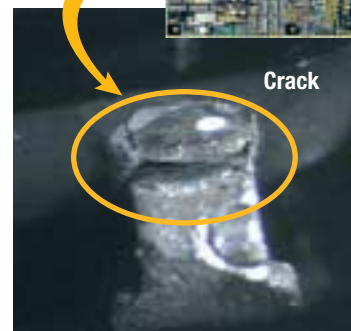
AEVC and circuit board

The latest Avionics Equipment Ventilation Computer (AEVC) standard clears two major issues. It can now deal with disruption of the electrical signals from the skin air valves, which previously caused AEVC and skin air valve faults, which could result in an in-flight interruption. This new controller also prevents spurious avionics smoke warnings in flight triggered by a pin crack at the level of the Random Access Memory module. With this latest AEVC standard, shock absorption has also been improved and the smoke detector test inhibited in flight.

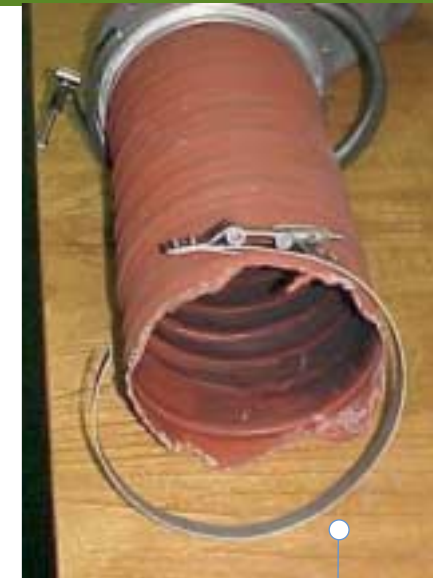
Rupture of clamps has caused pack bellows to break open, leading to cabin pressurisation difficulties. Replacing these clamps by corrosion-resistant and welded ones will minimize such occurrences.

Example of a failed clamp

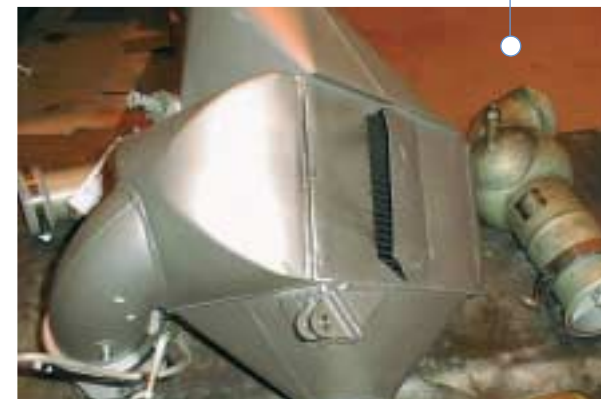
Some pressurisation difficulties have been linked to rupture of the condenser (see example of ruptured condenser below) of one air conditioning pack. The affected pack will then no longer supply air to the cabin due to the significant leak at the rupture. The solution has been to increase the thickness of the wall that exhibited this failure mode.

Example of a ruptured condenser

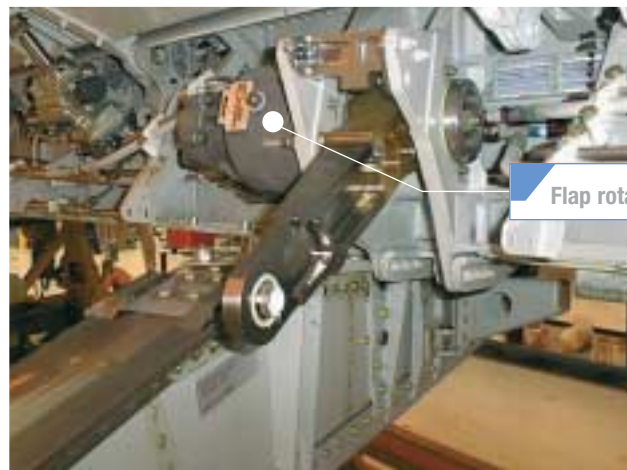
Flap rotary actuator

Investigation revealed that during accomplishment of removal or installation of the flap rotary actuators a slight mis-rigging in the flap transmission had been induced. This was found as a contributing factor in the reported flap locks.

Flap rotary actuators filled with grease pre mod 28898 or pre mod 28899 need removal for re-greasing approximately every 5 years (Refer to MPD task 275449-05-1). A new type of actuator post mod 28898 or 28899 (post SB 27-1138) embodied since MSN 1256 are filled with semi fluid and are serviceable on wing. This eases maintenance and avoids removal/installation of the actuators.

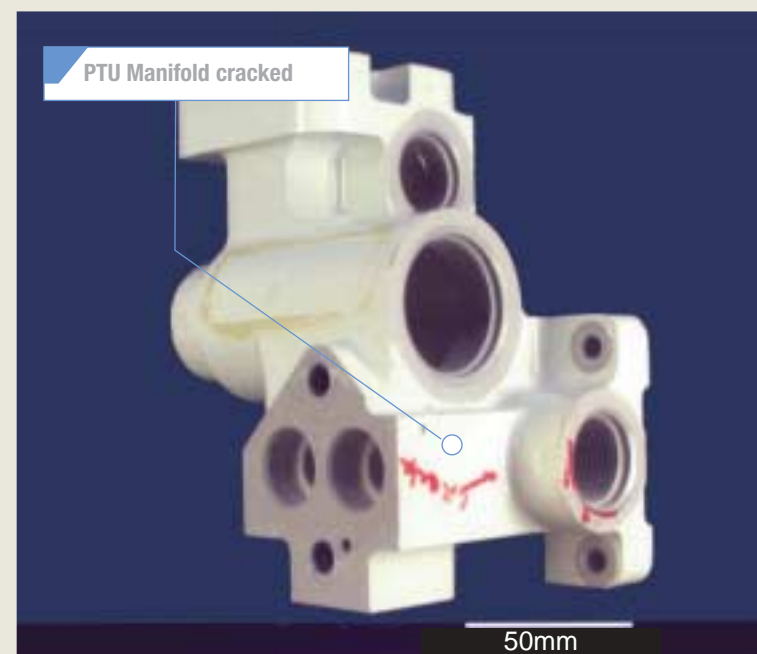
PTU and Ground Service Manifolds leakages represent 19% of in-flight interruptions due to hydraulic leakage for aircraft prior to MSN 972.

PTU Manifold cracked

Airbus recommends that the pre-mod 27490 Yellow PTU manifolds are replaced before reaching 15,000 flight cycles:

- Either by the same model PN D2907019000X00 with further replacements scheduled within 15,000 flight cycles
- Or by an improved PTU manifold PN 1556A9900-01 that has demonstrated enhanced fatigue endurance properties, by

embodying SB A320-29-1113. This requires some modifications to the plumbing installation surrounding the manifold.

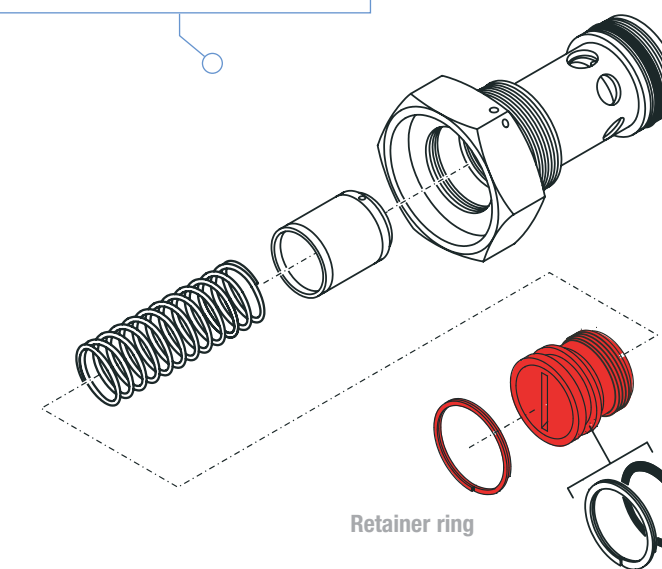
Breakdown of ZCV66 Check-valve

Further to several operator reports of hydraulic leakage from check-valve ZCV66 / ZCV67, Airbus has launched investigations to determine the root cause. Each time, it was found that a retainer ring was missing on the leaking units, leading to the cap loosening and subsequent O-ring damage.

- The preferred solution is to install a new check-valve, PN ZCV66-1/ZCV67-1, by Airbus SB 29-1107 (covering Circle Seal Controls SB ZCV66-29-1 & ZCV67-29-1)
- Otherwise, inspect, as per SB 29-1109, the already installed check-valves and verify that the retainer rings are correctly fitted. If not, VSB ZCV66-29-2/ZCV67-29-2 must be carried out to replace and safety (Loctite) the retainer ring.

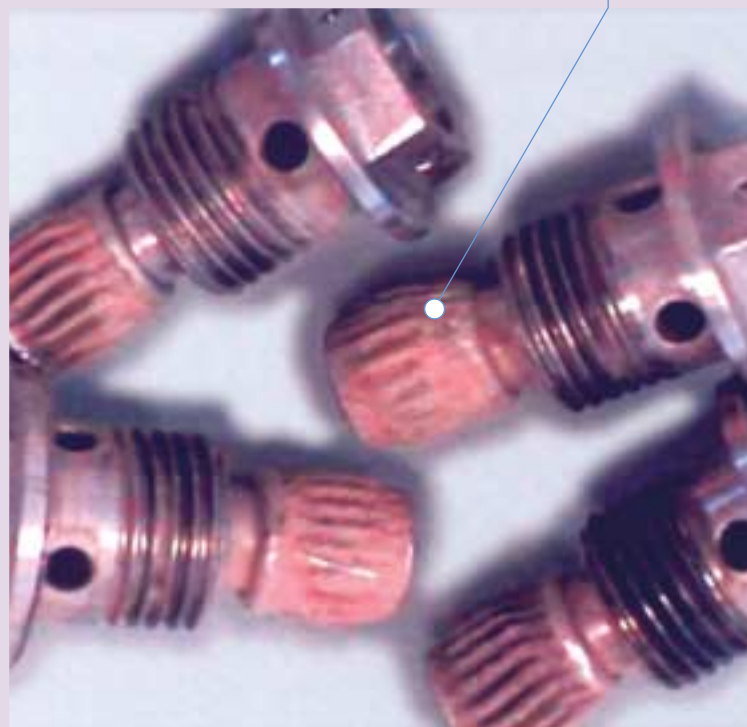
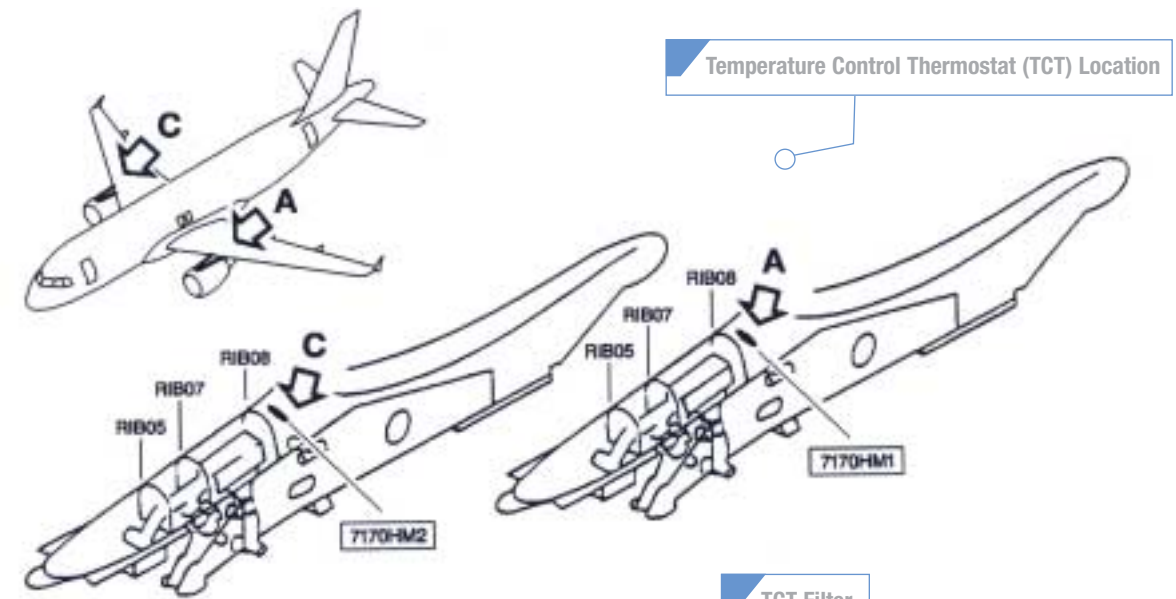
Examples of TCT clogged filters
