UNITED STATES COAST GUARD

REPORT OF THE INVESTIGATION INTO THE

FLOATING OCS FACILITY - TENSION LEG PLATFORM

LIFEBOAT FALL WITH LOSS OF LIFE ON JUNE 30, 2019

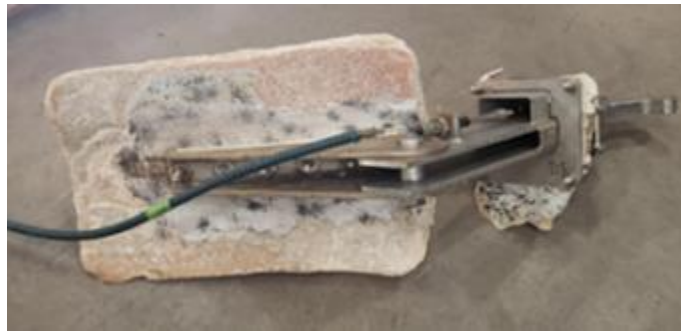
4.2.4.2.1. The bow end of the hull split, and the bow hook was torn free of the hull (see Figures 21). The bow split arrested approximately halfway along the length of the boat.¹⁵ The patch that pulled out is consistent in shape with a previous repair made to the FRP around the bow hook (see Figure 21).

Figure 21: Bow hook and surrounding FRP post-casualty. Credit: CG.

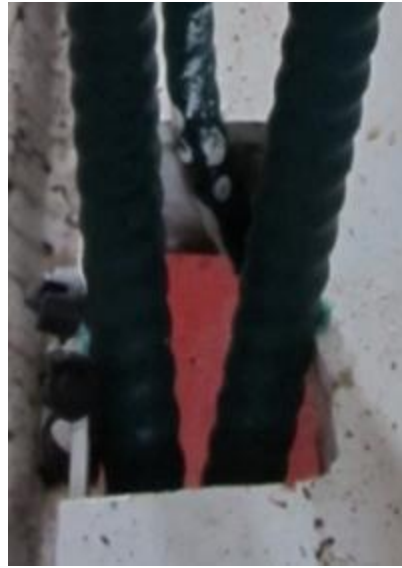
Figures 38 (left) and 39 (right): Photos of aft control cables in or around 2014. Credit: Shell.

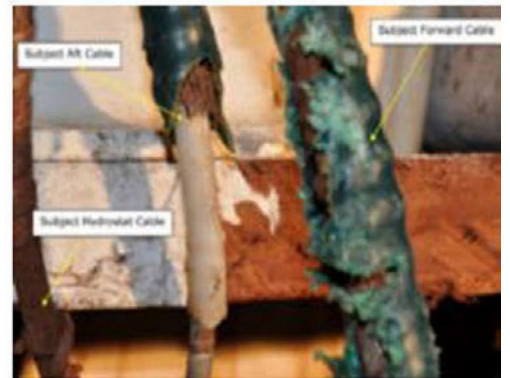
Figure 49: Lifeboat No. 6's aft hook control cable after the casualty. The aft cable is in the center of the picture. Credit: CG.

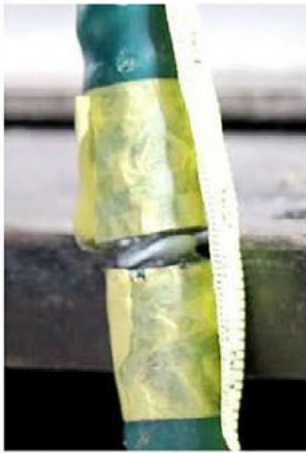
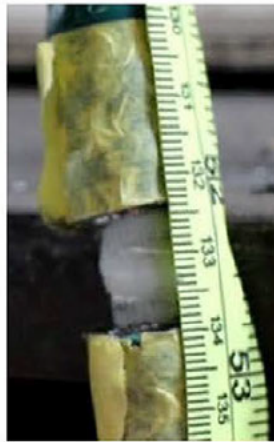
Figure 60 (far left) and 61 (right): The white polyethylene liner evidencing forces of compression and stretching after the wire layer is fully compromised. These photos were taken during the Coast Guard's experiment at MSTC. Credit: CG.
