**THE BUREAU OF OCEAN ENERGY MANAGEMENT,  
REGULATION AND ENFORCEMENT**

**REPORT REGARDING THE CAUSES OF THE APRIL 20, 2010  
MACONDO WELL BLOWOUT**

**September 14, 2011**

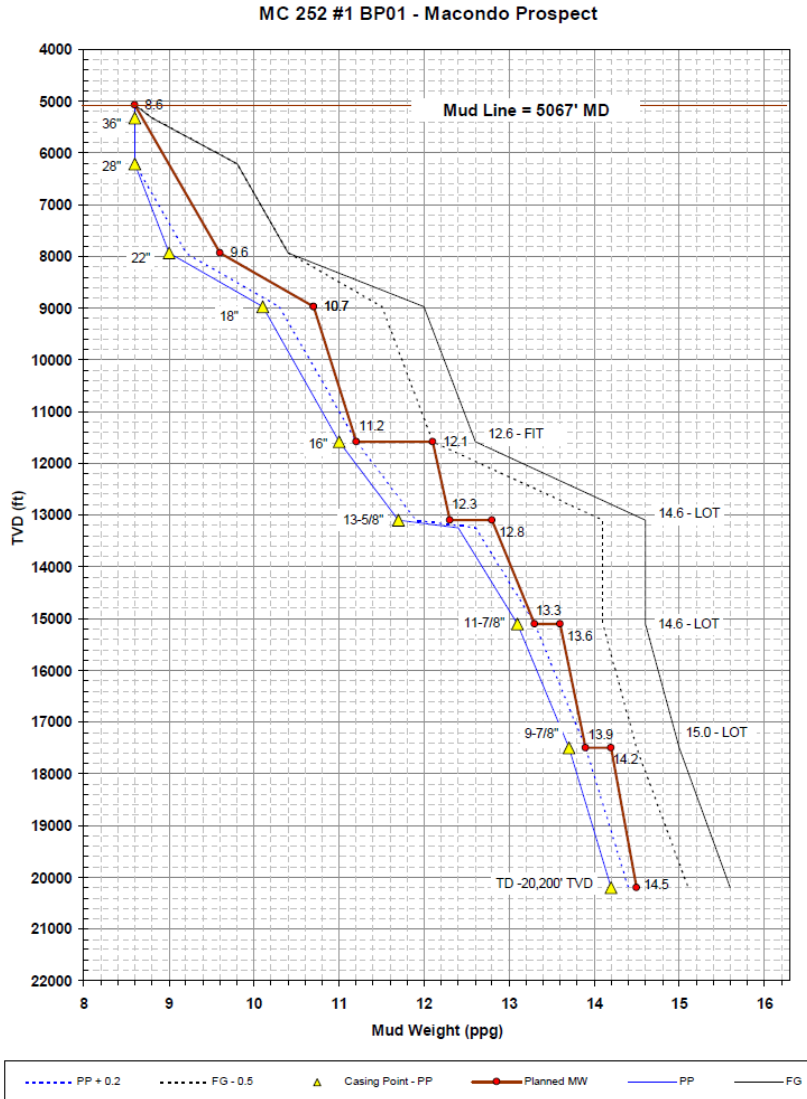
Figure 1 – Macondo Well Pore Pressure Fracture Gradient Plot<sup>65</sup>

The final estimated Macondo well pore pressure, mud weight, and fracture gradient plot submitted to MMS on March 26 is shown at Figure 1. The vertical axis of Figure 1 shows the depth of the well. The horizontal axis shows the mud weight. The red line depicts BP’s planned mud weight, which was designed to be between the kick margin and the swab margin identified in Figure 1.

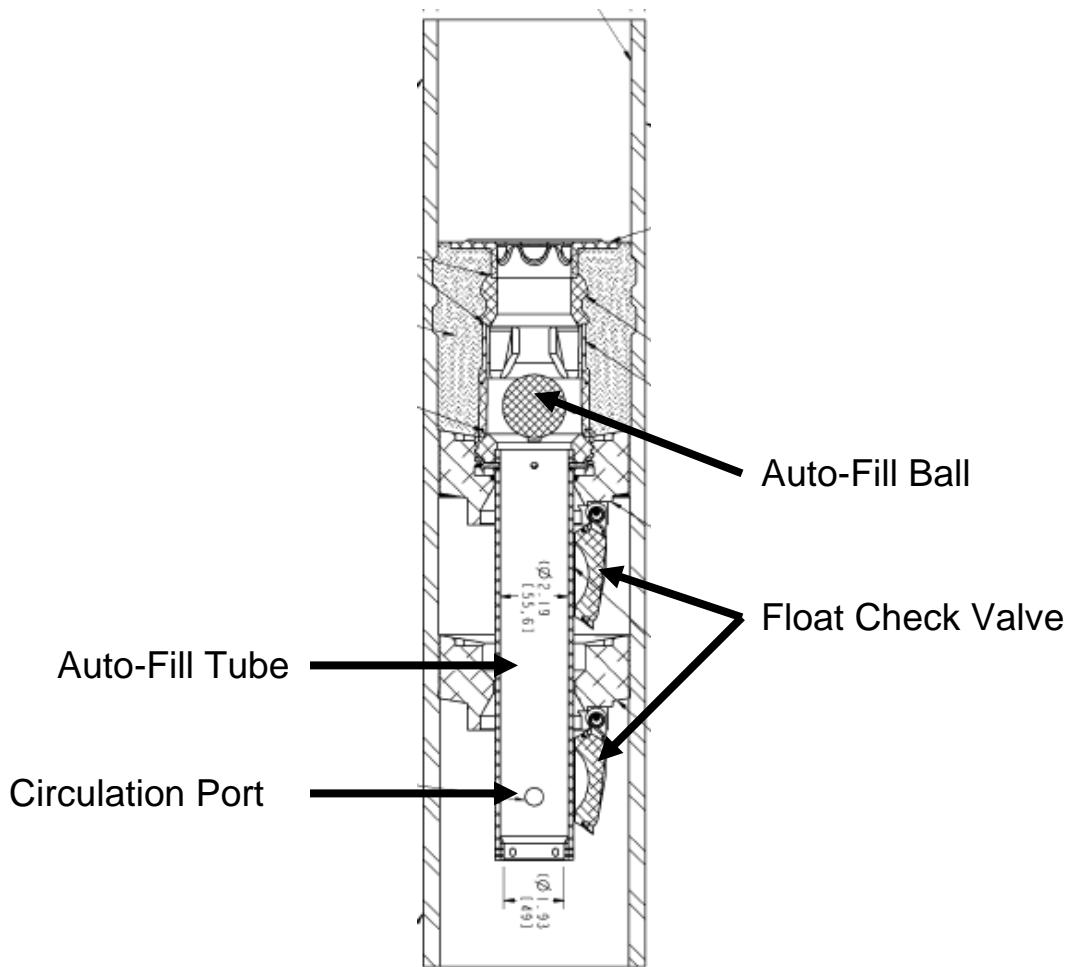
Figure 4 – Float Collar Utilized in the Macondo Well

As discussed above, the float collar was set at 18,115 feet measured depth, within the primary hydrocarbon reservoir sands (see Figure 2, above). Typically, an operator sets the float collar below the primary hydrocarbon sands to allow for perforation of the pay zone without the need to drill out the float equipment to get below the pay zone during the completion of the well. In addition, the lower primary sand was less than 100 feet from the bottom of the production casing shoe.<sup>116</sup> Normally, an operator would set the production casing shoe 200 to 300 feet below the primary sand to improve the chances of proper isolation of the pay sand.

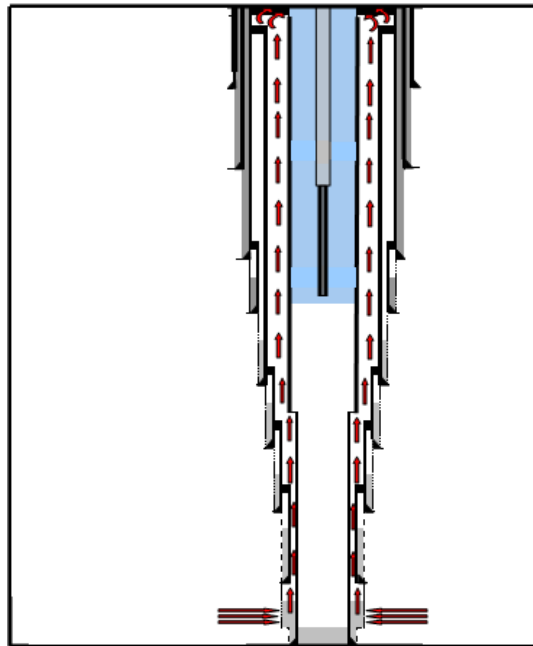
Figure 6 – Flow Up the Annulus and Through the Seal Assembly

Under this scenario, hydrocarbons would have flowed from the reservoir up the backside of the tapered casing string, and through the seal assembly into the riser. If this had occurred, the nitrified annular cement intended to isolate the hydrocarbon zone(s) at the production interval would have failed, the casing would have lifted or floated, and the seal assembly would have failed in conjunction with the casing lifting. This potential flow path is illustrated in Figure 6, below.

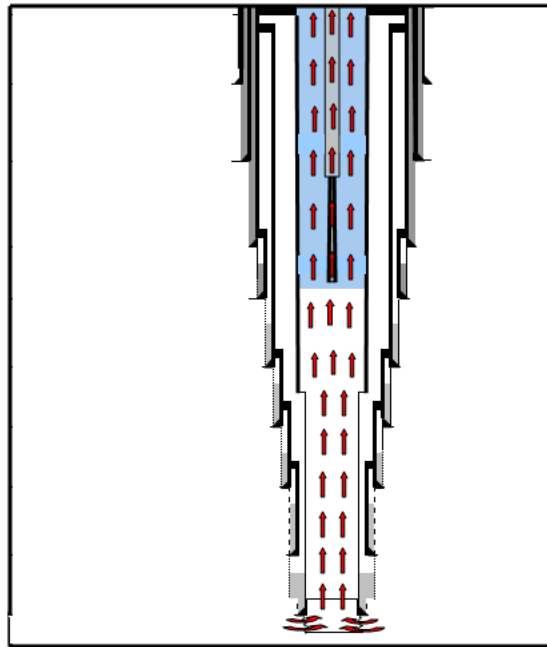
Figure 8 – Flow up the Production Casing Shoe Track

Under this scenario, hydrocarbons would have flowed from the reservoir through the casing shoe, into the well and up the riser to the rig. For this flow path to have occurred, the shoe track cement would have failed. A number of factors could have caused the shoe track cement to fail. First, mud in the wellbore could have contaminated the shoe track cement and caused the cement not to set properly. Second, the shoe track cement might have swapped out with the lighter drilling fluid in the rat hole. Third, some of the shoe track cement could have been lost into the formation. Finally, the failure of the shoe track could have resulted from a combination of these factors. This scenario is represented in Figure 8 below.

The approximately 189 foot bottom section of the casing in the well, called the shoe track, consisted of sections of casing with a reamer-guide shoe at the bottom and a dual flapper float collar on top. These sections of casing that make up the shoe track are meant to contain the top, or tail cement, which in the Macondo well was unfoamed cement.

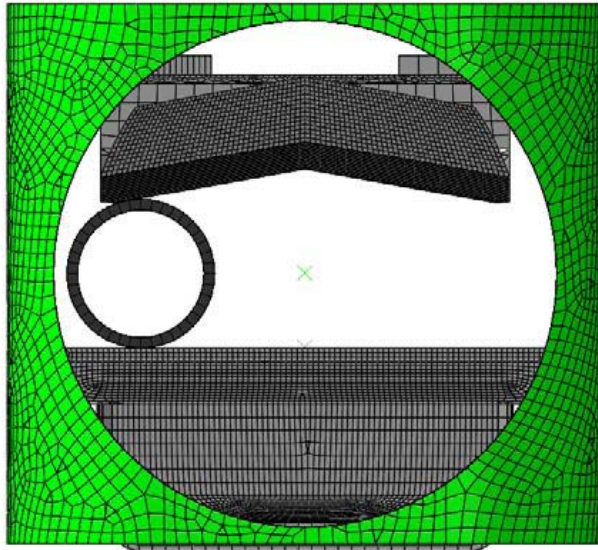
A forensic examination of the BOP stack revealed that elastic buckling of the drill pipe had forced the drill pipe up against the side of the wellbore and outside the cutting surface of the BSR blades. As a result, the BSR did not completely shear the drill pipe and did not seal the well. The buckling of the drill pipe, which likely occurred at or near the time when control of the well was lost, was caused by the force of the hydrocarbons blowing out of the well; by the weight of the 5,000 feet of drill pipe located in the riser above the BOP forcing the drill pipe down into the BOP stack; or by a combination of both. As a result of the failure of the BSR to completely cut the drill pipe and seal the well, hydrocarbons continued to flow after the blowout.

Figure 12 – Off-center drill pipe (Source: DNV)
