# UNITED STATES COAST GUARD

Report of Investigation into the Circumstances Surrounding the  
Explosion, Fire, Sinking and Loss of Eleven Crew Members

## *DEEPWATER HORIZON*

April 20 – 22, 2010

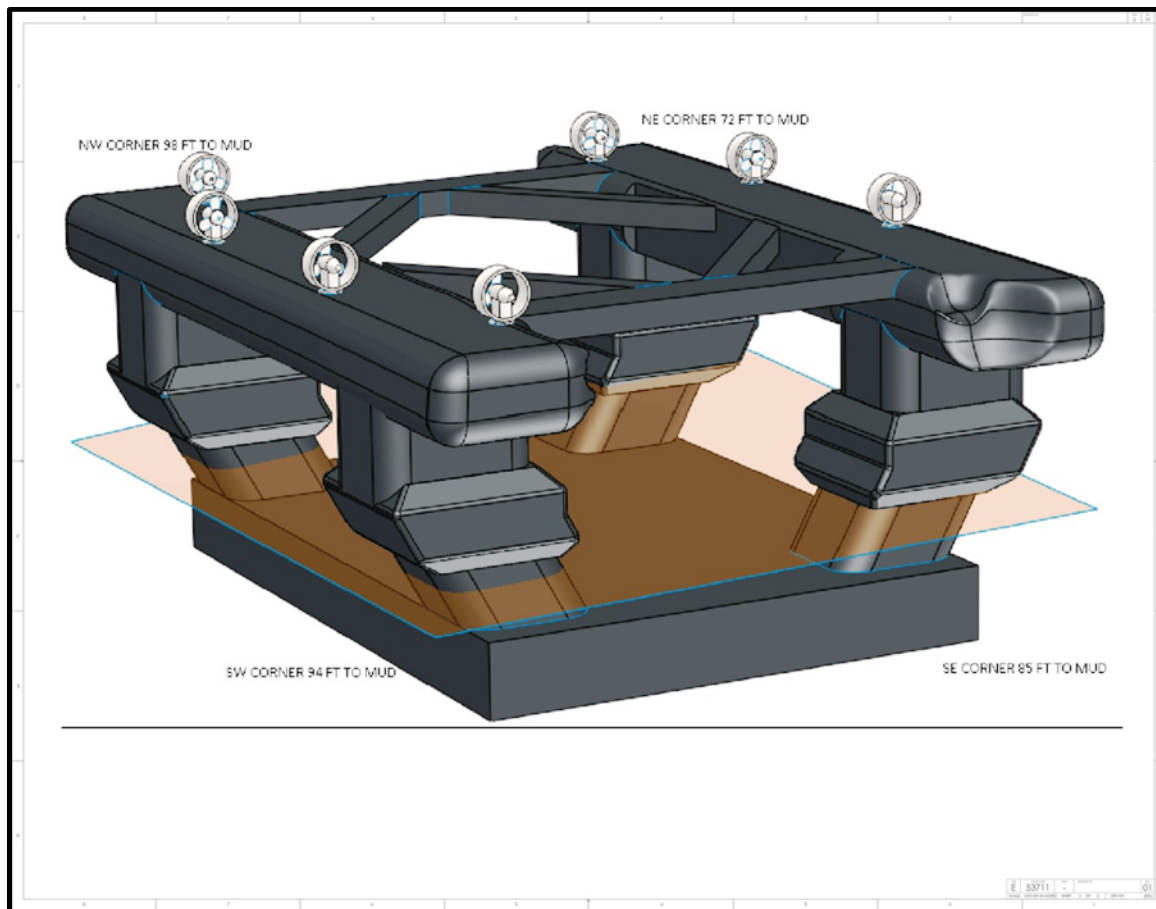
Figure 13 – *DEEPWATER HORIZON* on the Ocean Floor

Figure 13 shows *DEEPWATER HORIZON* as it came to rest on the ocean floor, depicting some of the damage and showing that the upper hull was buried and is not visible.<sup>278</sup>

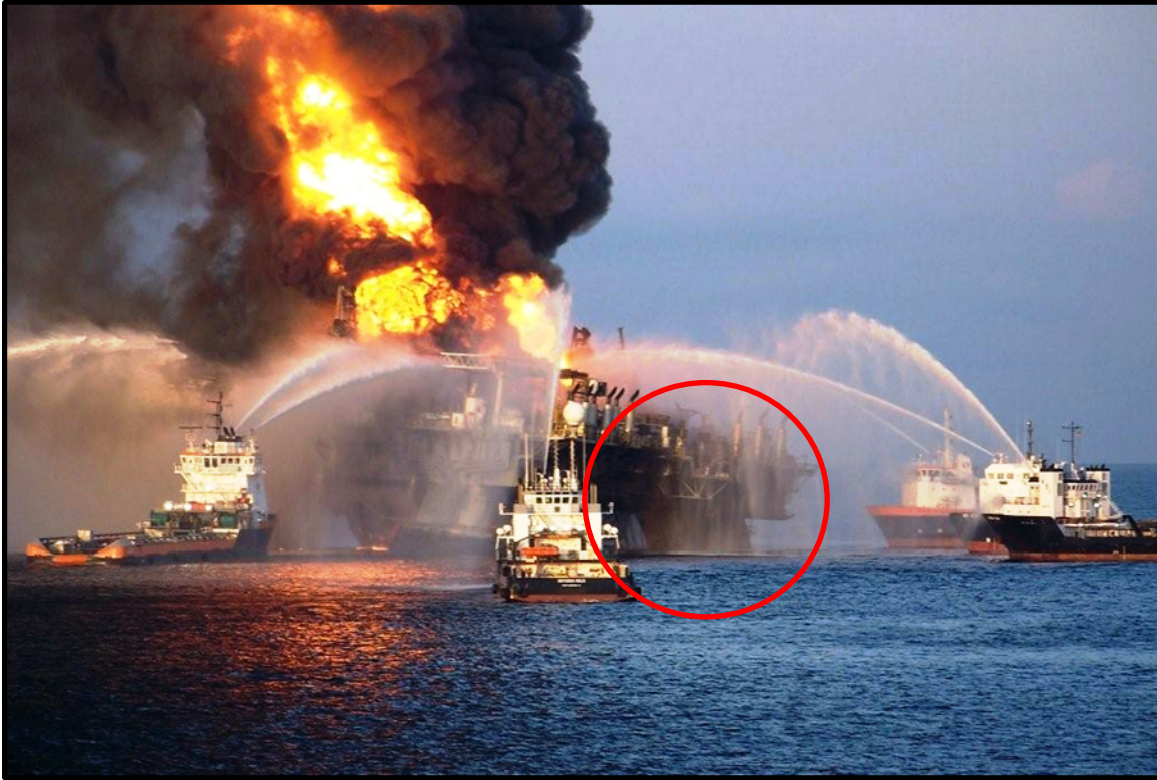
Figure 15 – Water from Responding Vessels Spilling Off the Deck of *DEEPWATER HORIZON*

- Some amount of water from firefighting efforts remained onboard, increased the weight of the vessel, and reduced its stability. Although there is insufficient data to determine what percentage of such water remained onboard, a Coast Guard post-casualty stability analysis (Appendix L) revealed that the MODU’s displacement of water increased by an amount that was too great to have been caused by the shifting of loads onboard prior to the explosion.

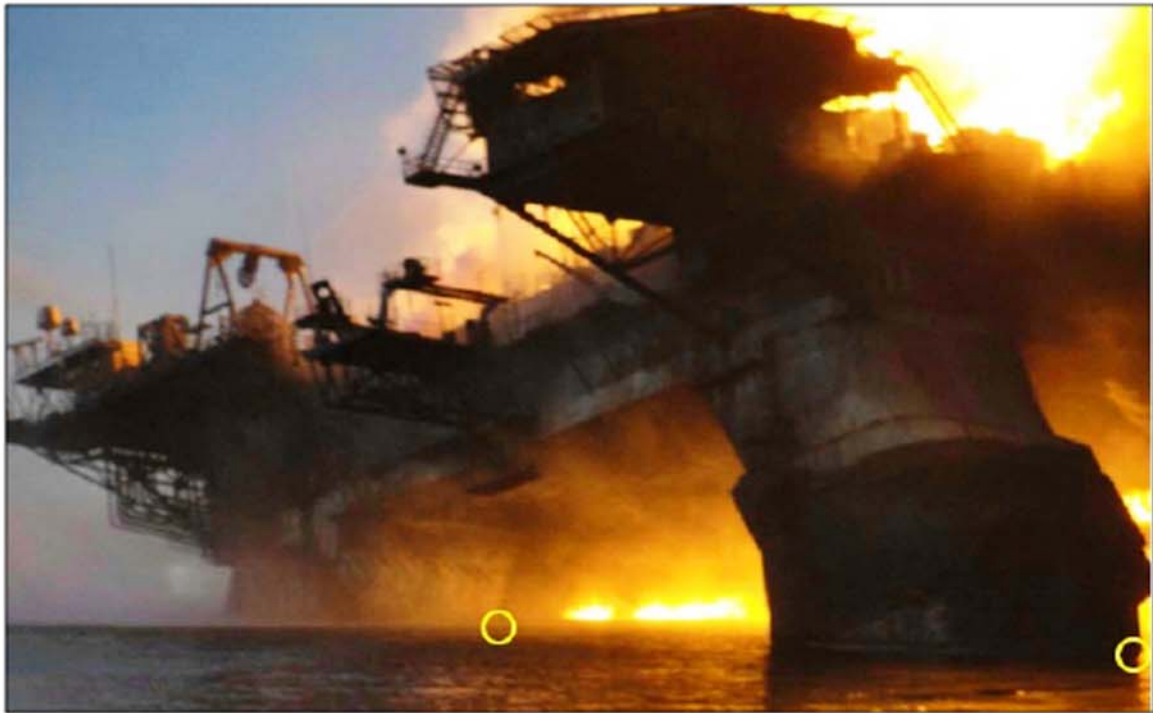
Figure 3: DEEPWATER HORIZON, Port Bow Aspect (0612 on 22 April 2010)

Without information on the rig’s loading prior to the casualty, it is impossible to analyze specific damage scenarios. We also lack precise information regarding the rig’s draft, heel, and trim as the casualty progressed. However, using photographs of the DEEPWATER HORIZON during the casualty, we estimated her waterplane in the damaged, floating condition. To estimate the waterplane, we used photographs taken at known times and identified three recognizable hull locations that intersected the waterline. The hull locations at the waterline that we used are marked on the photographs (see below) with yellow circles. Figure 3 and Figure 4 were reportedly taken at 0612 on April 22, 2010. Figure 5 and Figure 6 illustrate how the waterplane estimated from these photographs looks when applied to our computer model. Figure 7 and Figure 8 were taken at approximately 1030 on April 22, 2010, just prior to the rig sinking. Figure 9 and Figure 10 illustrate how the waterplane that was estimated from these photographs looks when applied to our computer model. Although the extent of damage shown in Figure 7 and Figure 8 indicate that some hull deflection may exist, our waterplane estimates cannot account for deflection and necessarily assume that the hull was not deflecting in the pictures.

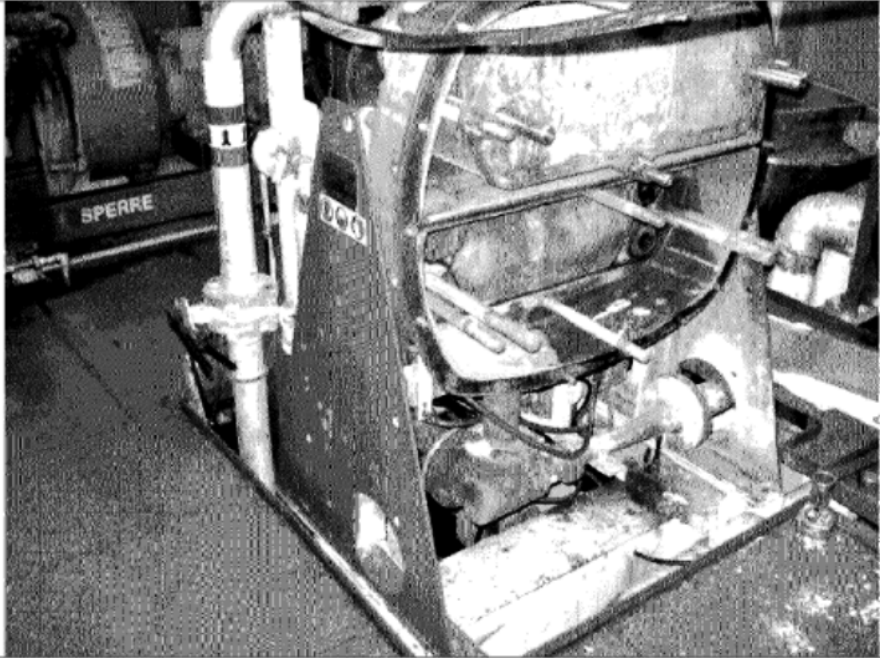
<b>Rig Name:</b>	Deepwater Horizon
<b>Date:</b>	September 2009
<b>ARAS Reference:</b>	1.1.5

<p><b>Observations or Comments:</b></p> <p>Maintenance on watermaker #5, note the front of the unit is opened up but none of the jacket water or seawater valves have been locked or tagged shut.</p>
