**FINDINGS OF CONCERN**

**Office of Investigations and Casualty Analysis**

Findings of Concern 015-23

**SEACOR POWER CASUALTY: DISPATCHER TRAINING,  
DRAFT READINGS, AND WEATHER FORECASTING FOR  
ALL COMMERCIAL VESSELS**

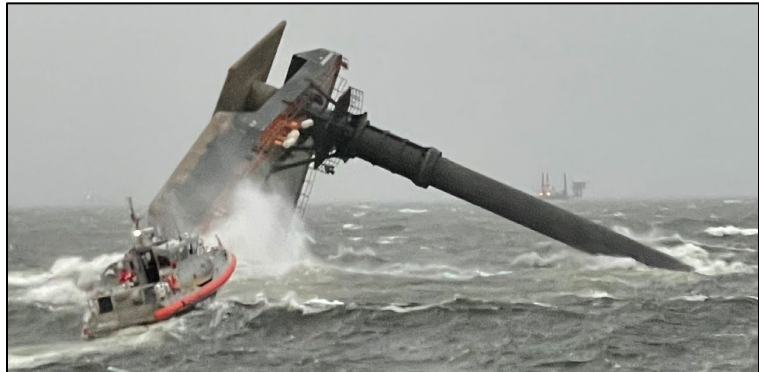
The Incident. In April 2021, a commercial liftboat carrying 19 individuals departed Port Fourchon and headed offshore in the Gulf of Mexico. Approximately seven nautical miles offshore, the vessel encountered unpredicted weather conditions that exceeded the vessel's operating limits. The winds were over 80 knots, and gusted up to 99 knots, which capsized the vessel and caused the tragic loss of 13 lives.
