National Transportation Safety Board

Marine Accident Brief

Fire On Board and Sinking of Liftboat *Mako*

Accident no.	DCA-12-LM-005
Accident type	Fire and sinking
Vessel	Offshore supply vessel (liftboat) <i>Mako</i>
Location	Atlantic Ocean, Gulf of Guinea, 6 miles off the coast of Nigeria 04°21.164' N, 005°47.053' E
Date	January 16, 2012
Time	0503 local time (coordinated universal time –1 hour)
Injuries	None
Property damage	Vessel was a total loss; estimated value of \$8,000,000
Environmental damage	Unknown
Weather	Foggy, winds 1–2 knots north, air temperature 80° F, visibility ¾ mile
Waterway characteristics	The Gulf of Guinea is the northeastern-most part of the tropical Atlantic Ocean. There are a number of active oil fields in this area off the coast of Nigeria.

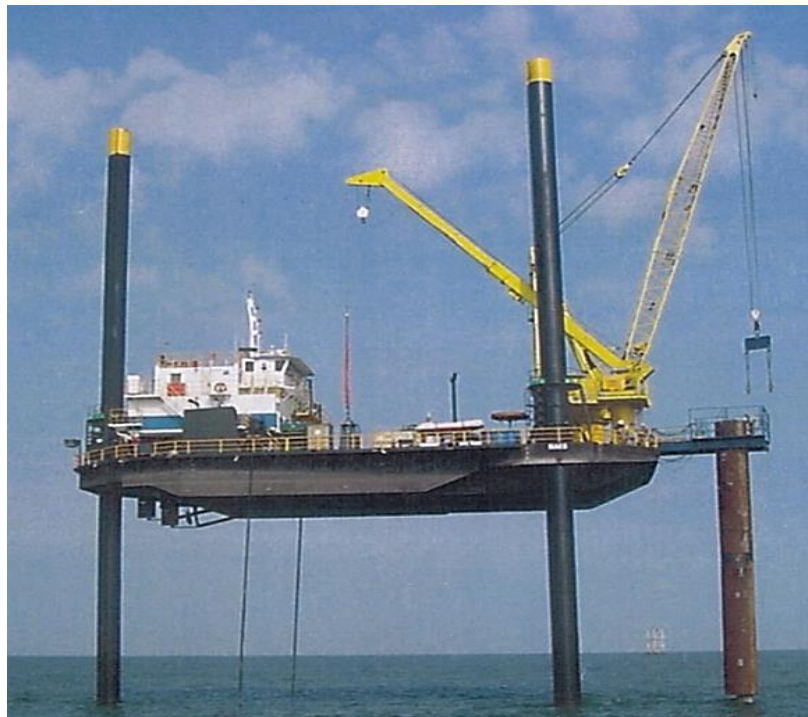
Liftboat *Mako* jacked up during operations. (Photo by Hercules Liftboat Company)

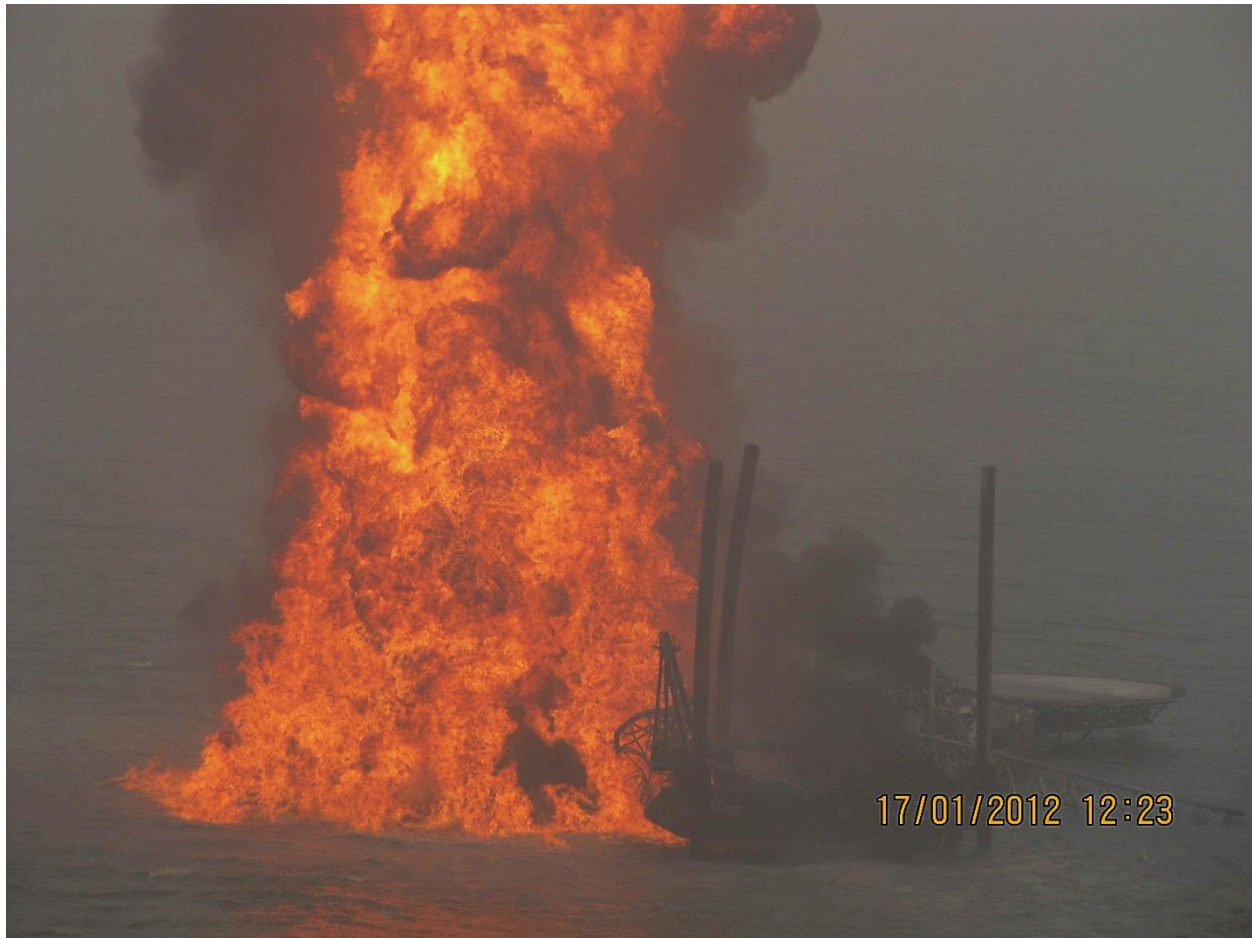
Photo of the fire, taken on January 17, 2012. The charred remains of the *Mako* are visible in the foreground, to the right of the flames. Photo provided by the US Coast Guard.

The *Mako* was consumed by the fire and eventually sank. The fire at the well continued to burn for about another month and a half, until March 2, 2012, when a portion of the well sealed itself. There were no fatalities or major injuries to personnel from the *Mako*; however, two workers from the *Endeavor* died.

The National Transportation Safety Board determines that the probable cause of the fire on board and sinking of the liftboat *Mako* was a blow-out of the well-head under the adjacent jack-up drilling rig *KS Endeavor*, which resulted in an uncontrollable gas fire that rapidly spread to the liftboat.
