# National Transportation Safety Board

## Marine Accident Brief

### Allision and Sinking of Offshore Supply Vessel *Celeste Ann*

<b>Accident no.</b>	DCA13NM025
<b>Vessel name</b>	<i>Celeste Ann</i>
<b>Accident type</b>	Allision and sinking
<b>Location</b>	Gulf of Mexico, 20 nautical miles southeast of Grand Isle, Louisiana
<b>Date, time</b>	June 14, 2013 0836 central daylight time (coordinated universal time – 5 hours)
<b>Injuries</b>	None
<b>Damage</b>	\$1 million
<b>Environmental damage</b>	Undetermined quantity of oil products discharged into the Gulf of Mexico
<b>Weather</b>	Clear, northwest winds 15 knots
<b>Waterway information</b>	Gulf of Mexico, seas 2–4 feet, current 2 knots

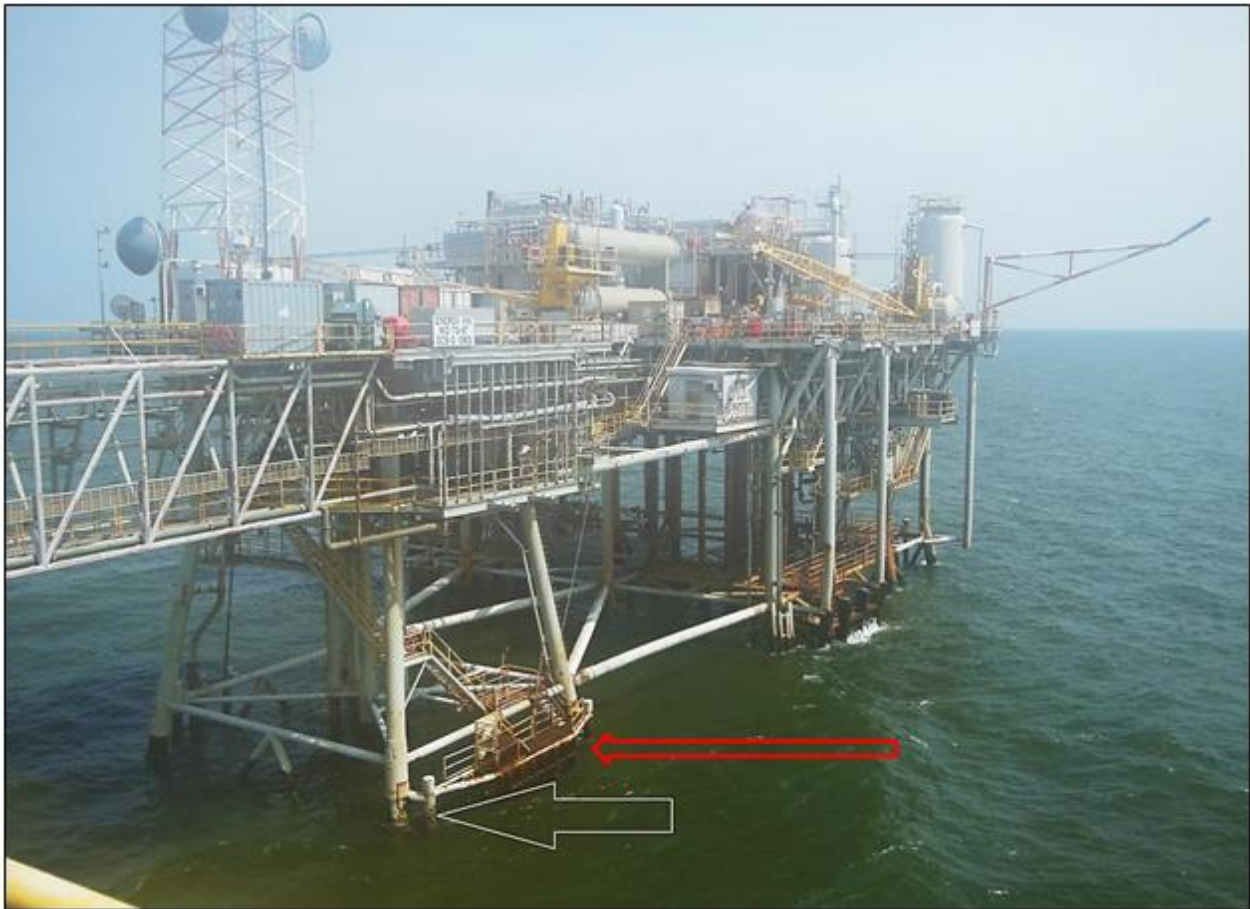
West Delta platform 73A, the landing platform (red arrow), and the area where the *Celeste Ann* allided after loading passengers (white arrow). (Photo by the United States Coast Guard)

The platform owner conducted an underwater survey of the landing area on the West Delta 73A platform after the accident. The survey noted that a vertical pipe on the platform was arranged with a clamp attaching the vessel landing to the platform. The clamp had two horizontal protrusions that extended off the vertical pipe that likely punctured the hull of the *Celeste Ann*.
