National Transportation Safety Board

Marine Accident Brief

Fire on Board Saturation Diving Support Vessel *Ocean Patriot*

Accident no.	DCA14LM003
Vessel name	<i>Ocean Patriot</i>
Accident type	Fire
Location	Gulf of Mexico, about 50 miles south-southwest of Port Fourchon, Louisiana 28° 13.1' N, 090° 23.4' W
Date, time	November 28, 2013 2215 central standard time (coordinated universal time – 6 hours)
Injuries	None
Damage	\$9.8 million
Environmental damage	None
Weather	Clear, visibility 10 miles, winds 10 knots, seas 1–3 feet
Waterway information	Gulf of Mexico

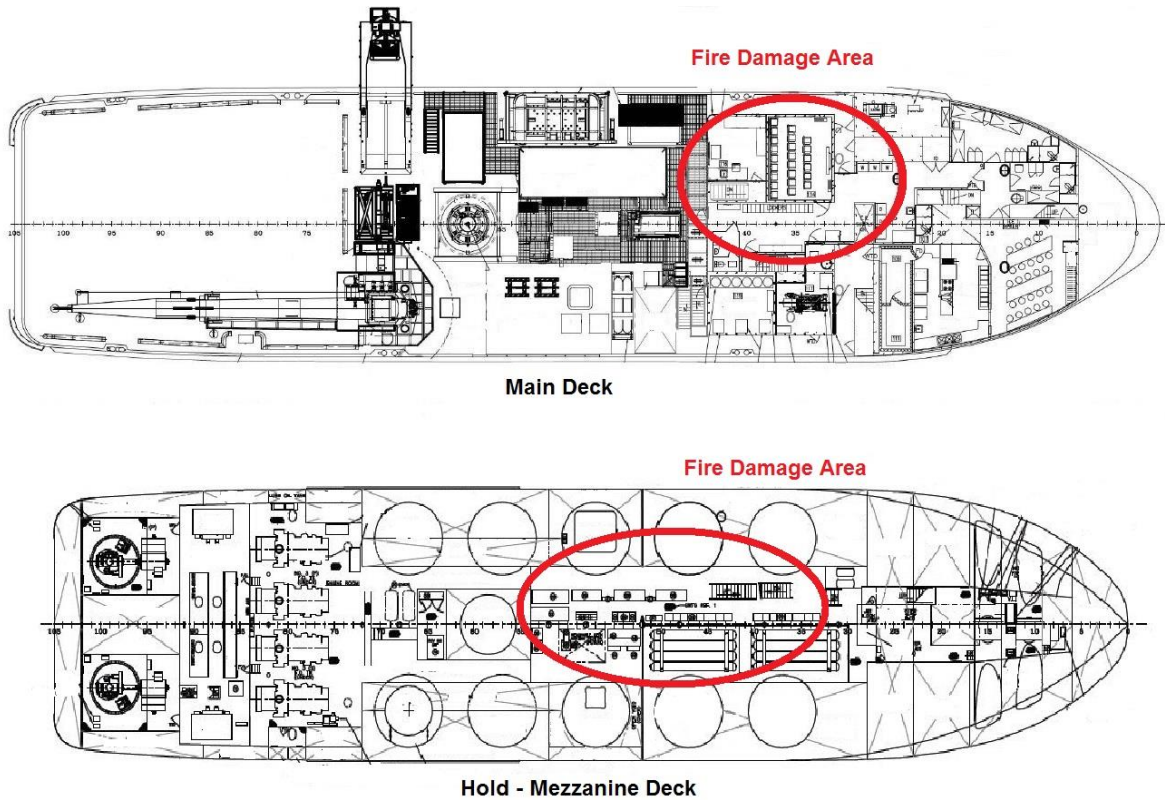
According to the assistant engineer, the fire was located in a cable tray above an electrical motor control center; the area directly underneath the cable tray was used for storing sundry items such as cardboard and air filters. He was first on the scene and attempted to fight the fire with a portable extinguisher, emptied the unit, but was not able to extinguish the fire. He returned to the engine room using an emergency escape hatch to muster with the rest of his department. On the bridge, the chief mate called the captain, rang the general alarm, and made a public address announcement to inform the crew of the situation. When the captain arrived on the bridge, he was briefed by the watch team and then notified the company via satellite phone, sent a distress signal via Global Maritime Distress and Safety System (GMDSS), ordered the ship's heading to be put into the wind, and directed the crew to be mustered. The captain then went below to the scene to assess the situation. Upon return, he ordered mayday to be called over the VHF radio. The crew gathered at their muster location, and all were accounted for. The fire teams assembled at their respective fire gear lockers.

Schematic drawings indicating location of fire damage on the main deck, top, and the mezzanine deck, bottom. (Drawings courtesy Oceaneering International)

About 15 minutes after the FM-200 was released, the chief engineer entered the change room directly above the fire to monitor the temperature of the deck. The deck was smoking and had buckled due to the heat, and the steel deck appeared to be breached. He used a fire axe to break cement above the steel deck to allow cooling water to be applied directly onto the steel; the water was continuously applied to the deck and temperatures began to drop. The crew consulted the FM-200 manual and was advised not to enter the space where the chemical was discharged.

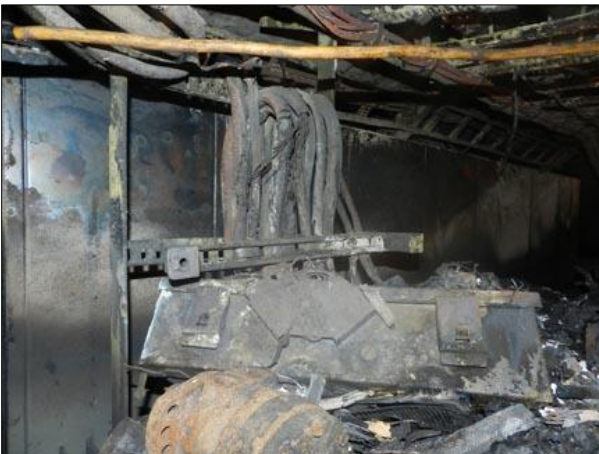
Oceaneering International hired an integrated forensic engineering investigation firm to conduct a survey of the damage to the vessel. The firm determined that the source of ignition was damaged electrical cables located in a cable tray that contained combustible material in storage racks just below. The fire damaged motor control centers and their associated cabling, helium storage bottles, a ventilation trunk, and various piping systems. Considerable smoke and soot damage was found in the machinery space, and the diving deck equipment stored there was also damaged. A main generator and frequency drive sustained water damage, and heat from the fire caused severe buckling to the main deck in the changing area.

Damaged electrical cables and cable tray, left, and motor control center, right.
(Photos courtesy Oceaneering International)

The National Transportation Safety Board determines that the probable cause of the fire on board the *Ocean Patriot* was damage to electrical cables due to the tightly installed metal securing bands in a cable tray chafing the protective layers of the cables and creating an ignition point. Contributing to the extensive damage was the combustible material stored immediately below the cable tray area, fueling the fire.
