National Transportation Safety Board

Marine Accident Brief

Collision of Offshore Supply Vessel *Gloria May* and Fishing Vessel *Capt Le*

Accident no.	DCA14LM017
Vessel names	Offshore supply vessel <i>Gloria May</i> Fishing vessel <i>Capt Le</i>
Accident type	Collision and sinking
Location	Gulf of Mexico, 16 nautical miles south of Pascagoula, Mississippi 30°02.918 N, 088°31.15 W
Date, time	August 24, 2014 2240 central daylight time (coordinated universal time – 5)
Injuries	None
Damage	<i>Gloria May</i> : est. \$50,000 <i>Capt Le</i> : loss of vessel valued at \$175,000
Environmental damage	Potential spill of about 10,000 gallons of diesel fuel and 200 gallons of lube oil on board the <i>Capt Le</i> ; salvage operations recovered 5,500 gallons of oil/water mixture.
Weather	Clear sky, visibility 10 nautical miles, air temperature 85°F, east-southeast wind 15–20 knots, current 1 knot from northeast
Waterway information	Gulf of Mexico

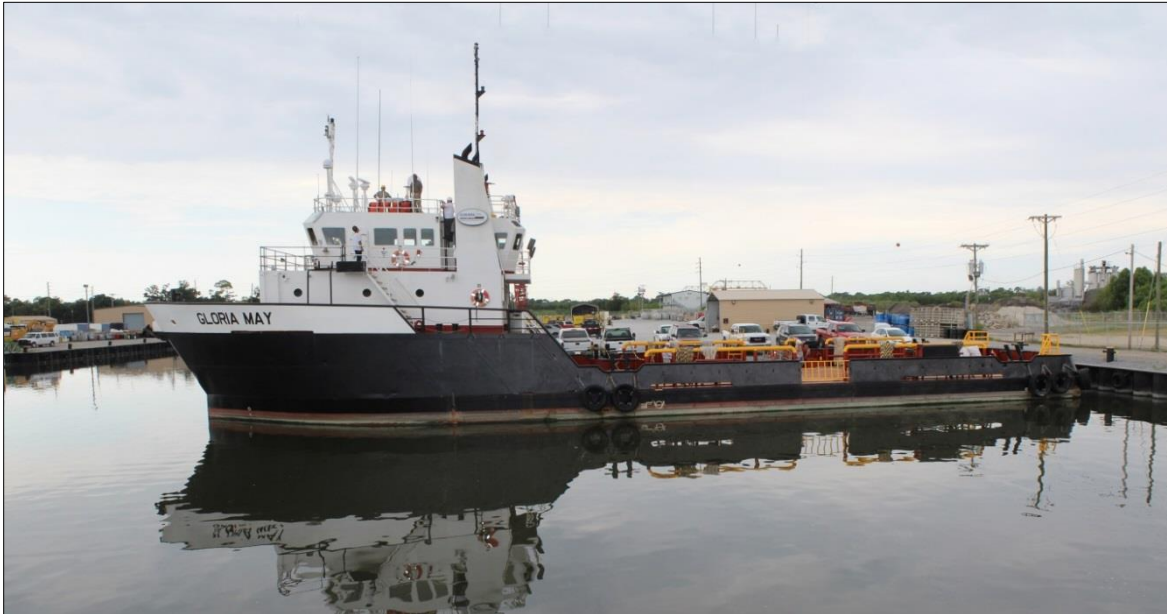
Offshore supply vessel *Gloria May* in port after the collision.

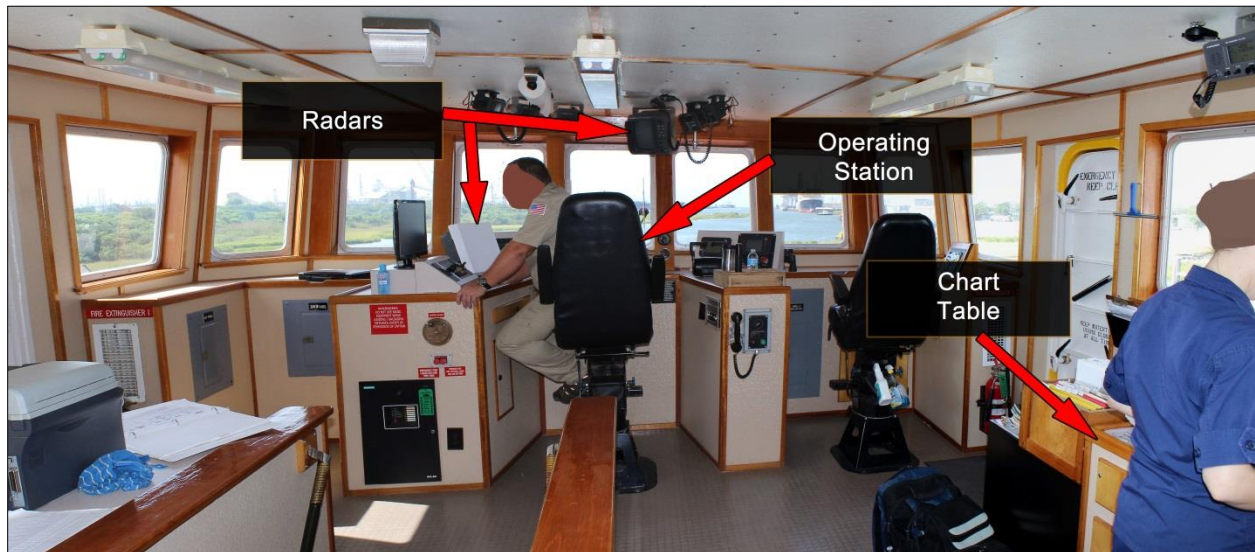
Wheelhouse of the *Gloria May*, looking from aft to forward at centerline. The operating station is at the forward area of the wheelhouse, and the chart table is at the starboard side.

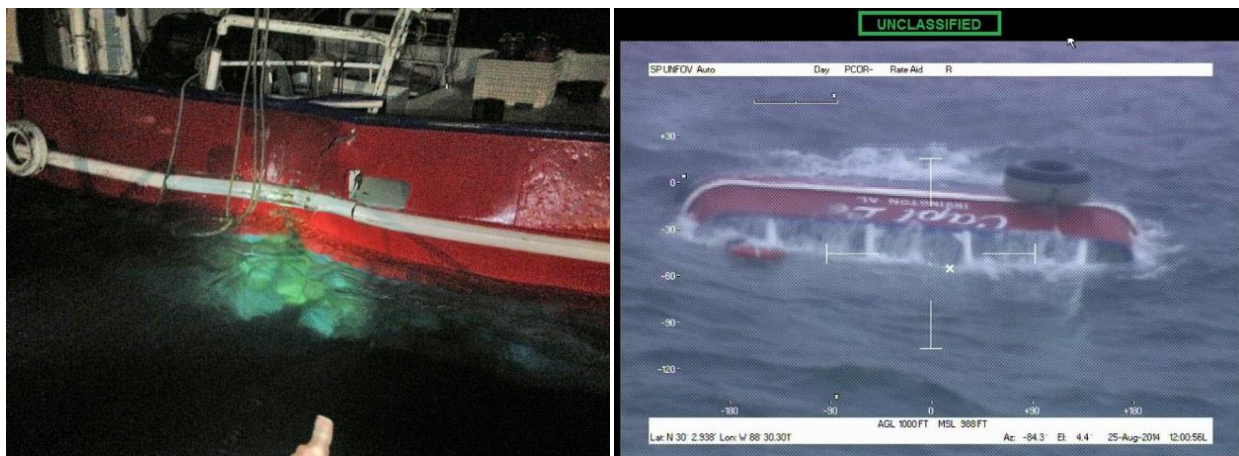
As a result of the collision, the port side of the *Capt Le*'s hull in the area of the bulkhead between the engine room and the fish hold was split open over a length of about 10 feet starting from 3 feet below the gunwale and extending downward toward the vessel's keel. The width of the split in the hull was about 2 to 3 feet, and the hull in the area of the split was inset about 1.5 feet.

Damage to port side of *Capt Le* (left) and the *Capt Le* after the collision with stern protruding above the sea (right). (Photos by Coast Guard)

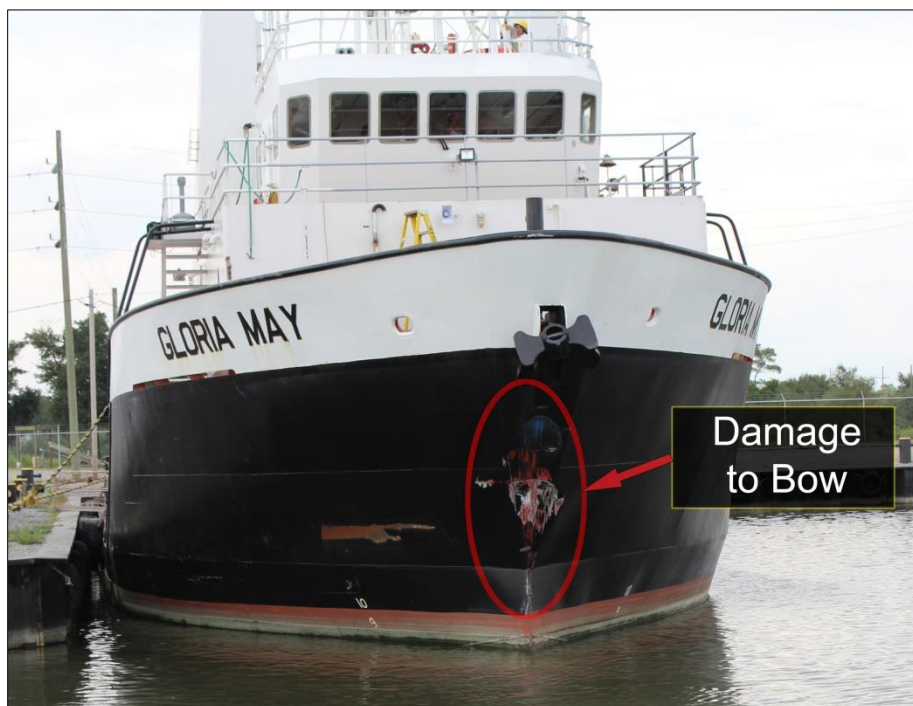
Damage to the *Gloria May* consisted of denting and scraping of the bow on either side of the stem above the waterline where the bow contacted the port side of the *Capt Le*. Additional damage was found to the hand rails at the walkway forward of the wheelhouse, the aft mast atop the aft end of the wheelhouse, a communication antenna and a radar antenna on the top of the wheelhouse, and other areas that apparently contacted the fishing vessel's port outrigger.

Scraping and denting damage to the bow of the *Gloria May*.
