National Transportation Safety Board

Marine Accident Brief

Allision of Offshore Supply Vessel *Connor Bordelon* with Unmanned Platform South Timbalier 271A

Accident no.	DCA15LM012
Vessel name	Offshore supply vessel <i>Connor Bordelon</i>
Accident type	Allision
Location	About 5.25 miles* south of Port Fourchon, Louisiana, jetty channel entrance 28°59.9' N, 90°13.75' W
Date	January 23, 2015
Time	0432 central standard time (coordinated universal time – 6 hours)
Injuries	None
Property damage	Between \$350,000 and \$500,000 to the <i>Connor Bordelon</i> , \$4.1 million to the platform and pipelines
Environmental damage	None
Weather	Cloudy skies with passing rain showers, winds from the northeast at 15 to 20 knots, visibility 3 to 5 miles, seas 3 to 5 feet
Waterway information	Gulf of Mexico

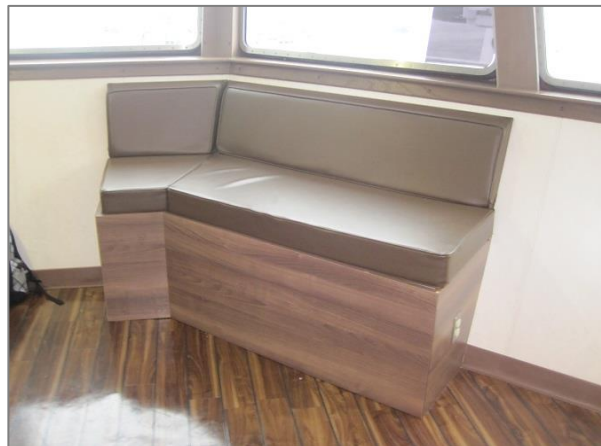
The bridge team on the accident watch consisted of the two mates, an able-bodied (AB) unlicensed sailor qualified to perform routine duties aboard the vessel, and an ordinary seaman (OS) who had less experience than the AB. The AB and the OS performed various duties as directed by the mates, including safety checks of the vessel and, when instructed, lookout duties. The two mates switched out the conn as they deemed appropriate. The mate on watch at the time of the accident took over the conn about 0340, about 50 minutes before the accident. The mate he relieved then went to rest but remained awake on a settee (small couch) located on the starboard side of the bridge below the bridge windows. At that time, the AB was below deck in the galley (with permission from the mate on watch). The OS was on the port side of the bridge in the captain's office, which had a small desk with a privacy wall that would not have allowed a view forward out the windows if he was seated at the desk. According to the AB and the OS, the mate on the settee could perform the lookout duties when called to do so. However, the mate on watch did not ensure that a designated lookout was on the bridge.

The left photo shows the captain's office on the port side of bridge, where the OS was located just before the allision. The right photo shows the settee on the starboard side of the bridge, where a mate was resting just before the allision. (Photos by the Coast Guard)

- **Watchstanding practices:** The officer of the watch needs to ensure that a proper lookout is posted during navigation. In this case, the officer did not designate one of the available watchstanders as the lookout, resulting in a missed opportunity to detect the platform earlier.
