# National Transportation Safety Board

## Marine Accident Brief

### Collision between Passenger Vessel *Diamond Edge* and Liftboat *B.W. Haley*

<b>Accident no.</b>	DCA15LM015
<b>Vessel names</b>	<i>Diamond Edge</i> and <i>B.W. Haley</i>
<b>Accident type</b>	Collision, with subsequent partial sinking of the <i>Diamond Edge</i>
<b>Location</b>	Freshwater Bayou Safety Fairway, Gulf of Mexico (29°27.84'N, 092°18.76'W)
<b>Date</b>	March 2, 2015
<b>Time</b>	1027 central standard time (coordinated universal time – 6 hours)
<b>Injuries</b>	None
<b>Damage</b>	Est. \$1.75 million
<b>Environmental damage</b>	None reported
<b>Weather</b>	Dense fog, visibility less than 0.1 mile; air temperature 65°F; winds easterly at 8 knots
<b>Waterway information</b>	Open waters of the Gulf of Mexico about 55 miles south-southwest of Lafayette, Louisiana

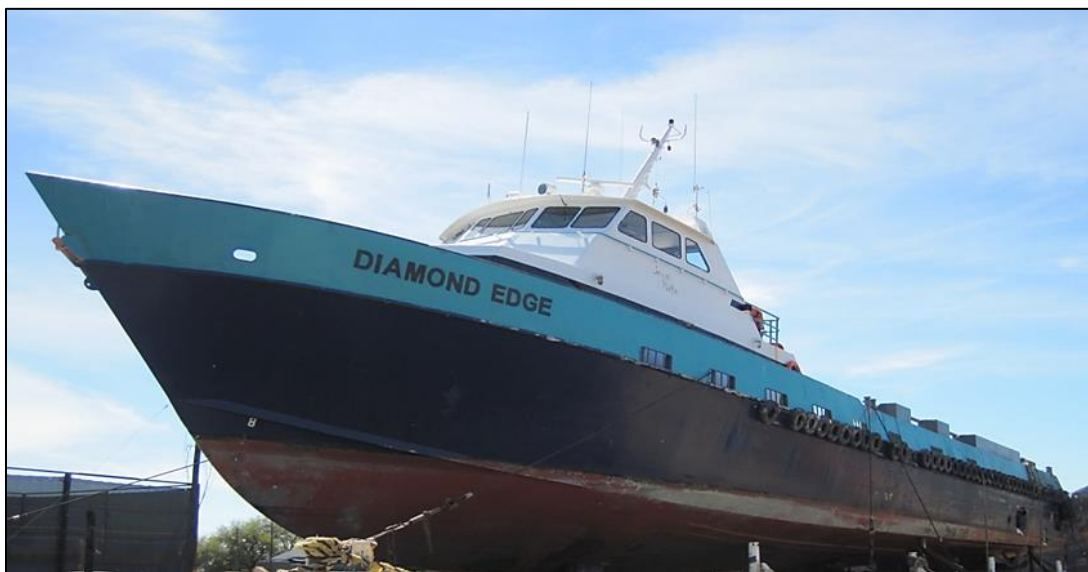
Passenger vessel *Diamond Edge* on a transport barge after it was salvaged.

The force of the collision spun the *B.W. Haley* around and caused over \$117,000 damage to the vessel, but it remained afloat. However, the *Diamond Edge* rapidly took on water from two holes in its aft port side and lost power. A little before 1100, the *B.W. Haley* came alongside the *Diamond Edge* and rescued the four *Diamond Edge* crewmembers. The *B.W. Haley* then returned to port under its own power. The stern of the *Diamond Edge* eventually sank, with its bow remaining above the surface. A few days after the collision, the *Diamond Edge* was lifted onto a barge for transport to a shipyard. Damage was estimated to be at least \$1.75 million.

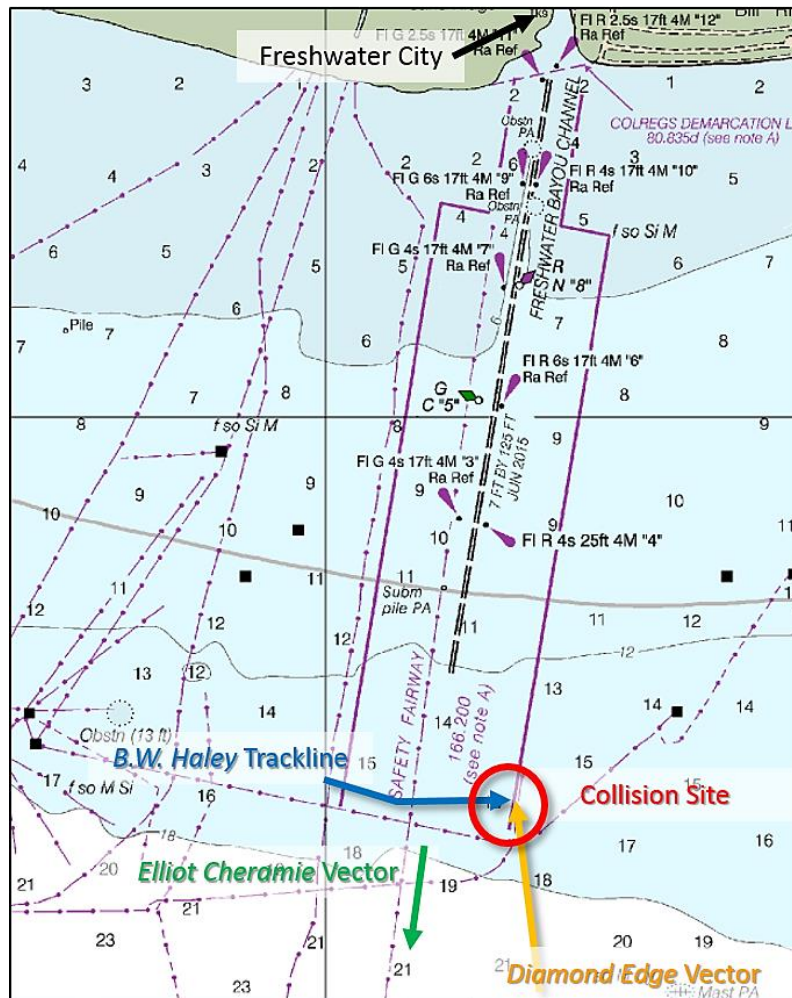
The *Diamond Edge* captain told investigators that, about 1030, he visually saw *B.W. Haley* coming out of the fog at a distance of 60 feet on a collision course with his port bow. The captain said he could not immediately go into reverse because it would have stalled the engines. Therefore, he sped up and turned his vessel to port—toward the *B.W. Haley*—to kick his stern away from the liftboat (information recovered from the *Diamond Edge*'s navigation computer indicates that the vessel initially turned to starboard before turning to port). The captain's maneuvers, however, did not clear the *B.W. Haley* and, according to AIS, the aft port side of the *Diamond Edge* impacted the liftboat's starboard bow and leg mat about 1027.

Chart depicting *Elliot Cheramie* and *Diamond Edge* AIS vectors, *B.W. Haley* GPS trackline, and the collision site. (Background NOAA chart 11349; overlay by NTSB using data compiled from *Diamond Edge*'s navigation computer)

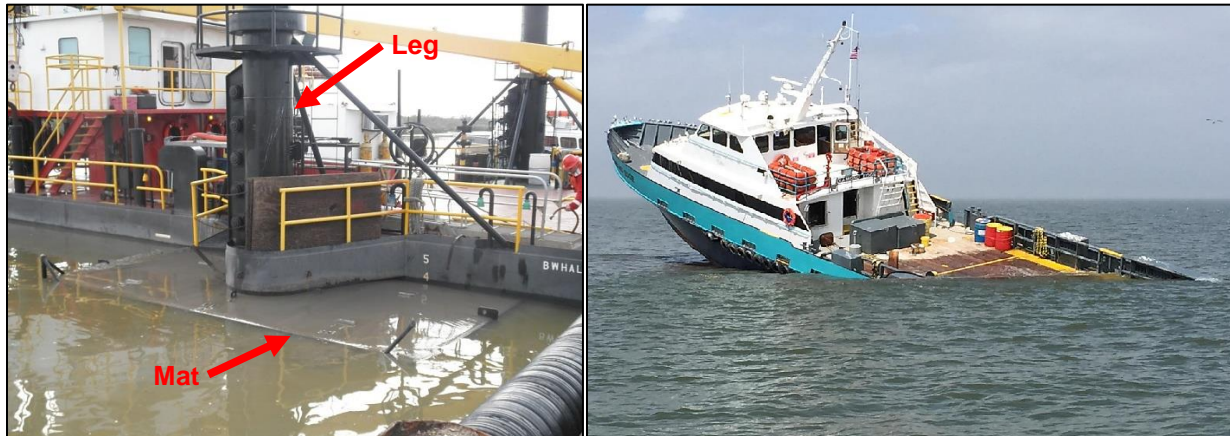
Left picture shows *B.W. Haley* with close-up of starboard leg and mat where the collision occurred. Right picture shows the partially submerged *Diamond Edge*. (Photos by US Coast Guard)

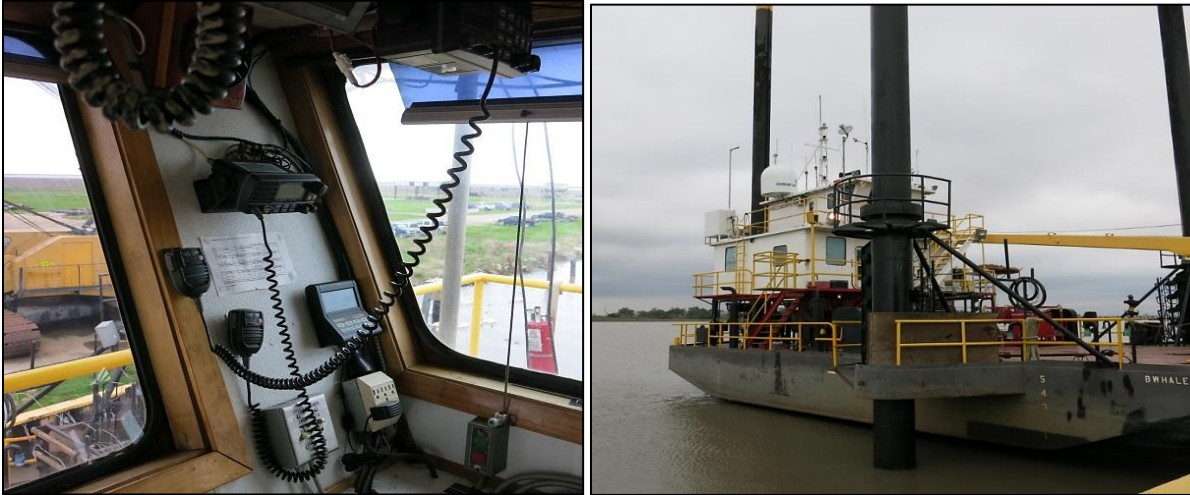
The *B.W. Haley* captain stated that he steered the liftboat; operated the whistle, radar, and VHF radio; navigated the vessel; and was the visual lookout. As lookout, the captain's field of vision was blocked by the wide forward corner column of the wheelhouse and by the position of the raised starboard lifting leg (see next photo). Both the deckhand/relief captain and vessel assistant stated it was hard to see the *Diamond Edge* visually because it was hidden by the leg.

Left picture shows view towards the starboard bow of *B.W. Haley* as seen from captain's wheelhouse conning position. Right picture shows radar shadow area to wheelhouse of *B.W. Haley*.

Since radar transmissions are basically line-of-sight, the lifting legs that visually impaired the captain also obstructed the radar mounted directly above the bridge. The lifting legs created radar shadow areas that could have masked contacts within these zones. Given that the *Diamond Edge* collided with the starboard leg mat and starboard bow of the *B.W. Haley*, it is possible that the *Diamond Edge* was in a shadow area at some point prior to impact. Long-range radar scanning would have mitigated this risk, but the captain told investigators that he did not use this practice.
