Personnel Abandonment of Weather-Damaged  
US Liftboat *Trinity II*, with Loss of Life  
Bay of Campeche, Gulf of Mexico  
September 8, 2011

**Accident Report**

NTSB/MAR-13/01  
PB2013-106633

# Marine Accident Report

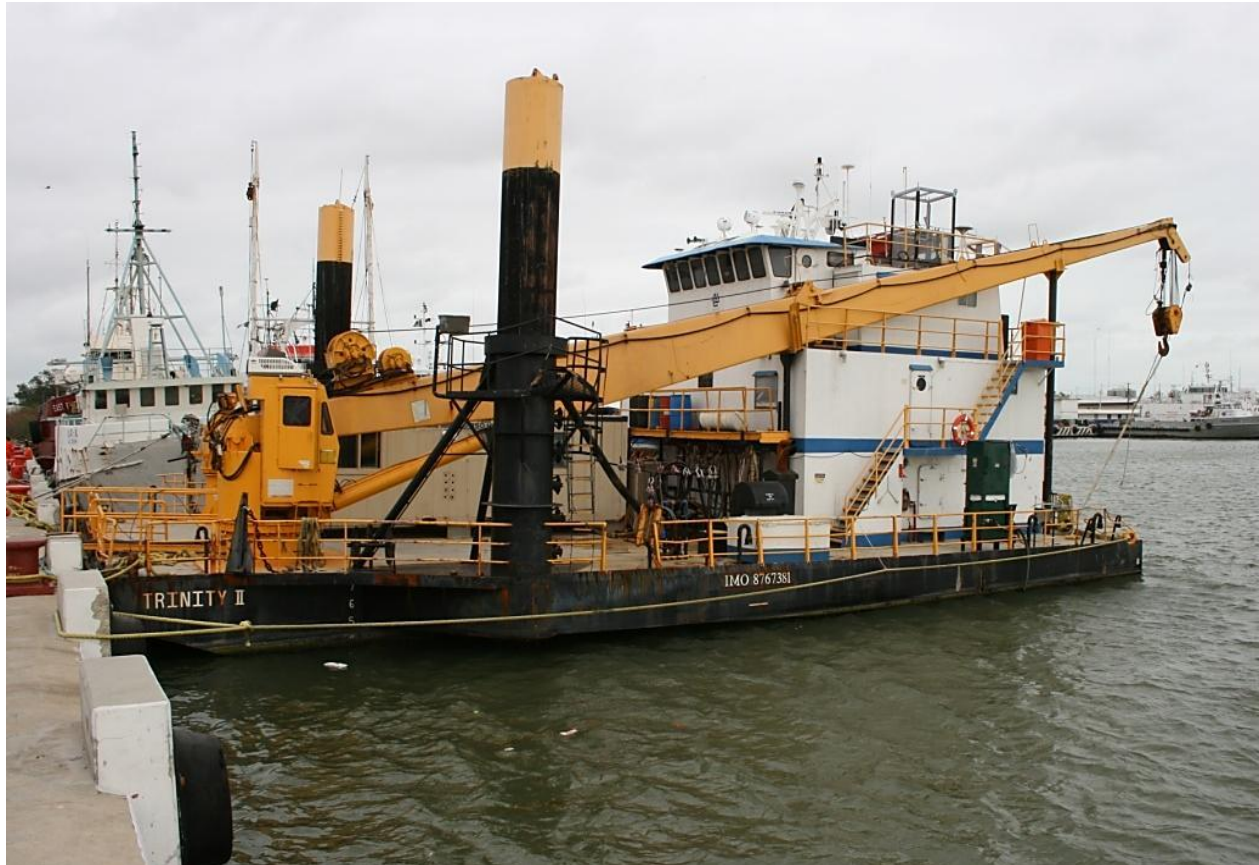
**Figure 1.** *Trinity II* after the accident.

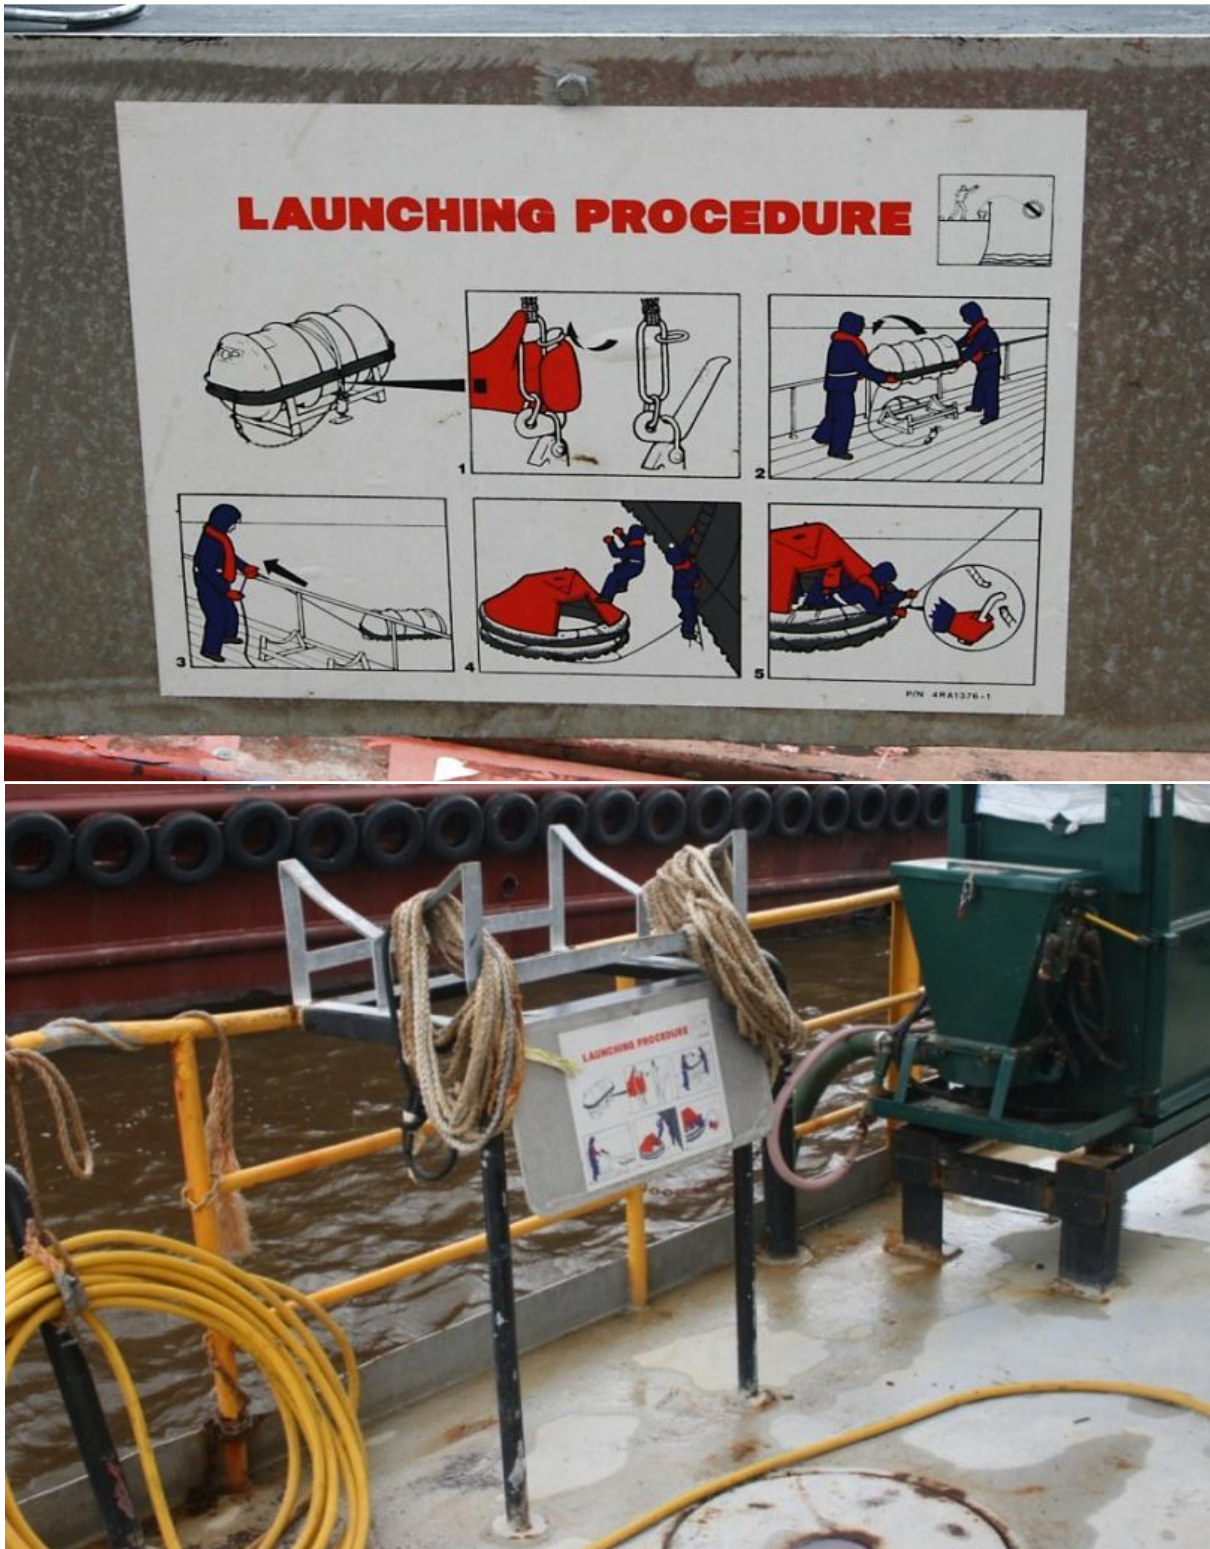
Figure 6. The illustrations, posted below the liferaft cradles, showing how to launch the liferafts.

The AB told investigators that before the personnel inflated the starboard-side liferaft, someone tied the liferaft's painter to the vessel's handrail.<sup>16</sup> They placed the liferaft canister onto the deck and inflated the liferaft. When the liferaft inflated on deck, the high winds caught it, parted (broke) the painter, and "just took [the liferaft] out to sea."

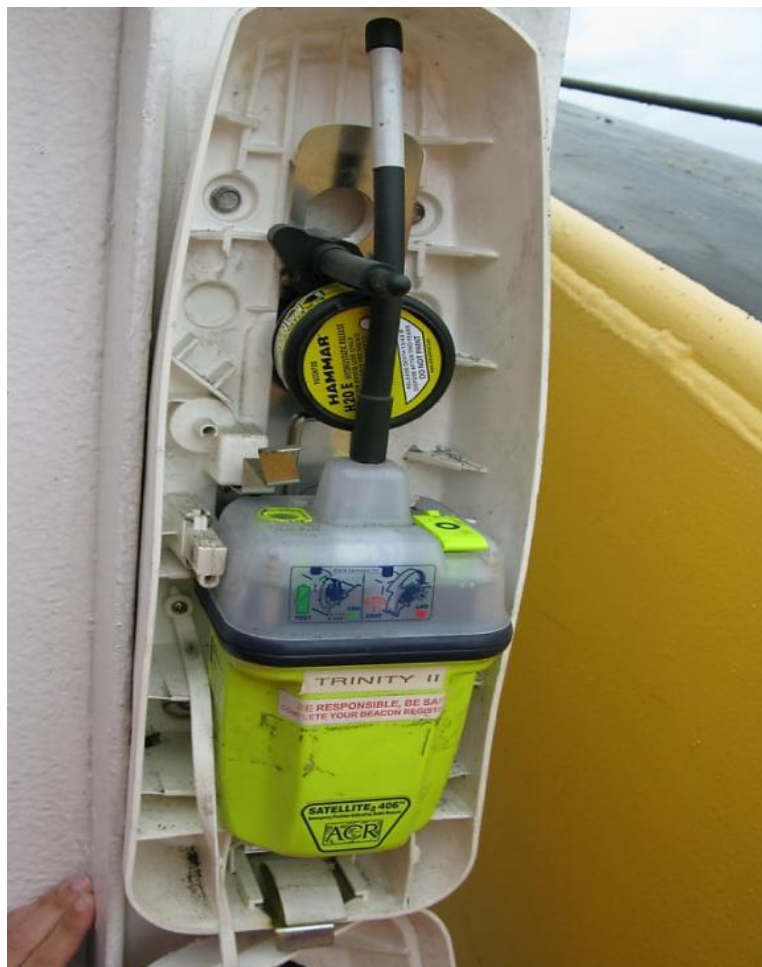
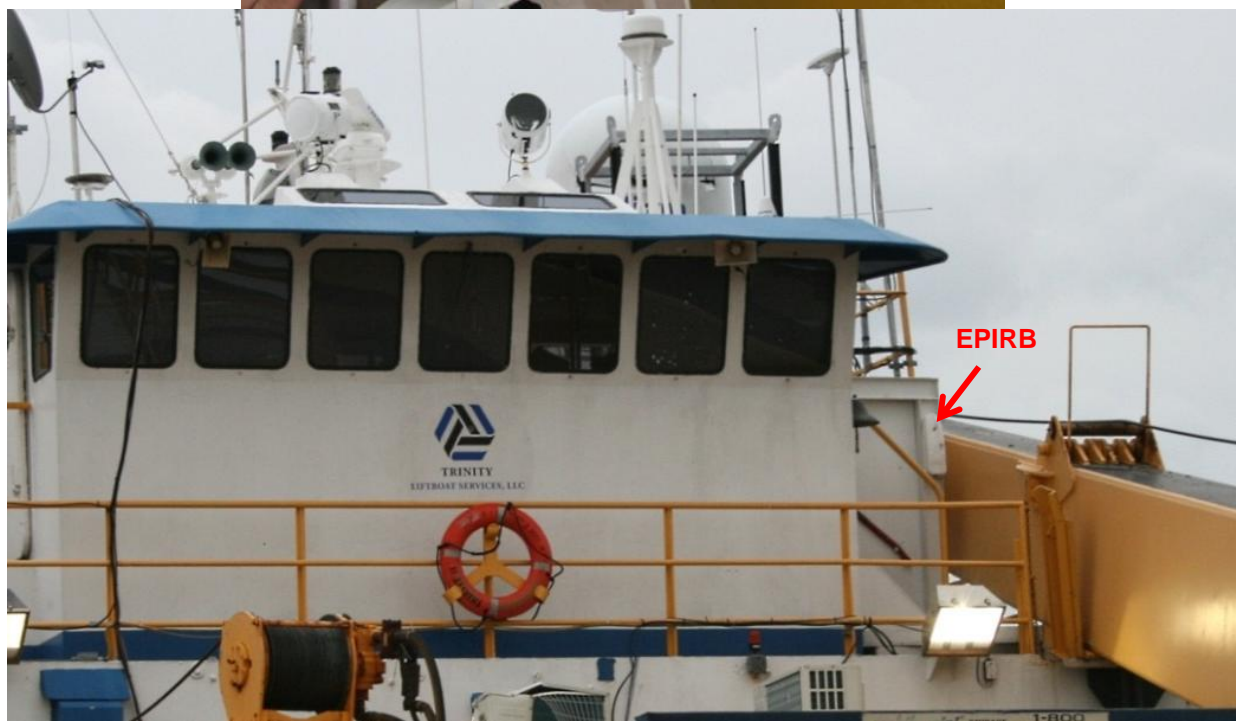
The master told investigators that he returned to retrieve the EPIRB, which was located on a port bulkhead immediately outside the wheelhouse (figure 7). The master said that he was unable to retrieve the EPIRB because the portside crane was "picking up and slamming side to side," and he thought that it would hit him if he got too close. The master returned to the main deck without the EPIRB. (After the *Trinity II* was salvaged and returned to port, investigators found the EPIRB still in its container. It was undamaged and had not been activated.)

**Figure 7.** The *Trinity II*'s EPIRB during postaccident examination, and the EPIRB's location on the portside bulkhead just outside the wheelhouse.

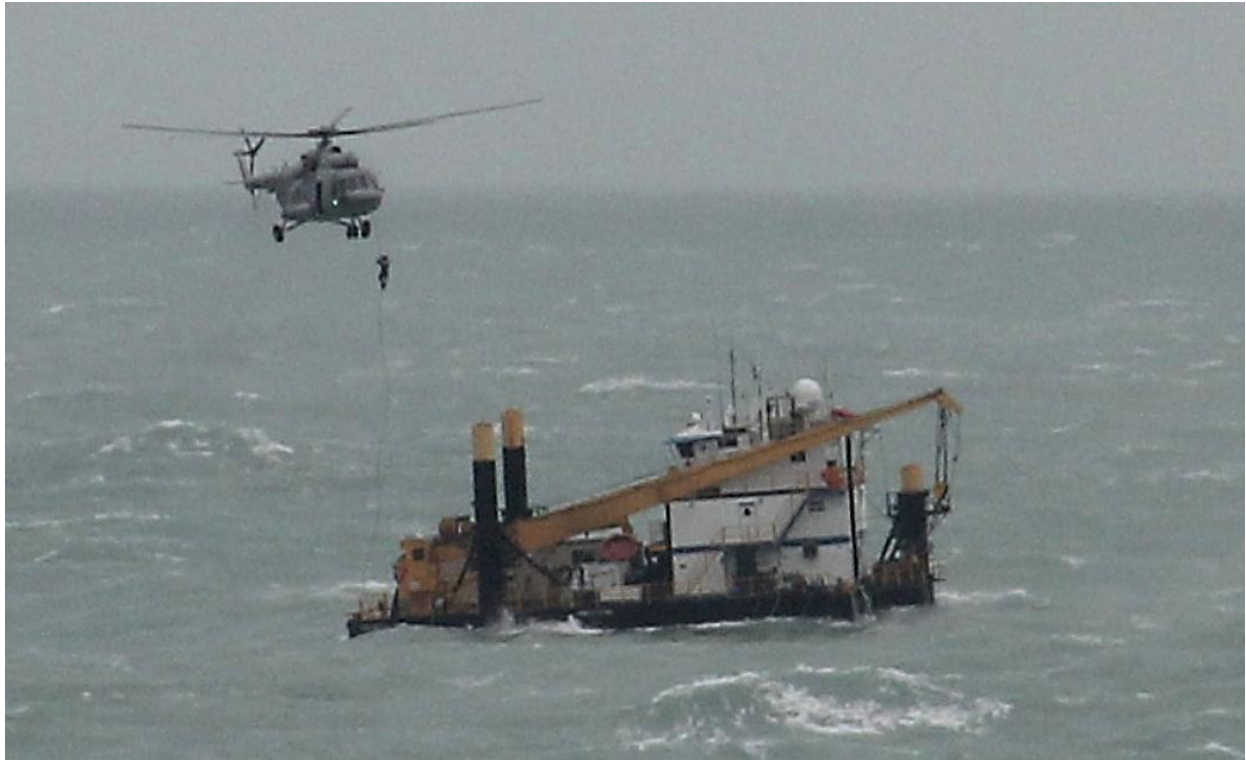
After the *Trinity II*'s two remaining jacking legs fractured and separated, the vessel drifted for several days. During the time the vessel was adrift, Mexican authorities, including the Mexican Navy—Secretaría de Marina, or "SEMAR"—were able to monitor the vessel's track by using automatic identification system (AIS) data transmitted from the vessel.<sup>18</sup> After several days adrift, the *Trinity II* threatened oil production platforms. SEMAR personnel then boarded the vessel and arranged to have it towed to Ciudad del Carmen. When SEMAR boarded the *Trinity II*, it was still afloat and stable in the water (figure 9).

**Figure 9.** Photo of the adrift *Trinity II*, taken while SEMAR personnel boarded the vessel.

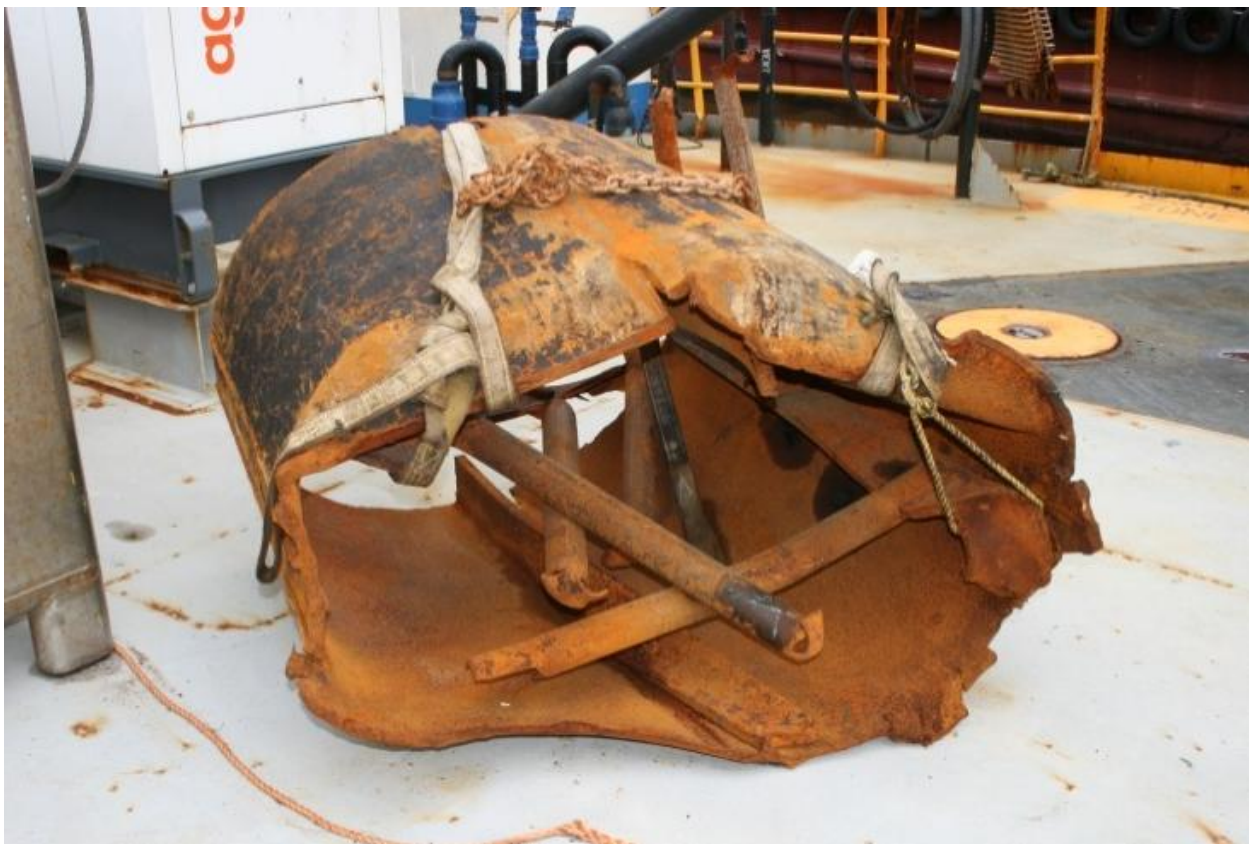
**Figure 11.** A section of *Trinity II*'s fractured stern leg.

In the case of the *Trinity II* leg failure, the vessel was subjected to wave impact forces on its hull. These forces, combined with the weight of water on deck from the boarding seas, likely caused the stern leg to fail. However, because of lack of information on the magnitude of the waves and the extent of the vessel's lateral movement, and because the condition of the seafloor and the exact amount of leg penetration are unknown, the leg failure could not be validated through modeling. In addition, the Coast Guard's design review files contained "incomplete calculations provided by industry," and metallurgical examination of the stern leg had not been conducted. As a result, other factors, such as design errors or fabrication/material defects, could not be excluded. Therefore, the NTSB concludes that the stern jacking leg of the *Trinity II* likely failed because it was subjected both to lateral forces from waves impacting the vessel's hull and to additional weight from water on deck, and this loading exceeded the stern leg's strength.

1. The mechanical condition of the vessel before the onset of the storm was not a factor in the accident.
2. The stern jacking leg of the *Trinity II* likely failed because it was subjected both to lateral forces from waves impacting the vessel's hull and to additional weight from water on deck, and this loading exceeded the stern leg's strength.

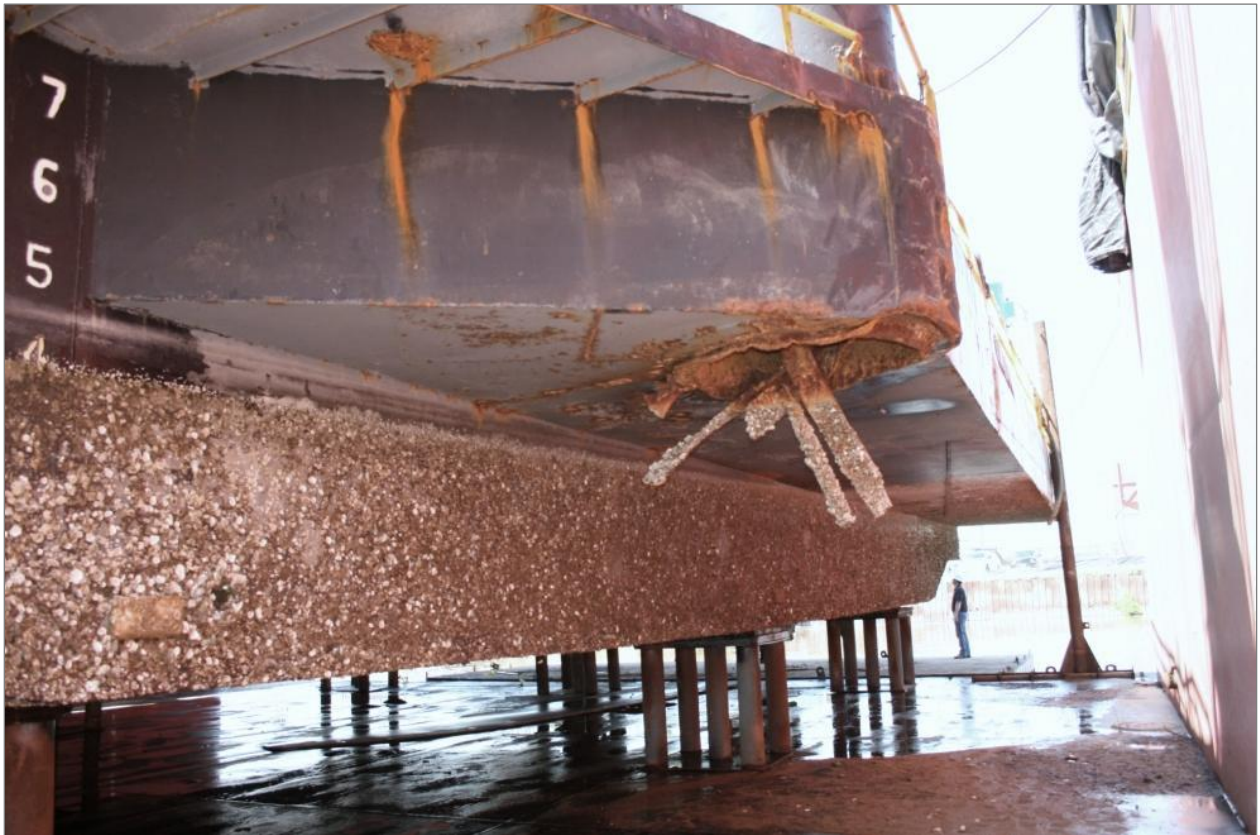
The *Trinity II* remained berthed in Ciudad del Carmen until mid-March 2012, and was then returned to the United States. NTSB investigators examined the vessel during two separate visits to Mexico, each time with the cooperation of the Secretaría de Comunicaciones y Transportes (SCT; similar to the US Department of Transportation), whose role included overseeing vessel inspections. NTSB investigators also examined the *Trinity II* while it was drydocked in the United States before being repaired. The stern leg had fractured about 10 feet below the hull (figure 11). The two forward legs had broken off just below the hull, which occurred at some point after the stern leg failed as the vessel continued to be pounded by seas and winds (figure 12).

**Figure 12.** The fractured starboard-side leg at the lower end of the tower support structure.
