NATIONAL TRANSPORTATION SAFETY BOARD

MARINE ACCIDENT REPORT

CAPSIZING AND SINKING OF THE
UNITED STATES DRILLSHIP
GLOMAR JAVA SEA
IN THE SOUTH CHINE SEA
65 NAUTICAL MILES SOUTH-SOUTHWEST
OF HAINAN ISLAND,
PEOPLE'S REPUBLIC OF CHINA
OCTOBER 25, 1983

NTSB/MAR-87/02
(SUPERSEDES: NTSB/MAR-84/08)

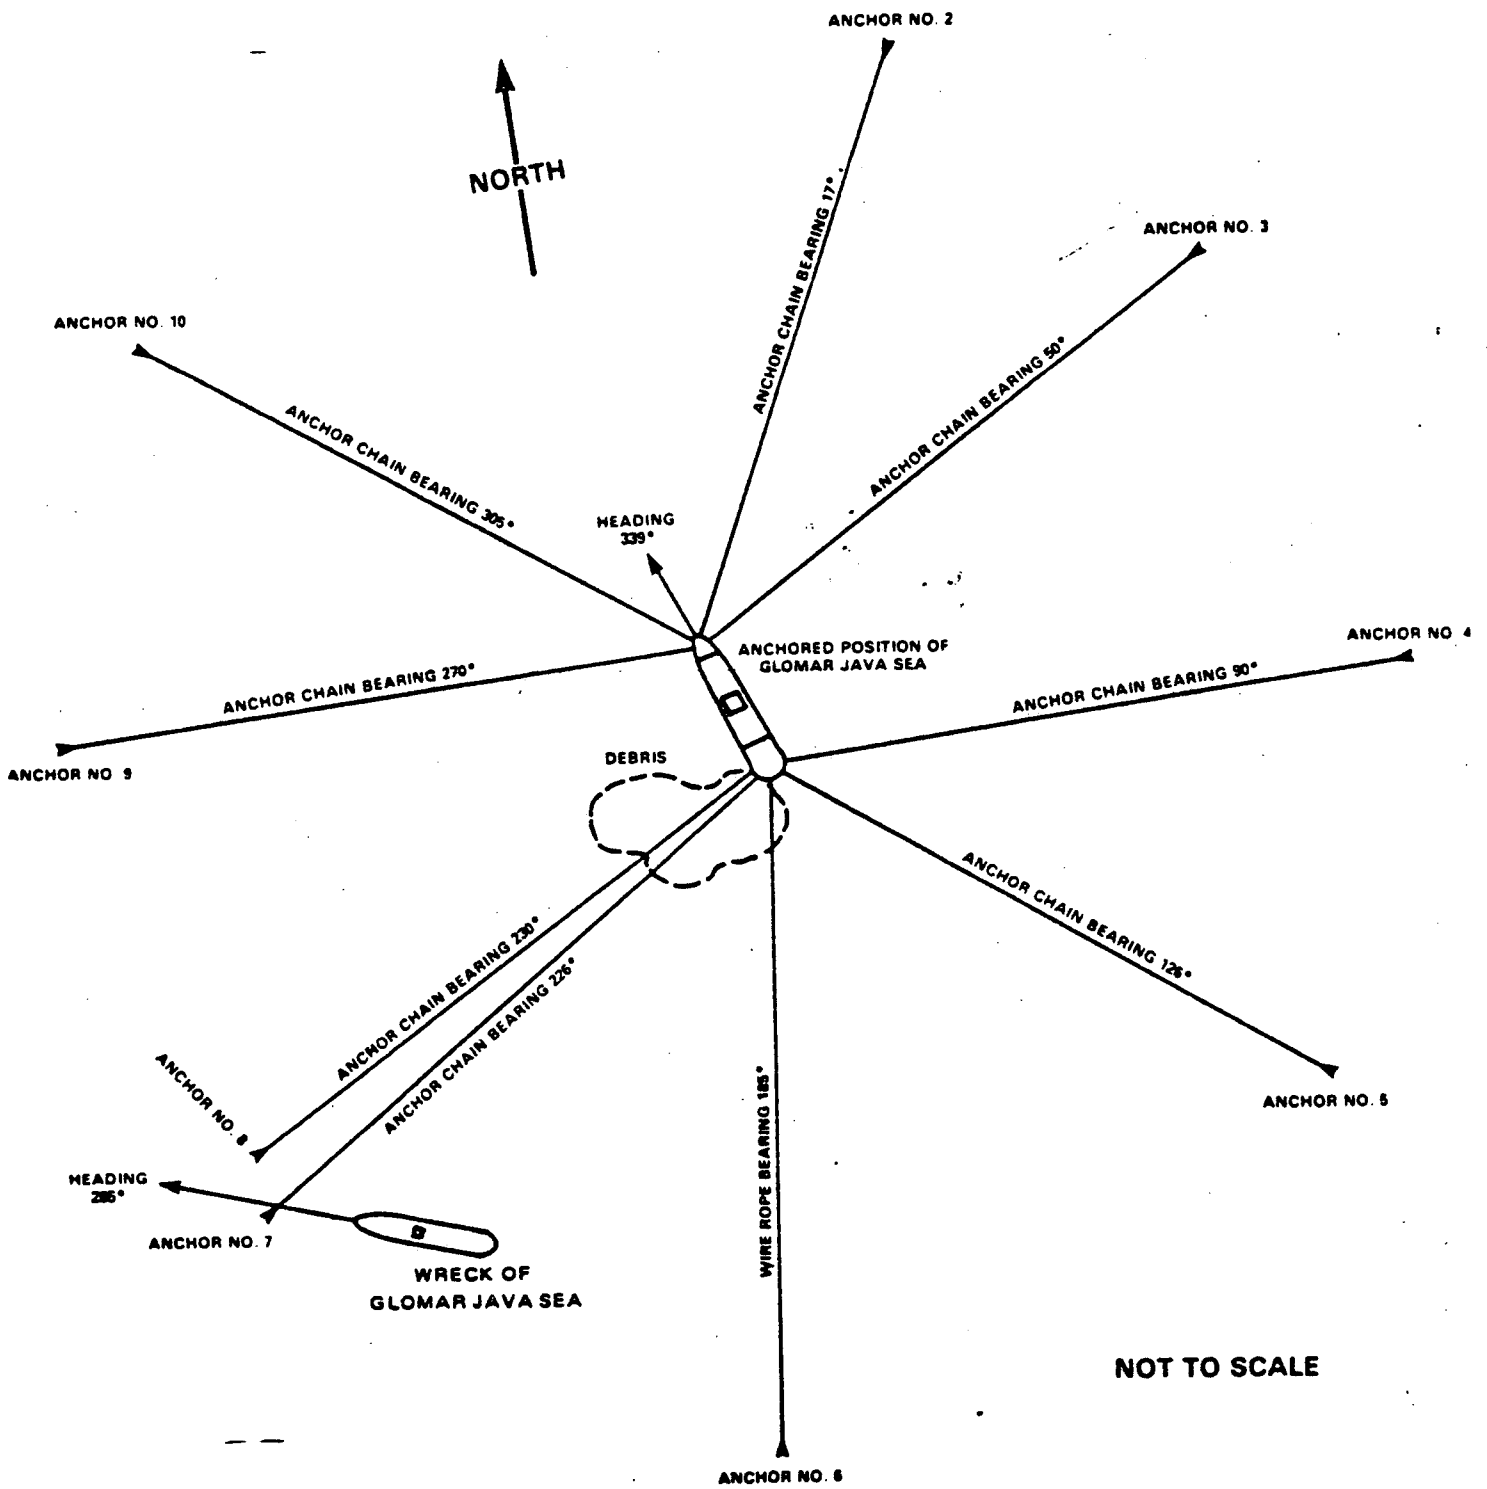
Figure 4.—Actual anchor pattern and position of wreck of GLOMAR JAVA SEA.

The GLOMAR JAVA SEA sank upside down in about 315 feet of water about 1,650 feet southwest of its anchored position over the well and is resting on the sea floor in an inverted position. Underwater videotapes of the sunken drillship were taken during November 1983 and March 1984. The videotapes showed a major structural failure amidships on the starboard side. The fracture ran from the main deck plating, down the starboard side shell plating, and into the bottom plating. The videotapes also showed a major deformation of the lower side shell plating for about 15 feet forward and 25 feet aft of the fracture and some damage to the shell plating near the bow. The drill tower was missing and the deckhouse was damaged. The value of the drillship was estimated at \$35 million.

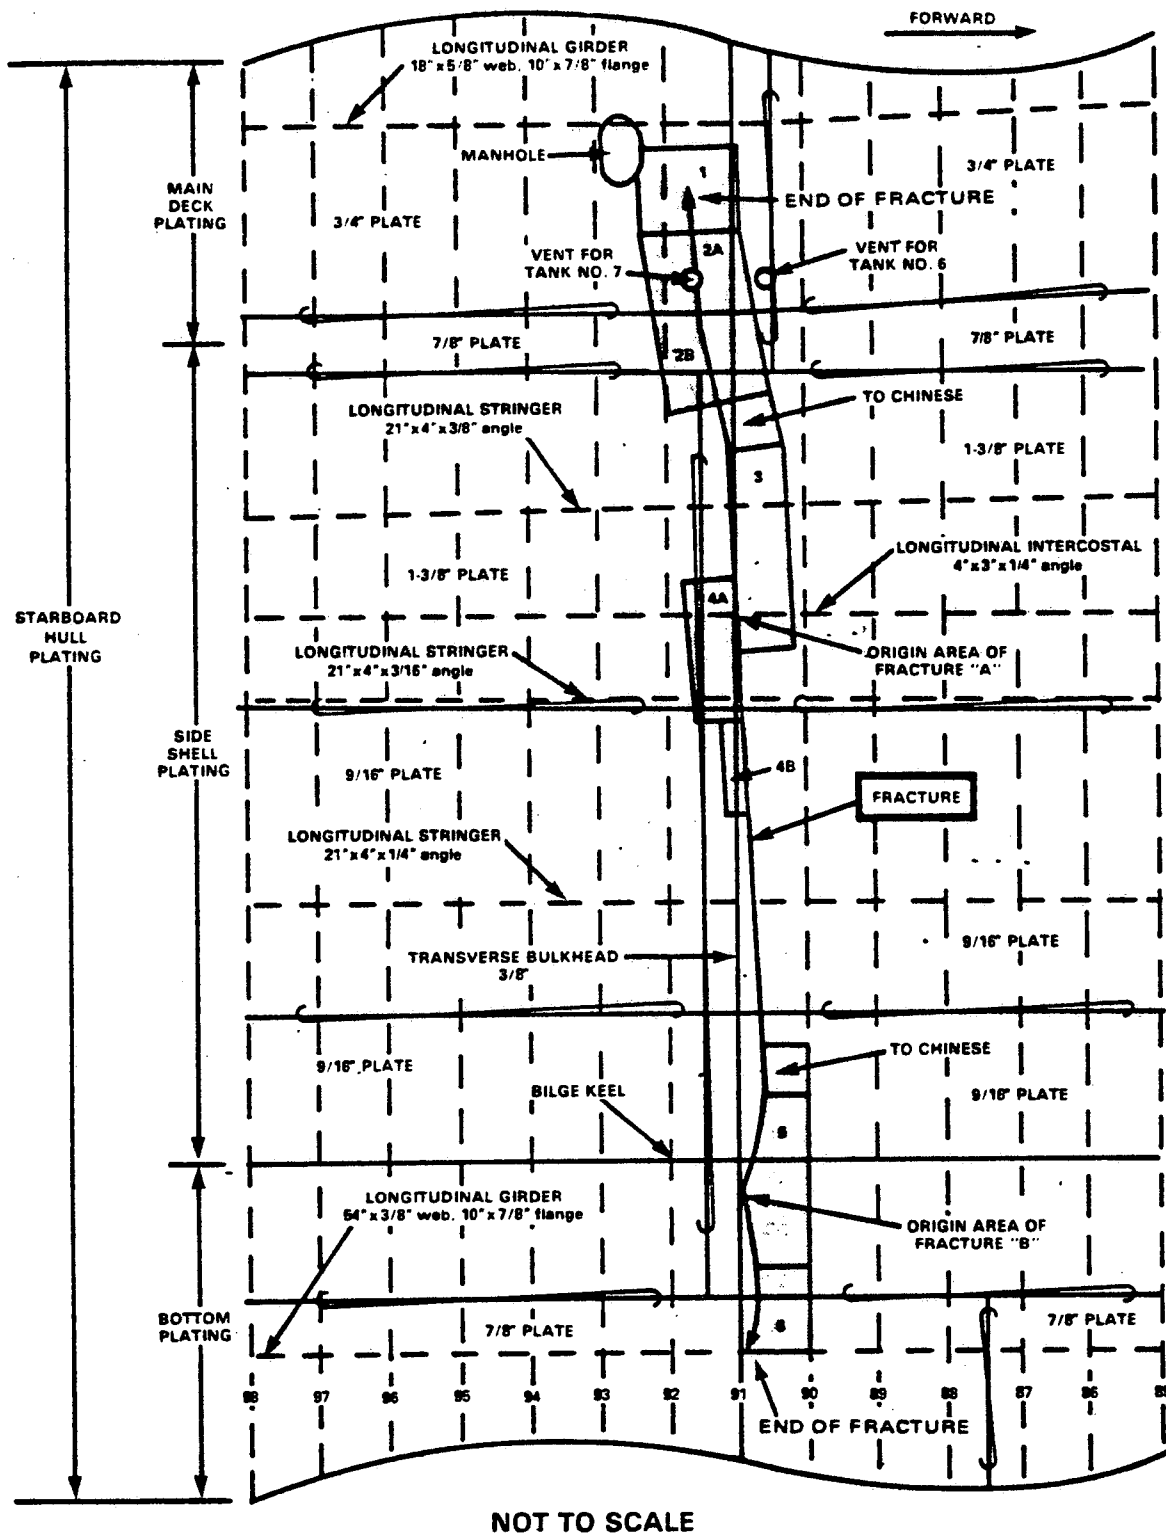
Figure 10.--GLOMAR JAVA SEA starboard plating showing fractured area and recovered coupons during March 1984.
