Issued May 9, 2023

MIR-23-08

Diesel Generator Engine Failure on board Offshore Supply Vessel *Ocean Guardian*

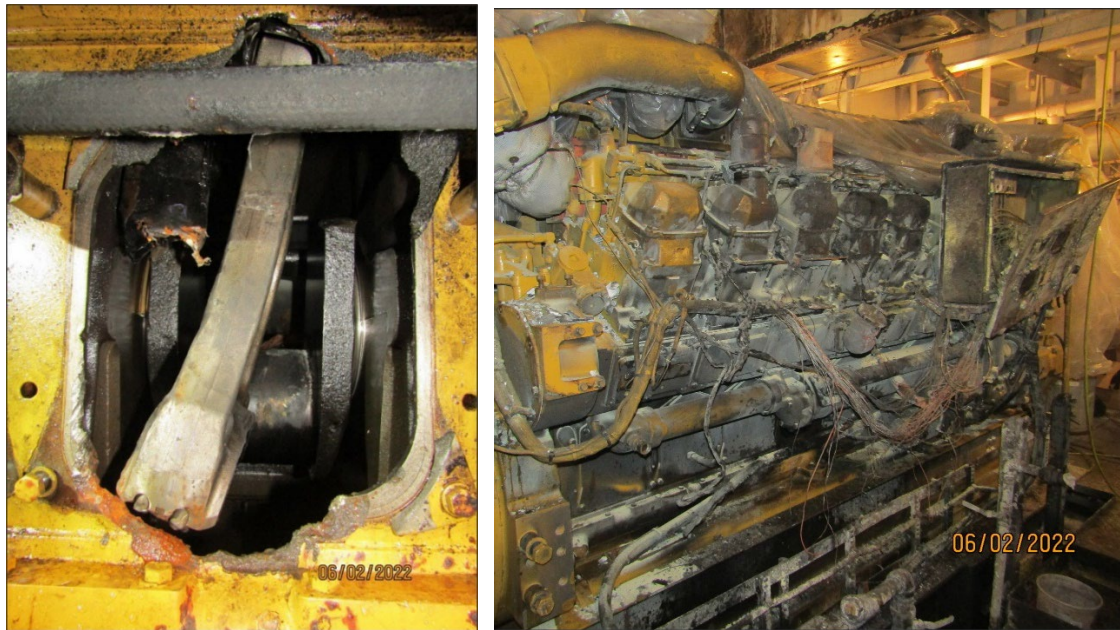
As a result of the mechanical failure and ruptured engine block, the no. 3 main engine was damaged beyond repair. The engine block, crankshaft, two connecting rods, counterweights, and other parts of the rotating assembly were damaged. Local service technicians and crewmembers removed the damaged engine from the vessel and replaced it with a spare.

Figure 4. Damage to the crankcase and connecting rod of no. 3 diesel engine (*left*) and engine (*right*).

According to the local service company's failure investigation report, the engine failed due to a lack of lubrication to the nos. 9 and 10 connecting rod journal bearings. The failure sequence began while the engine was running. The incorrect sizing of the no. 6 main bearing shell allowed lube oil to leak from the larger clearances of the bearing, decreasing lube oil supply pressure to the adjacent nos. 9 and 10 connecting rod journal bearings (which were fed from a cross-drilled galley from the no. 6 main journal bearing) by about 80%. The temperature of the nos. 9 and 10 connecting rod bearings increased rapidly due to the lack of lubrication. Bolts on the nos. 9 and 10 connecting rod bearing caps "overheated, annealed, and fractured." The nos. 9 and 10 connecting rods, bearing caps, and fractured bolts freely moved about the engine block as the engine kept rotating. The report stated that "random collisions amongst the flying parts of the two damaged reciprocating mechanisms (nos. 9 and 10) collided chaotically, damaging everything in the vicinity, blowing open the inspection cover, venting hot oil and blowby gas from the damaged piston above."

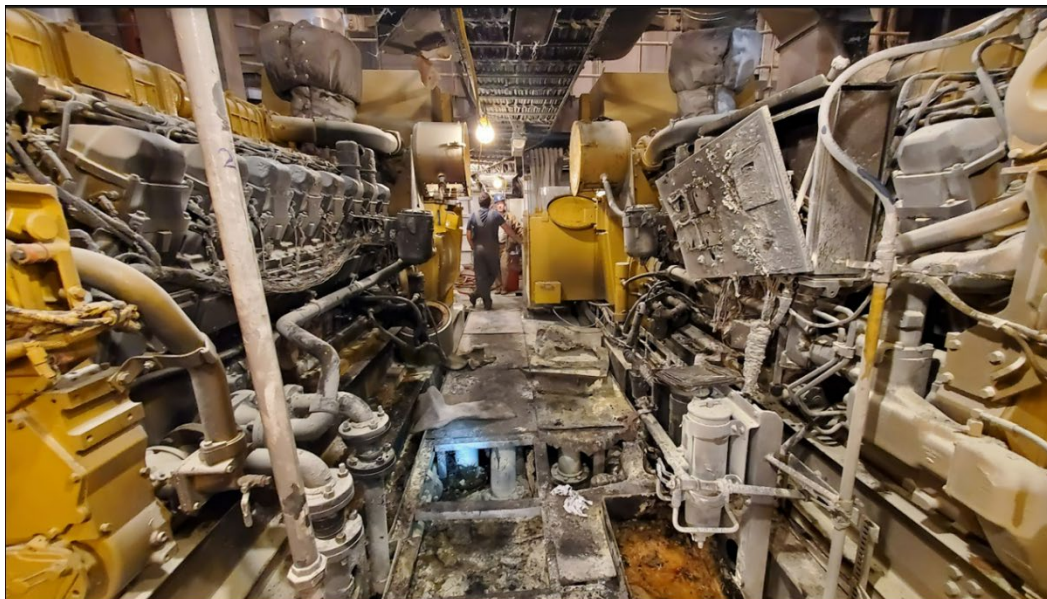
The area in the engine room around and above the no. 3 main engine sustained smoke and heat damage. Wiring harnesses on the remaining engines, electrical cables, lighting fixtures, walkways, and control cables in the engine room required replacements.

Figure 5. The walkway between the nos. 3 and 4 main engines after the engine failure (looking forward).

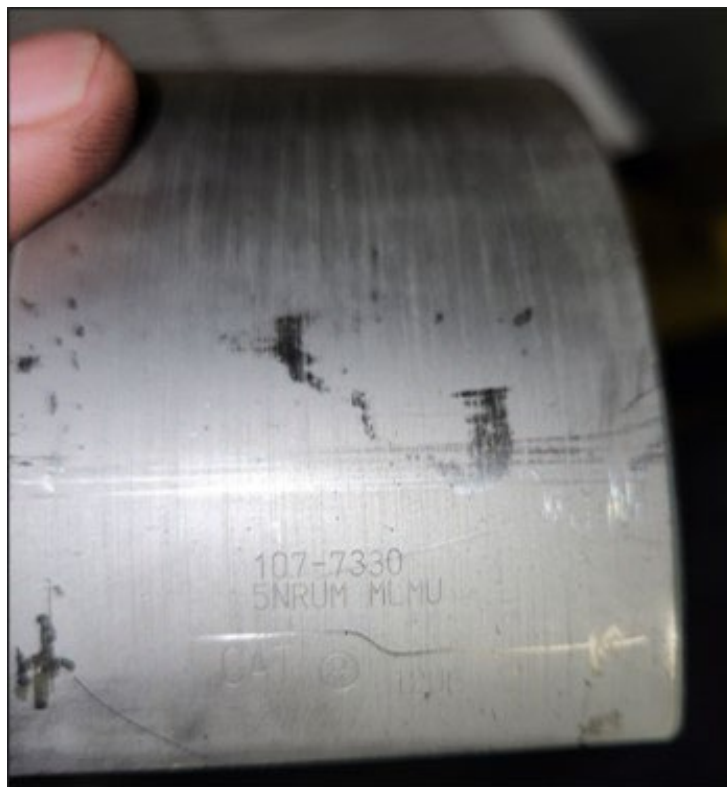
Neither the operating company (Stabbert) nor the service technicians received records of this crankshaft main journal and connecting rod journal machining. According to the local service managers, the part number of each bearing could be identified on the side of the bearing shell (see figure below). According to service managers, without removing the crankshaft from the engine, a main journal could not be measured to otherwise determine if it had been modified.

Figure 6. Part number on a typical Caterpillar main bearing. (Source: Stabbert Maritime)
