MARINE SAFETY ALERT

December 21, 2010
Washington, DC

Alert 10(a) -10

WRONG DIRECTIONS: A RECIPE FOR FAILURE

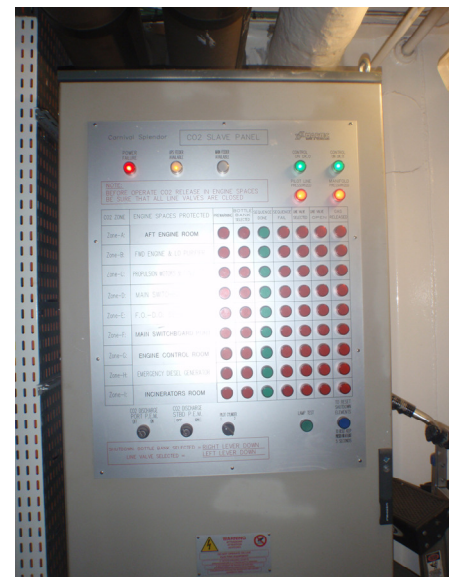
- Shipyard commissioning test procedures appear to differ from procedures documented in the vessel's Firefighting Instruction Manual (FIM). Commissioning procedures indicate that the discharge line selection to a specific protected zone should be made prior to releasing the gas contrary to the directions in the FIM.
- The FIM refers extensively to a Control Panel (left following image) that differs vastly from the one onboard the vessel (right following image).

- Ensure that all supporting documentation, piping schematics, plans, manuals, component labeling and instructions are consistent with each other and relevant to the systems, equipment, and components installed onboard the vessel.
