UNITED STATES COAST GUARD

MARINE SAFETY ALERT

Safety Alert 11-15

DRIED NOT FRIED

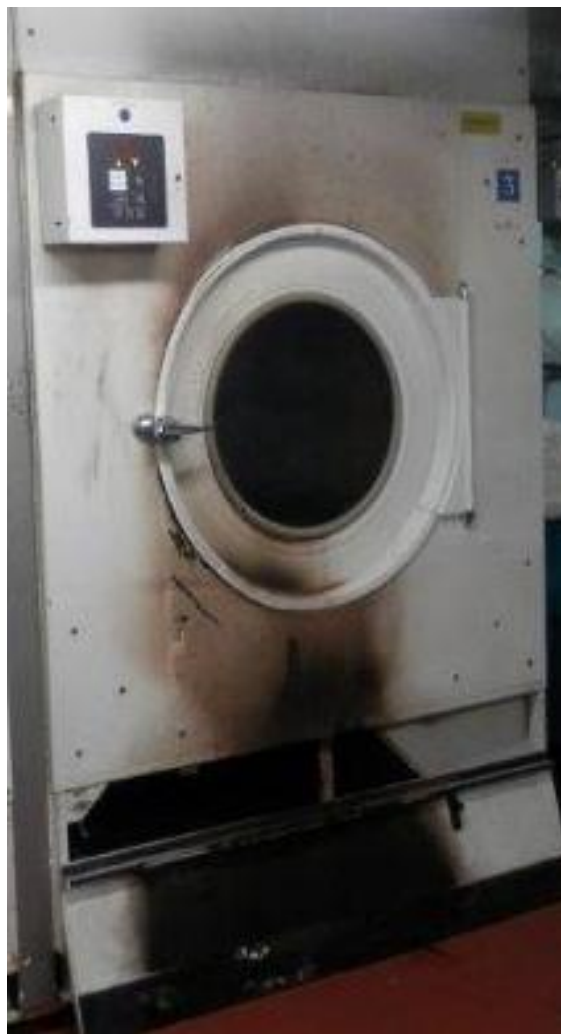
Recently a small fire developed in a dryer onboard a cruise ship. The fire was quickly extinguished by the vessel's crew and caused no significant damage. Subsequently, it was discovered that a built-in fire suppression system, a component of the dryers designed to spray water into the drums in case of fire, had been disabled on all six of the vessel's installed dryers. Initial investigation of the associated processes and procedures related to these suppression systems indicated they were not included in the vessel's maintenance systems such as "Infoship."

The exact cause of the fire is unknown. Highly worn cleaning cloths were being dried and the crew reported that none of their routine cleaning fluids were considered flammable. Investigators suspect that a minor spark occurred due to a loose or disconnected wire, igniting lint in the spaces under the dryer and then the rags in the dryer drum. Thermostats, thermistors, and other electrical components were destroyed, preventing a complete analysis of causal factors.

Although the impact of this incident was relatively small, if not for the response of the vessel's crewmembers and firefighters, the outcome could have been much worse. As a result, the Coast Guard **recommends** that owners and operators having similar industrial sized drying equipment:

- Re-evaluate the risks associated with the equipment;
- Identify and maintain all associated safety equipment and extinguishing systems;
- Establish clear lines of responsibility for equipment inspections, maintenance, and repair;
- Prohibit all personnel from overriding safety components; and
- Consider the necessity of additional signage and instructions in proper languages.
