**MARINE CASUALTY REPORT**

COLLAPSE AND SINKING  
OF MOBILE OFFSHORE DRILLING UNIT  
RANGER I IN THE GULF OF MEXICO  
ON 10 MAY 1979 WITH LOSS OF LIFE

U.S. COAST GUARD  
MARINE BOARD OF INVESTIGATION REPORT

REPORT NO. USCG 16732/93621

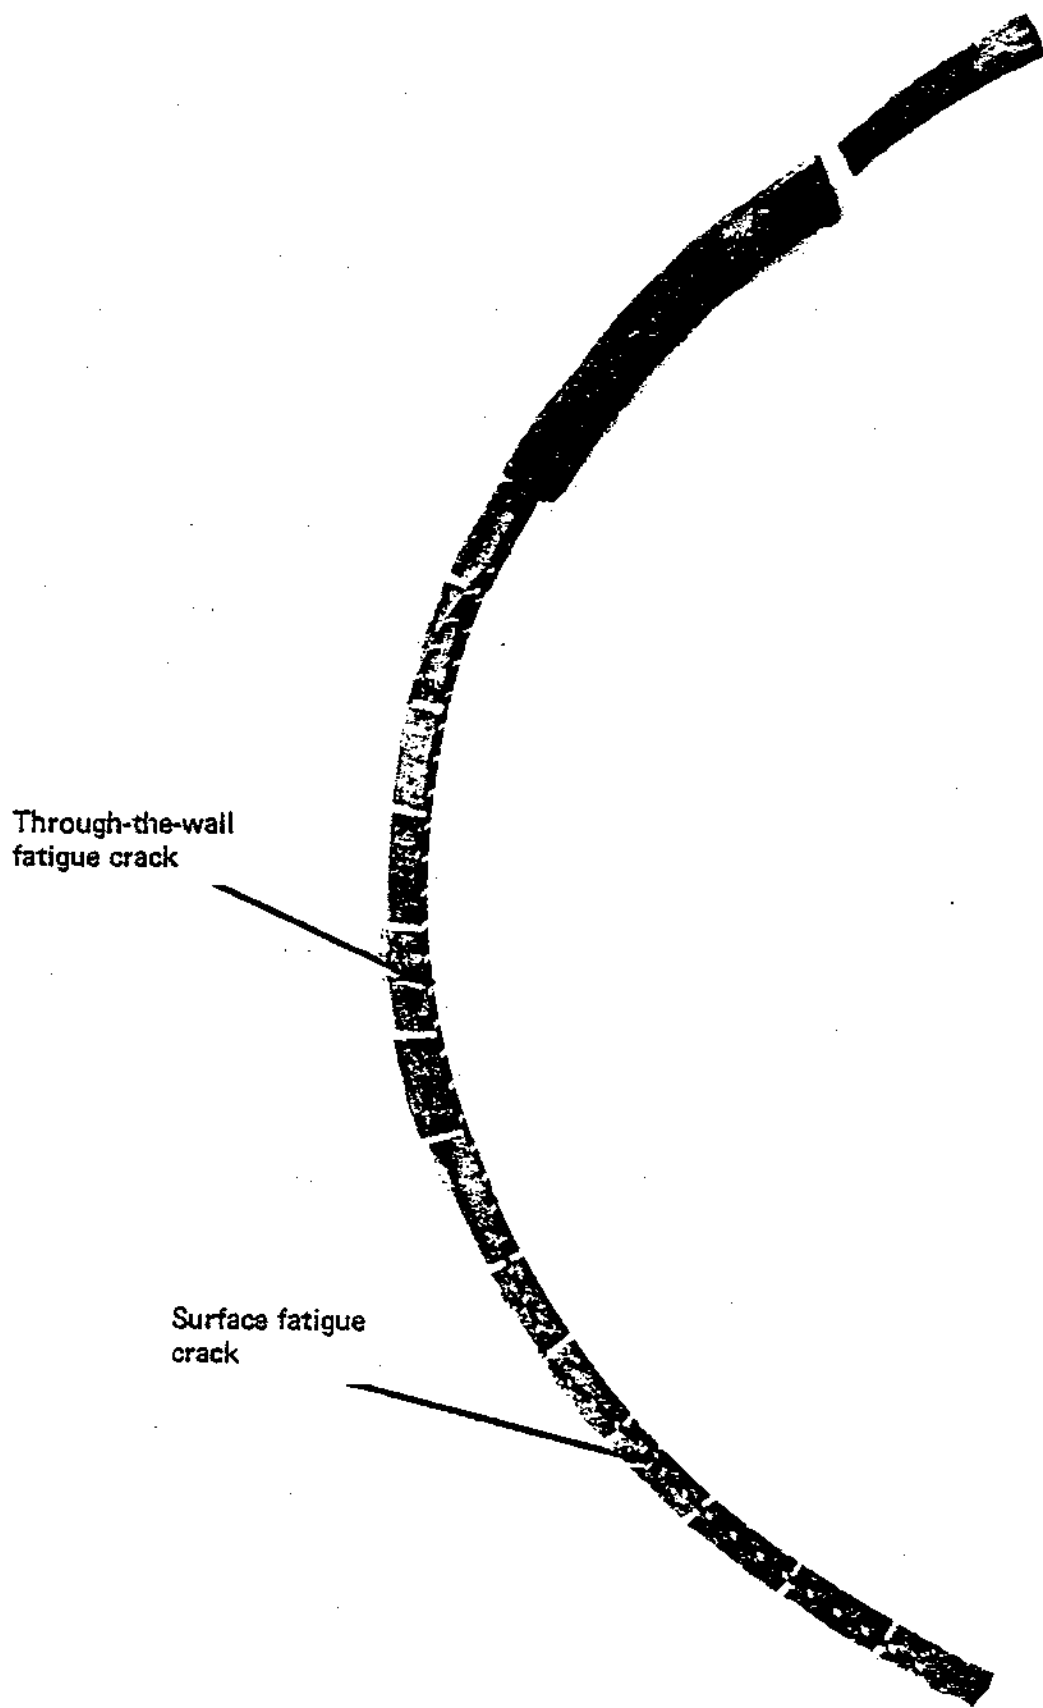
SEM studies were inconclusive in identifying fatigue on the catastrophic fracture surface because of heavy oxide and surface deposits. However, TEM studies showed a through-the-wall fatigue crack of about 23 inches centered on the port side of the stern leg and a surface crack of about 14 inches centered on the after port side of the stern leg. The two fatigue cracks joined on the port side. The surface crack extended 50 to 70 percent through-the-wall of the stern leg. Also, the TEM studies were used to count fatigue striations on the surface of the catastrophic

fracture. Although fine fatigue striations were removed by corrosive action of the sea water, the studies showed that the 23 inch fatigue crack was propagating for at least 400 days. TEM studies of the starboard side of the catastrophic fracture showed a quasi-cleavage mode of failure. (See figure 7)

FIGURE 7 – CATASTROPHIC FRACTURE SURFACE OF PORT SIDE OF STERN LEG.
