UNITED STATES COAST GUARD

COMMERCIAL DIVING ACCIDENT

ONBOARD THE MOBILE OFFSHORE DRILLING UNIT
CLIFF'S DRILLING RIG NO. 12 ON MARCH 4, 1996
WITH THE LOSS OF LIFE

**COMMANDANT'S ACTION
ON THE FORMAL INVESTIGATION INTO THE
CIRCUMSTANCES SURROUNDING THE**

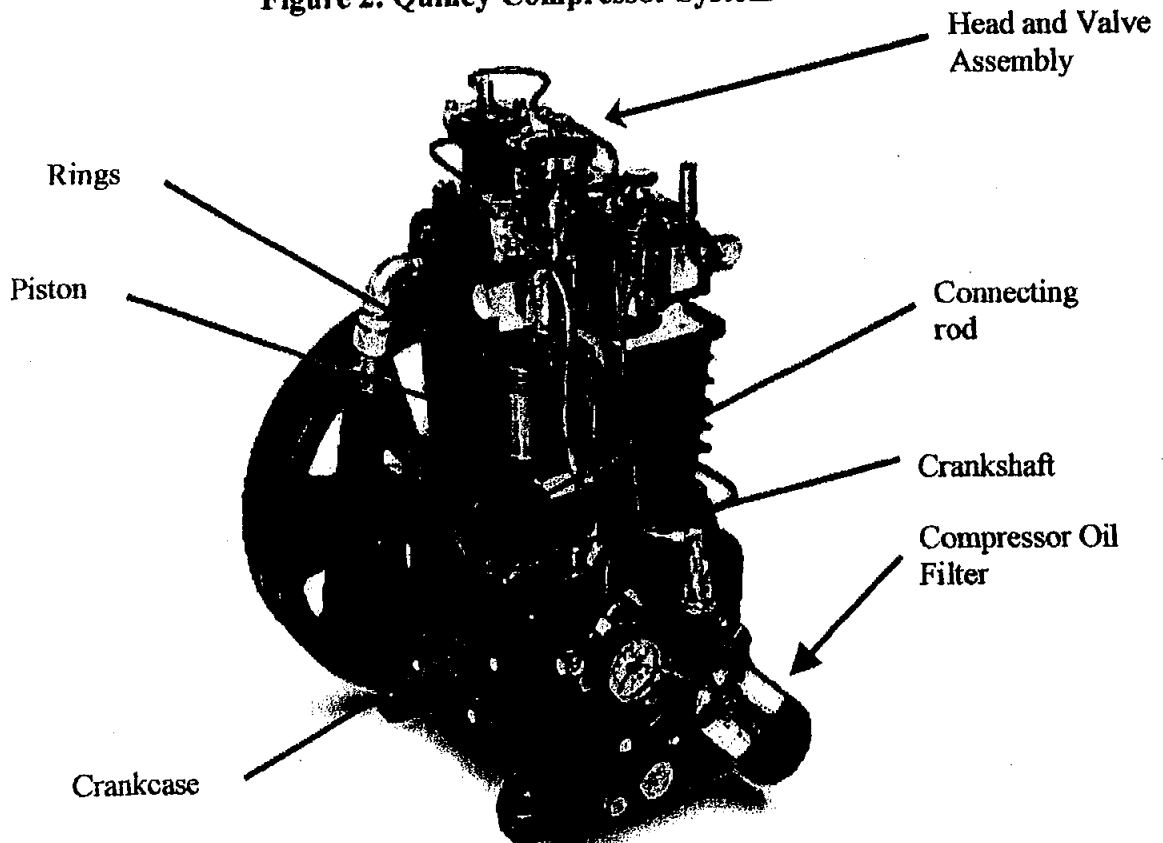
Figure 3: Quincy Compressor (cut-away)

Kirby concluded his write up by recommending Gilbert replace Compressor 2 rather than repair it.¹³⁷ Lawdermilk testified that when he returned to McKenzie's to pick up Compressor 2, a mechanic reported that the compressor's main problem was that a rag had been sucked through the cylinder.¹³⁸

replacement.”¹⁴¹ Husband testified that the oil carryover, bad rings, heads, and seats Guy Kirby described as bad were compressor parts, not engine parts.¹⁴²

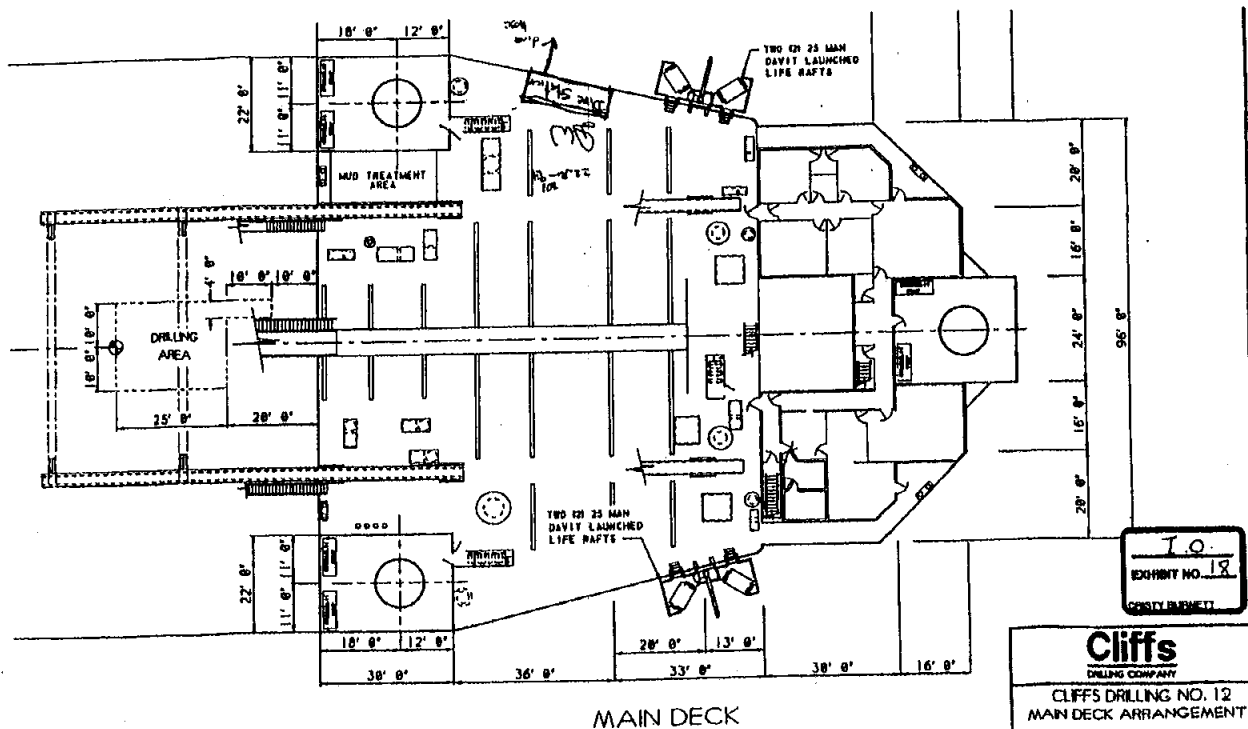
Figure 4: Main Deck Rig 12

testing, but expected to have no other control over the diving operations. "I was the – to look for terms, I guess, would be the prime contractor; and I subcontracted two divers from G&G."⁸⁶ While Austin talked to Townsend and Horton, Wiitala and Pilkington set up the dive station on the port side of Rig 12 (See Figure 4 below).

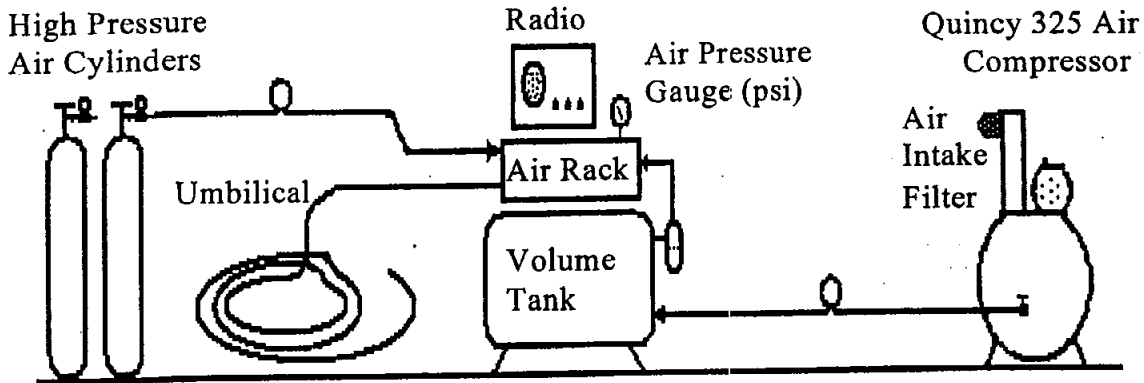
Figure 5: Schematic representation of Dive Station

35. The dive station (See Figure 5) consisted of a Quincy 325 air compressor connected by a 30-foot air hose to a 30-gallon volume tank. The volume tank was connected to an air manifold (a.k.a. air rack). Two high-pressure air bottles also were connected to the air rack to provide a secondary air supply if needed. The umbilical leading from the air rack to the diver's helmet consisted of an air hose, a communications line, a pneumofathometer, a lifeline, and the line from the NDT probe to the NDT monitor.⁸⁷ Next to the air rack was the communication box with batteries. Located nearby was the NDT scope used to interpret thickness readings measured by the probe operated by the diver.⁸⁸ The team set the compressor air intake upwind from the exhaust of the compressor's diesel engine.⁸⁹

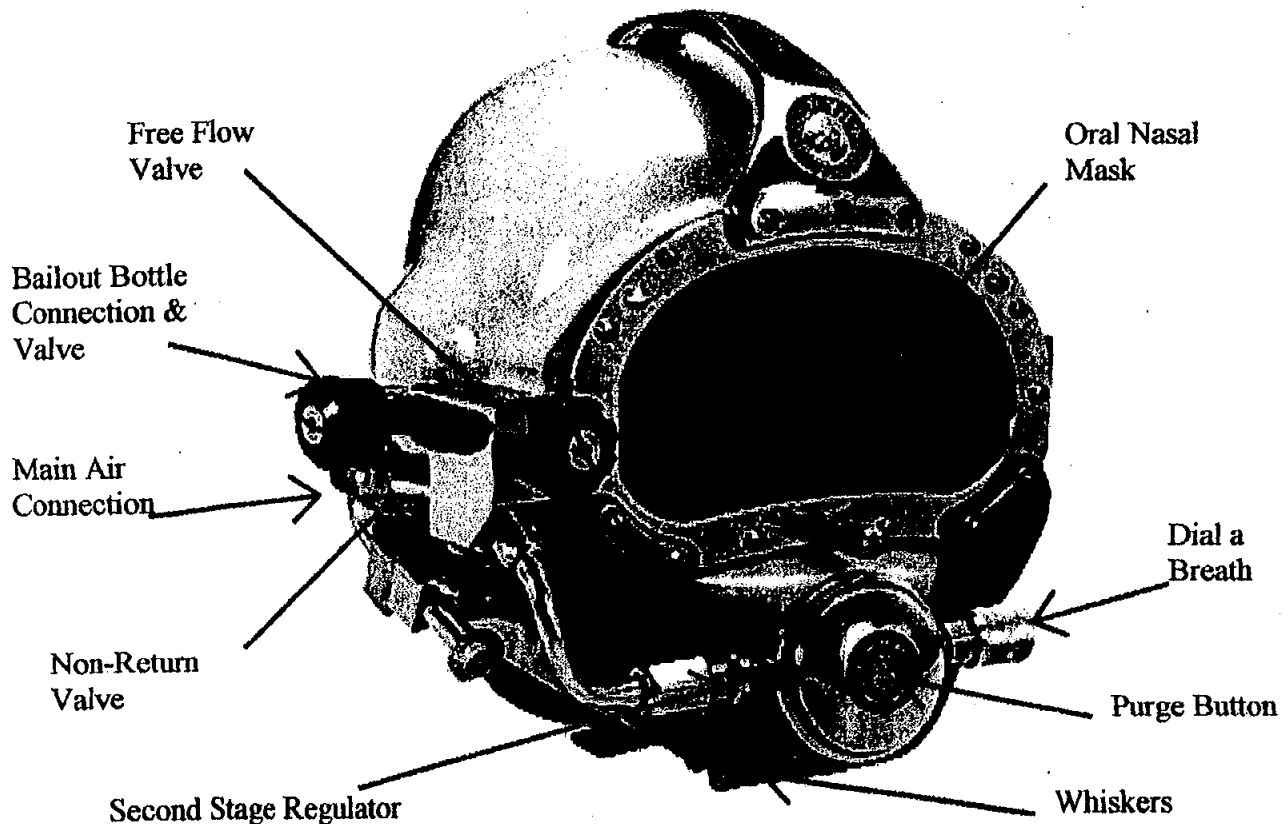
Figure 6: SuperLite 27 Dive Hat

39. At about 1330 hours, Pilkington entered the 65 to 70 degree water for the first time.⁹⁵ Pilkington wore a neoprene wet suit and his own Kirby, Morgan SuperLite 27 Dive Hat (See Figures 6 & 7).⁹⁶ He also wore Wiitala's weight belt and a harness with a quick release to which the umbilical, a knife and axe were attached. A three-foot lanyard attached the roofing axe to the diver's belt.⁹⁷
