**OCEAN EXPRESS (DRILLING UNIT); CAPSIZING
AND SINKING IN THE GULF OF MEXICO ON
15 APRIL 1976 WITH LOSS OF LIFE**

**U.S. COAST GUARD
MARINE BOARD OF INVESTIGATION REPORT**

REPORT NO. USCG 16732/ 61865

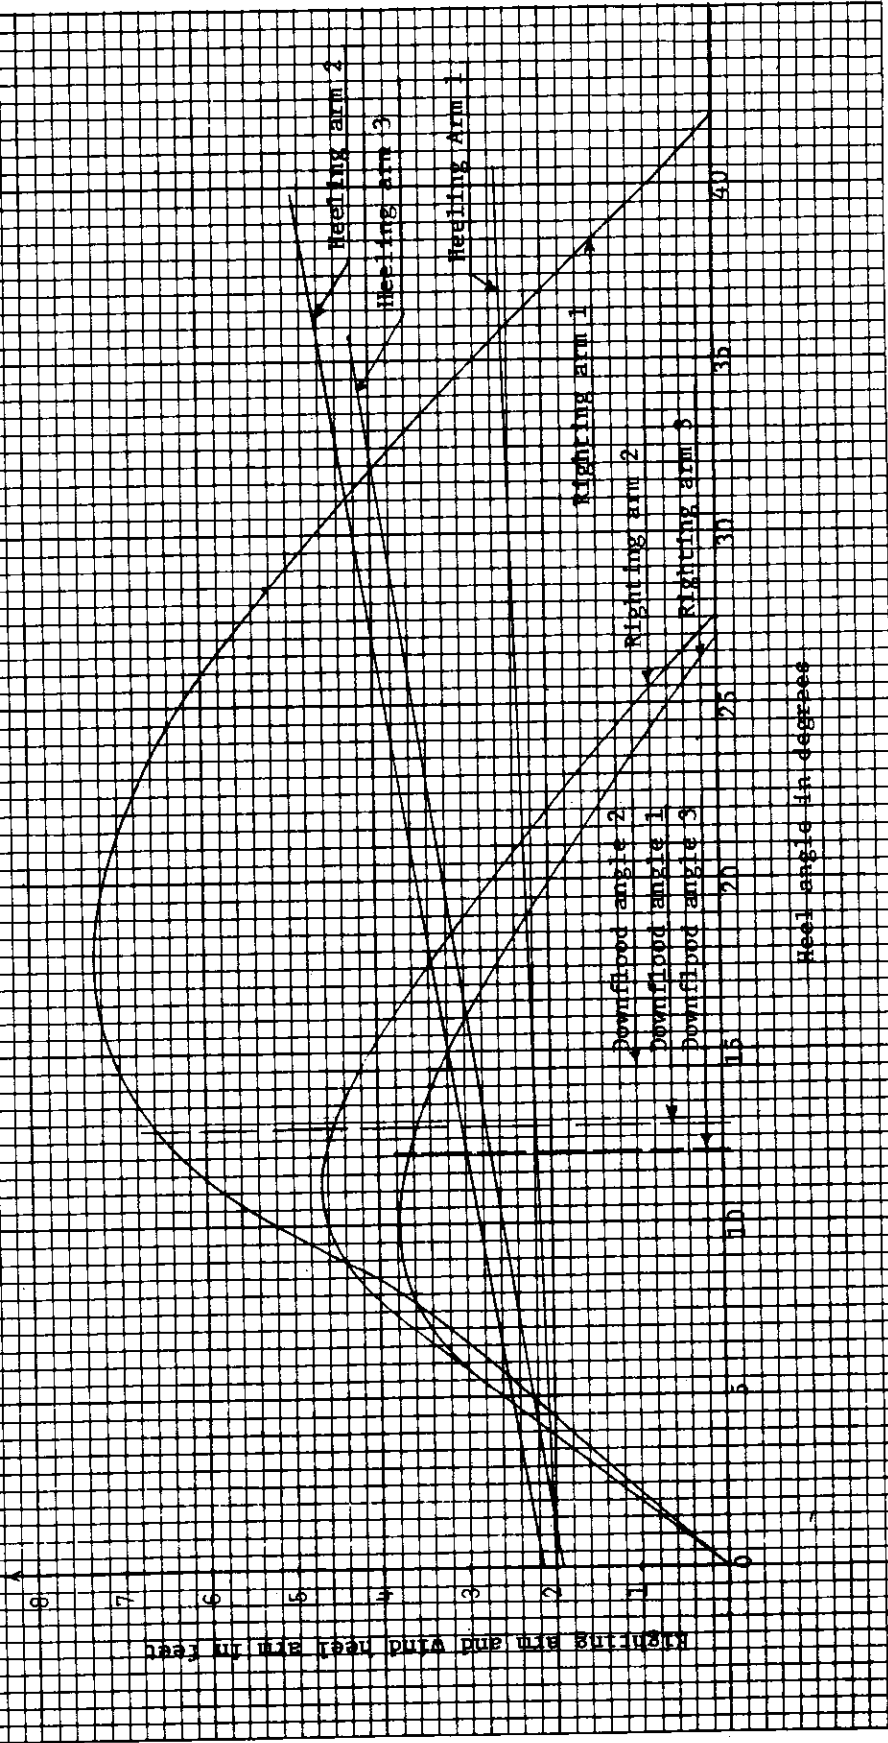
GRAPH 1

1. Mat at 2' separation
2. Mat lowered to 127' separation
3. Combination of mat lowered to 127' separation and an approximate 19" loss of freeboard

Mat at 2' separation (9' platform draft) (23' overall draft)	Mat lowered to 127' separation (9' plat- form draft) (148' over- all draft)	Combination of mat lowered to 127' separation and an approximate 19" loss of freeboard * (10.6' platform draft) (149.6' overall draft)
Range of positive stability	42°	28°	26°
Total righting energy over full range of positive stability (foot-degrees)	182	75 (59% loss)	60 (67% loss)
Downflooding angle	12.8°	14.5°	12.1°
Righting energy to downflooding angle (foot-degrees)	41	44 (7% incr)	32 (22% loss)
Maximum righting arm	7.3'	4.7'	3.8'
Angle of maximum righting arm	18°	11°	10°
Percent excess area, righting moment curve to heeling moment curve, as per ABS intact stability criterion **	40%	11%	10%
Nominal wind speed as per ABS intact stability criterion **	100 KTS.	91 KTS.	89 KTS.
