MARINE CASUALTY REPORT

**MOBILE OFFSHORE DRILLING
UNIT (MODU) OCEAN RANGER,
O.N. 615641,
CAPSIZING AND SINKING
IN THE ATLANTIC OCEAN,
ON 15 FEBRUARY 1982
WITH MULTIPLE LOSS OF LIFE**

REPORT NO. USCG 16732/0001 HQS 82

**REPORT OF THE U.S. COAST GUARD
MARINE BOARD OF INVESTIGATION CONCERNING
THE MODU OCEAN RANGER, O.N. 615641;
CAPSIZING AND SINKING IN THE ATLANTIC OCEAN
ON 15 FEBRUARY 1982 WITH MULTIPLE LOSS OF LIFE**

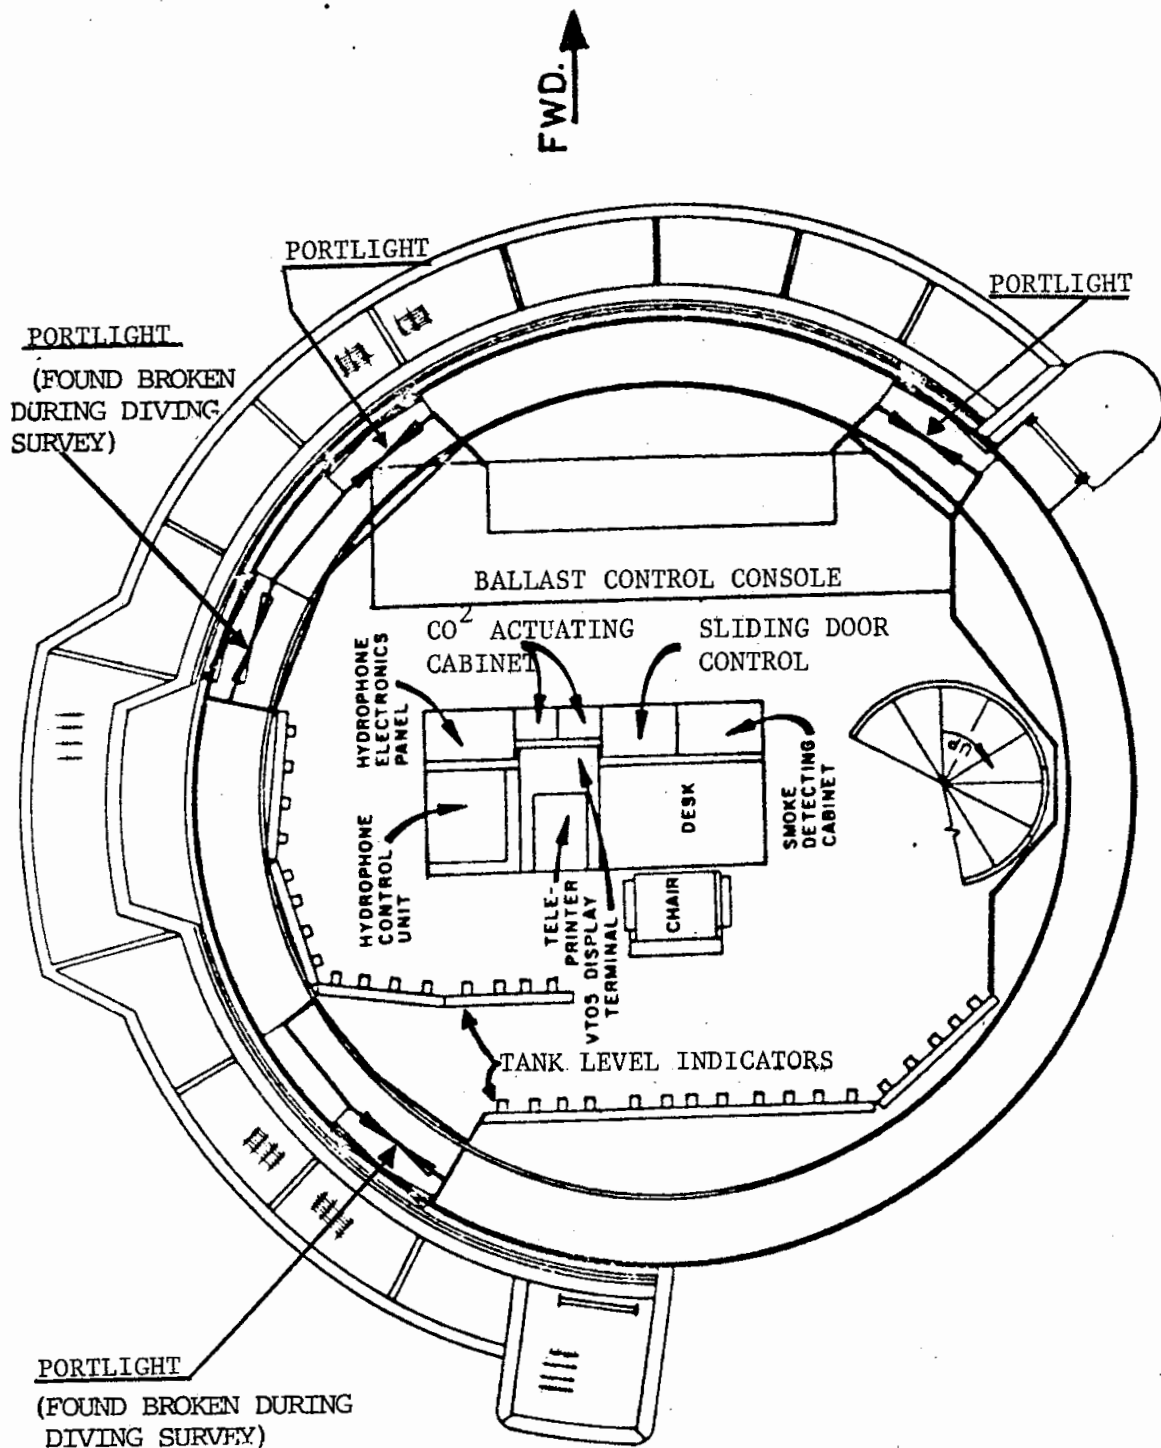
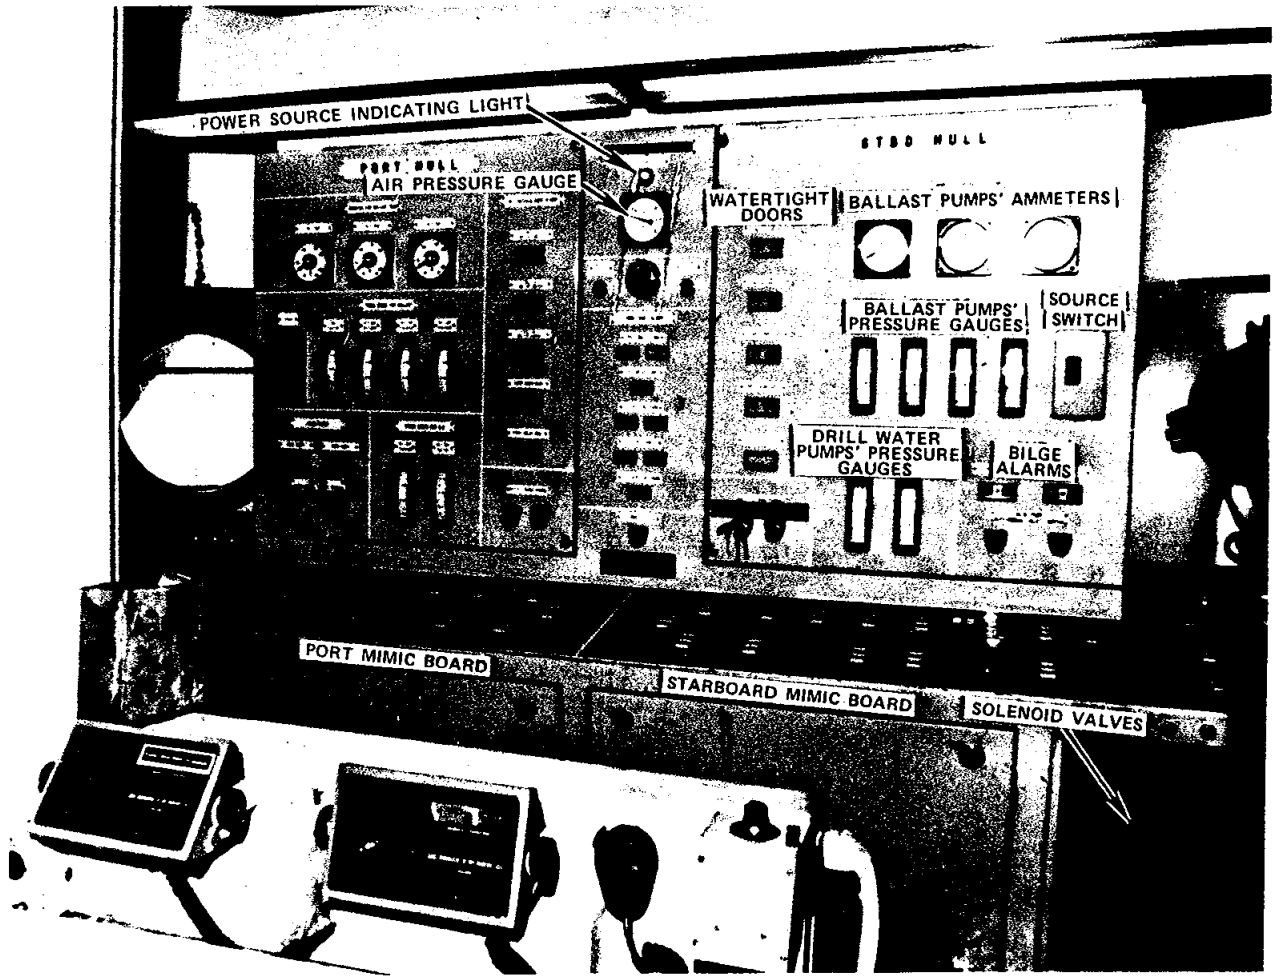
figure 9

BALLAST CONTROL ROOM ARRANGEMENT

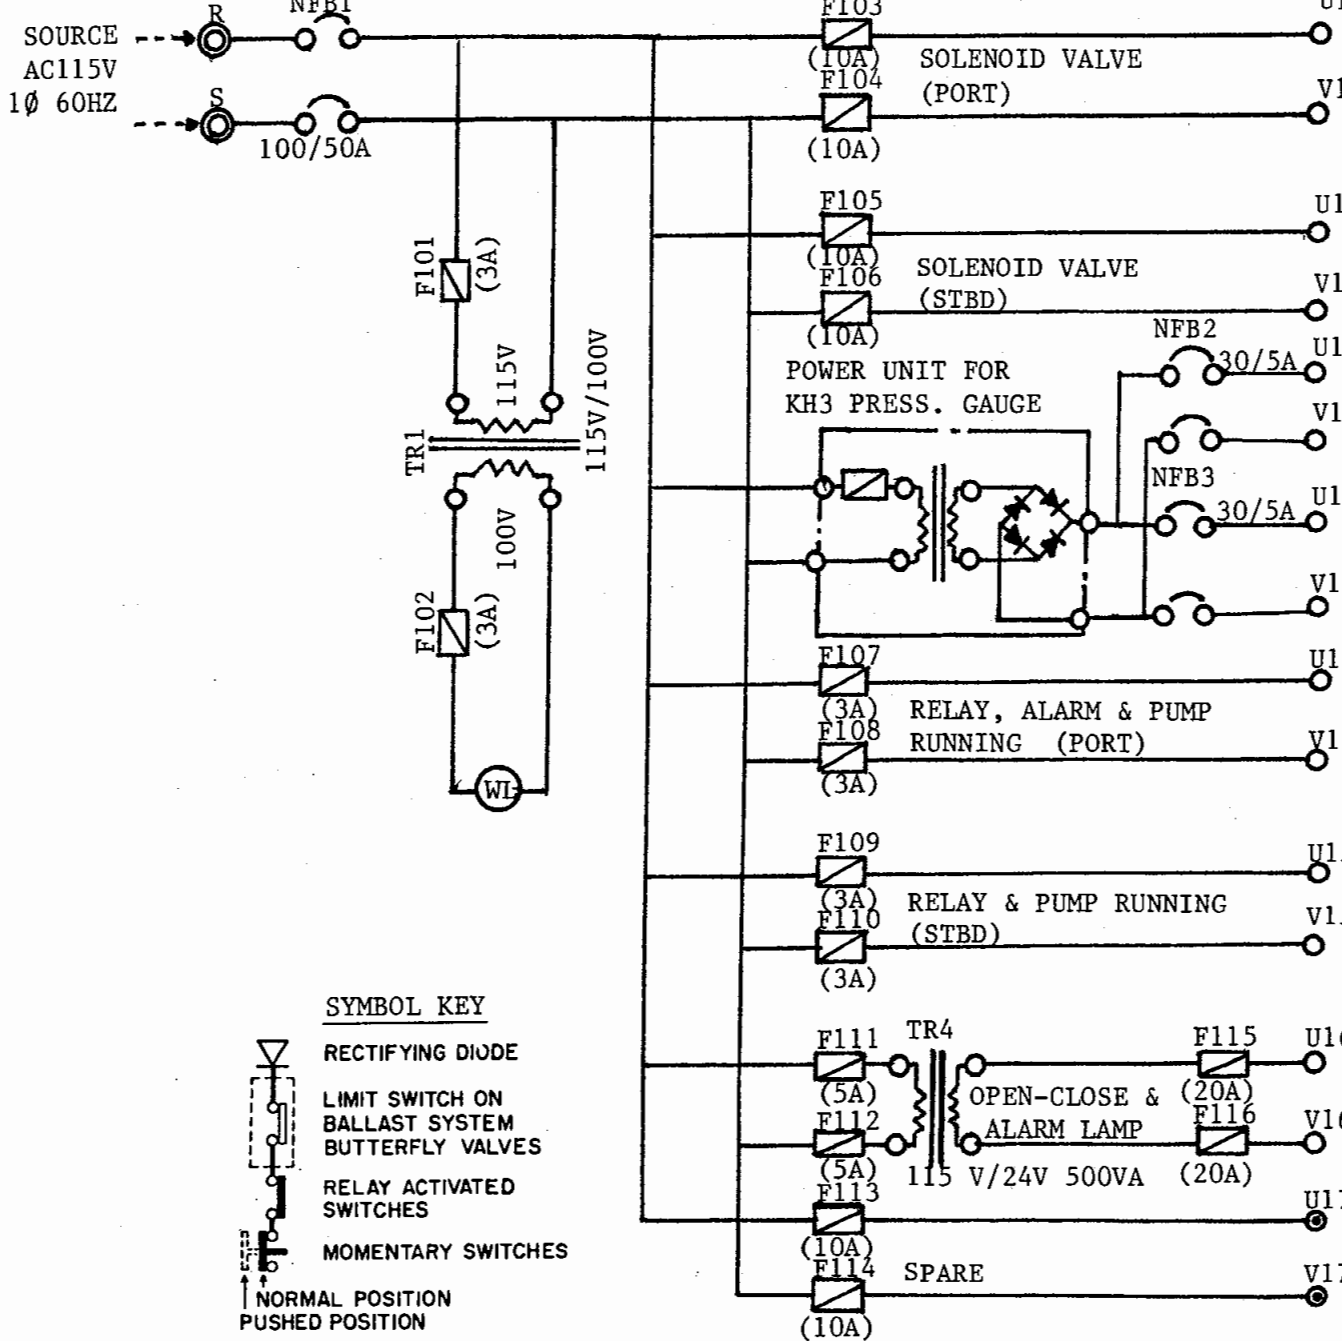
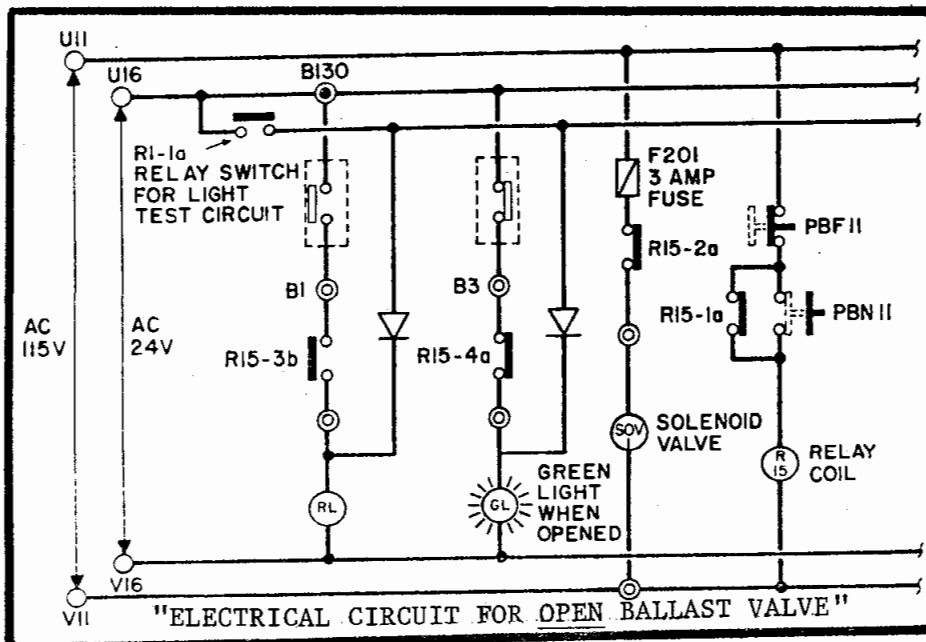
FIGURE 11
 POWER LINE CIRCUIT FOR BALLAST CONSOLE

In the event of a loss of electrical power to the control console for any reason, it was possible to activate the air solenoids by the insertion of brass actuating rods. Witness testimony indicated that these rods were normally stowed inside the console. Air solenoid valve actuation was effected by inserting and threading these rods into an opening in the solenoid. An examination of an actual air solenoid valve assembly by the Board disclosed that it was not readily apparent at what point the rod had been threaded into the bushing sufficiently to cause the valve to open. In addition to manually actuating the air solenoid valves with the brass rods, the ballast valves could be physically opened in the ballast pumprooms by turning each valve stem with a wrench, compressing the operating assembly spring.

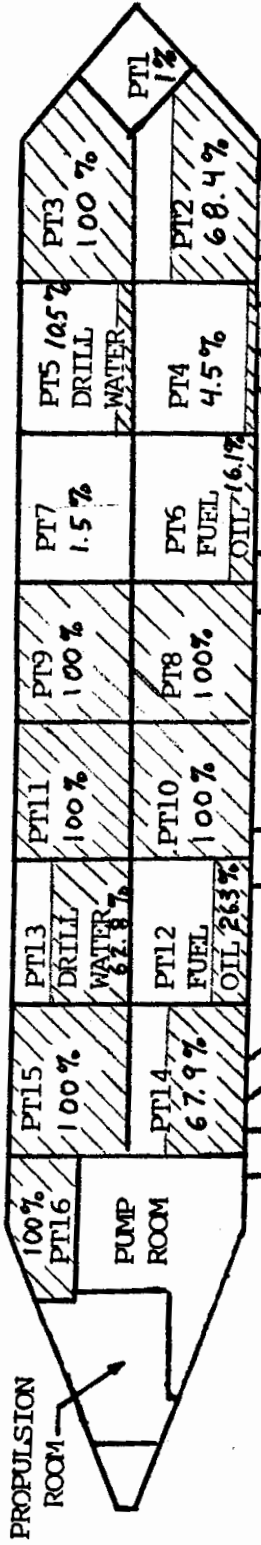
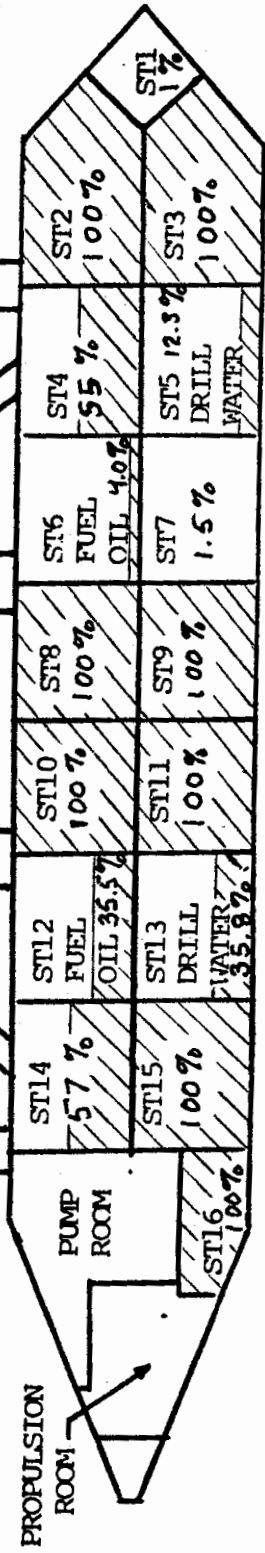
Figure 15: PERCENTAGE OF LIQUIDS IN OCEAN RANGER PONTOON TANKS, MORNING OF 14 FEBRUARY 1982

Figure 15 depicts the liquid levels in the ballast tanks on 14 February 1982 as indicated in the weekly ballast report work sheets recovered from the OCEAN RANGER. The report indicated that the after ballast tanks used for adjusting trim, PT 14 and ST 14 were respectively 67.9% and 57.0% of capacity. The ullage provided a potential moment to correct trim of 58,000 foot/long tons (F/LT). During the evening, the control panel was doused with sea water entering a broken porthole causing an actual or perceived panel malfunction. At the time of malfunction or when personnel attempted to correct the malfunction, the OCEAN RANGER either took water into the ballast tanks or water shifted to the forward tanks, or both, causing a list by the bow. At some point, the crew had taken the measure of closing the two manually operated sea inlet gate valves. Evidence indicates the rig may have had a 10 degree list for a period of time which the crew believed had stabilized. An approximate moment of 17,000 (F/LT) was required to cause a 10° trim by the bow.
