Learning from Earthquakes

The M_L 6.7 (M_W 7.1) Taiwan Earthquake of December 26, 2006

National Center for Research on Earthquake Engineering (NCREE)

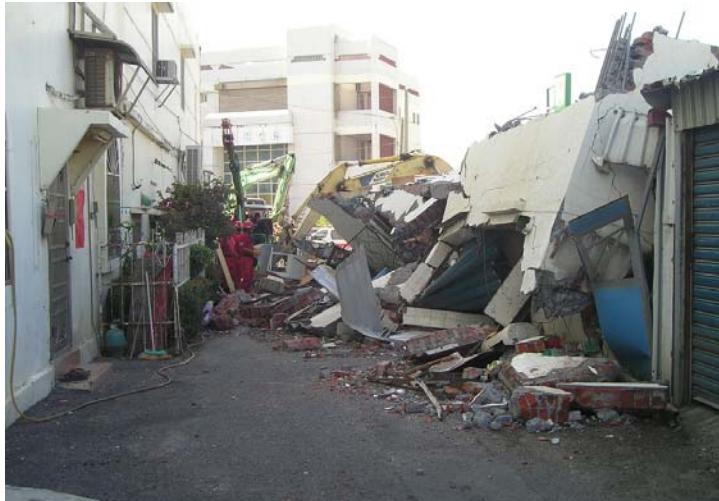
Fig. 8 Back view of the collapsed furniture store

tal width and length of this building are about 7 m and 23 m respectively. Large openings for doors and windows are located at the street sides of the buildings for commercial demand. On the other hand, the frames above the ground floor are in-filled with a brick masonry perimeter and partition walls. Thus, the bottom floor is comparatively soft and weak due to the open front and open space. This is the case of soft first-story damage mode. The floor plan of this collapsed 4-story mixed commercial

and residential building is shown in figure 10. The first floor of this building is for commercial use and the rest of the floors are for residential use. There are a total of 15 columns. Along the long axis, the number of spans ranges from four to six. But the number of spans along the short axis just ranges from one to two spans, so that the redundancy is highly inadequate. Most of the brick walls are located at right side along the long axis, which makes the planar lateral stiffness asymmetric obviously. The photos of the collapsed building are shown in Figures 8 & 9.

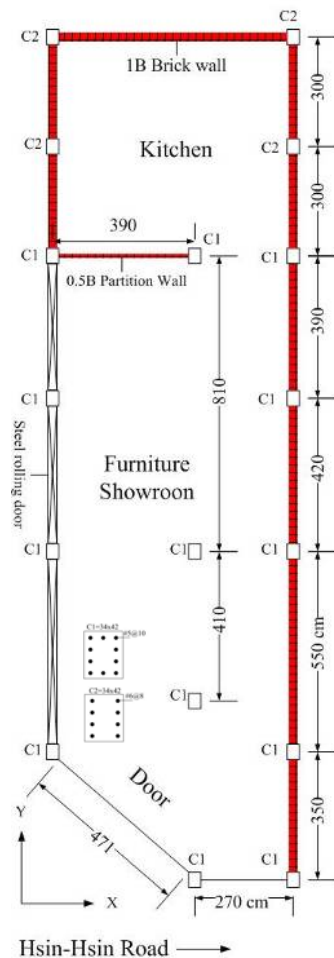
Fig. 10 Floor plan of a 4-story furniture store

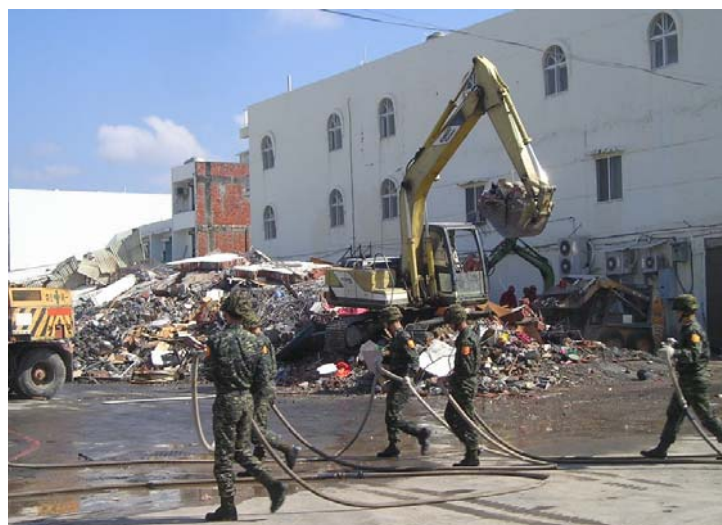
Fig. 9 Front view of the collapsed furniture store

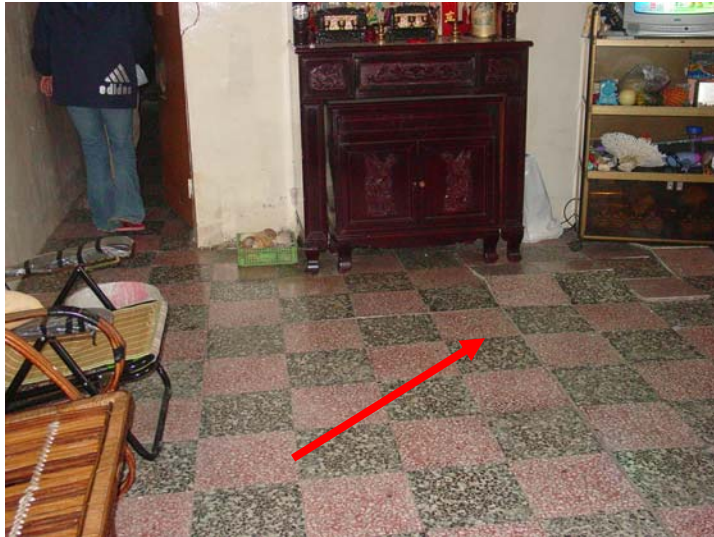
In addition, some street-front residential buildings were also damaged severely. Figures 11 and 12 show the damaged features observed in this type of building. Brick walls and beams were seriously damaged, and the interior ground was cracked and bulged obviously.

Fig. 11 The ground bulged inside the house

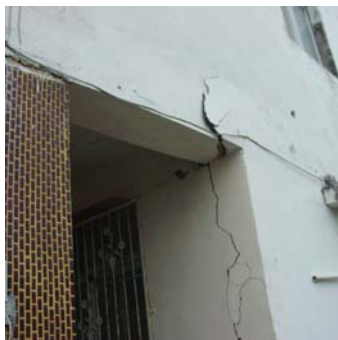
Fig. 12 The damage on the brick walls and beams

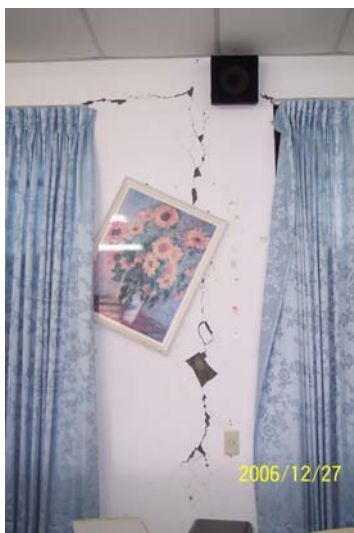
Fig. 13 The damaged column along the direction of the corridor

Taiwan, most school buildings at the primary and secondary levels usually lack integral planning, so the original structural system is easy to be seriously undermined. Most school buildings were constructed and expanded in a patchy way, which caused insufficient seismic resistance as an aftermath. The structural systems of school buildings have intrinsic defects. Classrooms are generally located side by side in a row. The plan of each classroom is about 10 m in width along the corridor and 8 m in depth perpendicular to the corridor. The corridor may or may not be cantilevered. The stiffness in direction perpendicular to the corridor is much higher than that along the corridor, and there is a strong tendency for damage to occur in this type of situation. In order to utilize the natural light and ventilation, windows and doors fully occupy both sides of the corridor. At the upper portion of the columns, they are constrained by the

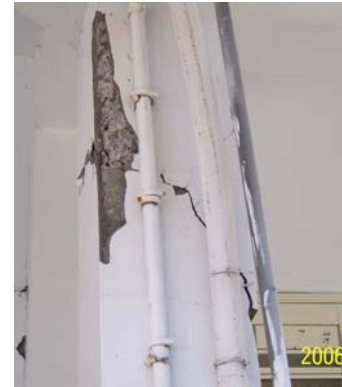
Fig. 14 Shear cracks were due to the short column effect

window frame made of aluminum or wood. The lower portions of the columns are constrained by the windowsill made of brick walls. Since the windowsill is rigid compared with the window frame, the effective length of the column is shortened. The shorter the column, the larger the shear force is. Therefore, the columns tend to fail in the shear mode rather than in the flexural mode. Figure 13 shows the column failure in shear mode while figure 14 shows a typical short column revealed the diagonal shear cracks and figure 15 shows the collapsed water tank on top of the school building.

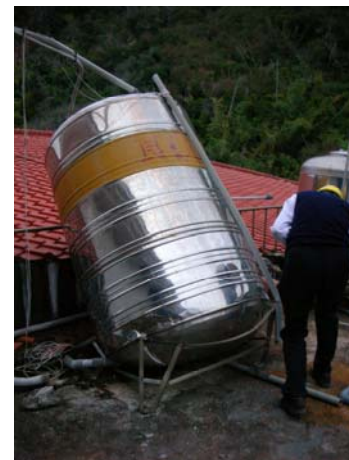
Fig. 15 The collapsed water tank on top of the school building

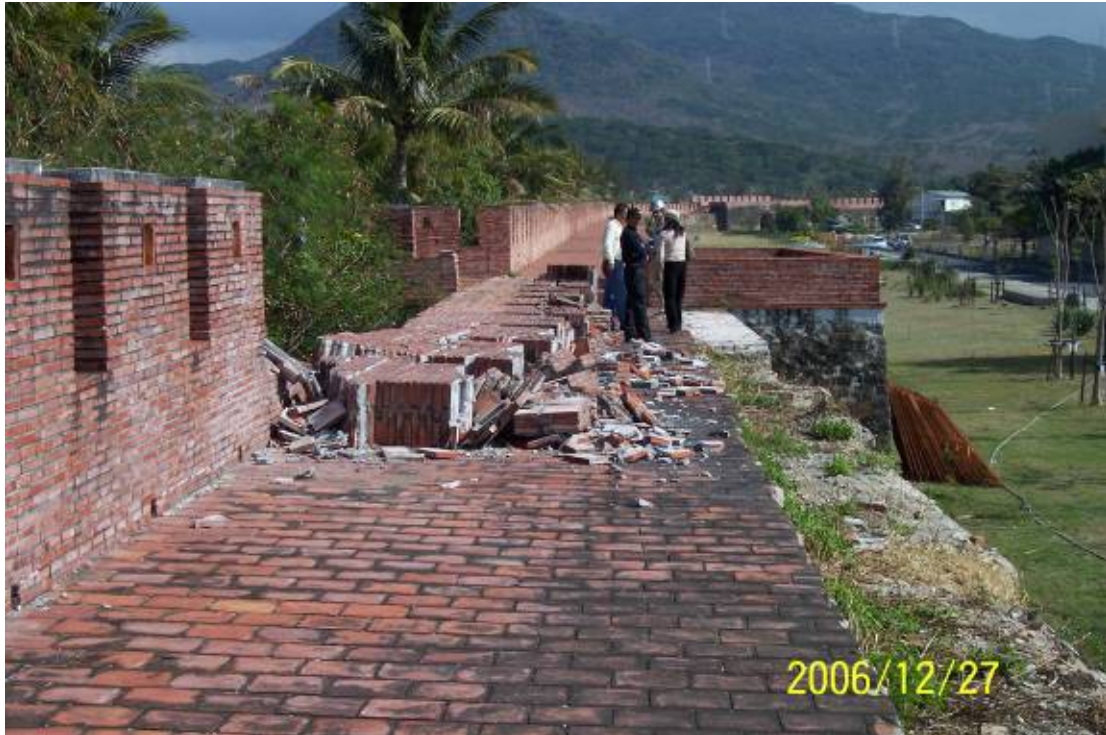
Fig. 16 Battlements of the old city wall at Hengchun were collapsed

The old city wall and gate tower of Hengchun were damaged as well. Several eaves of the gate tower were collapsed and a 30 meter long crack was found on the top of the wall. Around 15 battlements were collapsed, as shown in figure 16.

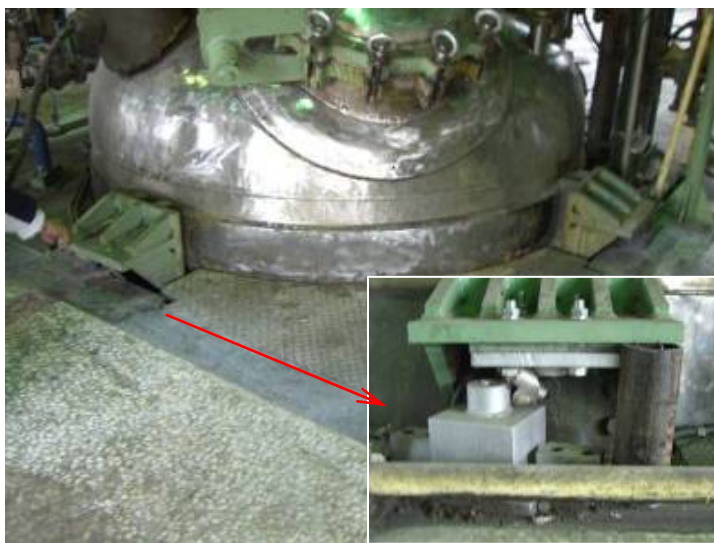
Counter Weight (CW) damage of elevators, and Automated Storage/ Retrieval System (AS/RS). Almost every reactor (about 8 to 10) supported on the third floor of a RC building was damaged. Each oval batch reactor, about 2 meters high, 1.5 meters in radius and weights 20 tons, was designed to penetrate the floor of a RC building and supported at the mid-height of the reactor on the RC floor (fig. 17). Below each reactor support there placed a load cell, providing vertical supports, to measure the weight of the

Fig. 17 Reactor with damage at supports

reactor. In the earthquake, reactors shifted and bumped into the edge beams around the floor openings. All the load cells need replacement and reactors need realignment. Two elevators in a 4-story building suffered the drop out of CW iron planks fell into the passenger carts (fig. 18). The AS/RS racks are about 16 m tall and are said to have deformed to a degree that auto-picking cars can not perform its designed function. All the storage tanks need to be removed before any AS/RS repair work can precede. This posed a significant loss to the operation of the chemical plant.

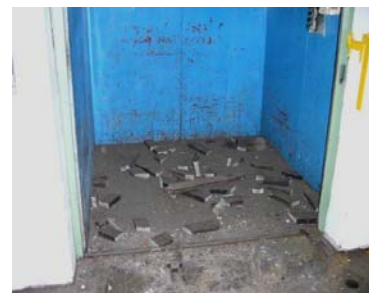
Fig. 18 CW iron plank fell in passenger cart

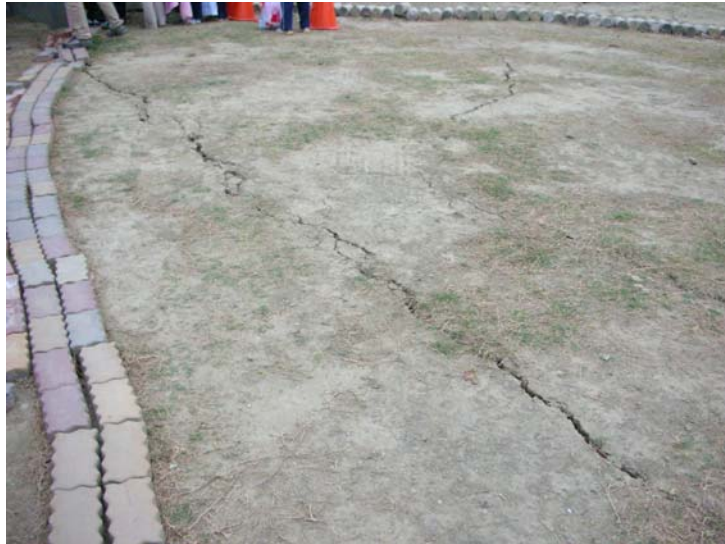
Fig.21 Ground cracks observed in school near Nanwan

widths are about 3 to 8 cm. In the Hengchun Elem. School – Nanwan campus, some cracks were observed on ground surface, as shown in figure 21. Besides, ground settlements and horizontal displacements around the school buildings were observed as shown in figures 22 and 23. Furthermore, several signs of soil liquefaction were observed nearby (figure 24).

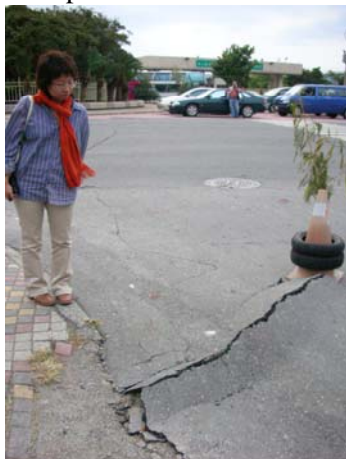
Fig. 19 Heave of pavement near Nanwan

There was no serious geotechnical hazard found this time, except slight ground surface cracks and permanent displacement of school buildings. The road surface with asphalt pavement near Nanwan was heaved and damaged, as shown in figure 19. Along a path near Nanwan, a series of parallel cracks (in the direction of NW to SE) on the road were observed, as shown in figure 20. Those cracks are parallel with distance 5-10 m apart, and the crack

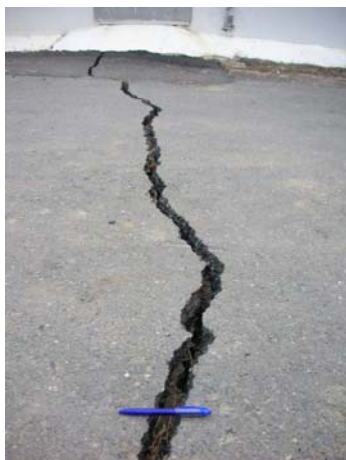
Fig.20 Crack observed near Nanwan

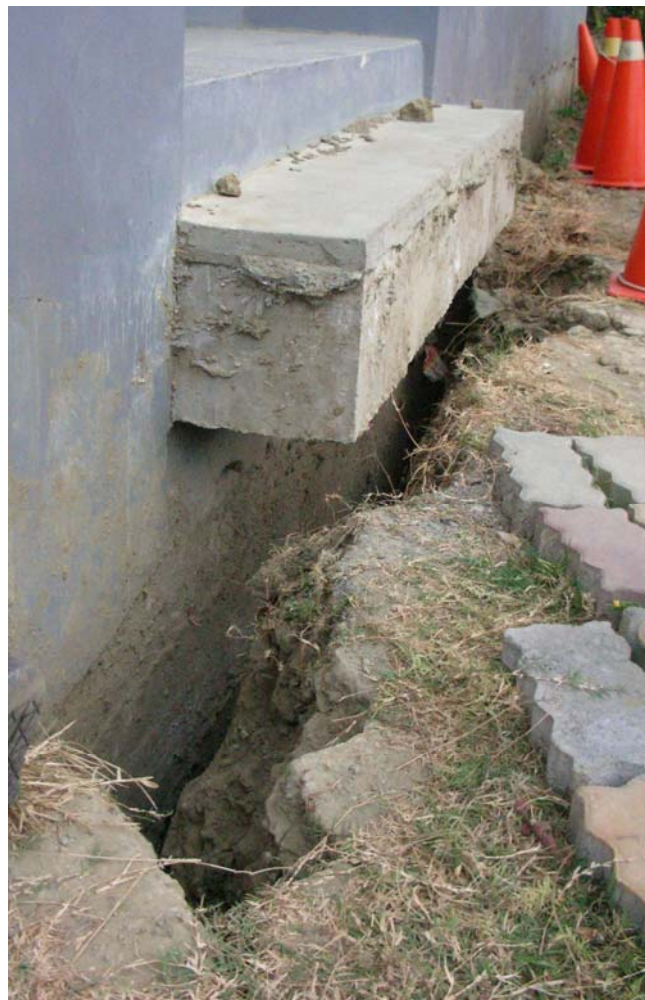
Fig. 22 Ground settlement and lateral displacement observed in school near Nanwan

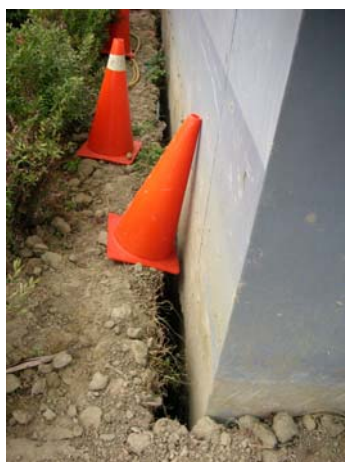
Fig.23 Ground settlement observed in school near Nanwan

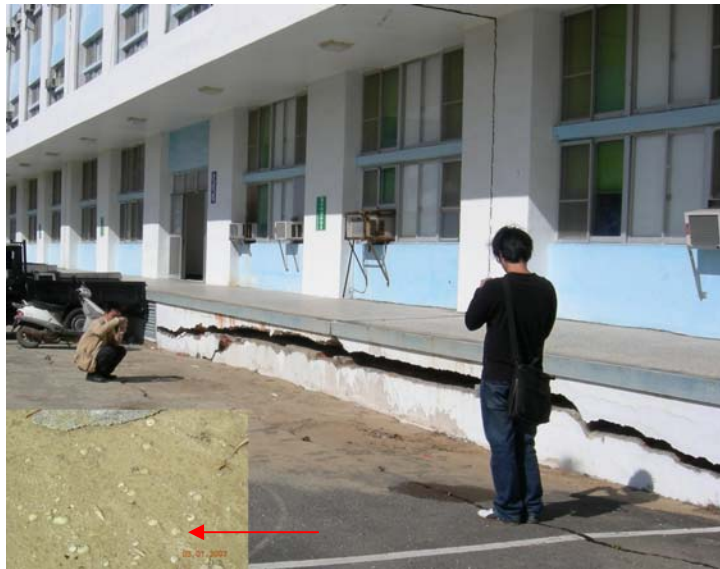
Fig.24 Ground settlement, Soil liquefaction and building damages observed near Nanwan, the shells were found in the sand

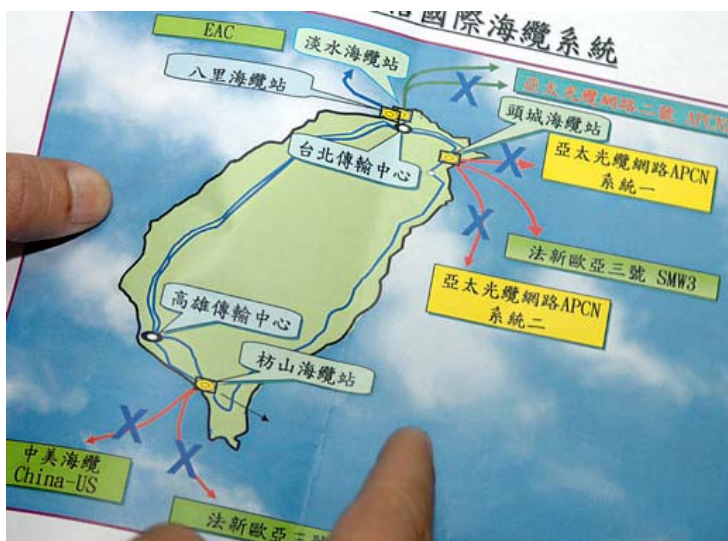
Fig. 25 The damage status of 5 undersea optic-fiber cables

More than 5 undersea telecom cables (APCN2, APCN1-North, APCN1-South, SMW3-South, and China-US, as shown in

Figure 25), which are connected to China, Hong Kong, Japan, South Korea, Philippines, and Singapore, were snapped by the earthquakes and estimated to be fixed in one month (Table 3). All the international communication including internet services, international telephone, the international banking transactions, the stock market, currency trading, business communication to millions of customers were interrupted, and even the check-in counter of Taiwan's China Airlines are affected.
