Chevron Pembroke Amine regeneration unit explosion 2 June 2011

An overview of the incident
and underlying causes

The explosion was caused by the unintended ignition of a flammable atmosphere within the tank (17T302), during what should have been a routine cleaning operation conducted in preparation for maintenance.

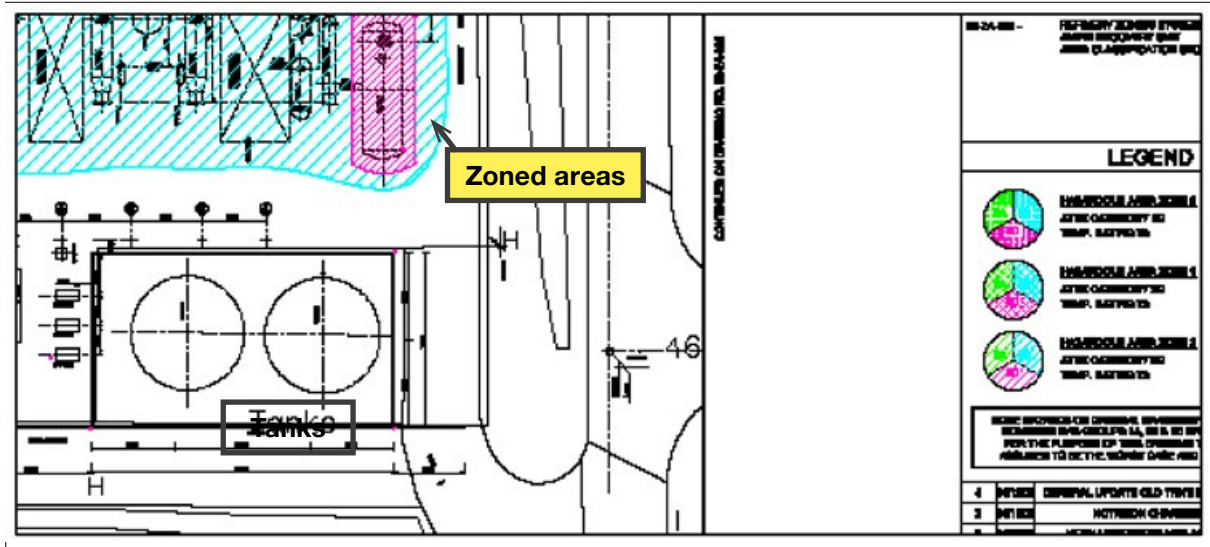
Figure 3 Hazardous area classification of ARU tanks

Over the years, Chevron progressively downgraded the hazardous area classification for these ARU tanks. They were initially rated as Zone 1 and subsequently downgraded to Zone 2. In 2008 the tanks were finally downgraded from Zone 2 status to ‘non-hazardous’ (Figure 3 illustrates the ARU tanks outside the zoned area). The running tank headspace should have been classified as Zone 0 (highest risk), with additional zones around the exterior and tank vent depicted within a three-dimensional diagram, as described within Section 1.5.3.1.

Chevron staff involved in the 2008 ARU hazardous area classification work were simply unaware of the light hydrocarbon contamination hazard caused by the process change in 1998 (when the ARU became a closed system) and so disregarded the risk of a flammable atmosphere. The classification exercise performed by these Chevron staff did not include side elevation drawings but only a plan view as shown in Figure 3. As a result, the vertical extent of the hazardous zone (eg around the tank body and vents) was not considered.

The hazardous area classification for the ARU was therefore incorrect and misleading. Had it been accurate, such a resource could have been utilised to inform Chevron employees and contractors of the location, nature and size of any relevant flammable atmospheres when starting to prepare the tank cleaning

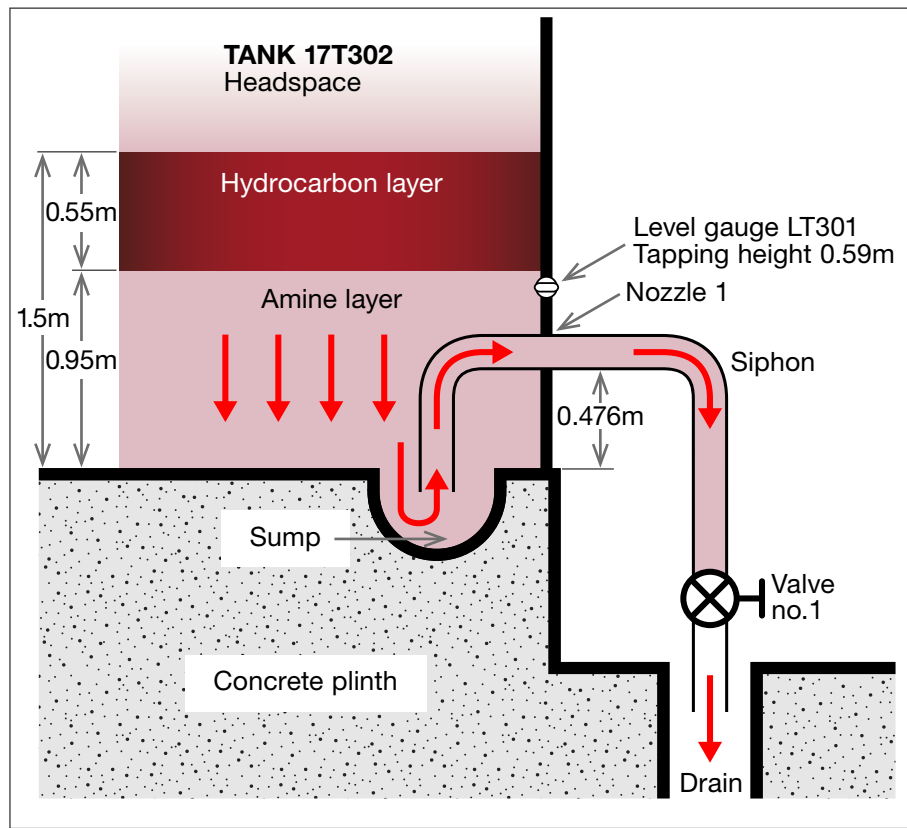
Figure 4 Schematic of tank 17T302 draining equipment

Tank 17T302 was also fitted with a float and tape level gauge, displaying tank liquid level on a dial and counter at ground level, capable of detecting and communicating liquid level right down to the tank floor. When emptying the tank, the Plant Operator relied solely upon the liquid level, which was displayed on the digital control panel within the unit control centre. This data was derived from level gauge LT301 installed in the tank wall, but 0.59m above the base, below which measurements were not captured. The last tank level for 17T302 observed on the control panel by the Plant Operator was 0.07m.

The Plant Operator opened the drain valve (valve 1 as shown in Figure 4) and observed a flow of material into the ARU sump. When flow from the drain valve ceased, he closed the valve, incorrectly believing that all the liquid had been drained and that the tank was empty. The float and tape level gauge was not used to confirm that the tank was empty. The Plant Operator was not aware that the cessation of flow had resulted from loss of the siphon, or that further draining of liquid may have been possible if the siphon had been re-established. In the shift log for the following day, the status of tank 17T302 was recorded as '*empty*' and this was repeated in subsequent shift reports, even though a substantial volume of liquid remained.

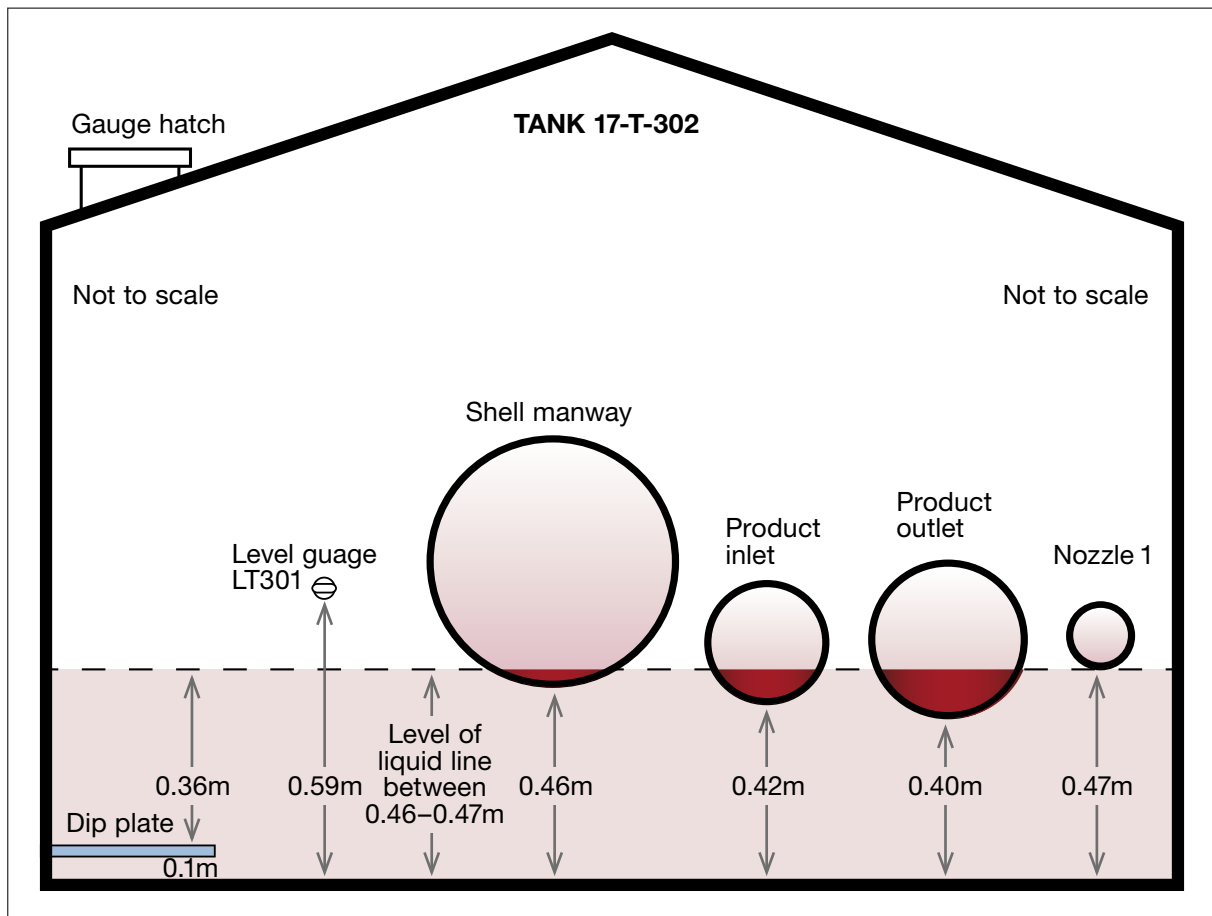
Figure 8 Schematic of liquid level in tank 17T302

The isolation task continued, despite the tank not being fully empty. Tank connections positioned higher than the liquid level (for example nozzle 1, connected to valve 1 and the sump) were successfully isolated by the contractors (see Figure 8). The main product inlet and outlet lines for the tank are relatively large (25.4 and 30.5 cm in diameter respectively) and situated at a low point, less than half a metre above the tank base. During isolation of these inlet and outlet lines, the contractors were met with a significant flow of liquid, gushing out of the valves. The contractors recall observing a shimmering haze, indicative of volatile hydrocarbon, and also registering a 'petrol-like' smell.

The engineering contractors returned to the vessel the following day and began to remove a shell manway, in order to ventilate the tank. The liquid inside was approximately 2.5cm above the bottom lip of the manway and continuously spilled from the tank for 45 minutes, until the manway gasket was replaced and the vessel resealed. As a result of this release, operatives were convinced that tank 17T302 had been totally emptied but that, prior to isolation, diethanolamine liquid had leaked back into the vessel through process lines. This mistaken belief was captured within the shift report for 28 May 2011 and repeated in all the subsequent shift reports until the explosion occurred.

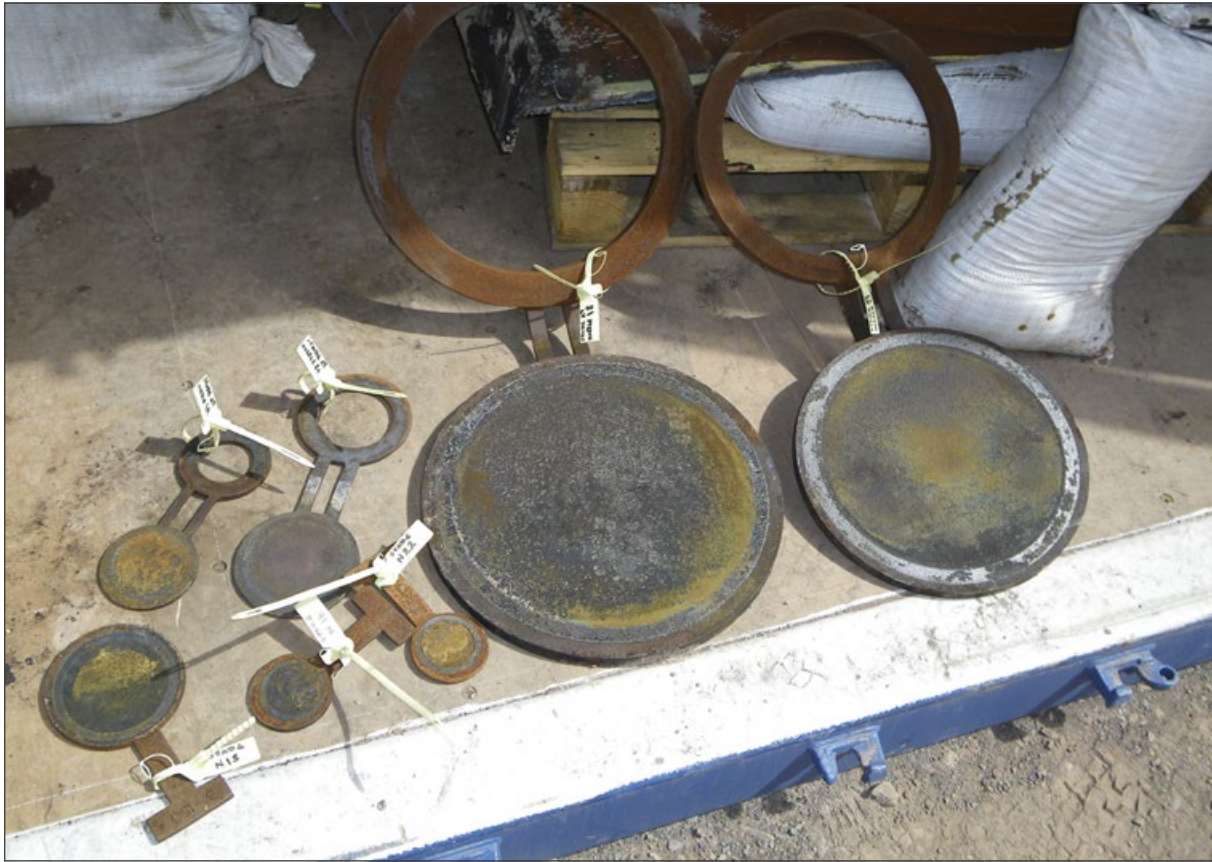
Figure 9 Photograph of isolation spades and blinds from tank 17T302

Close inspection of the inlet and outlet valves, coupled with examination of the spades and blinds (see Figure 9), confirmed that the possibility of liquid leaking through isolated valves was not a credible scenario. The liquid seen to leak from the tank during isolation was the remaining hydrocarbon layer, which had previously not been effectively drained or removed.

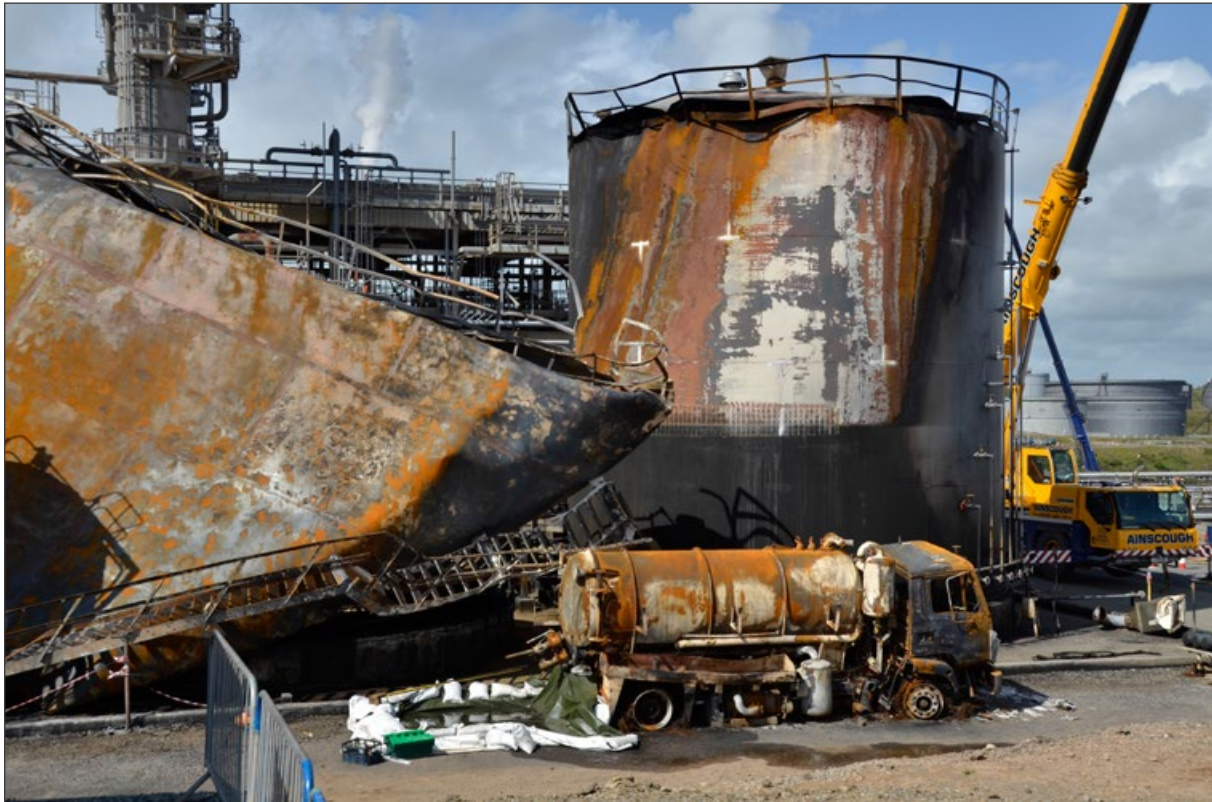
Figure 11 Post-incident – tank 17T302 minus vessel roof

The fire was brought under control using on-site firefighting staff and equipment. It was extinguished within approximately 23 minutes. Mid and West Wales Fire and Rescue service attended, deploying 10 pumps. A police helicopter used thermal imaging cameras to search for additional casualties. The COMAH on-site emergency plan proved largely effective in this case, as the fire was contained and did not spread to neighbouring vessels.

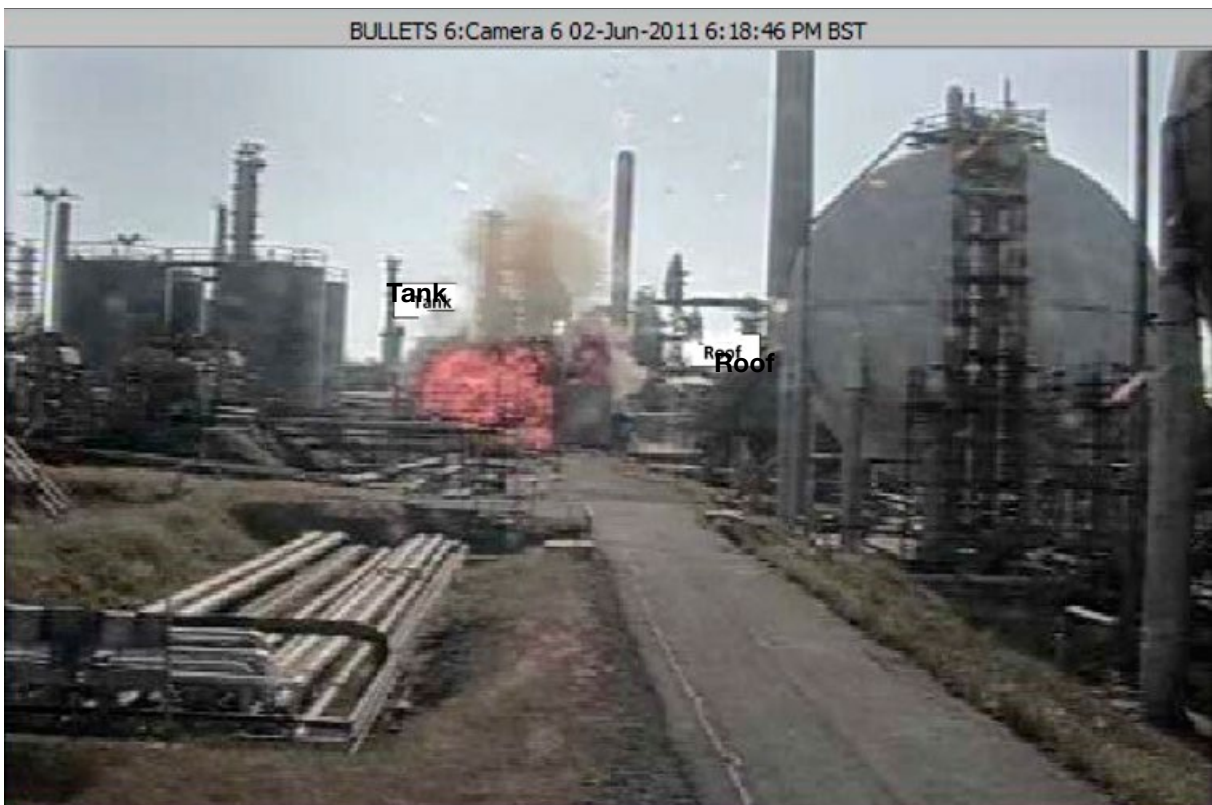
Figure 12 CCTV image showing ejection of tank 17T302 roof

The explosive force projected the 5-tonne tank roof approximately 55m (see Figure 12) in a north-easterly direction to its first point of impact with the ground, narrowly missing a multi-fuel pipe track by 1m, before somersaulting and colliding with a butane storage sphere, causing structural damage to the vessel legs and supports (see Figure 13).

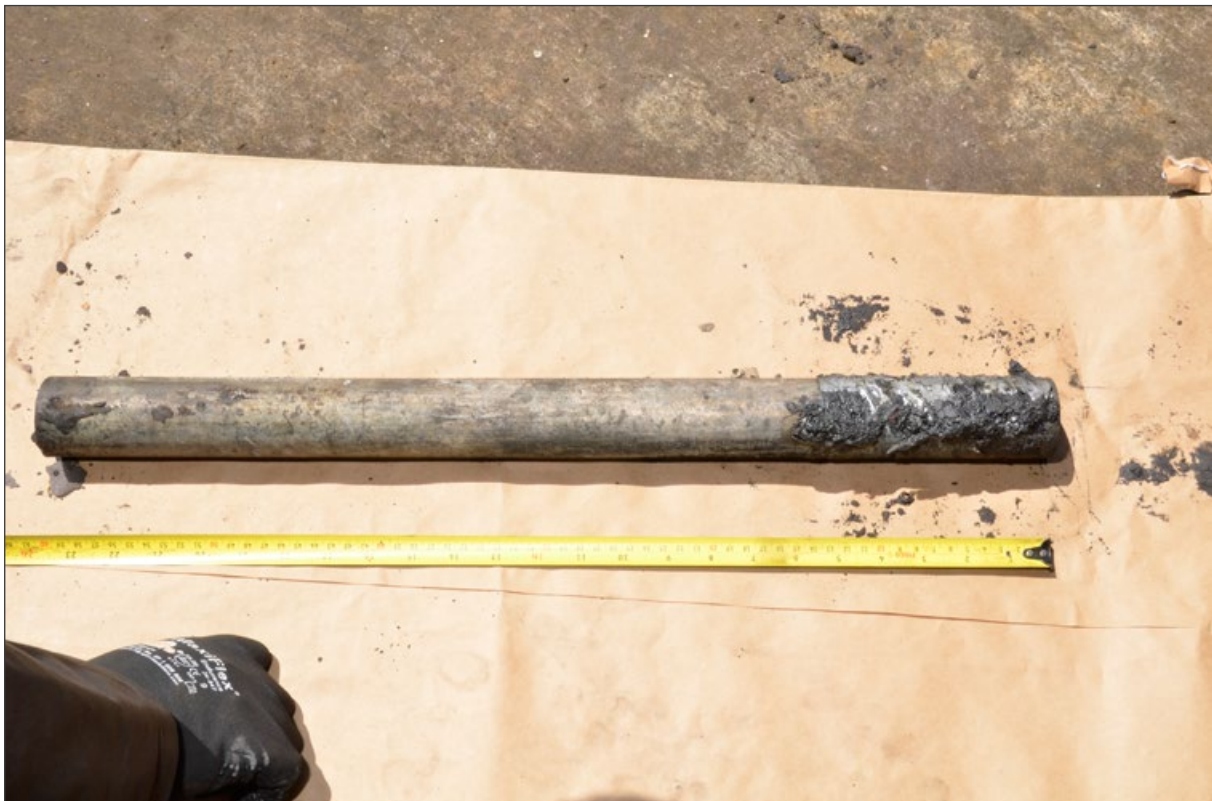
Figure 14 Photograph of scaffold pole found within tank 17T302

retrieved from inside the tank, trapped beneath an internal heating coil. This pole may have been attached to the open end of the green hose to act as a weight, which the investigation discovered was common practice amongst B&A staff when using vacuum tankers.

A galvanised steel scaffold pole was located within tank 17T302 after the incident (see Figure 14) and it is believed (but not conclusively confirmed) that this was attached to the hose to weigh

it down during the cleaning operation. Witness evidence indicated that this was common practice by B&A across both the Chevron and Murco refineries.
