**Investigation Report on
the Mirror Concert Incident
at Hong Kong Coliseum
on 28 July 2022**

Leisure and Cultural Services Department

November 2022

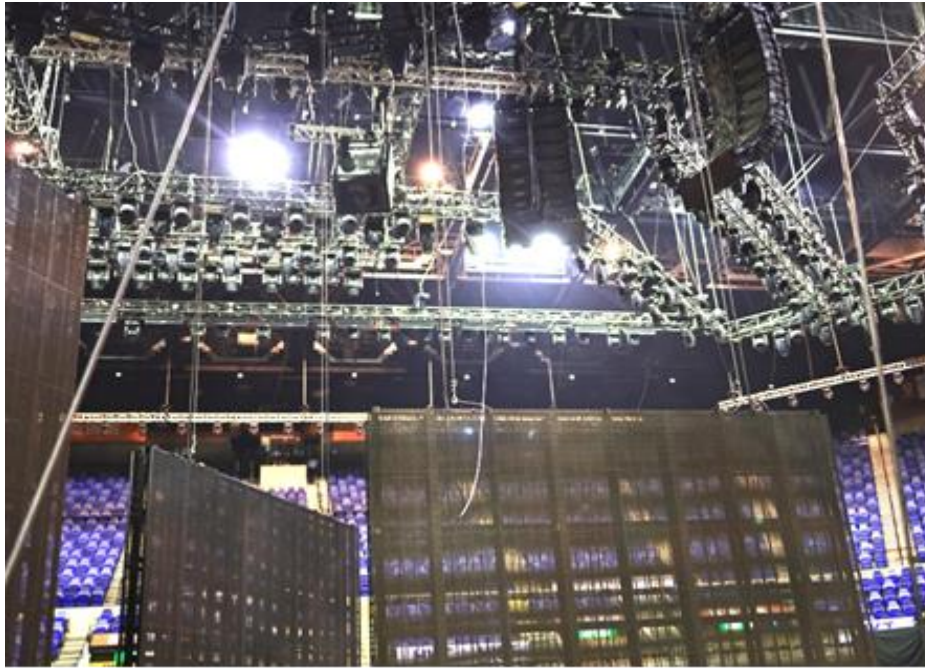
14. The investigation identified that the accident had been triggered when one of the two suspension wire ropes of the LED panel had broken. The pair of ropes was suspended from a winch system with grooved drum with the aid of a pair of spooling guide rollers assisting the sitting of the ropes into the grooves during spooling.

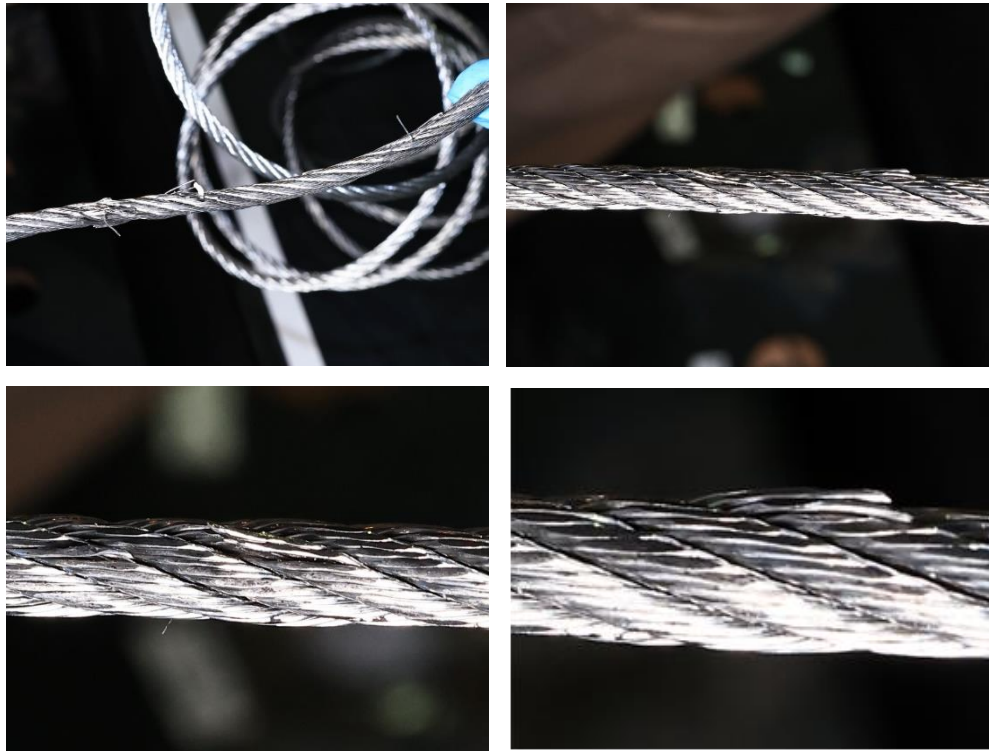
- (a) The broken suspension wire rope was fabricated from 6 strands of wires around a fibre core, with each strand of wires fabricated from 19 steel wires, and of right hand regular lay (i.e., a wire rope of 6x19 fibre core construction, which is normally designated as 6x19 fibre core wire rope). Its nominal diameter was 5 mm;
- (b) The condition of the broken rope was examined along its length using a binocular microscope. Many wire breaks with broken ends of wire as well as short lengths of fibre protruding from the rope were found;

- (c) Seven short pieces of broken wires (one exhibiting tensile overload feature and the remaining with comparatively flat fracture surface) were selected and cut out from the broken wire rope, and were examined in a Scanning Electron Microscope (SEM) to characterise their mode of failure. It was observed that apart from the one piece that exhibited cup and cone ductile overload fracture surface by which dimple like features were observed under the SEM, signs of fatigue striations were observed on the fracture surfaces of the remaining 6 pieces of wires which exhibited comparatively flat fracture ends. The findings confirmed that the wire rope had deteriorated to some extent by the formation of fatigue cracks, and the final failure occurred with the remaining wires of the suspension rope not being able to cope with the service stress induced, i.e., the mode of failure was metal fatigue; and

- (d) Tensile test as per BS EN12385-1 was carried out on the length of wire rope that had not been subject to the service load from the LED panel (i.e., the redundant length along the dead end beyond the rope grip of the suspension

rope tied to the eyebolt that broke away from the frame of the LED panel). The breaking strength of the rope was tested to be around 1100 kgf, which was lower than the minimum breaking strength of ropes of similar construction (6x19 fibre core wire rope of 5 mm nominal diameter) commonly available in the market.

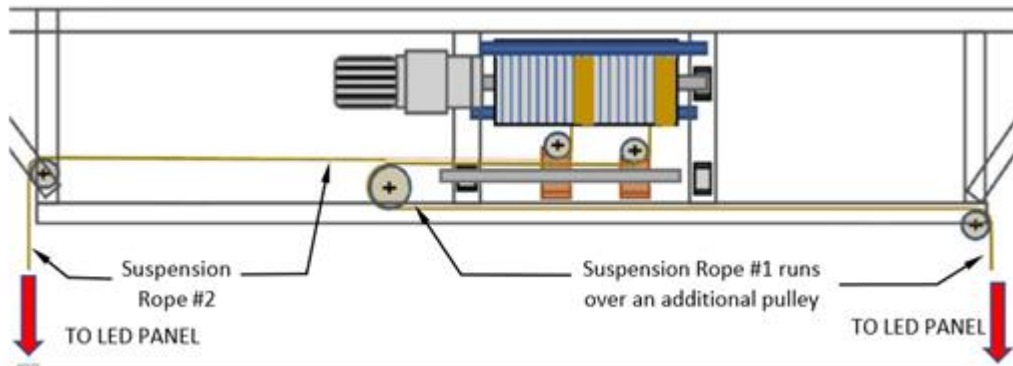
- (a) The winch for suspending the LED panel was fitted with an AC Servo Motor, and its output shaft was connected through a planetary reducer gear box to the grooved winch drum which accommodated the pair of suspension wire ropes for lifting each LED panel. The winch was designed in a manner that one of the two suspension wire ropes made an additional 180° turn at an additional pulley so that both of the ropes were spooled onto the grooved

winch drum under the guidance of a pair of spooling guide rollers which moved in the same direction along a worm gear which was driven through a driving chain linked to the motor of the winch.

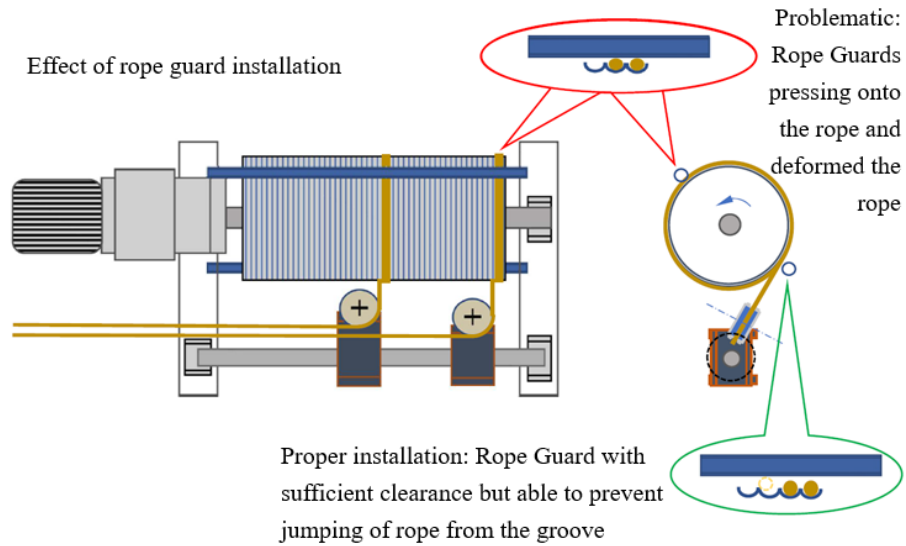
- (c) It was found that almost all of the rope guards could not be rotated freely as they had been overtightened to the frame of the winches whereas by slightly releasing the bolts at the two ends of the rope guards, the rope guards became free to rotate. As a result, the rope guard(s) as installed not only resisted the free movement of the rope during the spooling action of the winch, and hence induced extra load and stress onto the rope during the spooling action, but also caused excess wearing and crushing to individual wires forming the rope and disordering of rope lay all of which seriously affected the integrity of the rope. These types of damage led to repeated plastic deformation of the rope and lowering load carrying capacity of the rope, and when worked in combination with increased loads imposed on the suspension wire rope, the fatigue resistance of the rope was enormously reduced.

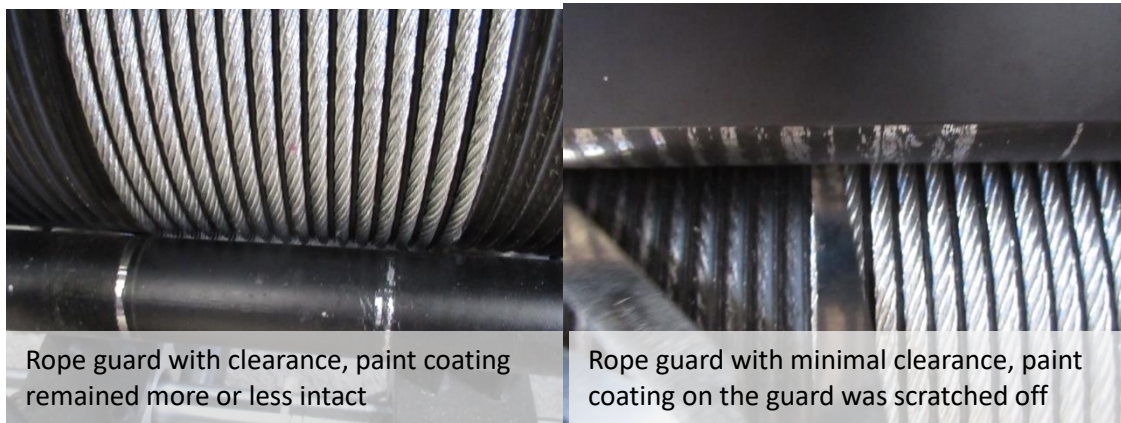
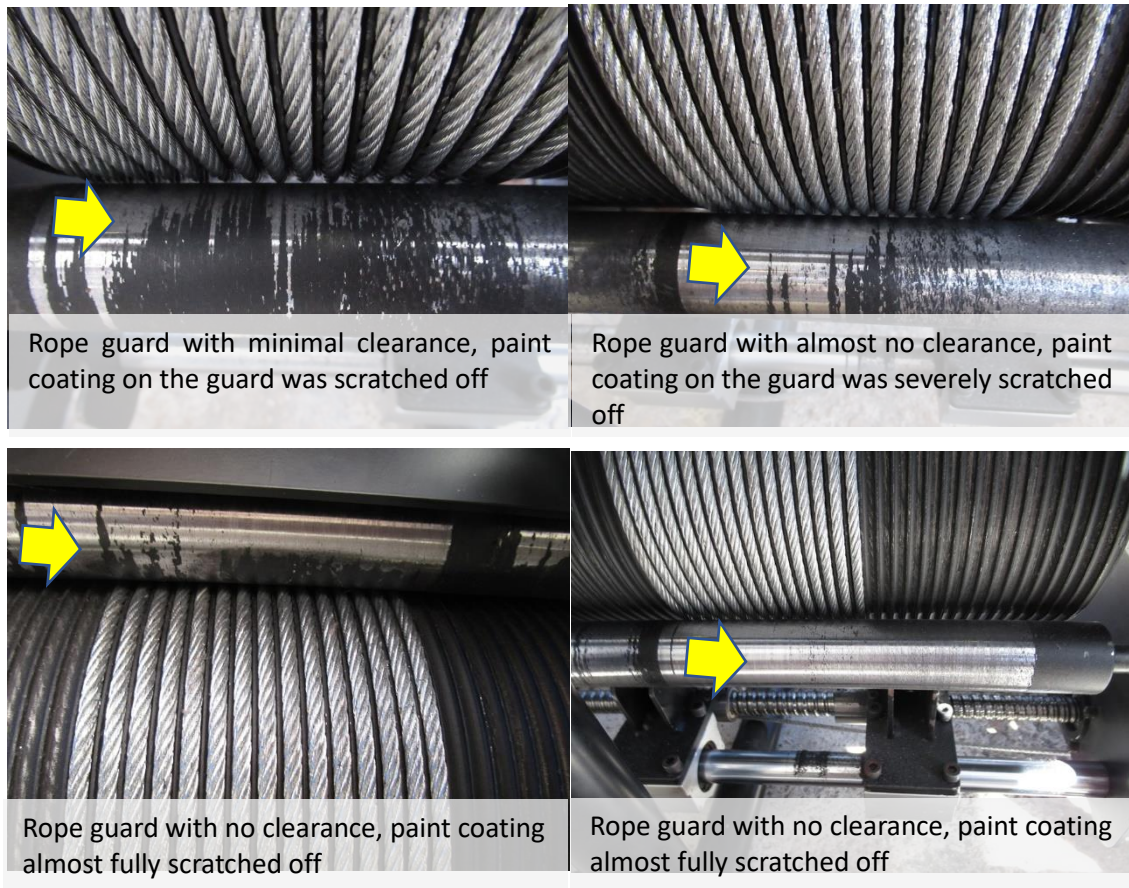
- (d) The extent of wearing could be best revealed from the extent of paint coating removal on the rope guards. On the rope guards of the winch suspending the fallen LED panel, the extent of paint coating removal was found to be rather severe, with the coating almost completely removed on one of the rope guards.

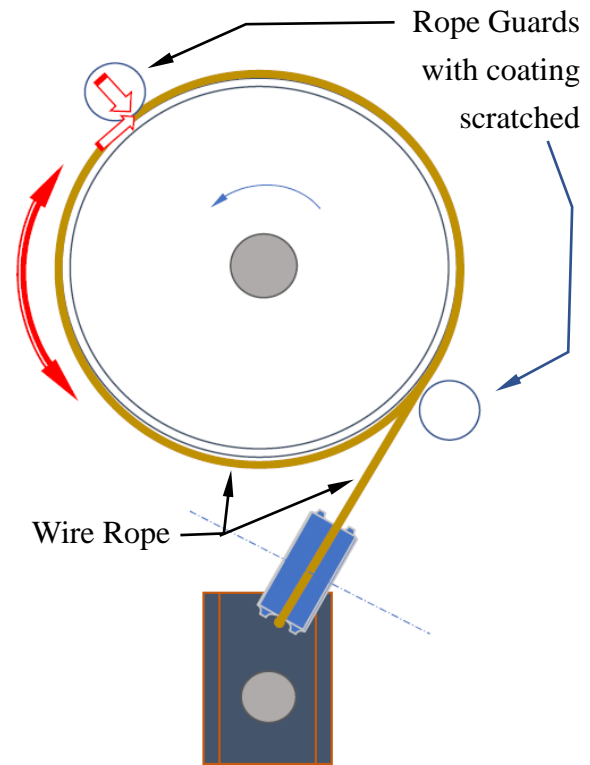
(e) The effects of rope guard(s) onto the rope are summarised in the following diagram.

- i. The rope guard would press against the rope and this would deform the rope. The rope lay would become disordered.
- ii. Significant wearing and crushing of the rope would occur as the rope was pulled across the rope guard, with worn powder formed acting as abrasive to further accelerate the wearing.
- iii. Additional stress would be induced on the rope as the rope guard would be preventing movement of the rope.

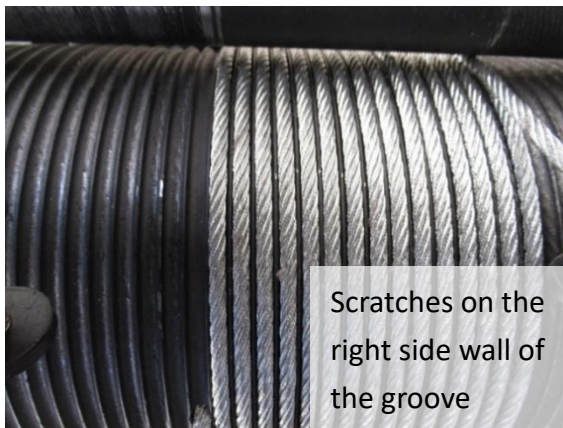
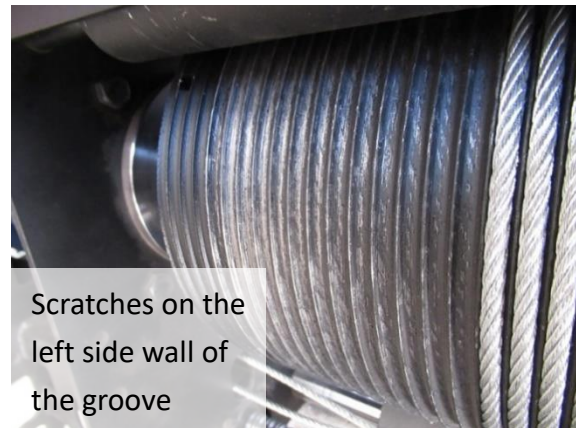
- (f) Signs of scratching along the edges and walls of successive grooves on some of the winches were observed. Additional damage to the rope in the form of rope twist was induced by the slightly misaligned spooling guide rollers of the winch that further increased the stress imposed on the suspension wire ropes, and hence further reduced the fatigue resistance of the rope.

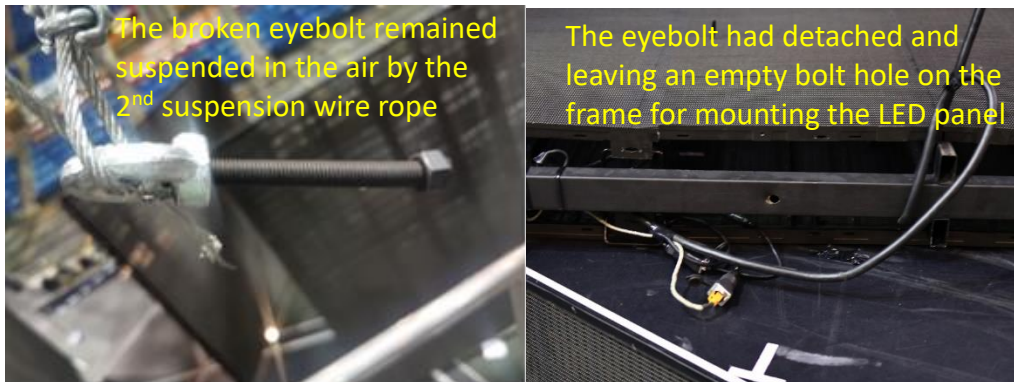
16. The investigation also revealed that after the failure of one of the suspension ropes, although the LED panel was still being suspended by the second wire rope, the eyebolt which was bolted onto the frame of the LED panel for tying the suspension rope broke.

16.1 The eyebolt was found fabricated by welding a M14 eye to a M12 steel stud for tying of suspension wire rope without the use of any turnbuckle to facilitate levelling adjustment of the LED panel. As such, the levelling adjustment was achieved by adjusting the protruded length of the eyebolt and as a result significant length of the steel stud could protrude from the frame after levelling adjustment. The eyebolt was found inserted into a bolt hole on the frame of the LED panel with a nut at the top and two nuts at the bottom. There were no signs of washer in place at the tightened joint to help spread the load and maintain the tightness of the joint but a reinforcing plate was found welded to the bottom part of the frame around the bolt hole. While the upper and lower nuts which were in contact with the frame could serve to hold the bolt in place, the lowest nut could be used as a lock nut to ensure that the bottom nut would not come loose. However, the fixing method of the eyebolt is prone to loosening by untwisting action imposed by the wire rope if any rope twist had been developed by any means in the suspension wire rope, especially if the lock nut was not sufficiently tightened.

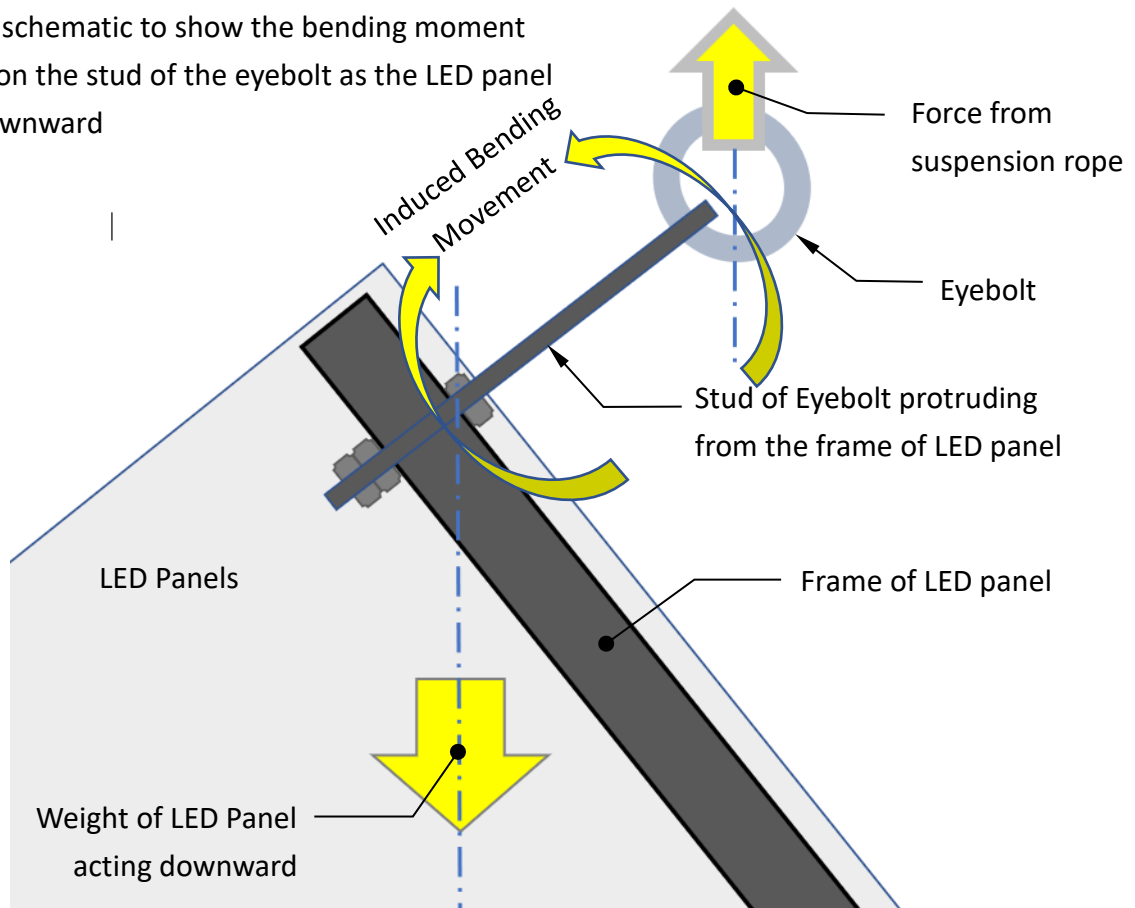
A simple schematic to show the bending moment induced on the stud of the eyebolt as the LED panel swing downward

16.3 After one of the suspension wire ropes failed and the LED panel swung by about 45°, very high bending moment was then acting onto the stud of the eyebolt. The resulting tensile stress induced by the bending moment exceeded the tensile strength of the stud and this led to the failure of the eyebolt.

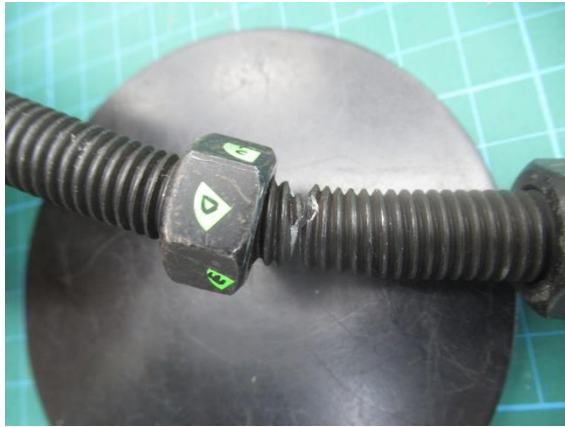
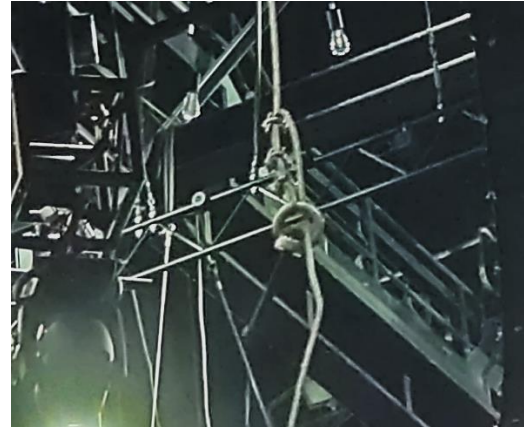
16.2 A total of 3 samples of the stud of the eyebolt, including the eyebolt from the broken suspension wire rope of the fallen LED panel were tested. The tensile strength of these studs were determined to be 840 MPa, 865 MPa, 846MPa which suggests that these studs were likely to be of Grade 8.8 (required minimum tensile strength of M12 Grade 8.8 bolt/stud is 830 MPa). No abnormality was observed in the breaking mode of these studs.

20. For the eyebolt, tensile strength testing revealed that the eyebolt in use should have been able to support the load of the LED panel when it was being lifted upward along the direction of the stud. However, the way the eyebolt being mounted to the frame was such that one may leave a long length of stud protruding from the frame, after having made levelling adjustment to the LED panel as no turnbuckle was installed for such adjustment. A simple bending moment analysis revealed that with a long length of the stud (140 mm) protruded from the frame of the LED panel, a high bending moment was created onto the eyebolt when the LED panel was suspended only by one suspension point. As a result, the eyebolt had been subjected to extreme bending stress that exceeded its tensile strength when the LED panel was lifted simply by one eyebolt with the LED Panel at about 45° to the horizontal. Therefore, the eyebolt which was tied to the second suspension wire rope broke and led to the falling of the LED panel at the time of the accident.
