Defence
Safety Authority

Service inquiry

Loss of F-35B Lightning
ZM152 (BK-18) of 617
Squadron RAF, embarked on
HMS QUEEN ELIZABETH

SERVICE INQUIRY INVESTIGATION INTO THE LOSS OF F-35B LIGHTNING ZM152 (BK-18) FROM 617 SQUADRON, EMBARKED ON HMS QUEEN ELIZABETH, ON 17 NOV 2021

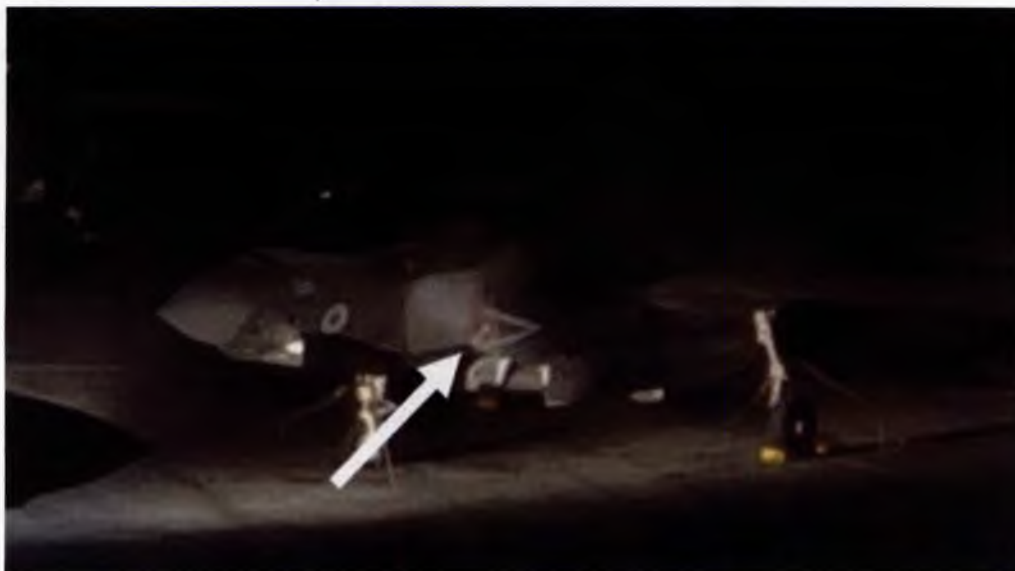
Figure 1.3.12 – BK-18 at 19:54 on 16 Nov 21 with left blank just visible in intake.²⁵

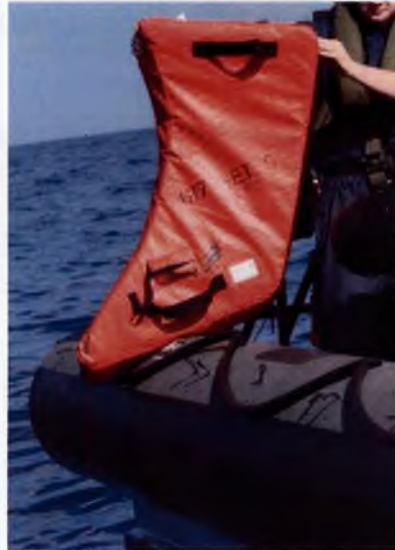
Figure 1.3.15 – Left intake blank recovered by QNLZ sea boat.

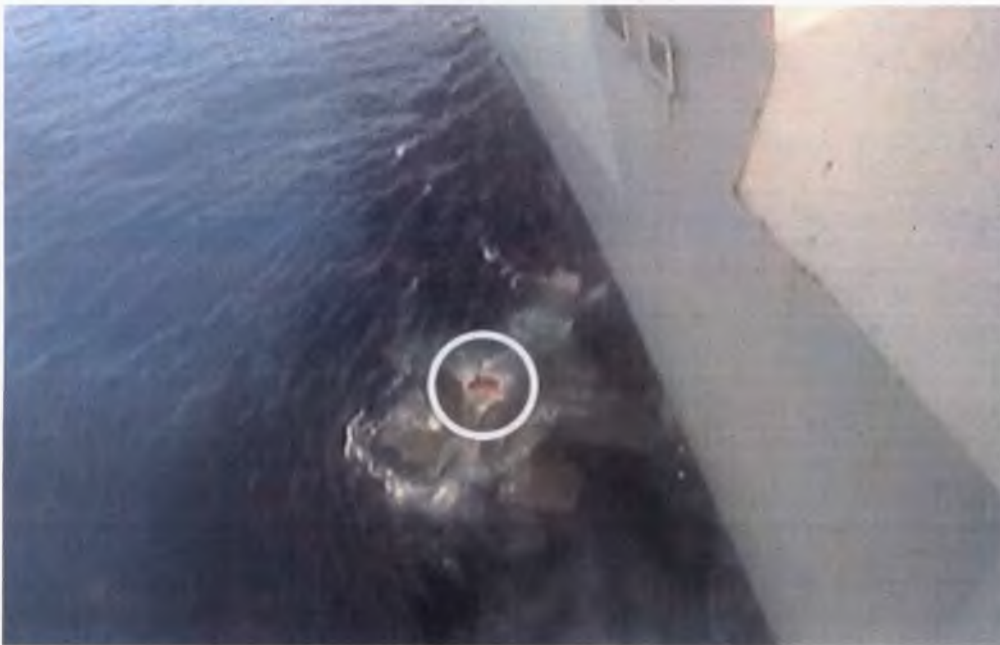
Figure 1.4.3 – Left intake blank floating out of BK-18.

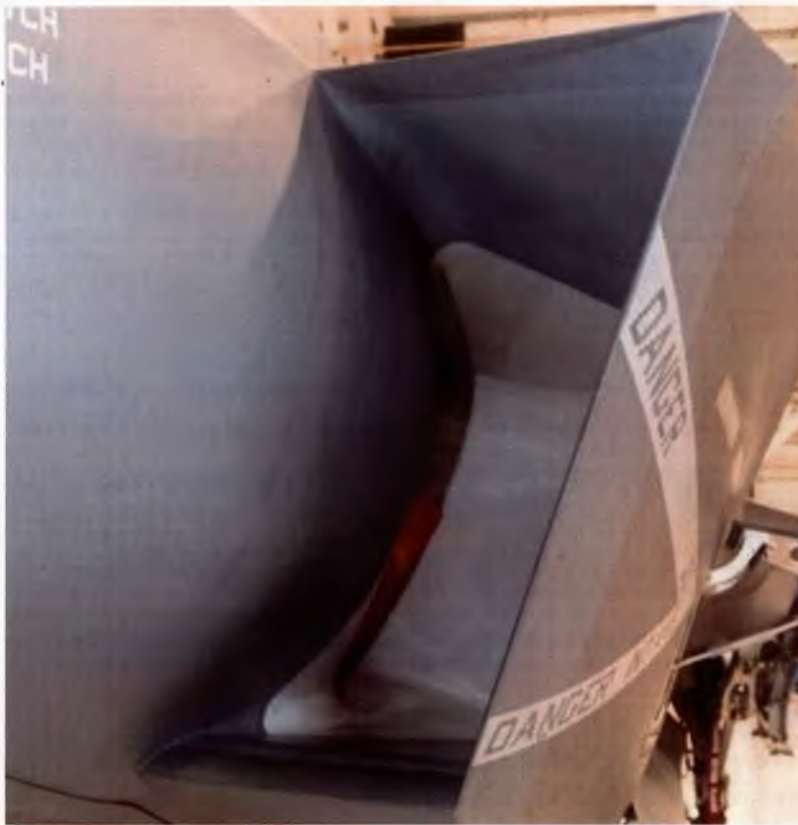
filtered light in a dark intake would have decreased the likelihood of it being seen (Figure 1.4.4). The panel concluded that not using white light for servicing was a **contributory factor**.

Figure 1.4.4 – Reproduction of F-35B with displaced left intake blank in shadow.

1.4.29. Recommendation. Director Force Generation should define the procedures for use of white light on the Queen Elizabeth Class flight decks at night in order to ensure engineering standards and practices can be achieved.

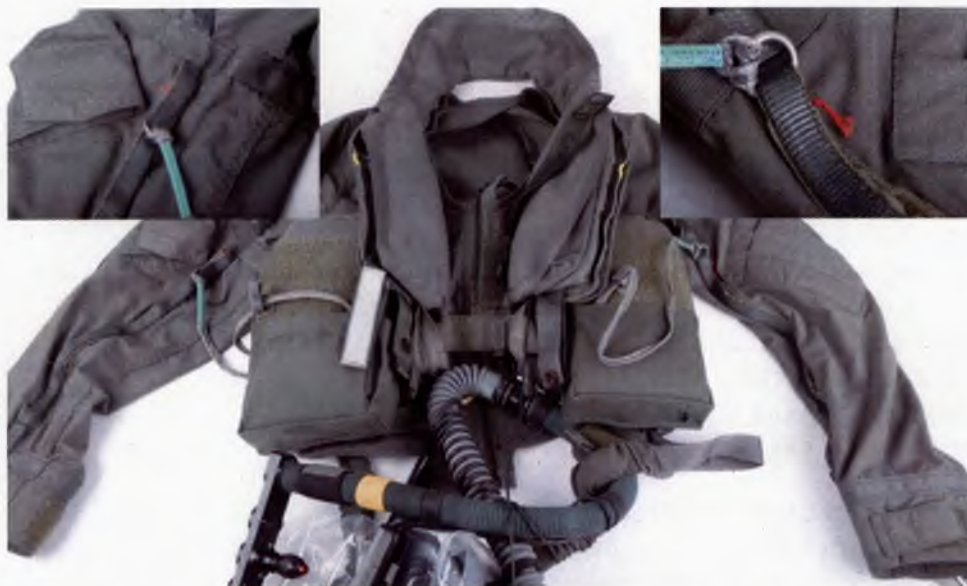
other factor. RAFCAM determined that all other aircrew equipment worked correctly.

Figure 1.4.6 – BK-18 pilot’s flight jacket. AREL red tie on left sleeve remained intact.

1.4.52. Recommendation. The Lightning Type Airworthiness Authority should provide clear guidance to aircrew and survival equipment technicians on the correct selection, fitment, and use of arm restraint extension lines (AREL), to include length selection and use of ‘white whistles’, in order to improve the likelihood of correct AREL function.

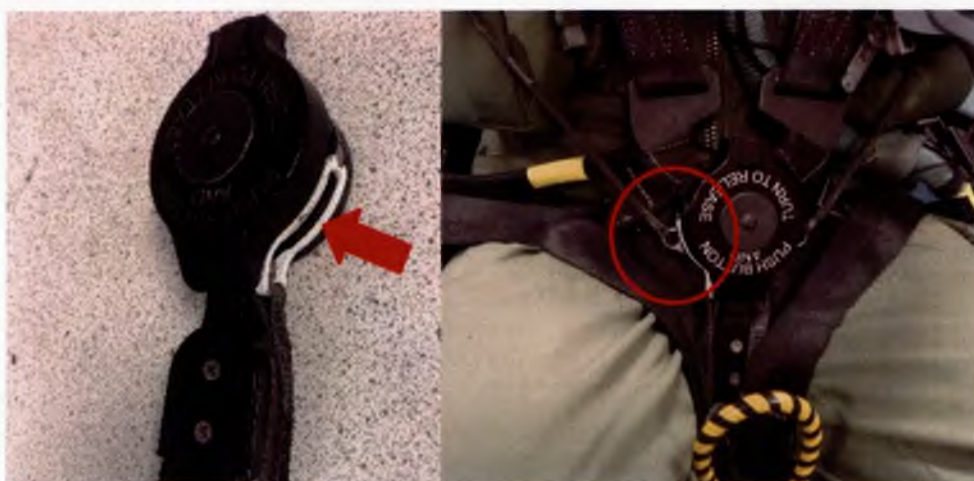
Figure 1.4.7 – ‘White whistle’ into which the lower lug of the AREL was fitted.

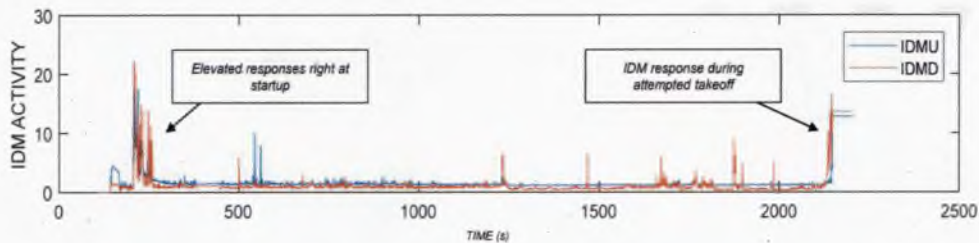
1.4.119. BK-18's IDMS data (Figure 1.4.16) showed readings on the IDMD throughout the period the engine was at idle which increased as air flow through the engine increased. The IDMU and EDM showed no such indications. If the FOD was significant enough to cause engine damage it is likely that an associated engine caution or warning would have been triggered. The data suggested there was FOD in the vicinity of the IDMD, but behind the IDMU.

Figure 1.4.16 – BK-18 IDMS trace from start-up to accident.⁴⁸

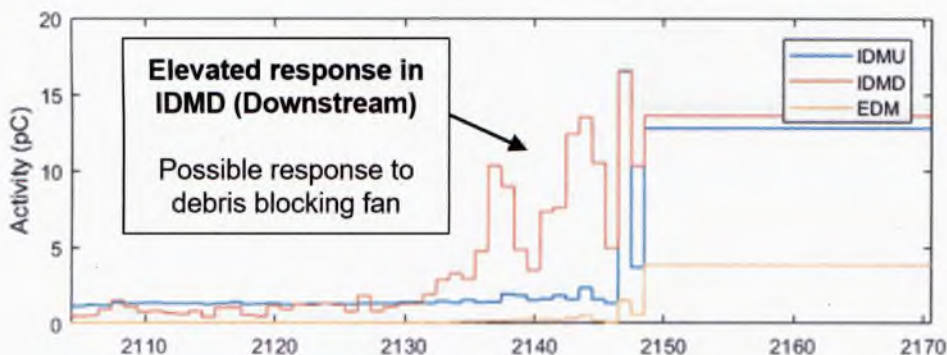
1.4.120. Analysis of the time period from 2129 to 2135 seconds (just prior to brake release) showed an elevated IDMD response during the period at 34% Engine Thrust Request (ETR) (Figure 1.4.17). An increase at 2135 seconds (97% ETR, brakes release) remained after the selection of idle at 2141 seconds. The ejection at 2145 seconds was likely to have caused the elevated readings at that point. The aircraft impacting the water at 2148 seconds creating the final elevated then flat readings. The panel concluded that the left intake blank was laying against the front face of the engine. The panel went on to investigate the effect of the blank on the engine's performance.

Figure 1.4.17 – IDMD elevated response from BK-18.⁴⁹

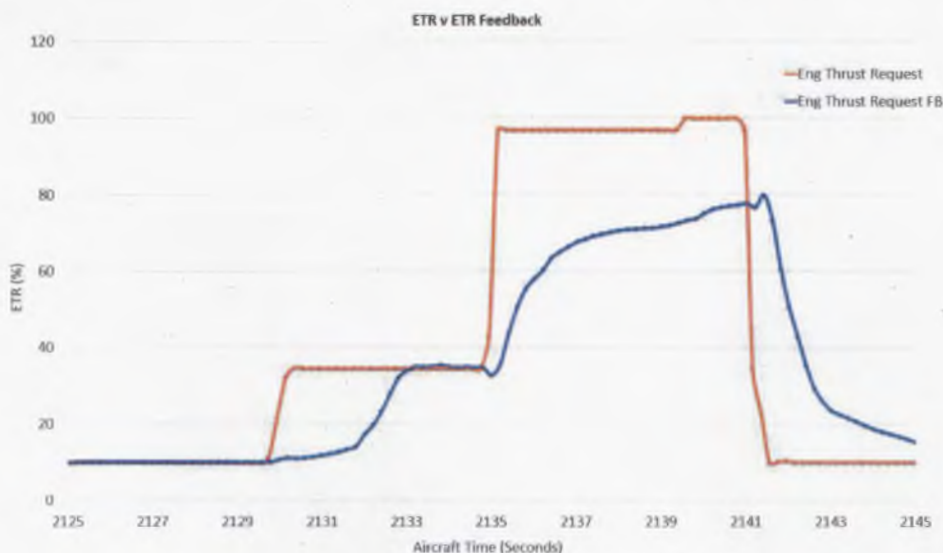
Figure 1.4.19 – BK-18 engine power demand versus delivered.⁵¹

1.4.123. There was a minimum of 17% deficit between demanded and delivered thrust, which equated to 38,000lb thrust requested, but only 31,500lb of thrust delivered. There was a lag between the time the 97% and 100% ETRs were demanded, and the 80% maximum was delivered (Figure 1.4.19). The time spent at a significantly lower than demanded thrust resulted in the poor acceleration.

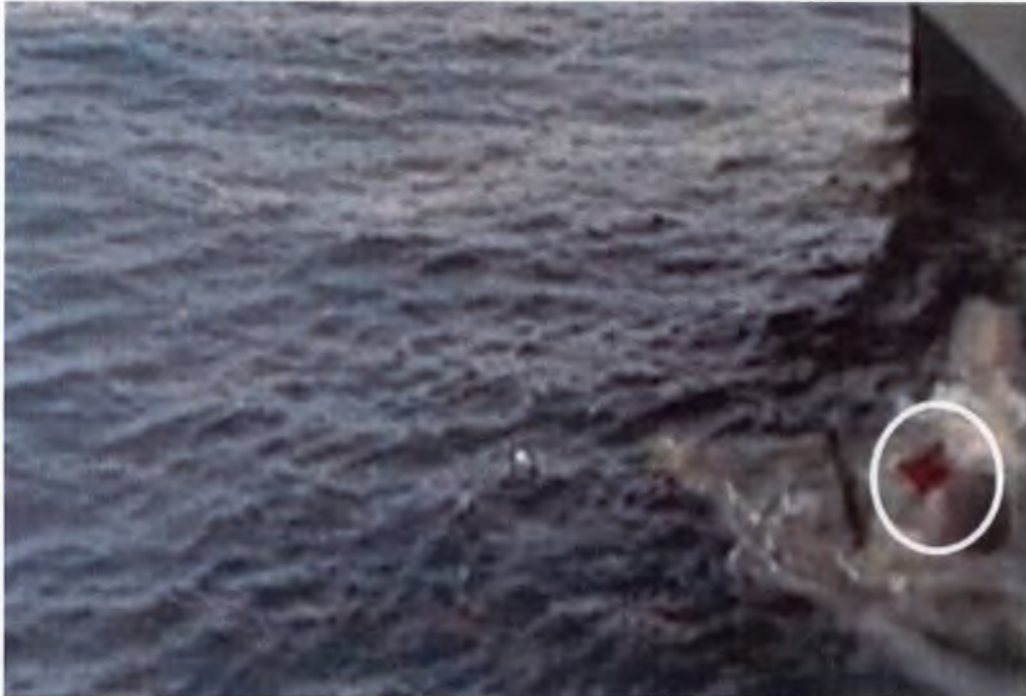
Figure 1.4.20 – Intake blank (circled) on top of BK-18.

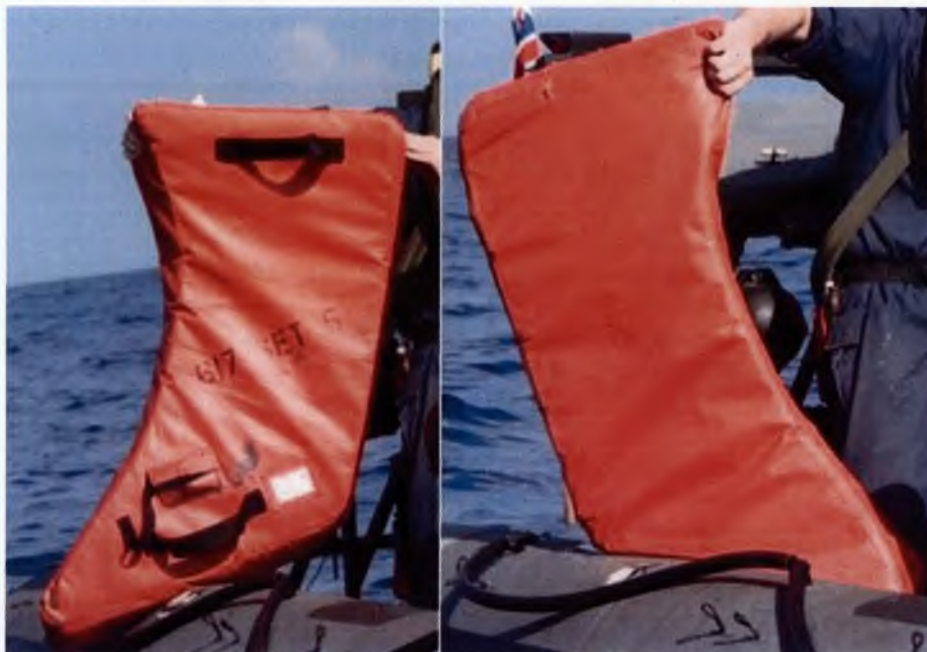
Figure 1.4.21 – BK-18 left intake blank on recovery from the sea.

1.4.127. Examination of the wreckage of BK-18 and the intake blank by 1710 NAS revealed damage to the front face of the engine, to the rubberised

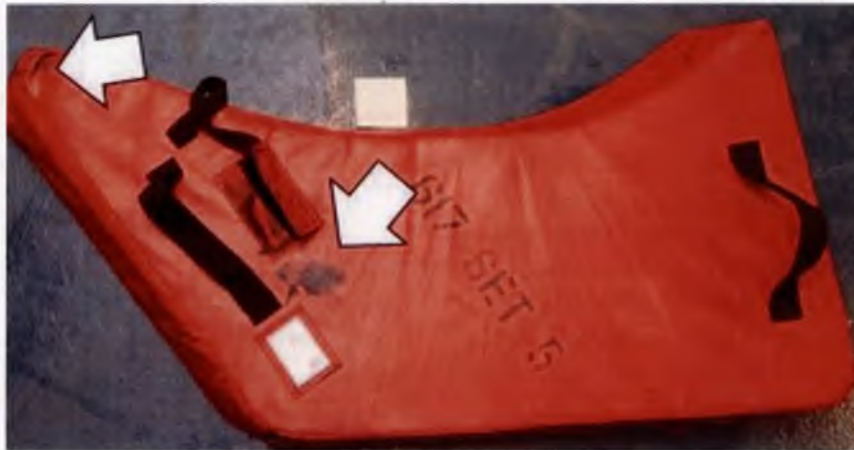
Figure 1.4.22 – BK-18 left intake blank. Arrows show black marks which were subject to chemical analysis.

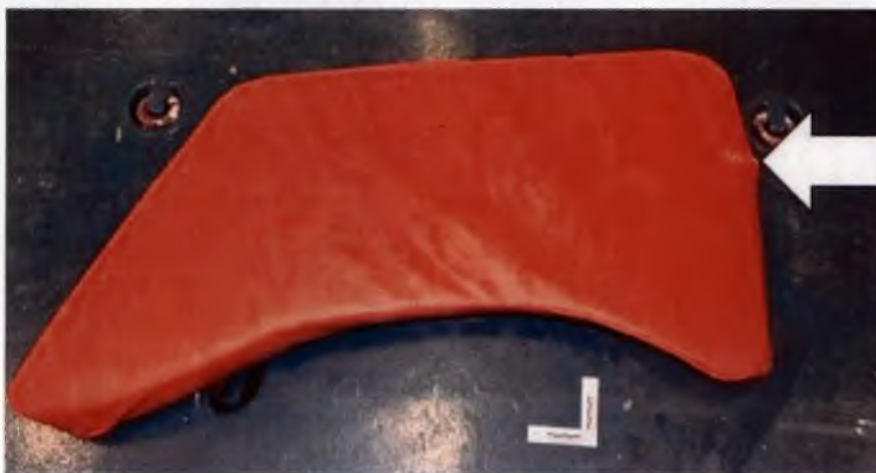
Figure 1.4.23 – Cuts to the top edge of BK-18 left intake blank.

1.4.128. Based on all the evidence, the panel concluded that the left intake blank was at the front face of the engine compressor during the aircraft launch and determined this to be the **causal factor**. This factor is addressed by the recommendation at para 1.4.36.

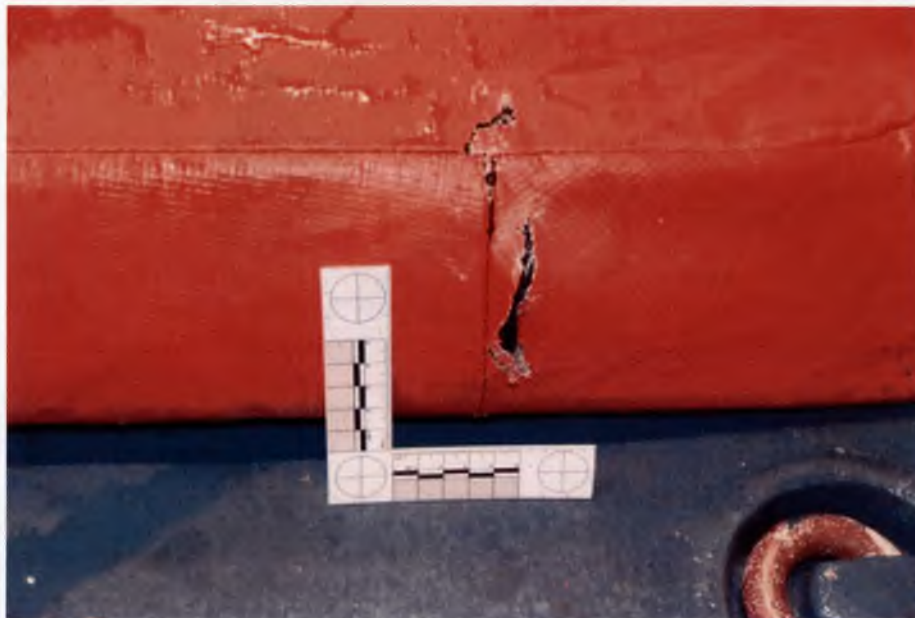
Figure 1.4.24 – Close up view of damage to BK-18 left intake blank top edge.

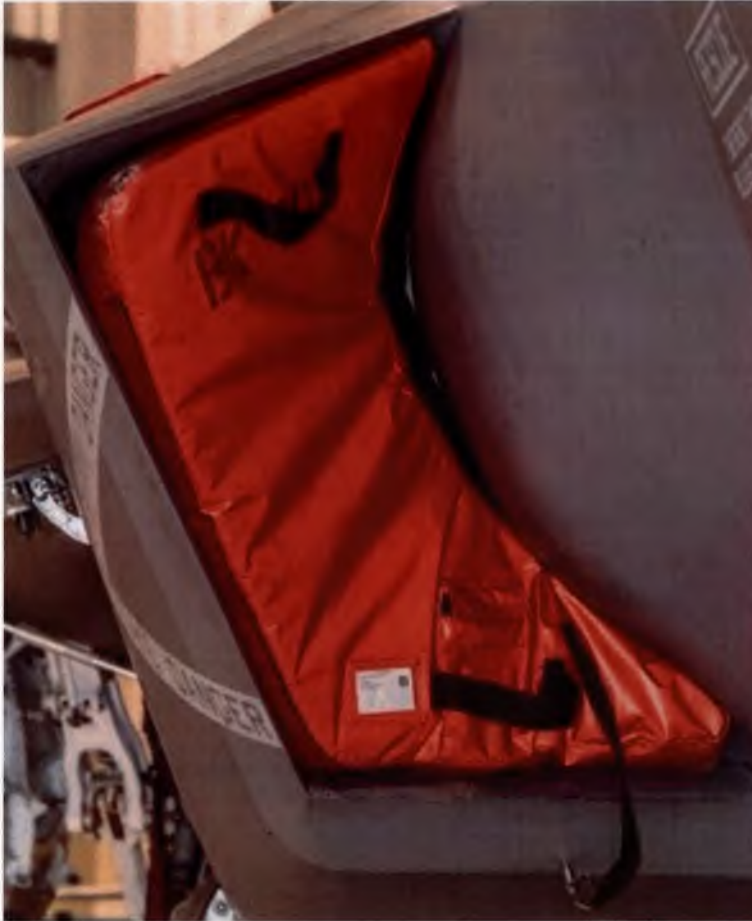
Figure 1.4.26 – Example of poorly installed intake blank seen at RAF Marham.

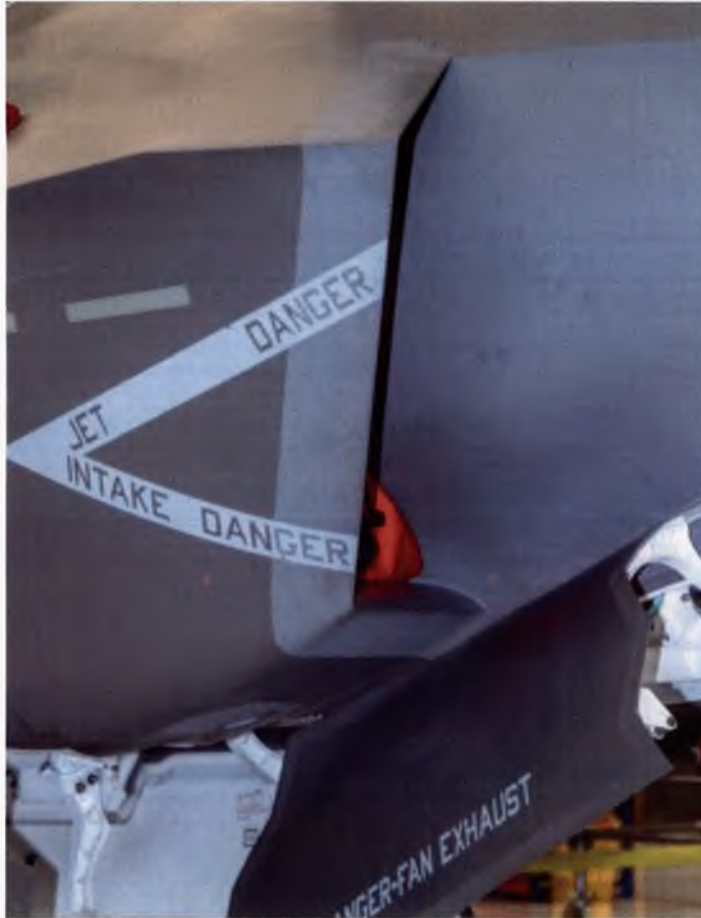
1.4.139. The intake blank was fitted using the photographs in the intake blank engineering evaluation test plan as a guide. It was notable that the inboard lower corner was exposed even when the rest of the blank was protected by the airframe (Figure 1.4.27). The curvature of the intake behind where the blank was fitted was complex in this region and the investigation noted that the geometry limited the ability of the blank to be pushed further aft into the intake.

Figure 1.4.27 – Blank fitted using Lockheed Martin engineering test plan. Intake blank inboard lower edge remains exposed.

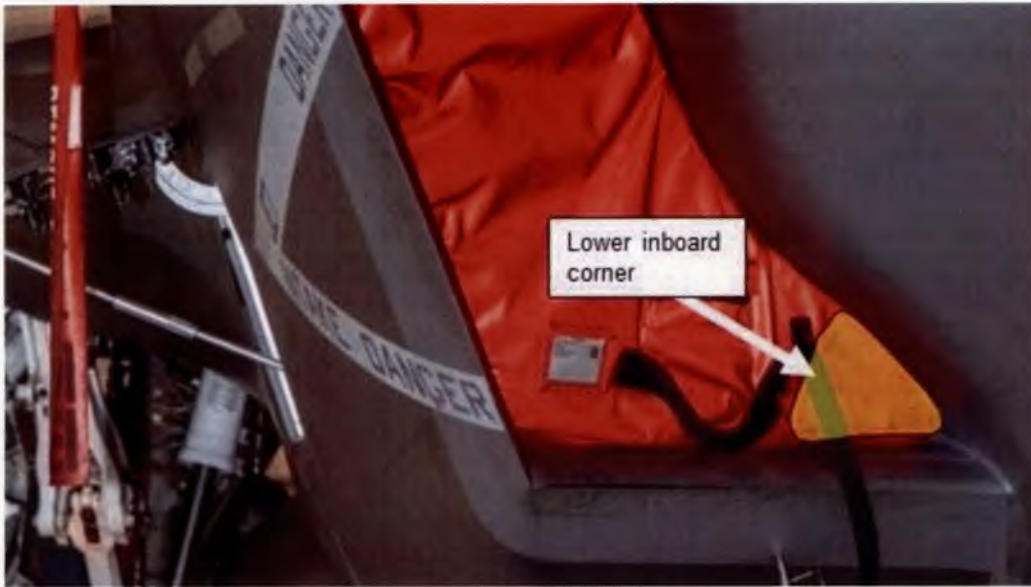
Figure 1.4.28 – Example of observed intake blank fitted to aircraft under maintenance, highlighting the inboard lower corner.

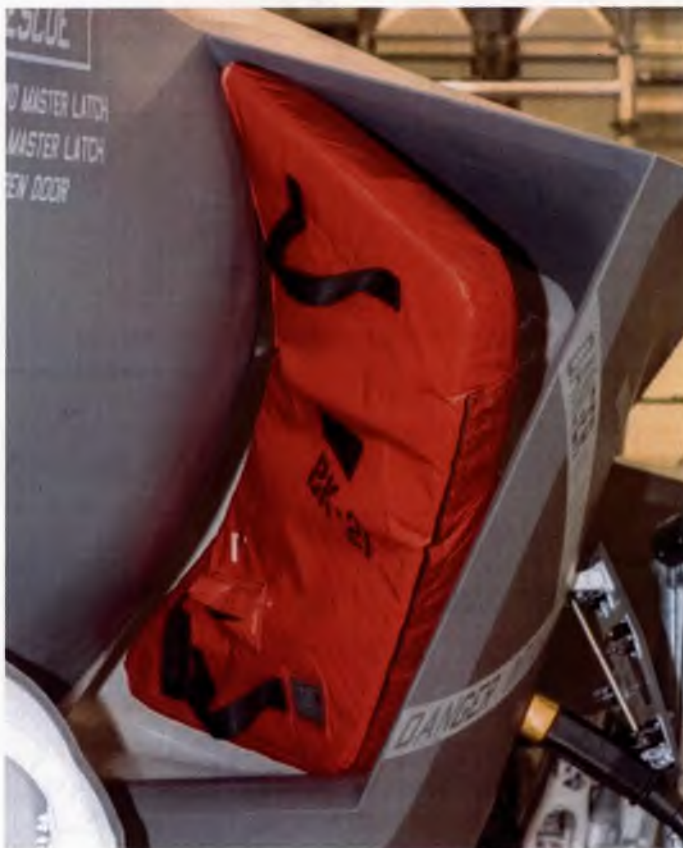
Figure 1.4.29 – Blank in the process of rotating following application of force in the bottom inner corner.

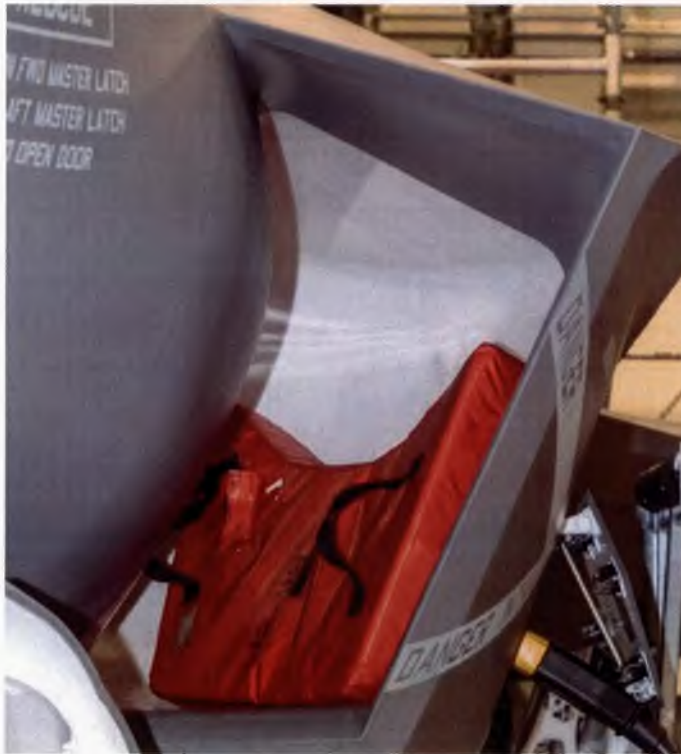
Figure 1.4.30 – Intake blank orientation after displacement.
