November 7, 2023

RE: Existing Building Structural Assessment – 1962 Market Street

EXISTING BUILDING ASSESSMENT
 1962 MARKET STREET
 DENVER, CO

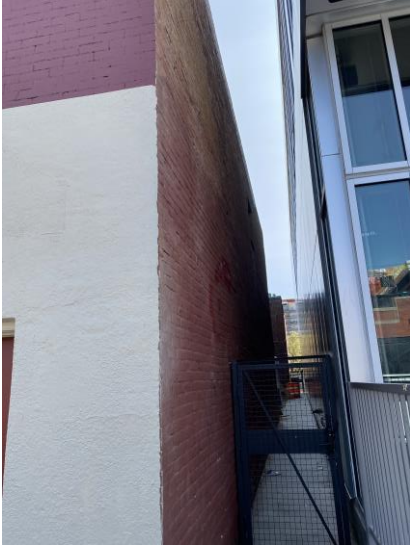
Image 1 – South Elevation

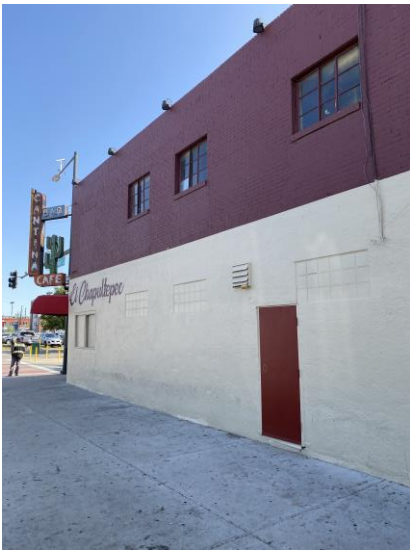
Image 2 – West Elevation

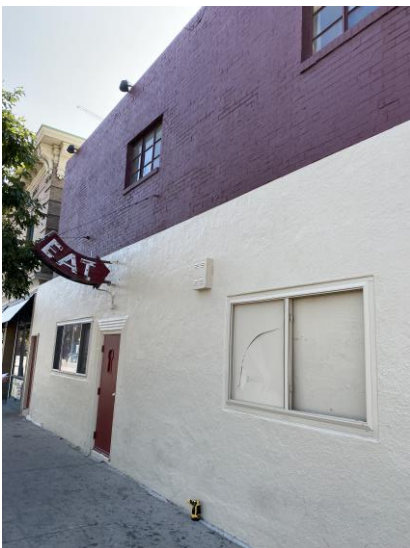
Image 3 – North Elevation

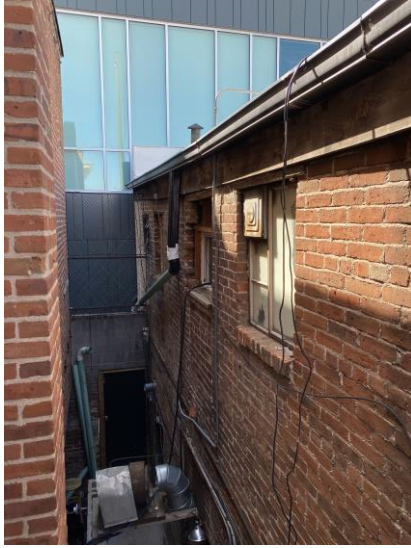
Image 4 – East Elevation (Looking South)

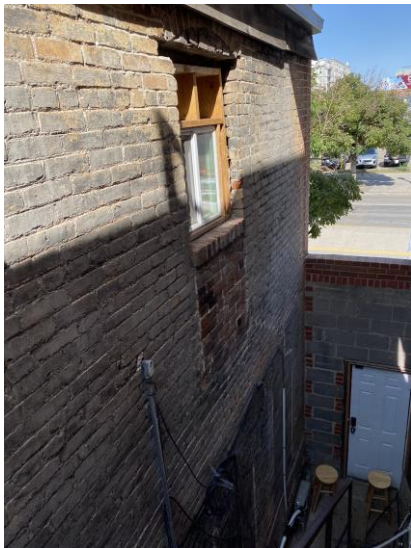
Image 5 – East Elevation (Looking North)

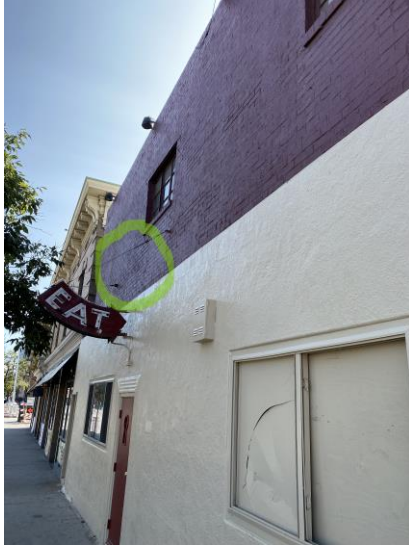
The north exterior wall near the east side appears to bow outward above the second floor level, which may be due to separation of the brick wythes. Image 6 highlights the area of the wall of concern.

Image 6 – North Elevation – Area Where Wall Appears to be Bowing

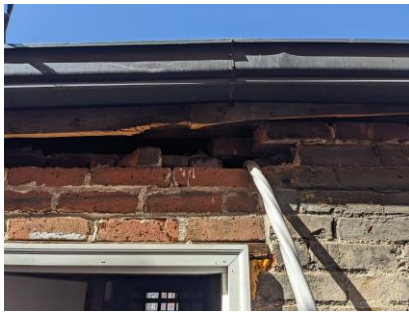
The roof slopes down from west to east, and the roof extends over the top of the roof on the low side, and deterioration on the top of the brick wall is evident (shown in Image 7), most likely from years of water infiltration. This condition has compromised the bracing of the top of wall and lateral ties from the roof diaphragm to the wall.

Image 7 – East Elevation – Top of Wall Deterioration

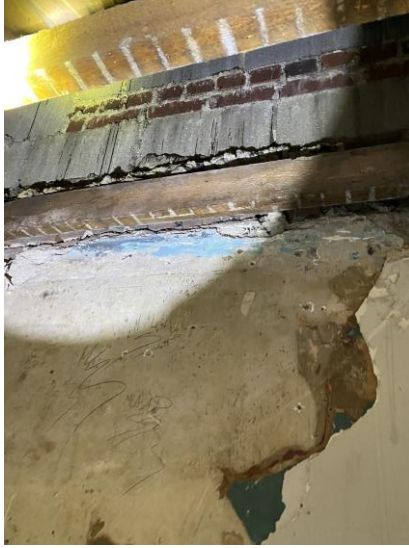
Top of walls on the west and south side were modified with some CMU block and newer brick at top of wall, which leads us to believe the top of the wall had water damage and was rebuilt. This condition is shown in Images 8 and 9. It is anticipated that significant portions of the exterior brick walls cannot be repaired and will require complete reconstruction.

Image 8 – West Elevation – Top of Wall Past Rehabilitation

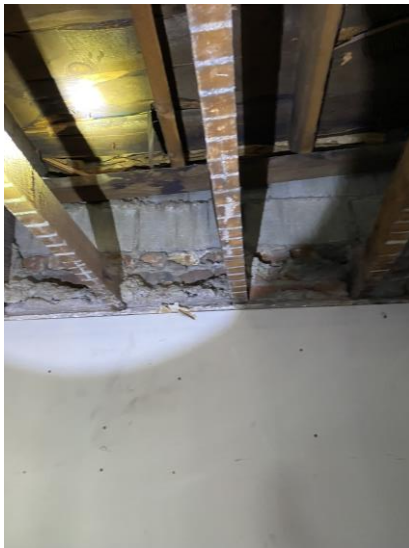
Image 9 – South Elevation – Top of Wall Past Rehabilitation

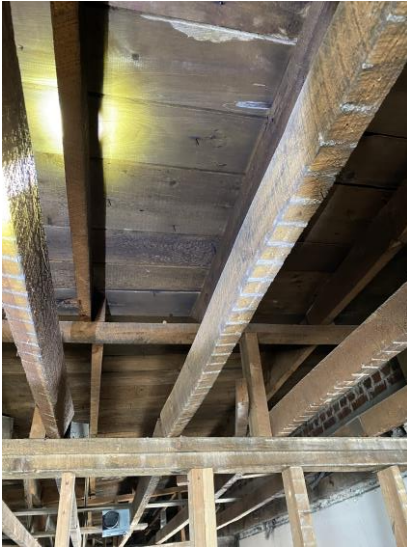
Image 10 – Existing Roof/Ceiling Framing Bearing on Interior Wall

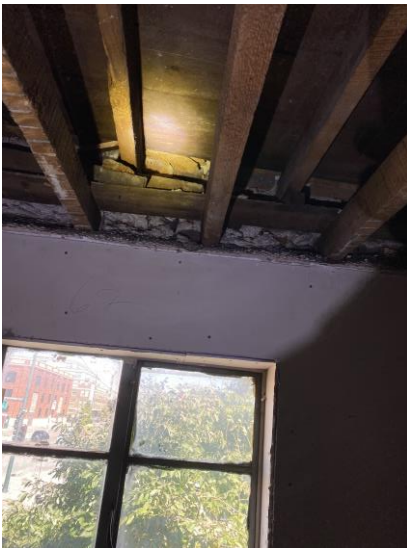
Image 11 – Existing Roof/Ceiling Framing Bearing in Brick Pockets

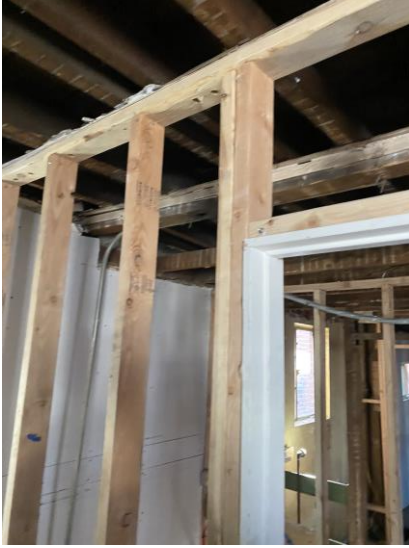
Image 12 – Altered Bearing Wall Location – Northeast Section

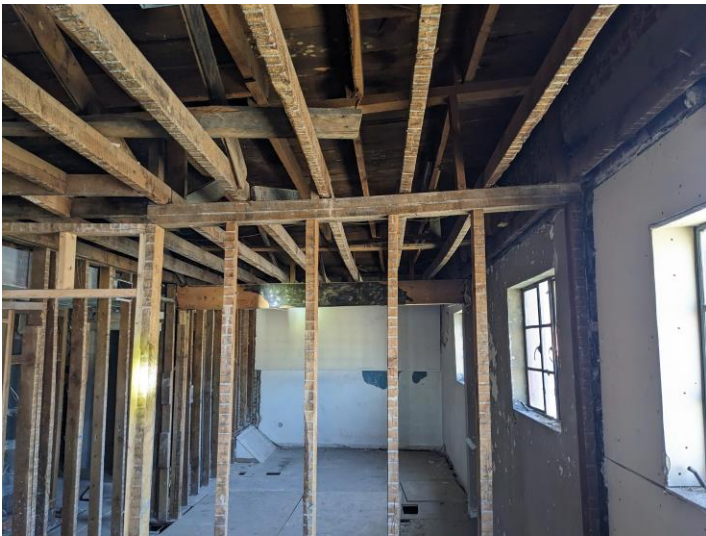
Image 13 – Altered Bearing Wall/Beam

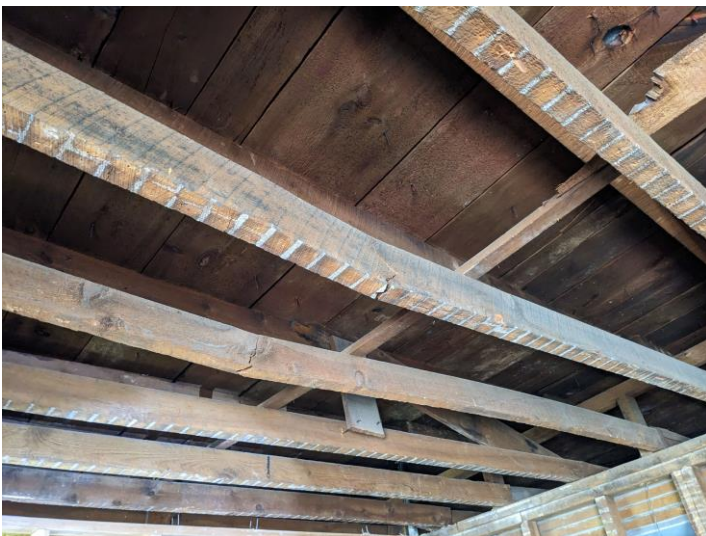
Image 14 – Overloaded Framing

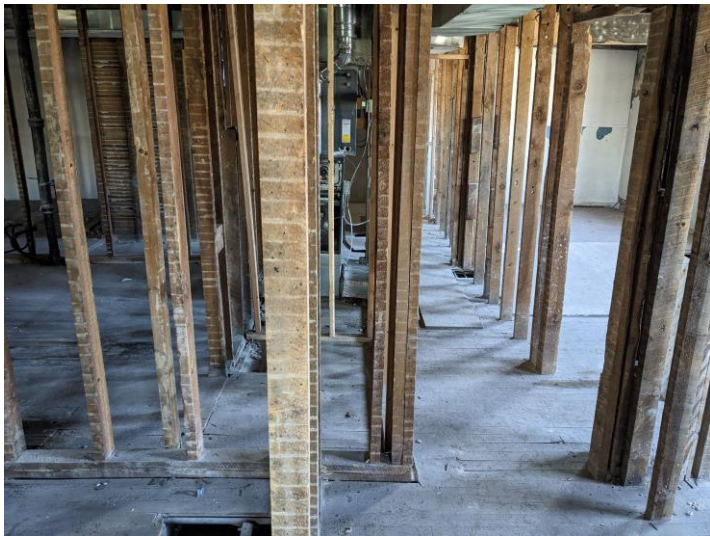
Image 15 – Second Floor – Current Condition

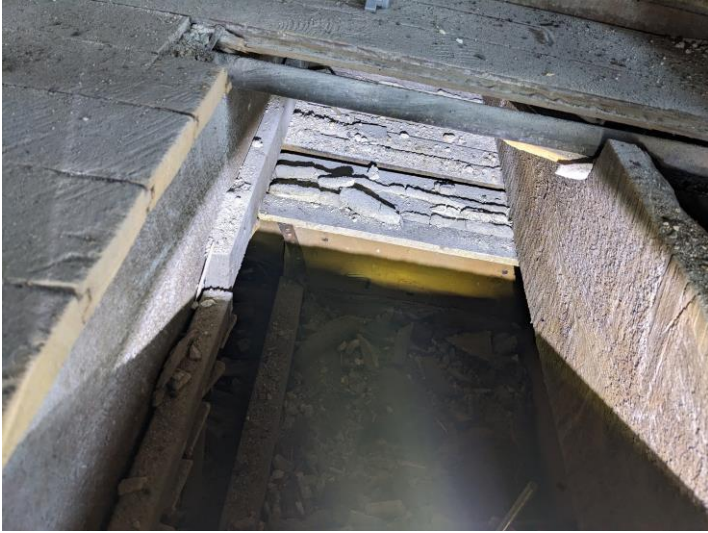
Image 16 – Second Floor – Damaged Joists Bearing on Modern Built Up 2x Wood Beam

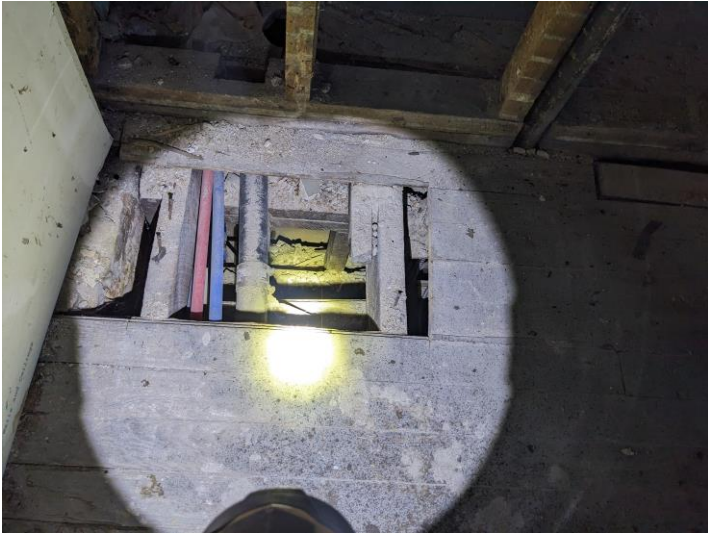
Image 17 – Second Floor – Joists Bearing on Original Wood Bearing Wall – Southeast Area

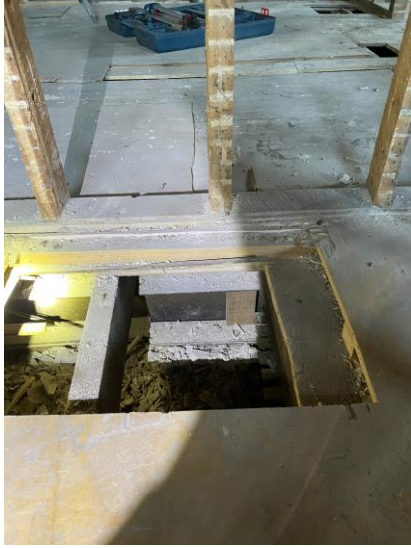
Image 18 – Second Floor – Original Steel Beam Support

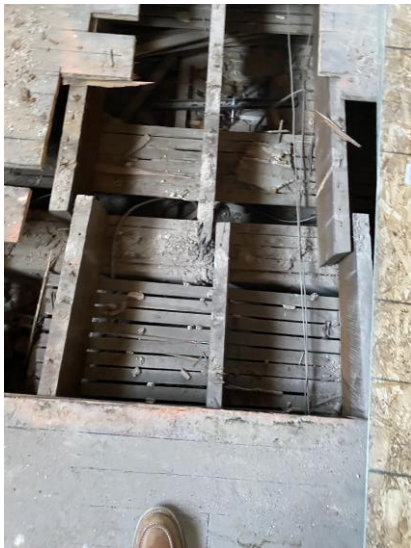
Image 19 – Second Floor – Bearing Wall Below Replaced by Beam

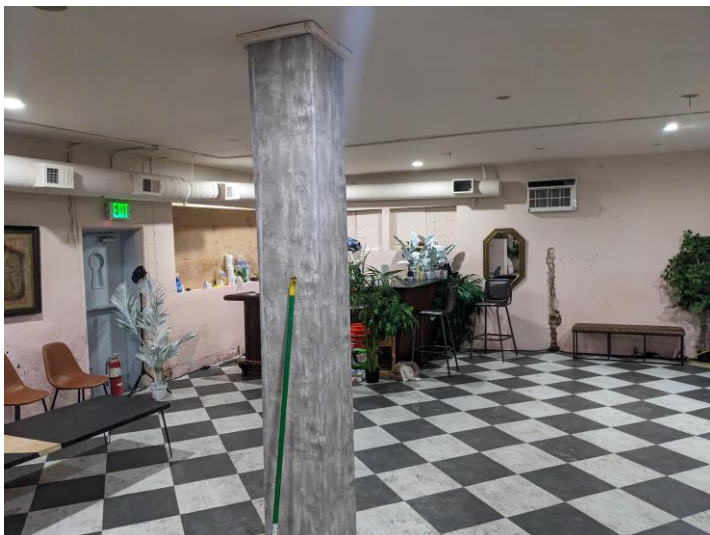
Image 20 – Main Level – Original Assumed Support Column for Original Assumed Steel Beam Above

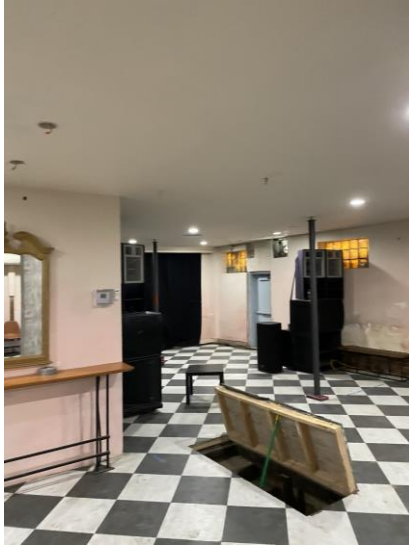
Image 21 – Main Level – Temporary Columns (Looking Southwest)

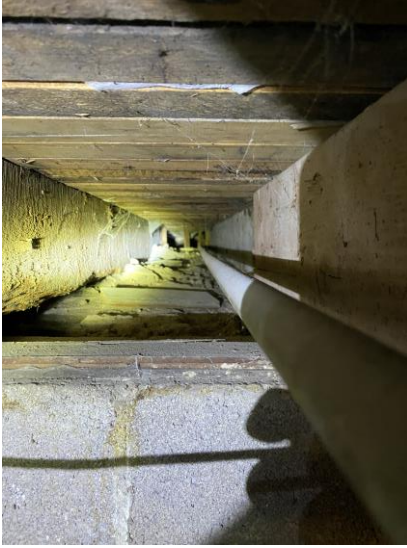
Image 22 – Main Level Framing – Existing Joists Above Soil

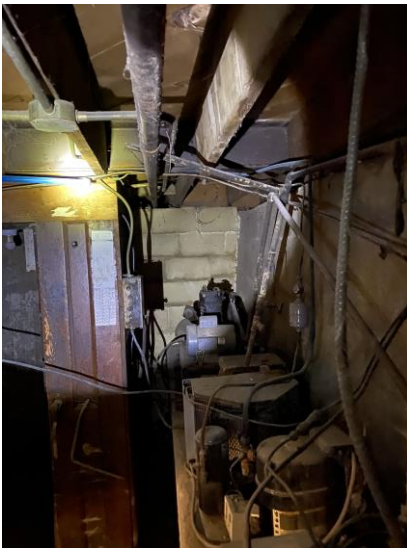
Image 23 – Main Level Framing – Modified Crawl Space/Framing

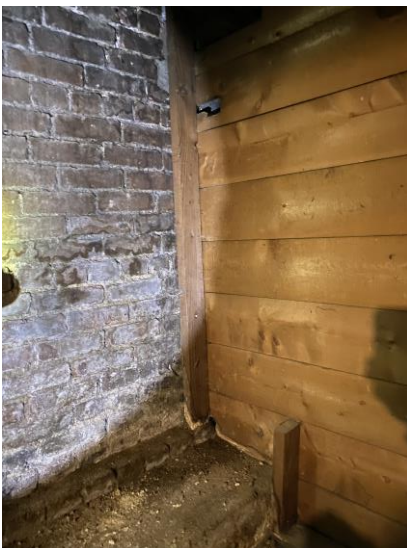
Image 24 – Crawl Space – Original Brick Foundation/Footing

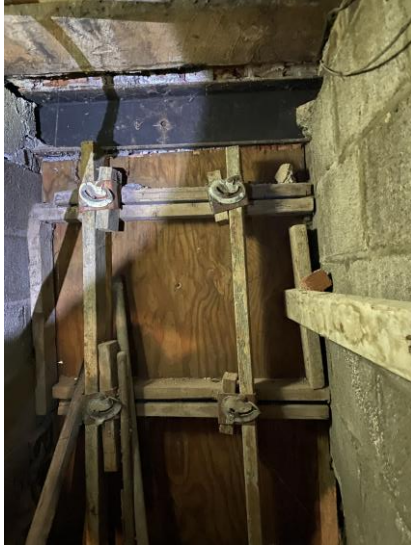
Image 25 – Crawl Space – Past Remediation Work (West Wall)

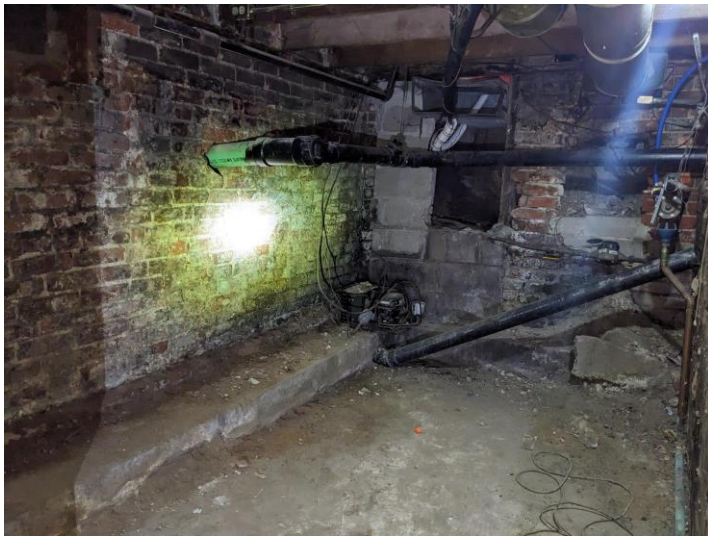
Image 26 – Crawl Space – Compromised Section – Northeast Corner

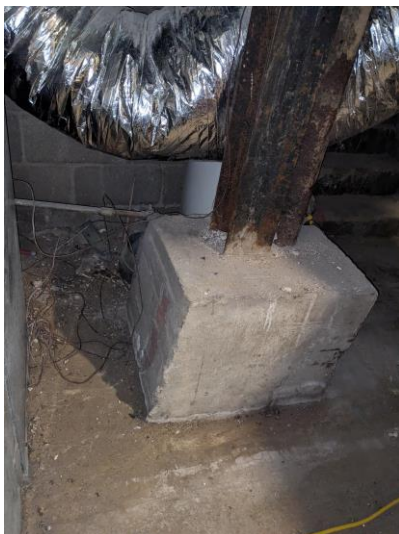
Image 27 – Crawl Space – Existing Column Support

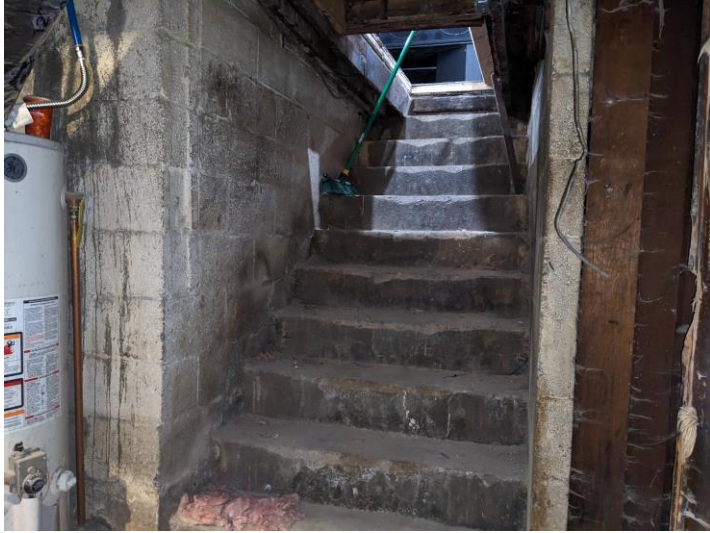
Image 28 – Crawl Space Stairs – Not Original
