Planning Register - Part 1

Reference Number: 24/00044/LBC

Description of Development: Remove existing floor slab and replace at lower level. Remove and replace existing ceiling at higher level With like for like materials. Remove 2 no. horizontal Roof beams. Service penetration through walls and Roof, opening and reinstatement of a section of Roof to facilitate lifting of distillery equipment. Door removed and to be replaced with louvre screen

Supporting statement to accompany application for listed building consent
For
Nunton Steadings, Isle of Benbecula

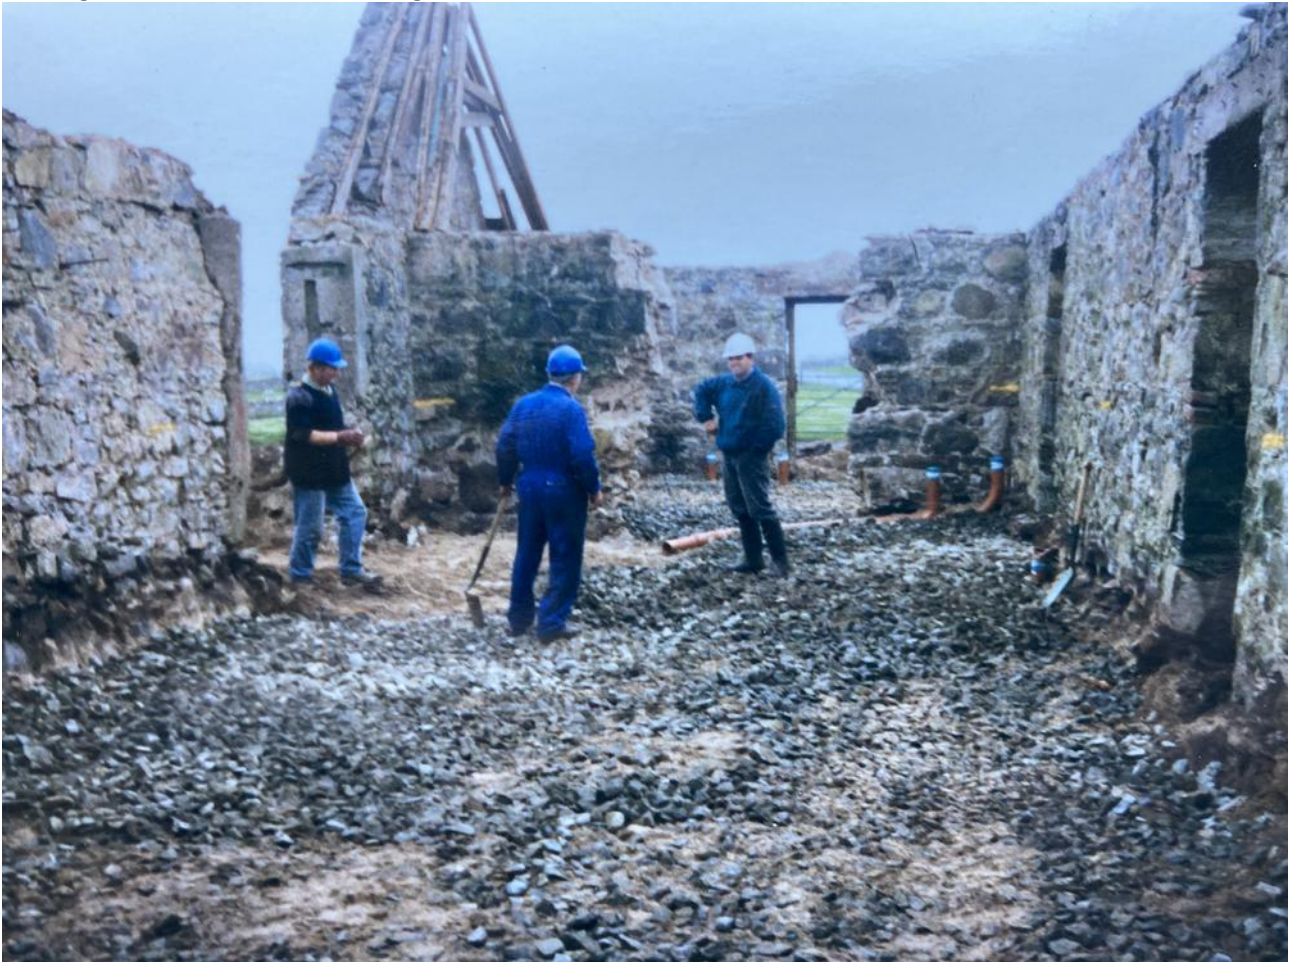
Image 4 – View of 1999 replacement concrete floor works indicating depth of excavations and existing drainage, Central, North West Wing.

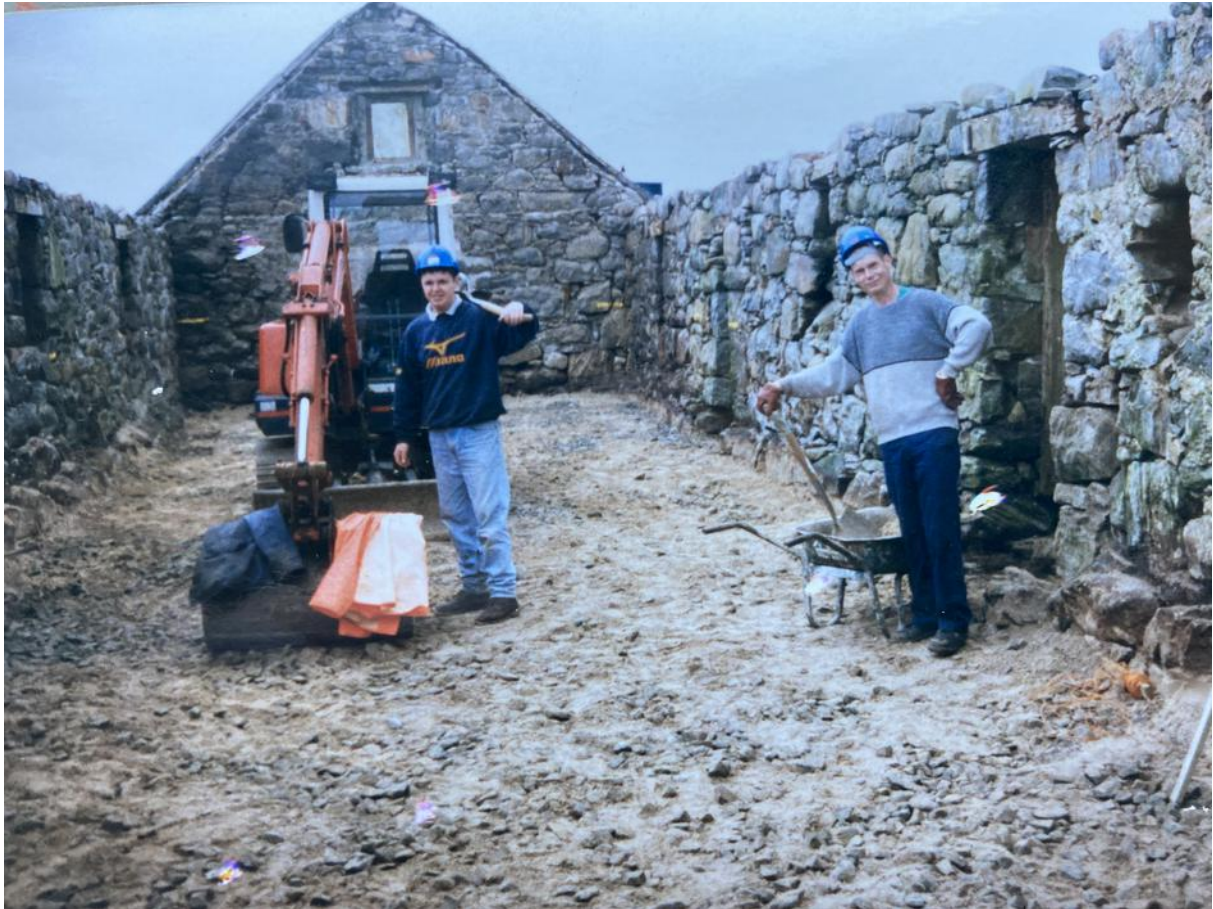
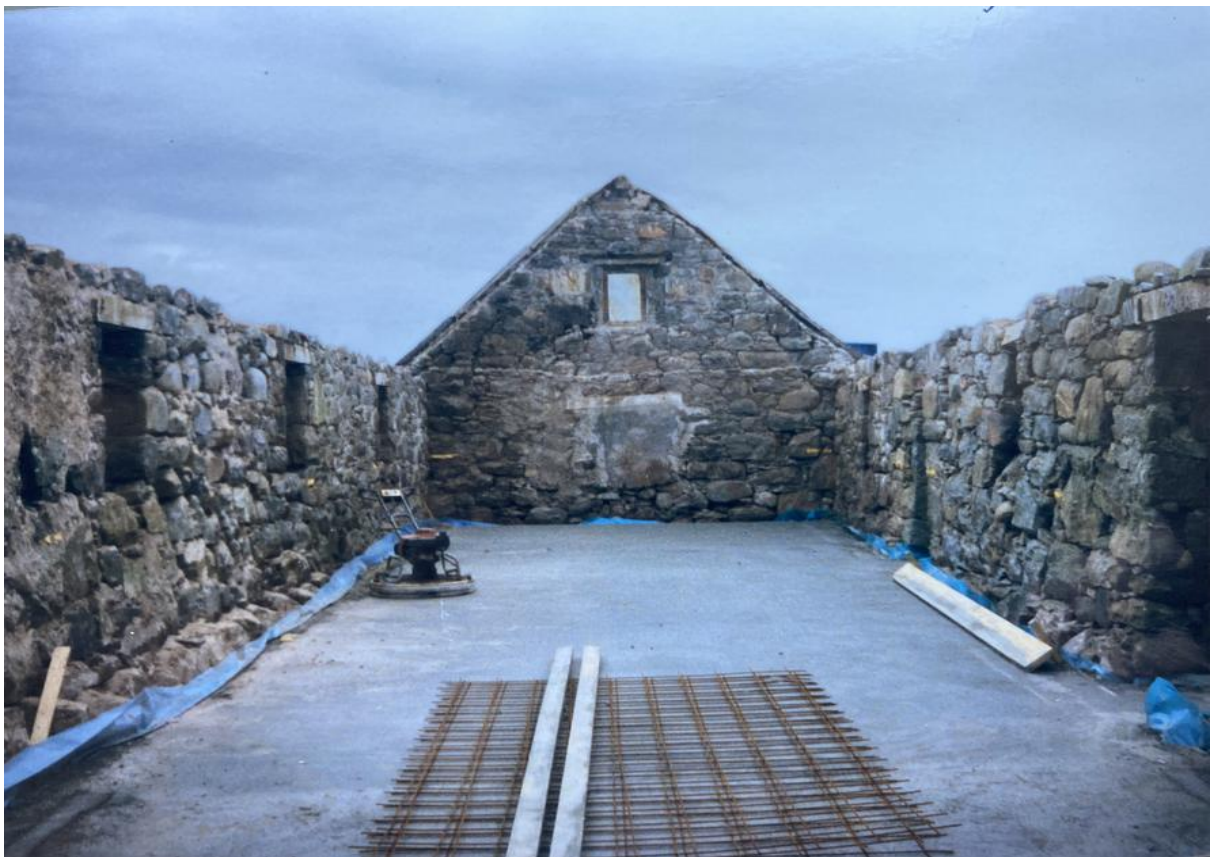
Image 5a and 5b – View of 1999 replacement concrete floor works indicating depth of excavations and existing drainage, North Wing – To become Still Room

- a) The floor laid in the North Wing during the course of the 1999 Works is proposed to be replaced. The new slab will have a finished floor level 100mm lower than the existing floor.
- b) The floor and sub floor here was previously excavated during the course of the 1999 Works
- c) refer to Images 4, 5a and 5b and 6 for reference.
- d) It is expected that the risk of further disturbance to the existing historic fabric is low, given the use of appropriate working methods.

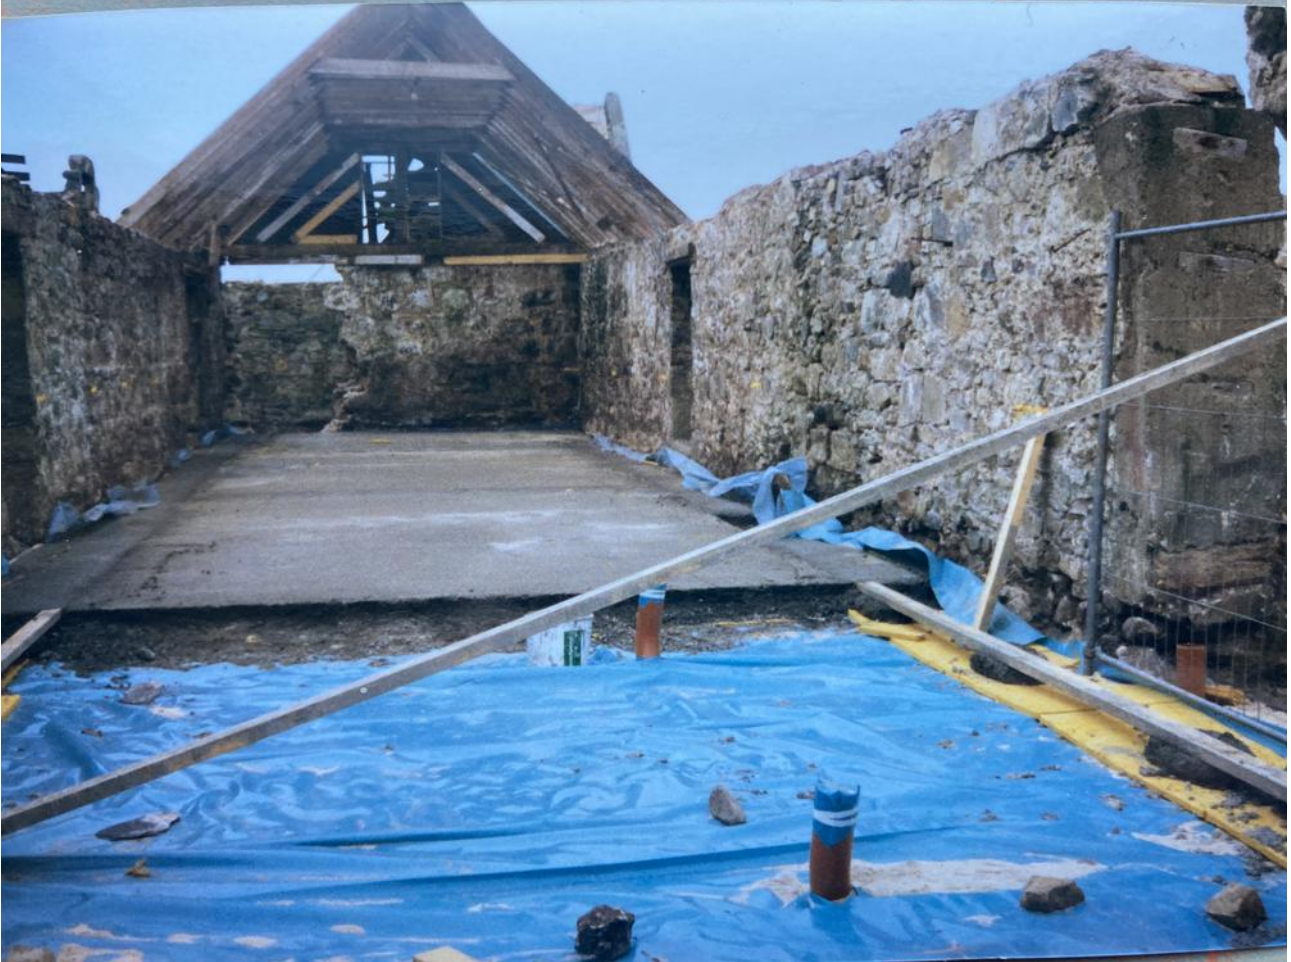
Image 6 – View of 1999 replacement concrete floor works indicating depth of concrete slab and presence of DPM

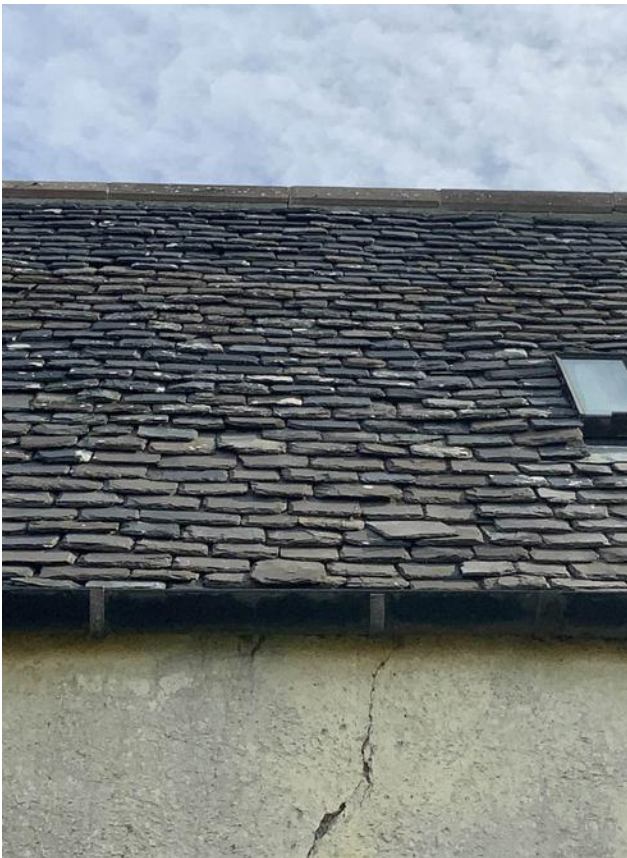
- The traditional slate, laid in diminishing courses has been repaired over time but also the lower rows, nearest the eaves , have been replaced with what is assumed to be Spanish slate at a fixed gauge.

- Generally, however, the roof covering appears to be in a serviceable state of repair, with no significant defects.

Image 8 – Existing Slate roof condition

- Some defects requiring attention were observed from ground level and as noted on drawing E_100
- It is proposed that the lead valley is initially cleaned, inspected and replaced as required.

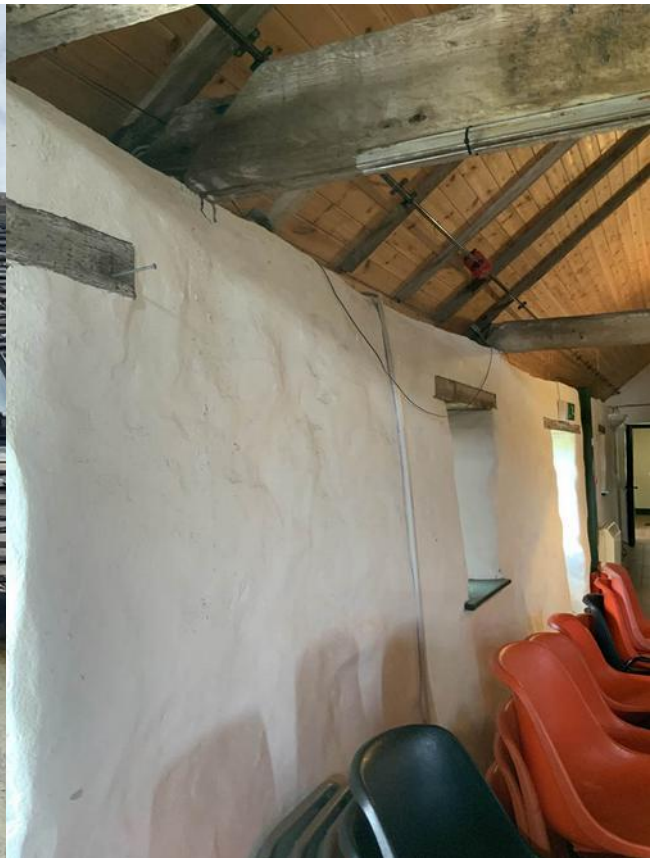
- This work is indicated on drawing E_100
- The base course, below floor level appears to have been pointed mostly with sand and cement , as opposed to a lime based mix.
- Deflections to the outer wall was observed. This is anecdotally attributed to the work carried out in 1999.
- Care to be taken when working adjacent to all historic structures.

Image 9 – deformed wall

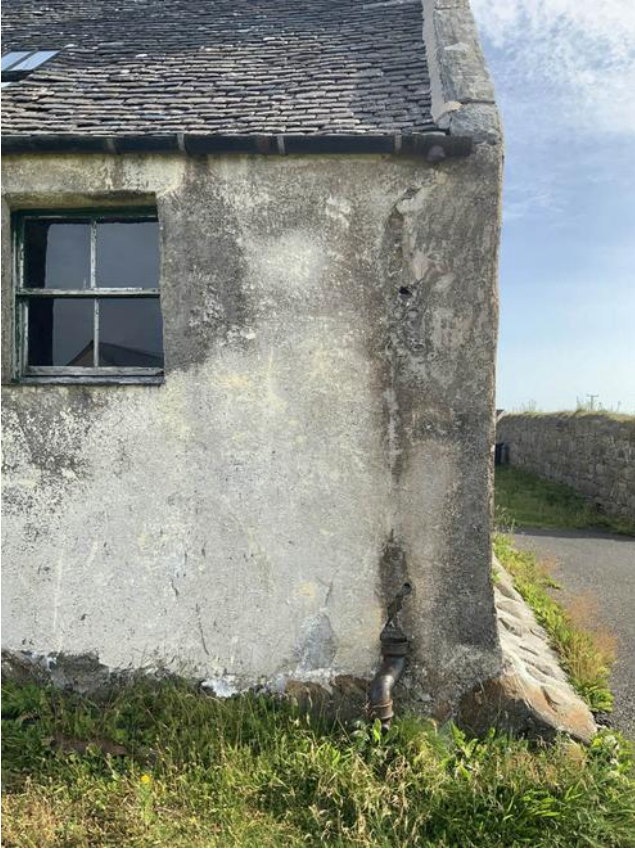
Image 10 – Example of missing rainwater goods

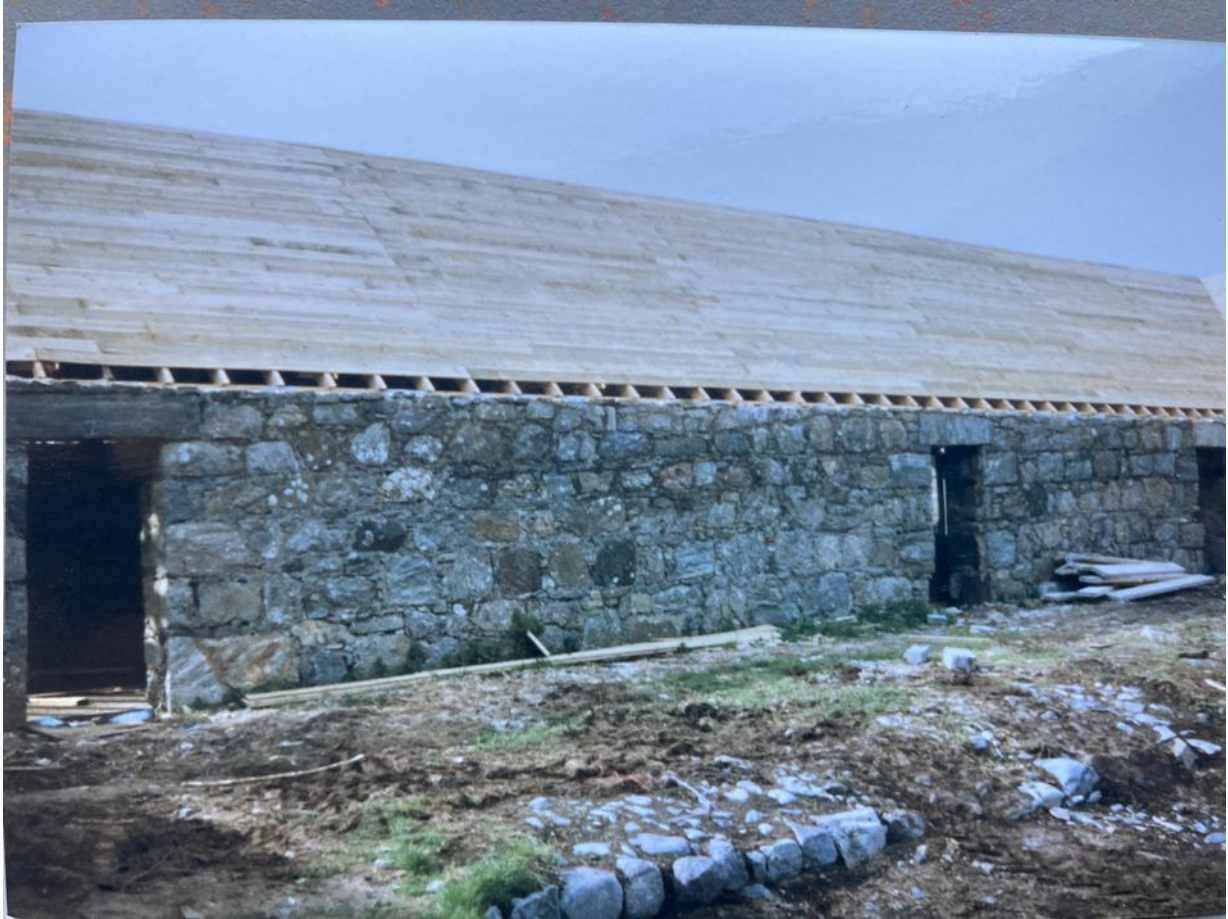
Image 11a – Example of rebuilt and repointed walls (1999 Works)

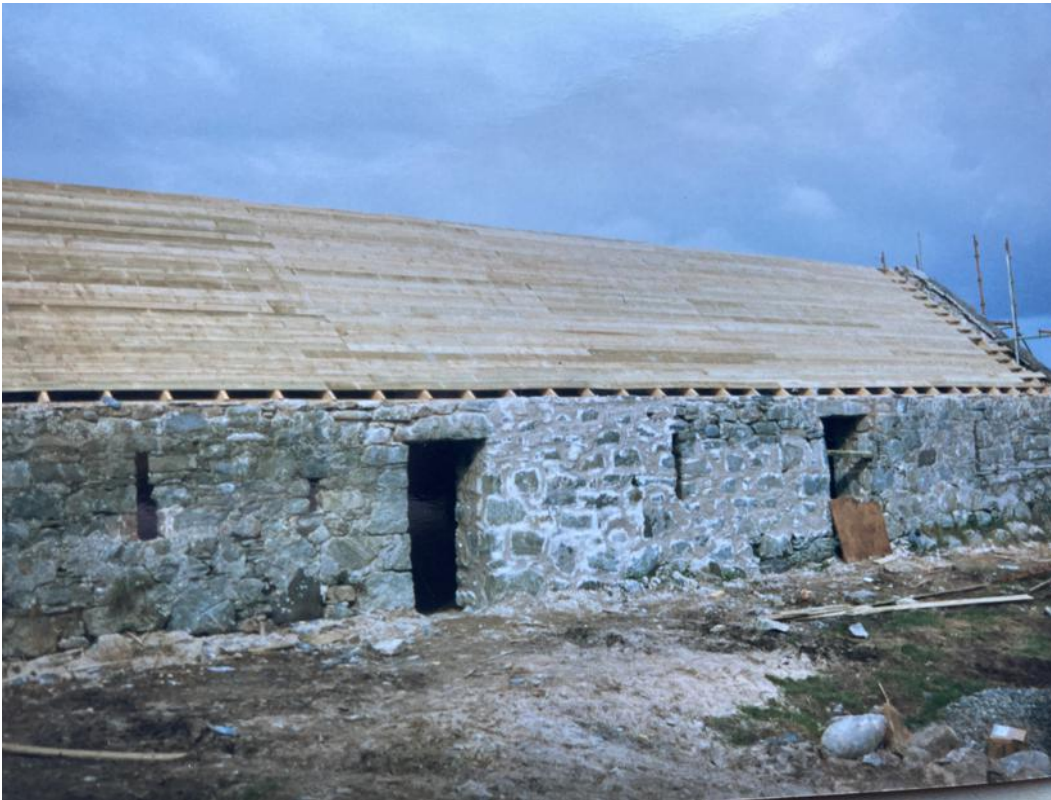
Image 11b – Example of rebuilt and repointed walls (1999 Works)

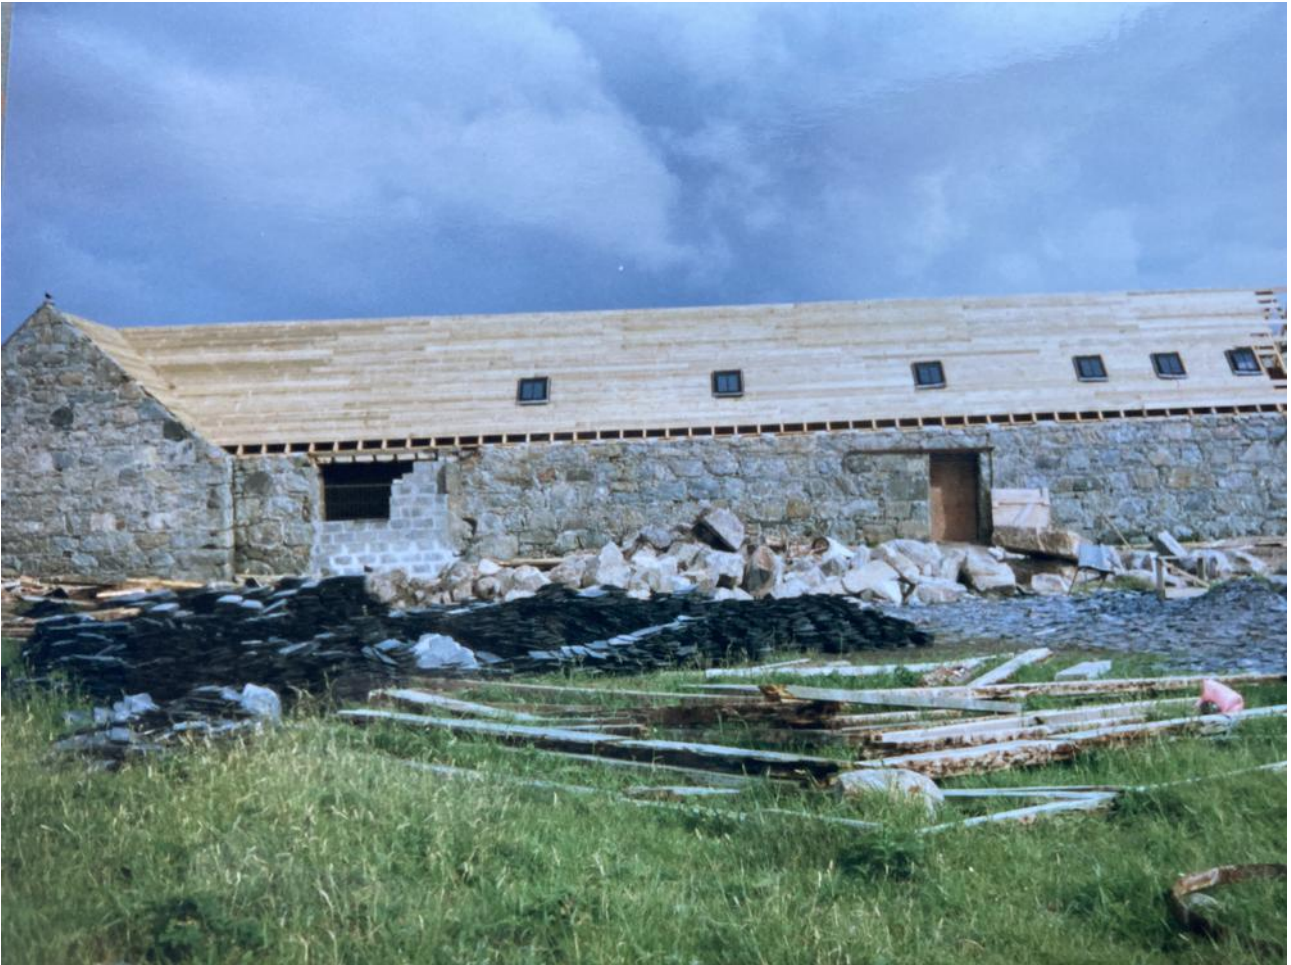
Image 15 - Area to Rear of Steadings showing replacement roof, blockwork to old cart opening, disturbed ground.(1999 Works)

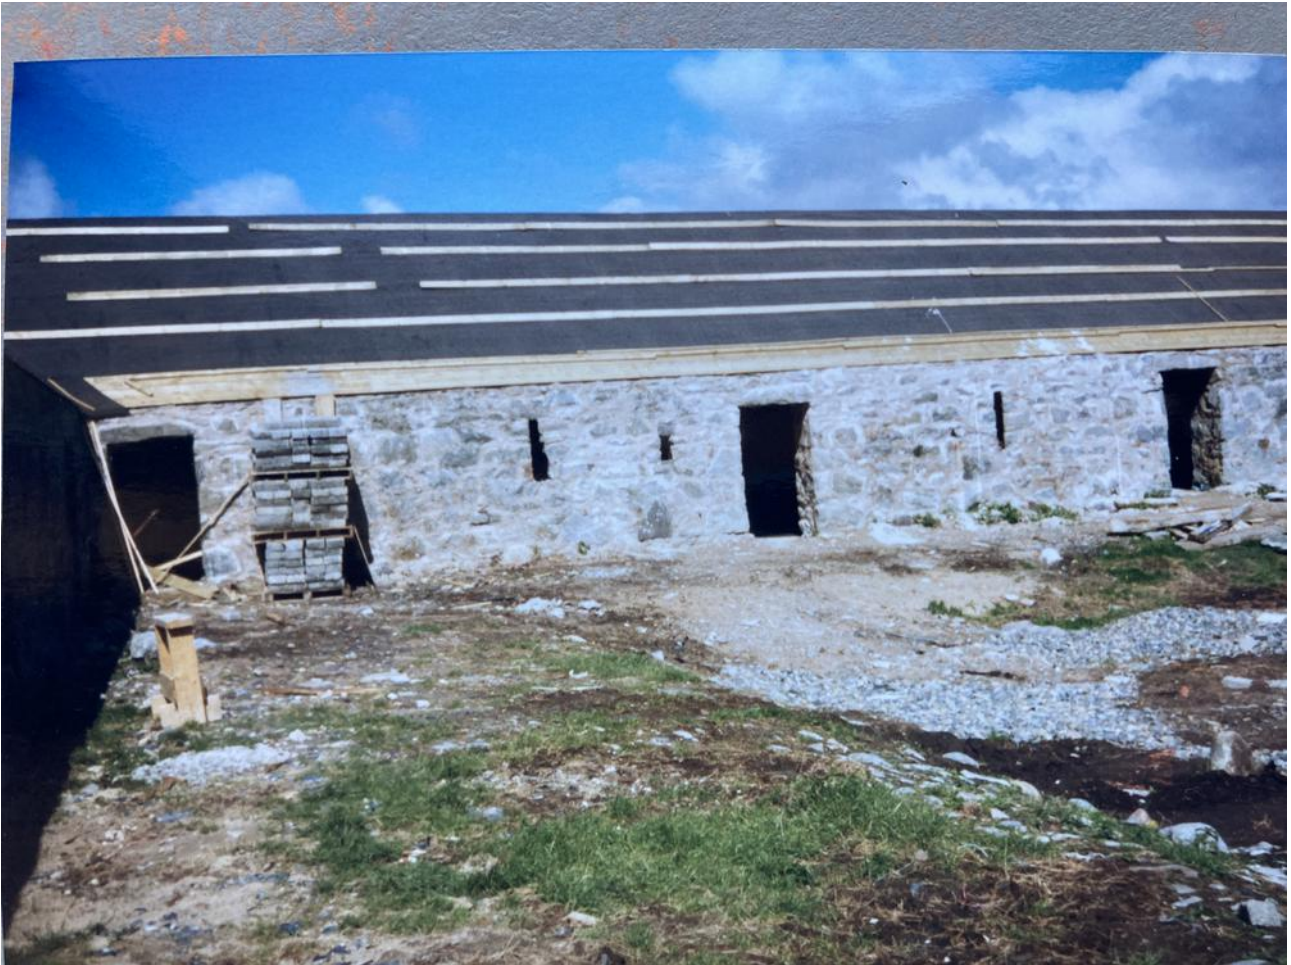
- There is some thermal insulation to the roof void above the wooden panelled ceilings.
- It is essential for roof voids with impermeable felt to be ventilated, to reduce the risk of condensation and consequent rot to timbers. There are existing vents to the roof voids that should be retained indicating that the roofing underlay may be 1F type.

Image 16 – Image showing finished openings and use of Type 1F (non Breathable) Roofing Felt (1999 Works)

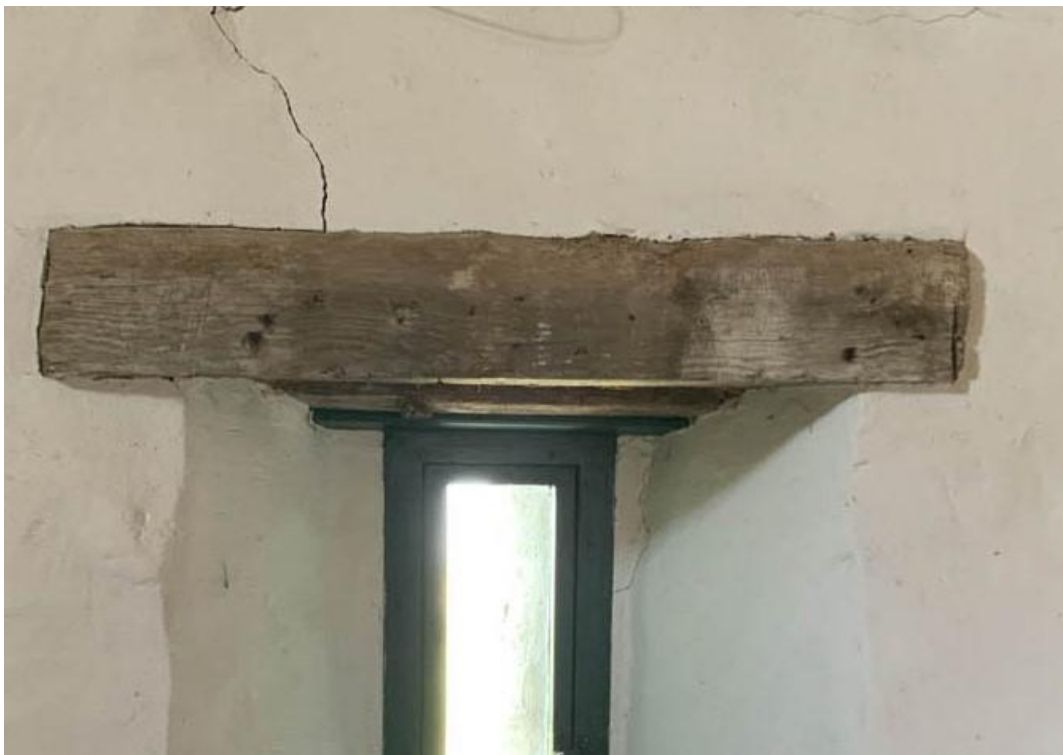
- Exposed timber lintels were examined at several windows.
- There is evidence of wood worm although this is not believed to be an active infestation.
- Exposed wood was observed to be dry with no obvious signs of rot or fungal growth.
- The walls of buildings of this age sometimes incorporate concealed timbers which are at risk of decay and wood beetle (for example, timber lintels and any areas of panelling or dry lined walls).
- All structural timbers will be inspected by a Structural Engineer.
- Any replacement timber will be on a like for like basis.

Image 18 – Example of timber lintel

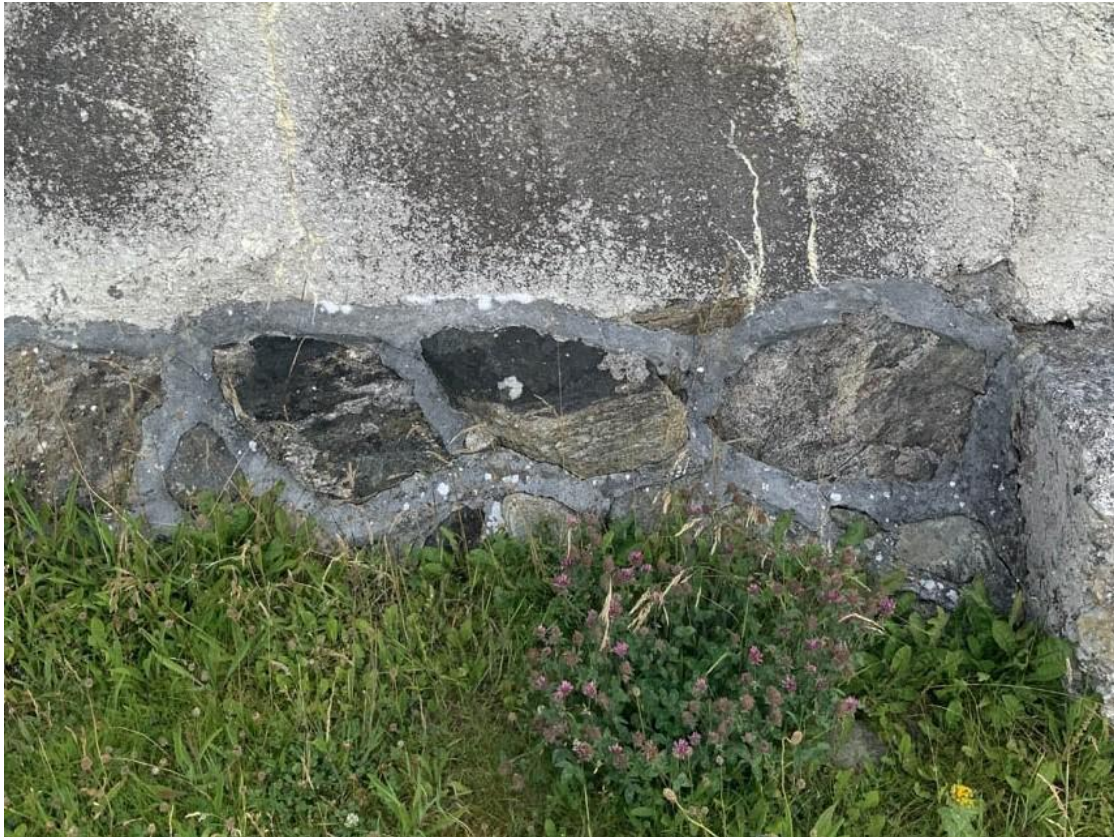
Image 19 – Example of Existing Cement Based pointing at ground level

- MASONRY REPAIRS**
1. Re-pointed using a lime: sand mortar mix in the ratio of 1:2.5.
 2. Hydraulic Lime (NHL5) and sand is to be sourced from a local quarry.

3. Rake out open, deteriorated or loose lime mortar, dirt and organic material only as deep as necessary to reach sound bedding and jointing mortar, generally to a minimum depth of 25mm or twice the joint width, whichever is the greater. Do not rake out very fine joints.

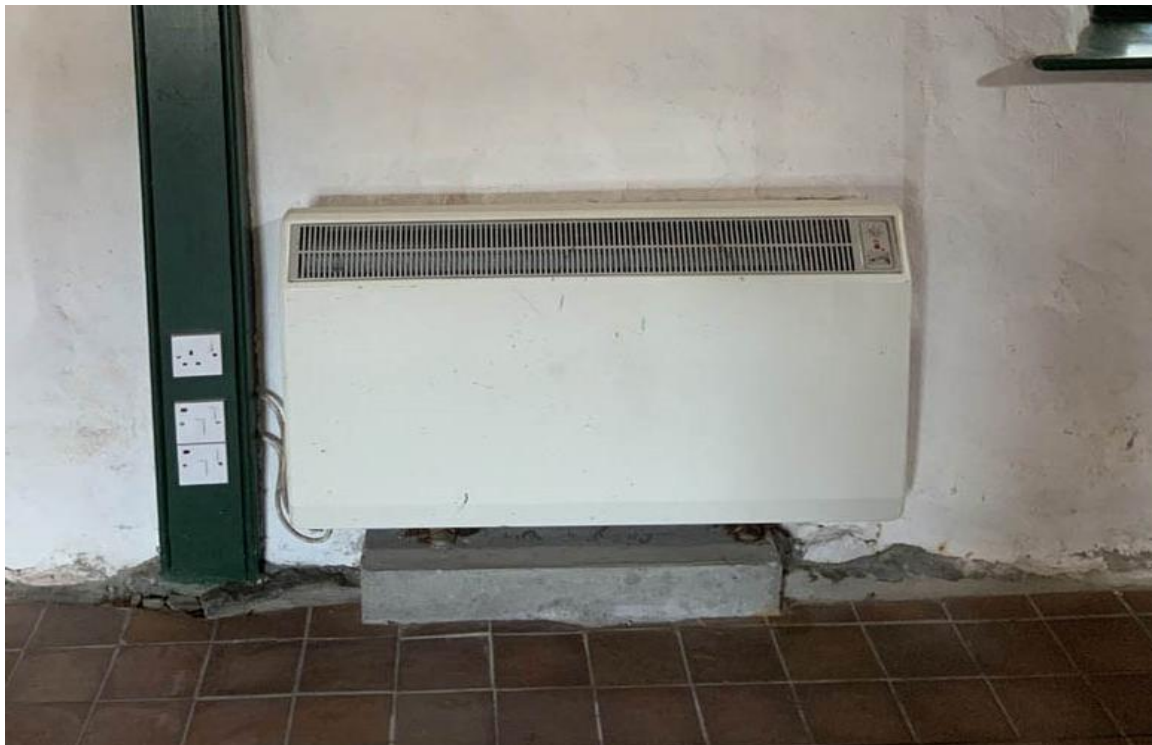
Image 20 – Example of current electric heater and surface mounted service run TO BE REMOVED

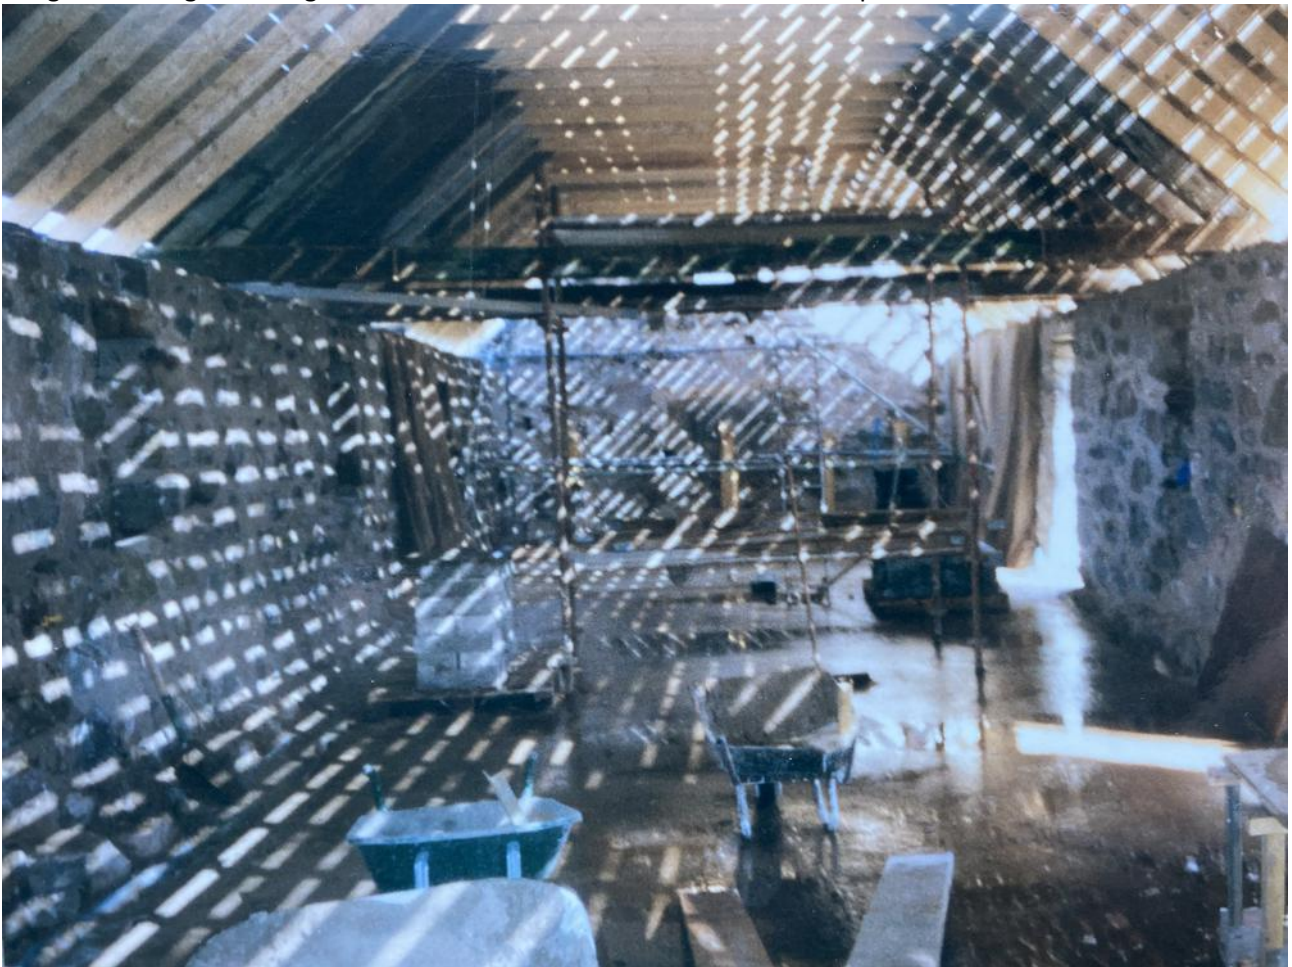
Image 21 – Image showing Horizontal Roof Beams that were inserted as part of 1999 Works
