Review of Failures of Photovoltaic Modules

PHOTOVOLTAIC
POWER SYSTEMS
PROGRAMME

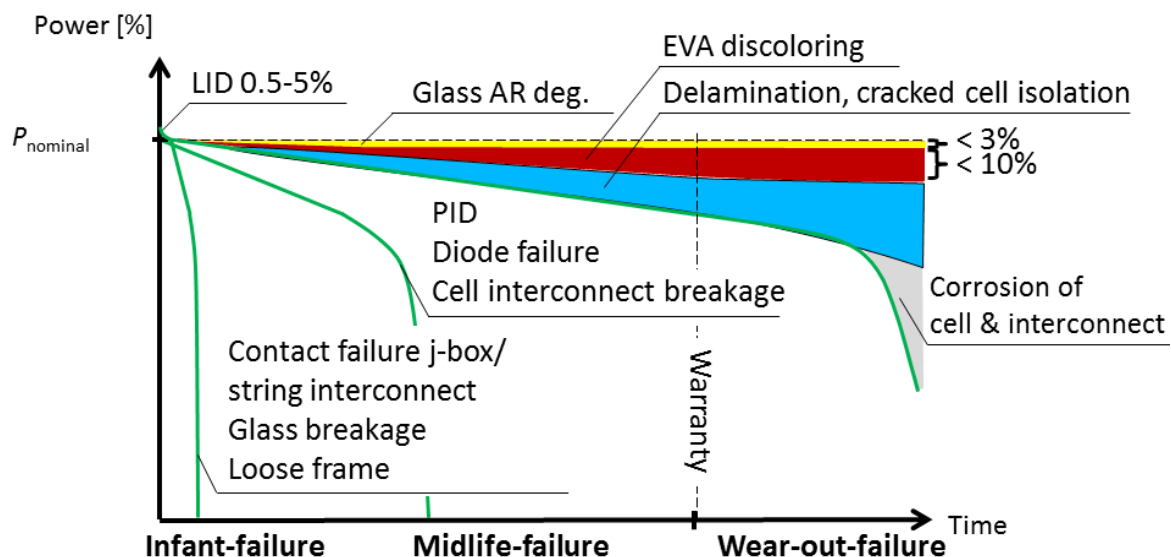
Fig. 3.1: Three typical failure scenarios for wafer-based crystalline photovoltaic modules are shown. Definition of the used abbreviations: LID – light-induced degradation, PID – potential induced degradation, EVA – ethylene vinyl acetate, j-box – junction box.

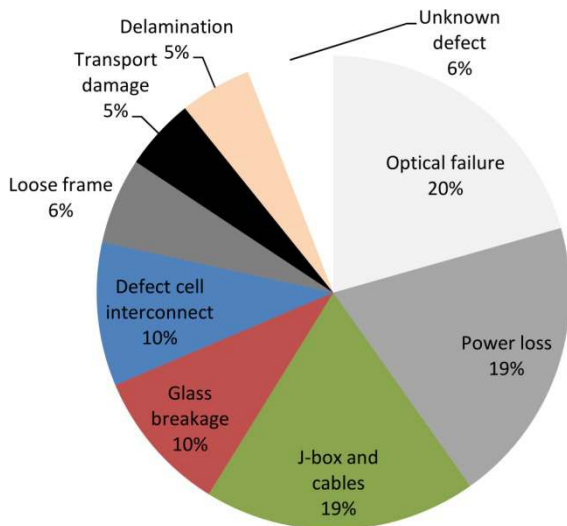
Fig. 3.2: Failure rates due to customer complaints in the first two years after delivery. The rate is given relative to the total number of failures. The PV modules are delivered by a German distributor in the years 2006-2010 [redrawn from Richter11]. The statistic is based on a total volume of approximately 2 million delivered PV modules. Categories not found in other module failure statistics are drawn in grey scale.

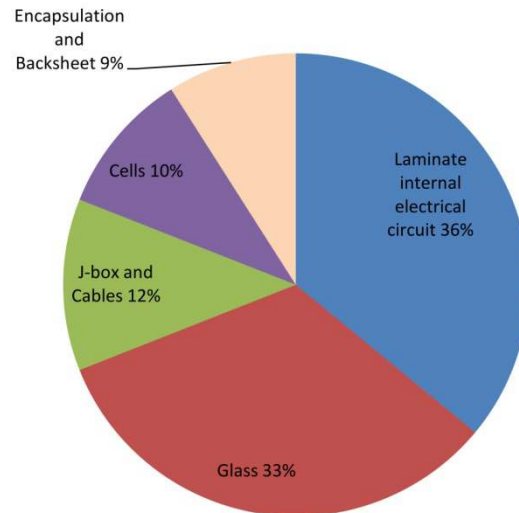
Fig. 3.3: Field study of PV module failures found for various PV modules of 21 manufacturers installed in the field for 8 years [redrawn from DeGraaff11]. The rate is given relative to the total number of failures. Approximately 2% of the entire fleet are predicted to fail after 11-12 years (do not meet the manufacturer's warranty).

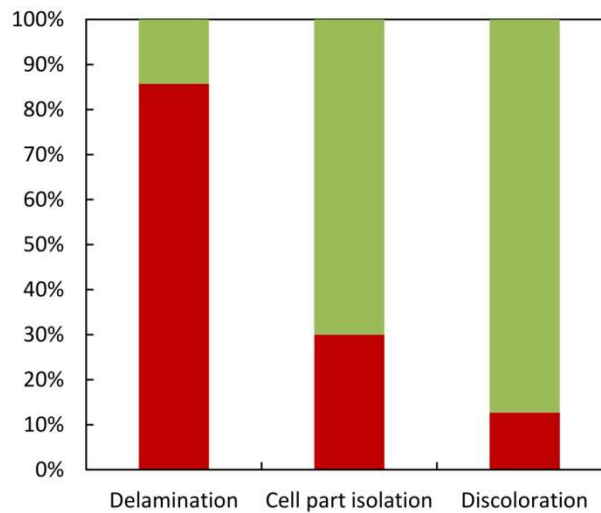
Fig. 3.4: Failures occurring in a fleet of 272 PV modules of 3 different manufacturers after more than 15 years of operation [redrawn from Schulze12]. Each PV module may be affected by more than one failure type. The red and green colours indicate the percentage of modules having or not having a specific failure respectively. Each PV module may show more than one failure type.

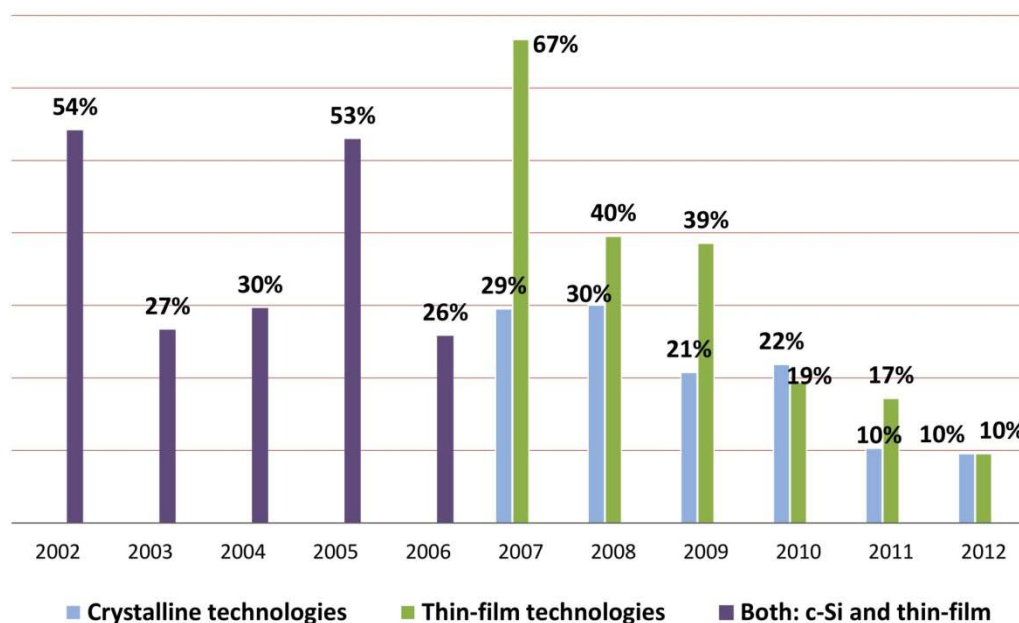
Fig. 3.5: Failure rates of 2000 certification projects for IEC 61215 and IEC 61646 type approval tests for the years 2002 to 2012. The given figures are the annual percentages of IEC projects with at least 1 module test failure compared to the sum of all conducted IEC projects. Since 2007 figures of crystalline and thin-film technologies are shown separately.

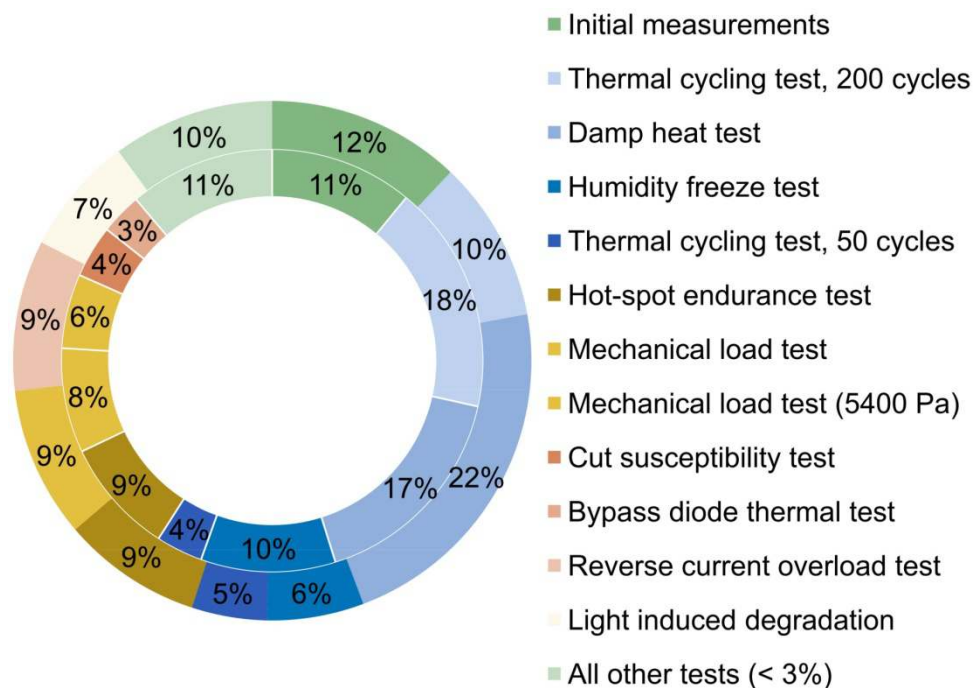
Fig. 3.6: Distribution of failed tests of 1740 IEC projects for crystalline PV modules (inner ring) and of 370 IEC projects for thin-film PV modules (outer ring) between 2006 until June 2013. A test is considered a failure, if one or more PV modules will not pass the specific test. One certification project may contribute to one or several test failures.

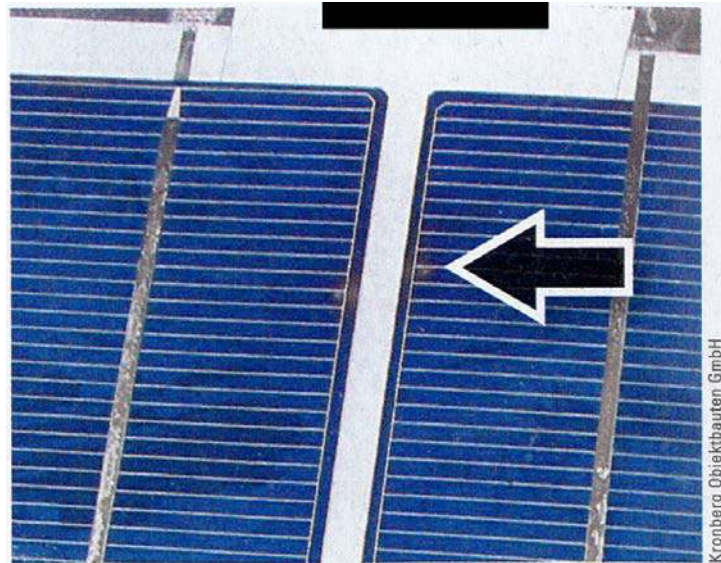
Fig. 4.2.1: Brown marks at the edge of the solar cell are no failure.

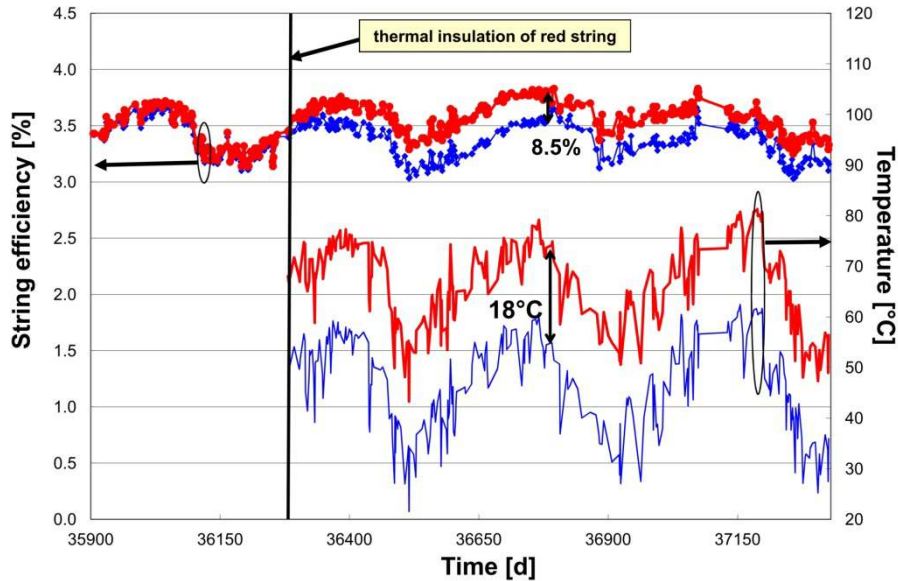
Fig. 4.2.2: Comparison of a ventilated string (blue lines) and a back-insulated string (red lines) of single-junction amorphous silicon PV modules.

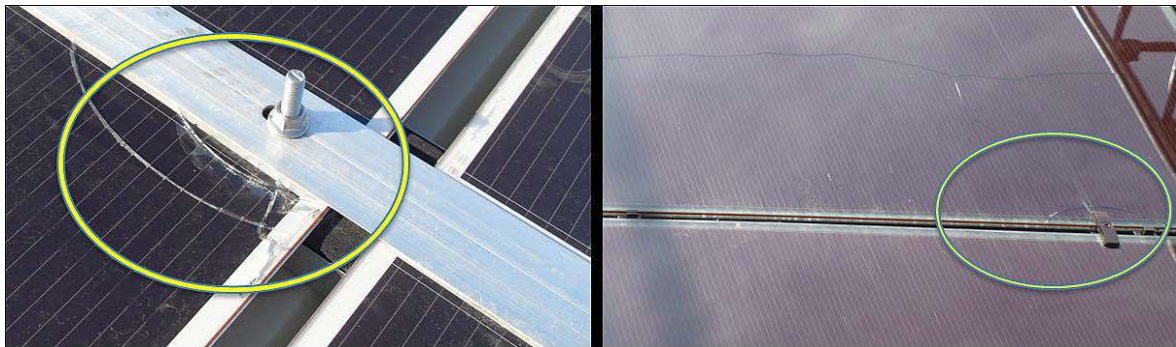
Fig. 4.3.1: Left figure shows glass breakage caused by too tight screws and the right figure a PV module that broke due to poor clamp design.

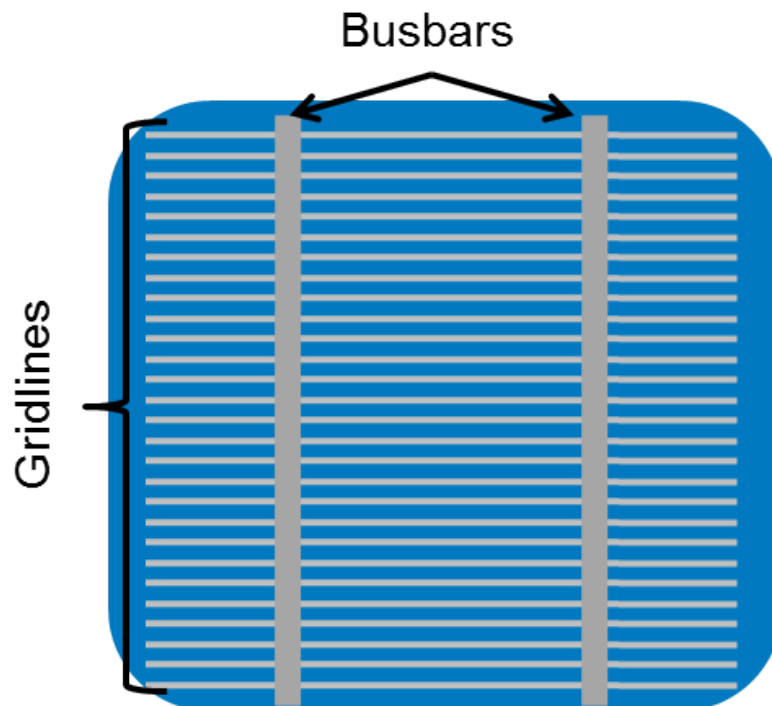
Fig. 4.6.1: Metallisation on a silicon cell consists of gridlines and busbars.

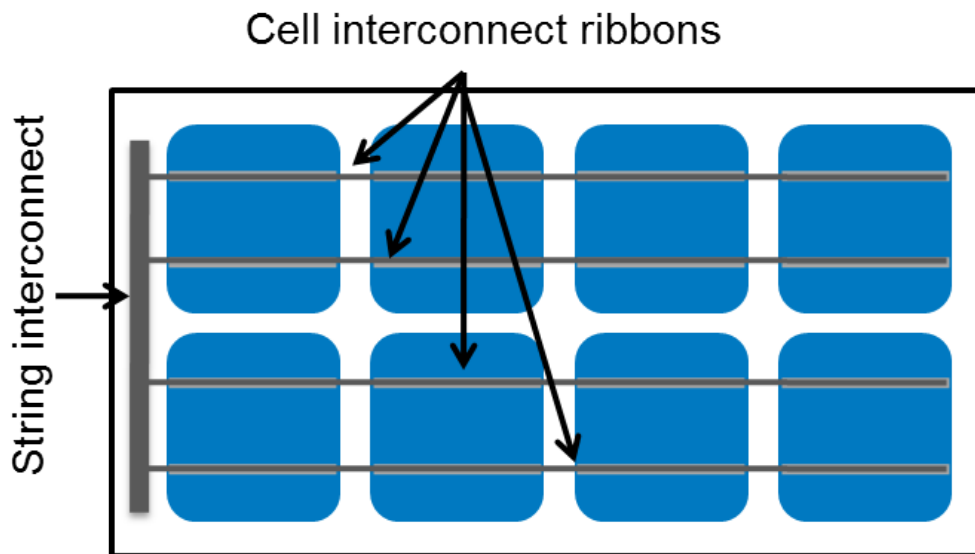
Fig. 4.6.2: Cells are electrically connected into strings via cell interconnect ribbons and the string interconnect connects multiple strings of cells.

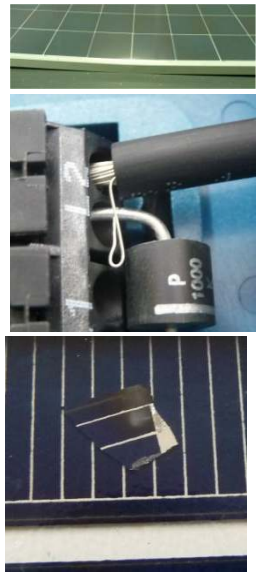
6.2.2, 6.2.3	Crack in cell - a propagation which could remove more than 10% of the cell area from the electrical circuit	A	<u>D</u>

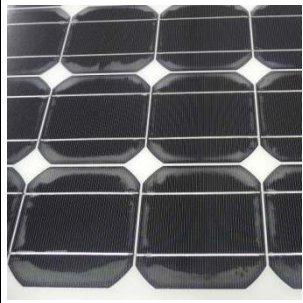
-	Electrochemical corrosion of a thin-film module and associated delamination	B(e)	<u>D/E</u>

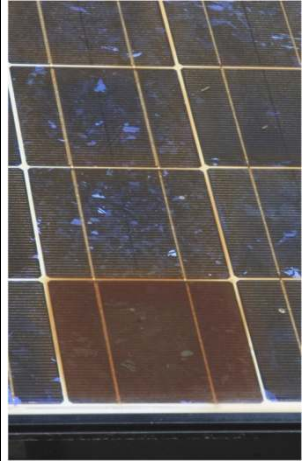
6.2.1, 6.2.2	Browned EVA on top of a cell with two cracks in a cell. Photobleaching takes also place along cell cracks therefore the crack is visible. The browning takes several year to appear. This may not be mistaken for Snail tracks.	B(f)	<u>C</u>

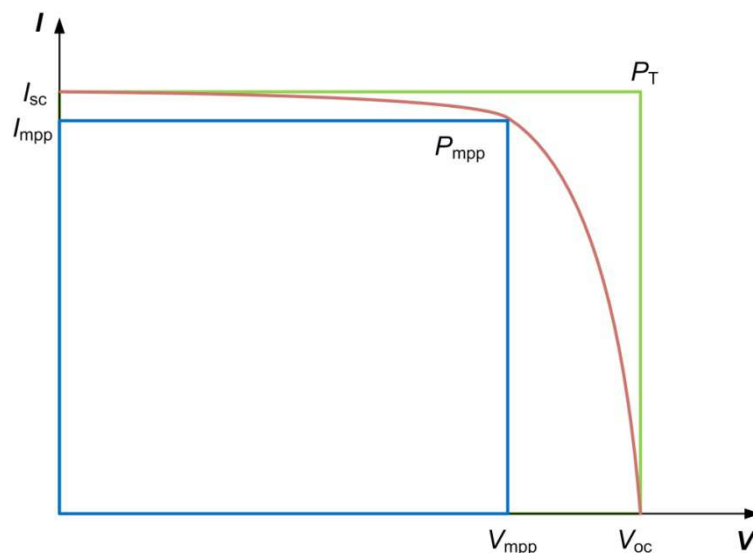
Fig. 5.2.1: The figure shows a schematic I - V curve of an illuminated PV module and the most important parameters: short circuit current I_{sc} , open-circuit voltage V_{oc} , the maximum power point P_{mpp} , the current and voltage belonging to the maximum power point I_{mpp} and V_{mpp} , and the virtual power point P_T .

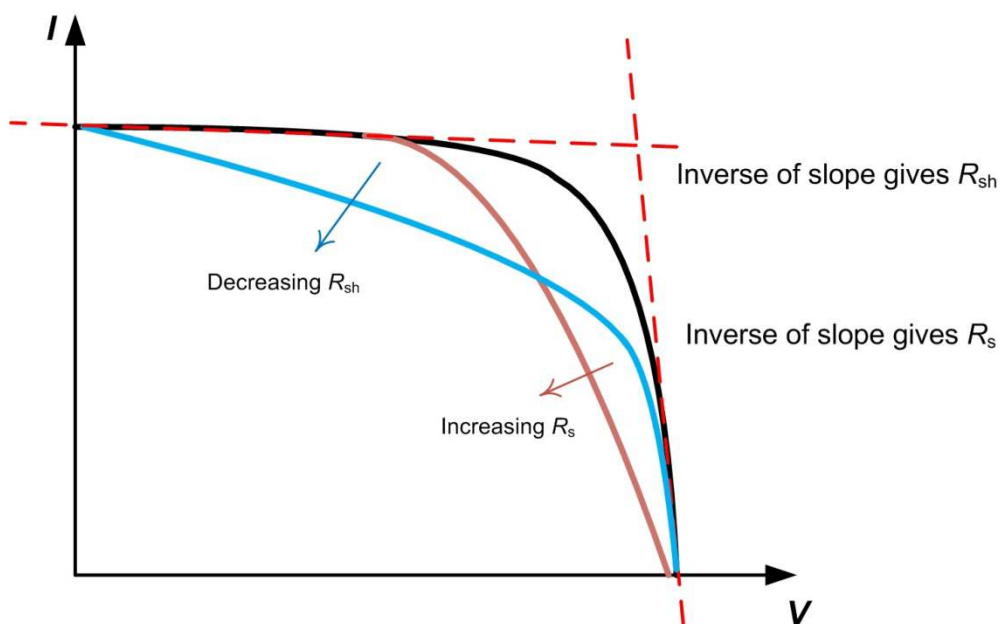
Fig. 5.2.2: Schematic I - V curve of an illuminated PV module and the influence of a series resistance R_s and a shunt resistance R_{sh} to the I - V curve.

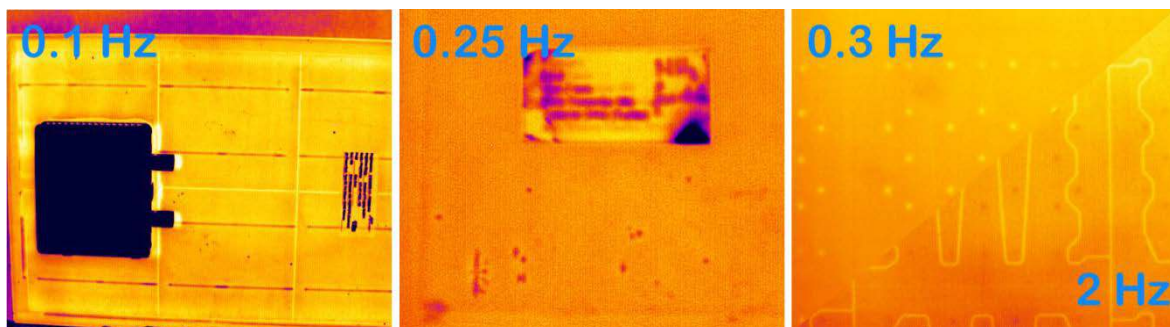
Fig. 5.3.1: Pulse phase thermography images obtained through opaque back sheets. Left hand side: backside cell interconnects between pSi-cells; Middle: bubbles within an encapsulant material; Right hand side: Interconnection structure within a back-contact module: 0.3 Hz image depicting the interconnection points, while the 2 Hz image shows the structure of the copper foil [Voronko12].

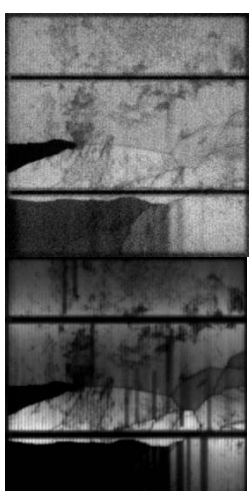
6.2.2	Cross crack line/cross crack	B(f)	<u>A</u>

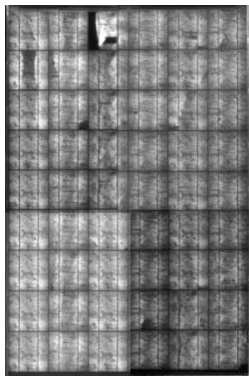
6.2.2	Heavy homogeneous mechanical load. The overall crack pattern in the module looks like a X-crack pattern. The X-crack pattern is visualized in the image by the red lines.	B(f)	<u>C</u>

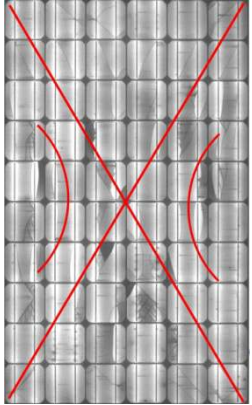
6.2.2	Tilt over PV module. Many dendritic like cracks are located mainly in the cells in the middle of the module.	B(f)	<u>C</u>

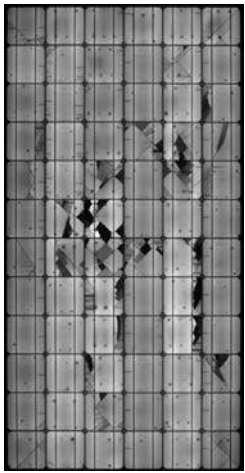
6.2.7	Shunted by pass diode or break in current flow somewhere in the string.	B(f)	<u>E</u>

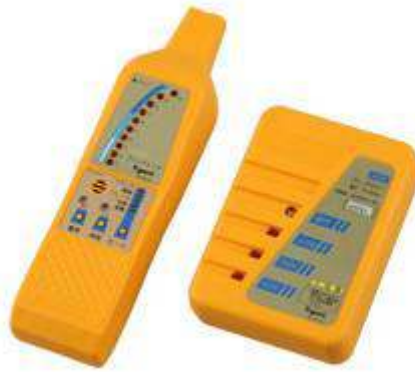
Fig. 5.6.1: An example of the Signal Transmission Device (STD).

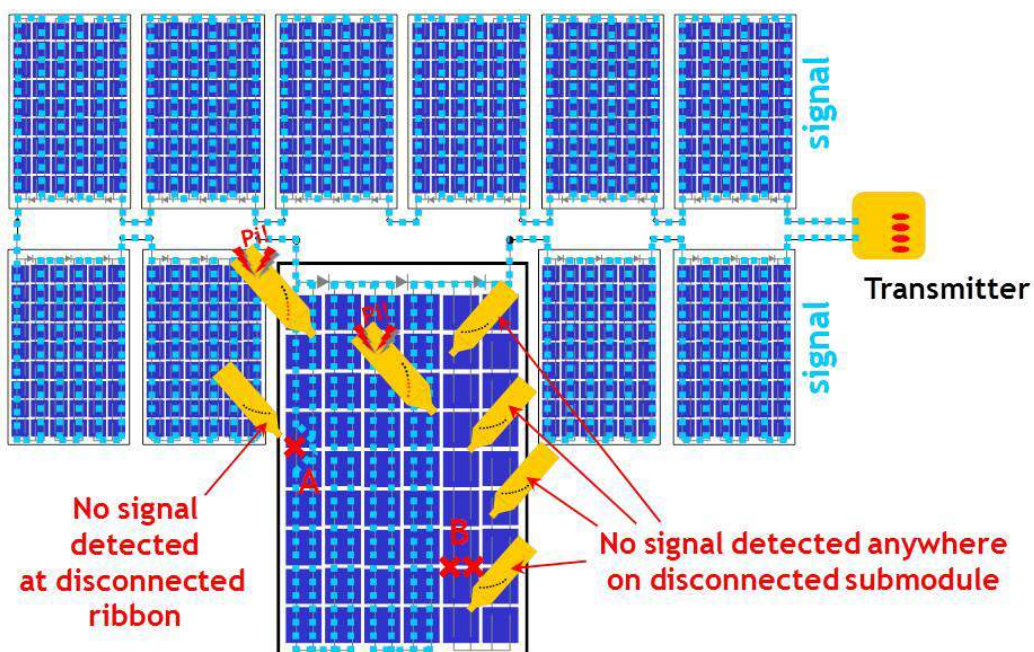
Fig. 5.6.2: A schematic procedure for detecting local disconnection of interconnect ribbons in PV modules.

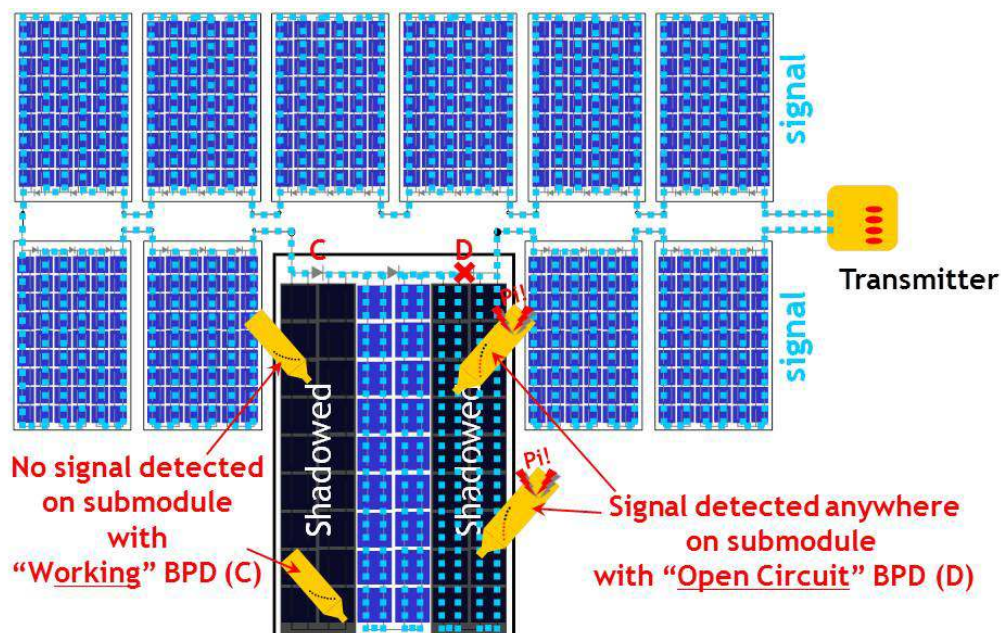
Fig. 5.6.3: A schematic procedure for detecting open-circuit bypass diode failures in PV modules.

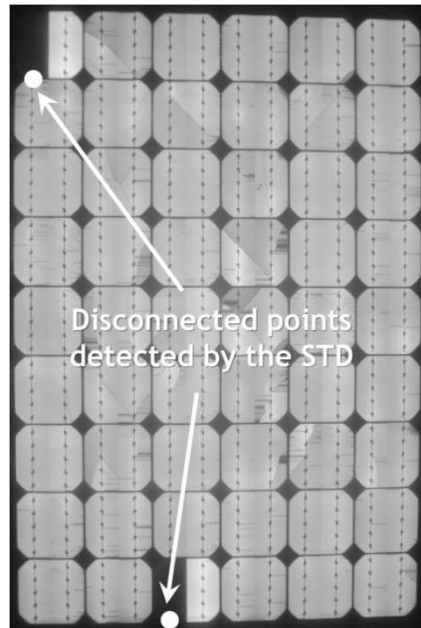
Fig. 5.6.4: The detection results of the STD detected at a working PV module are inserted into the EL image of the PV module. The EL image indicates that two solar cells, on which finger grids are separated for the two cell halves, have disconnected cell interconnect ribbons on the left half of them. Both results completely match.

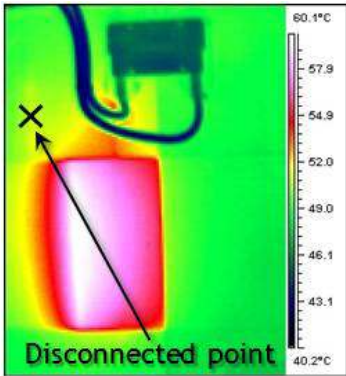
5.3.8	All cell interconnect ribbons of one cell are disconnected or disconnected string interconnect: No signal detected anywhere on the disconnected submodule.	B(f)	<u>E</u>

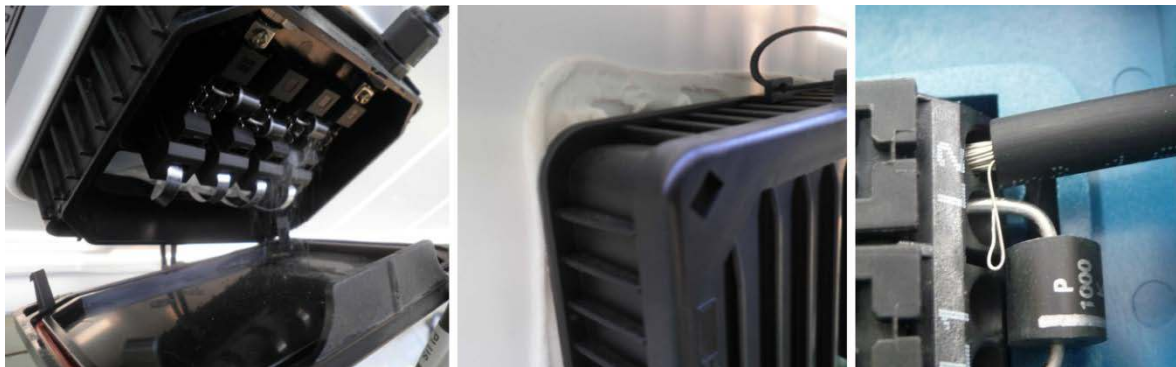
Fig. 6.1.3: Junction box failures: Left photo shows an open junction box in the field, the middle one a poorly bonded JB on the backsheet, and the right one a JB with poor wiring.

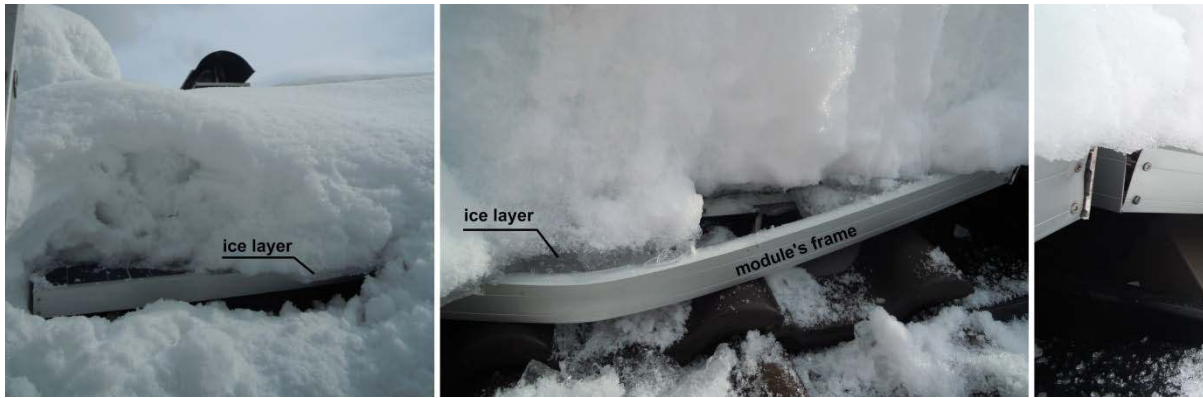
Figure 6.1.4: Damaged module frames after heavy snow load of 1.2 m, melted down to 35 cm, in winter 2012. Alpine location at 620 m a.s.l., tilt angle 25°. 60 cell modules with dimensions 1660 mm x 990 mm, 50 mm Al-frame. Left hand side: Ice layer slides over module's edge; Middle: Ice bends frame; Right: Failure of the corner screw joints [Leitner12].

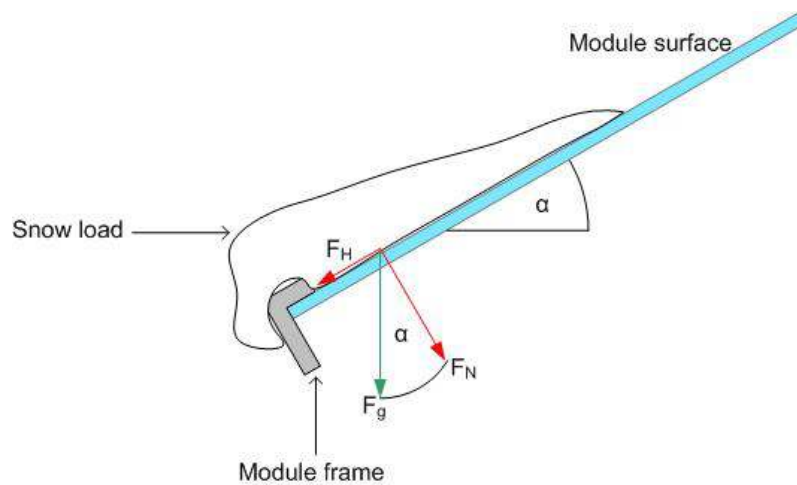
Figure 6.1.5: Introduction of snow loads, difference between load vectors.

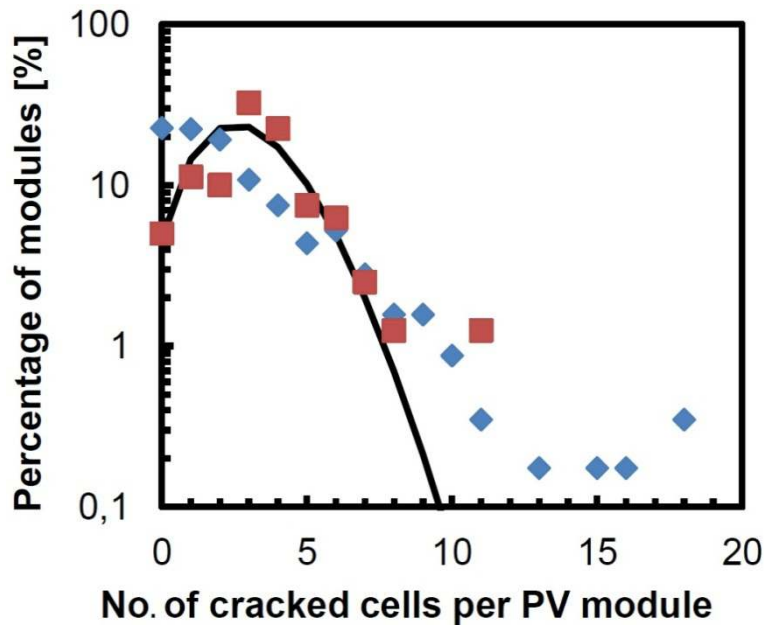
Fig. 6.2.1: Logarithmic histogram of 60 cell PV modules showing a specific number of cracks per PV module. The red squares show the crack distribution of PV modules (#80) directly after production from one manufacturer. The blue diamonds show the crack distribution (#574) of PV modules found in the field [Koentges2012]. The straight line depicts the binomial distribution of equation (6.2.1) for $p=5\%$.

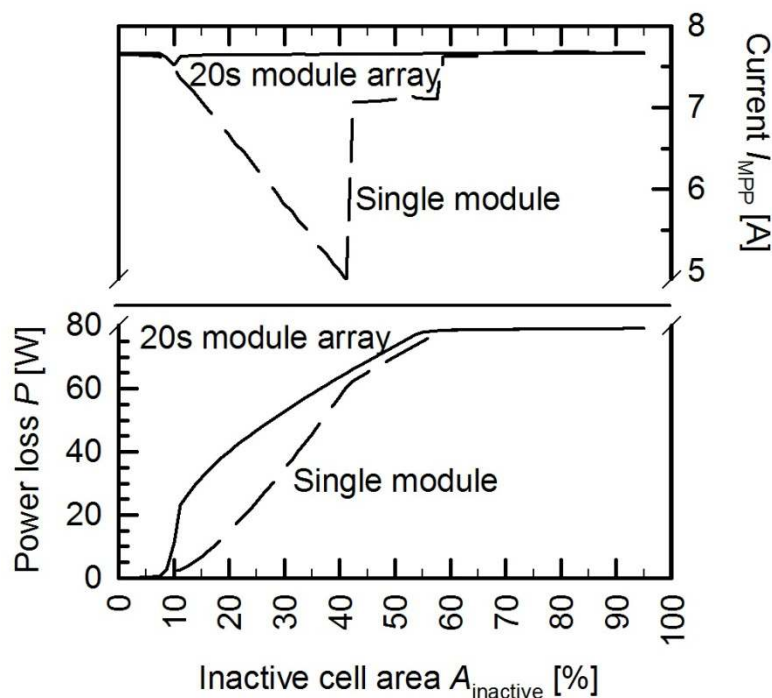
Fig. 6.2.2: Simulation of the power loss of a single 230 Wp PV module with a single solar cell having a varying inactive cell area. The simulated power loss of a 20 PV modules array containing this defective module is also shown. More than 8 % of inactive cell area in the 20s module array leads to a much higher power loss compared to the stand-alone PV module. These simulations depend on the reverse bias characteristics assumed for the silicon modules.

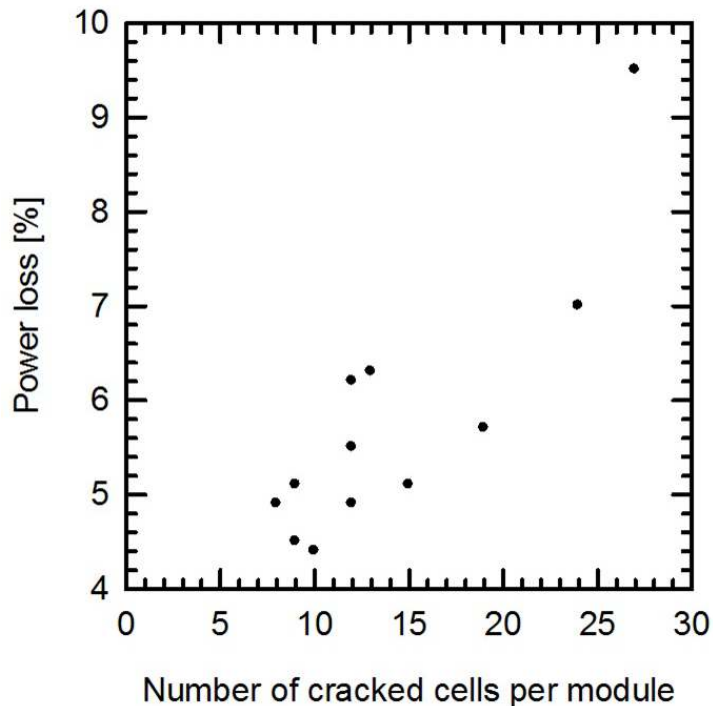
Fig. 6.2.3: The power loss after a test sequence of mechanical load and 200 humidity freeze cycles correlates with the number of cells cracked in the mechanical load test. Each point represents a single PV module. A bias power loss of about 3% is caused by glass corrosion.

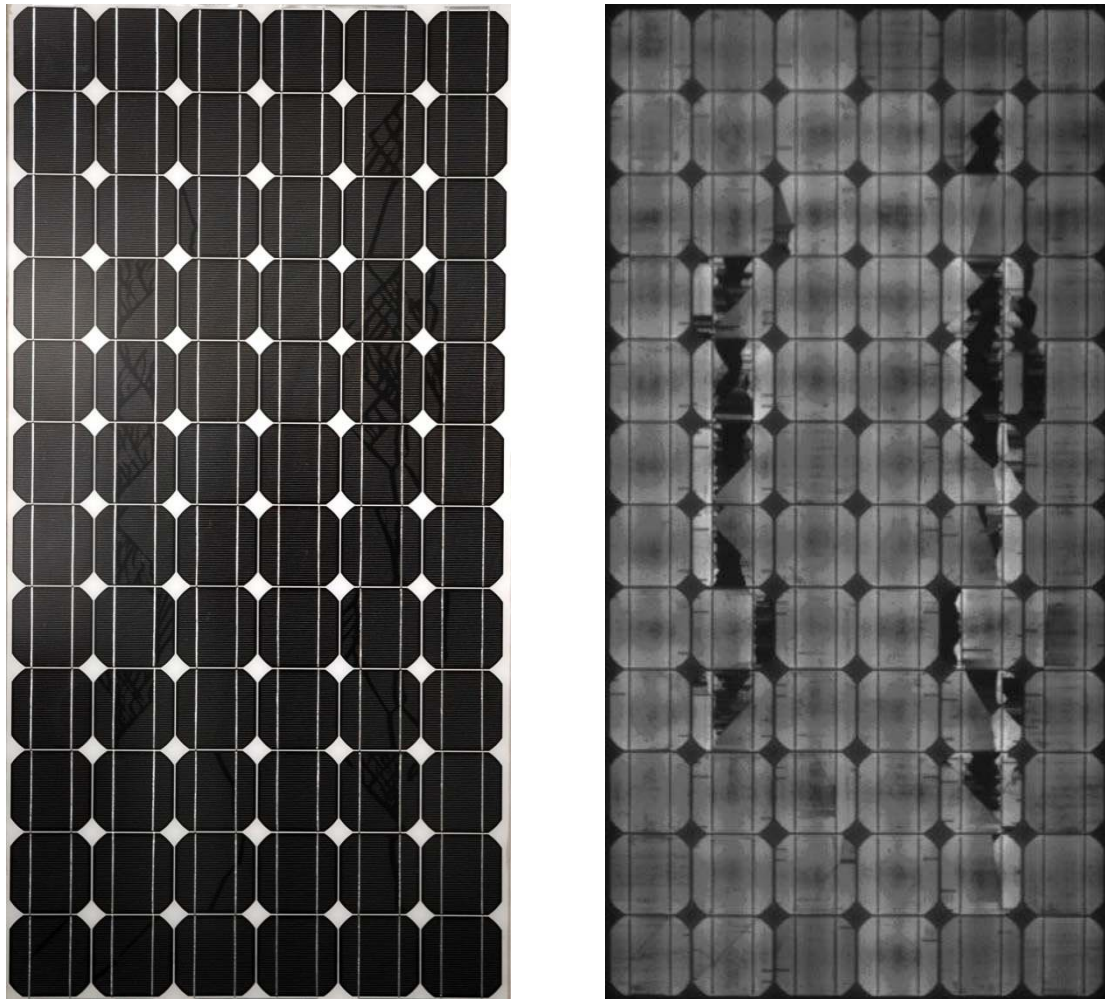
Fig. 6.2.4: Left: photograph of a snail track PV module. Right: EL image of the same snail track PV module. A snail track occurs along the edges of a solar cell and along cell cracks [Koentges08].

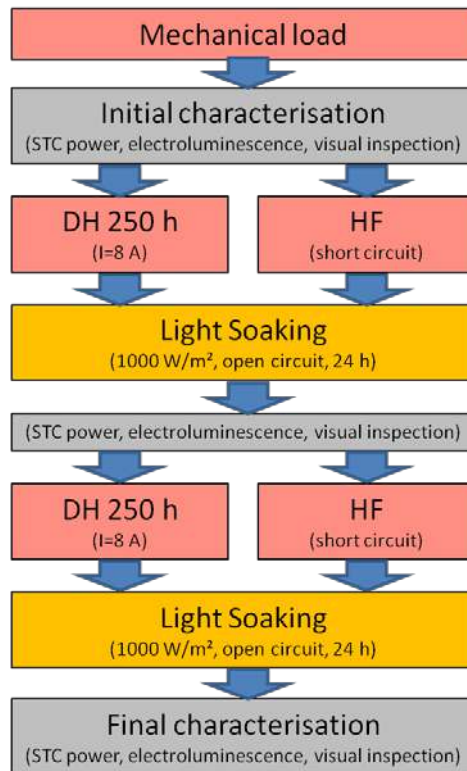
Fig. 6.2.5a: Suggested test procedure to provoke snail tracks in PV modules [redrawn from Berghold12].

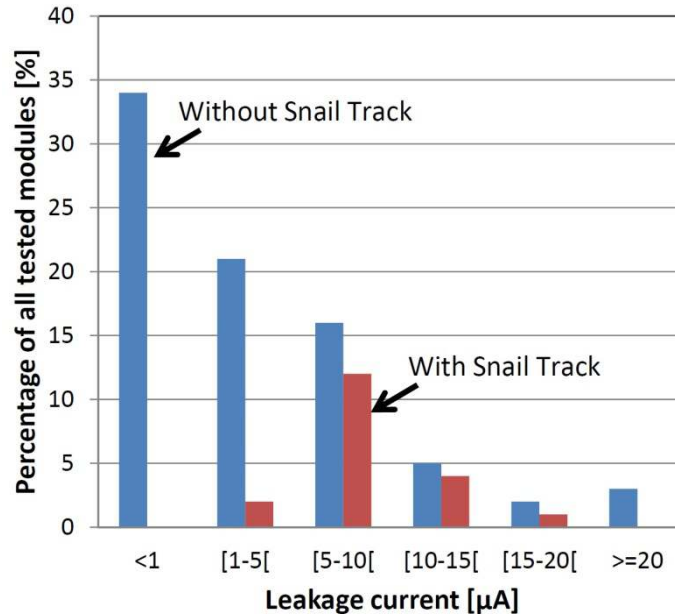
Fig. 6.2.5b: Histogram of leakage current measured in wet leakage testing for snail track affected panels. Given percentage values are relative to the number of all tested PV modules [Berghold12].

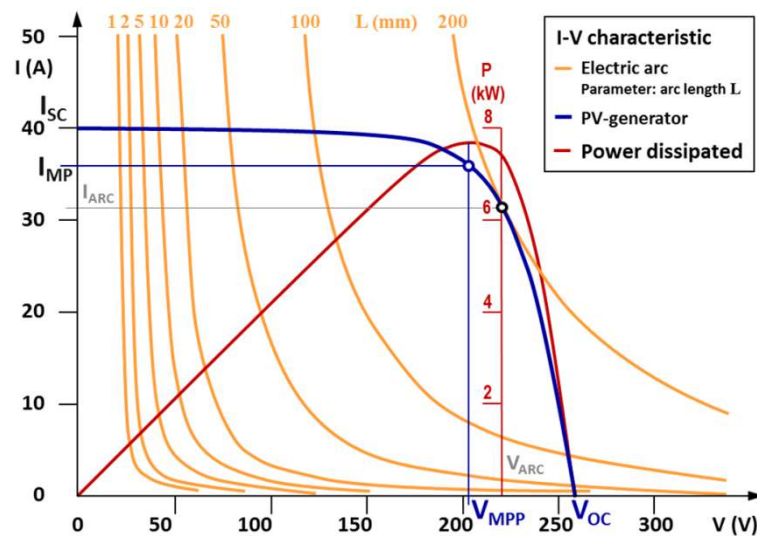
Fig. 6.2.6: I-V characteristics of free burning DC arcs in air on copper electrodes depending on arc length (in orange, from [Rieder55]) in comparison with typical PV system characteristics (blue curve).

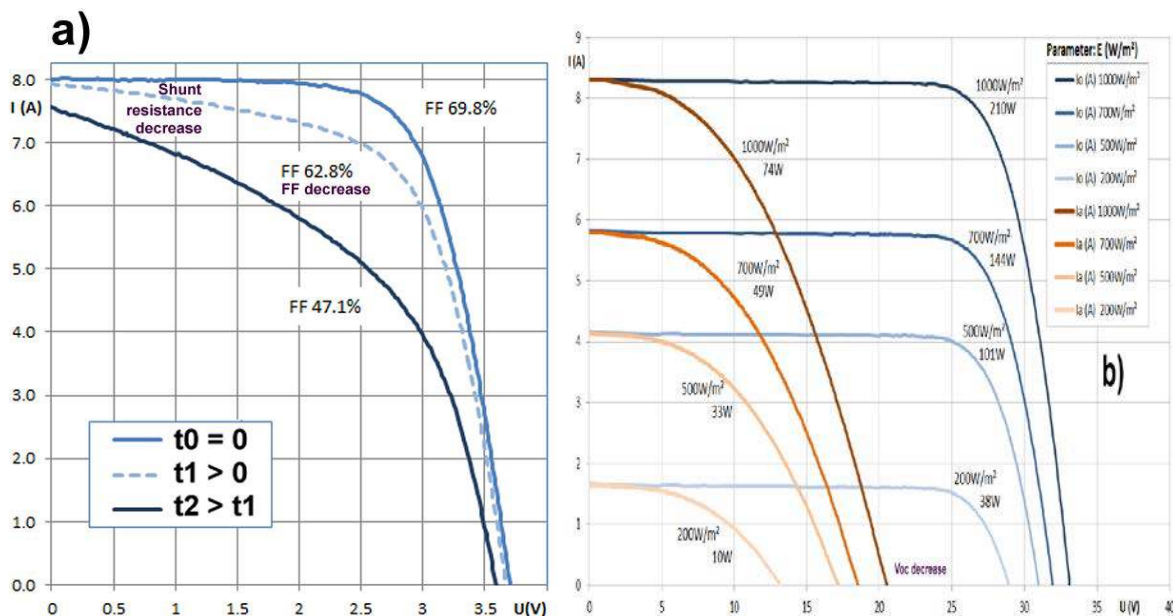
Fig. 6.2.7: I - V curves of PV modules with polycrystalline cells. On the left a): I - V curves measured at STC from a 2x3-cell-module kept in a climate chamber at 60°C/85% rel. humidity; t_0 ... t_1 : 96 h at -1000 V, t_1 ... t_2 : 96 h and -1500 V between cells and frame. The power is decreasing with increasing PID effect over time. On the right b): I - V curves of a fielded (I_a) and initial (I_0) 6x9-cell-module at ± 400 V system voltage measured under various Irradiation levels [Berger13].

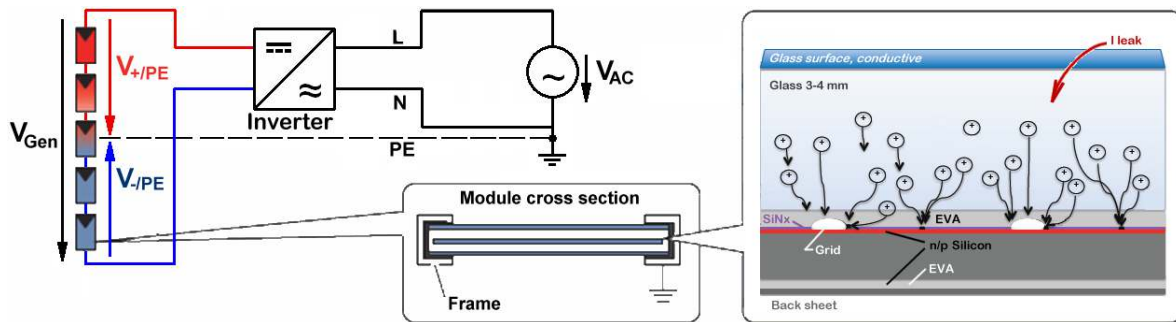
Fig. 6.2.8: On the left: Schematics of a PV array connected to the grid by means of a transformerless inverter. Middle: Module cross section. On the right: Detail drawing of the cross section next to the (grounded) frame. Left and middle part from [PID-TI-UEN113410], right figure from [Hacke12a].

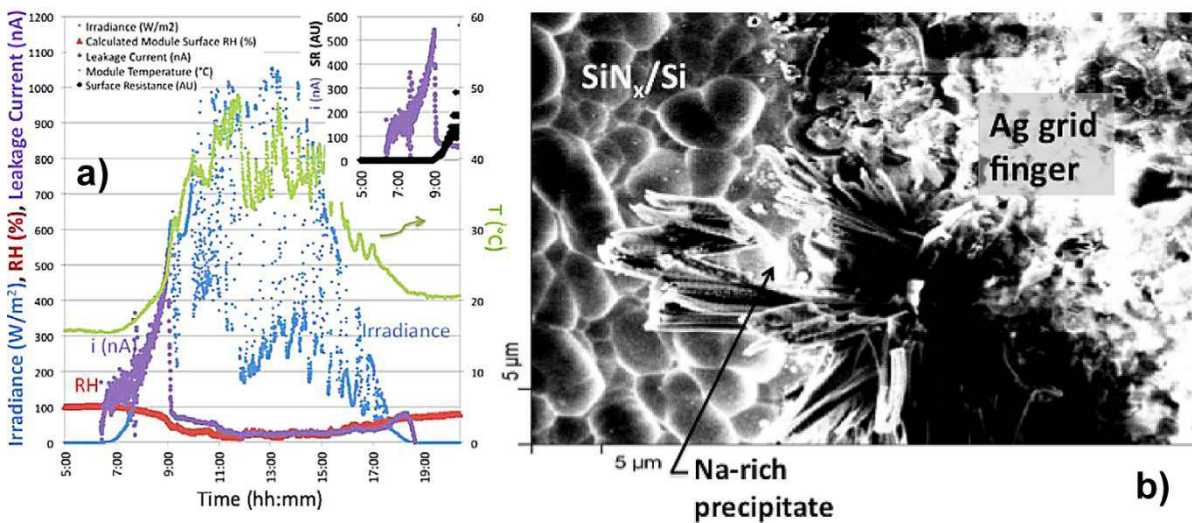
Fig. 6.2.9: a): Irradiance, humidity, leakage current, and temperature during daytime [Hacke11]. b): AES imaging of the SiN_x/Si boundary [Hacke11].

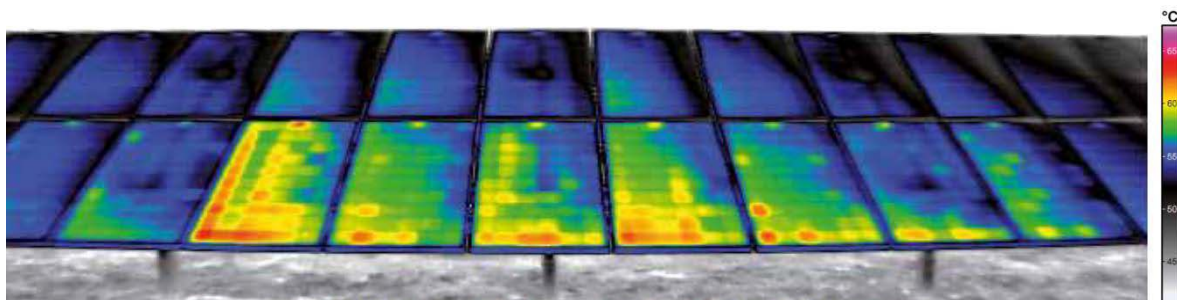
Fig. 6.2.11: Operating module array investigated by thermography under illumination. The negative module voltage decreases from the right to the left side, and the power losses heating the modules in the shunted areas are also increasing from the right to the left [Weinreich13].

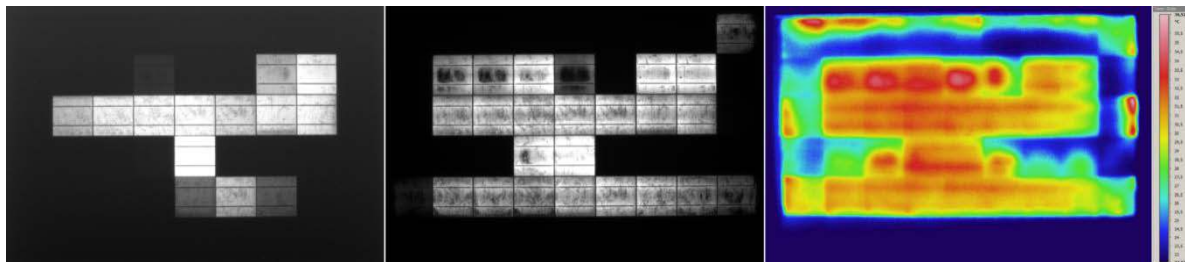
Fig. 6.2.12: Fielded 6×9-cell-module with the I - V curves depicted in Fig. 6.2.7 (b), investigated with electroluminescence images made at 10% I_{sc} (left), 100% I_{sc} (middle) and dark IR thermography at 100% I_{sc} (right) [Berger13].

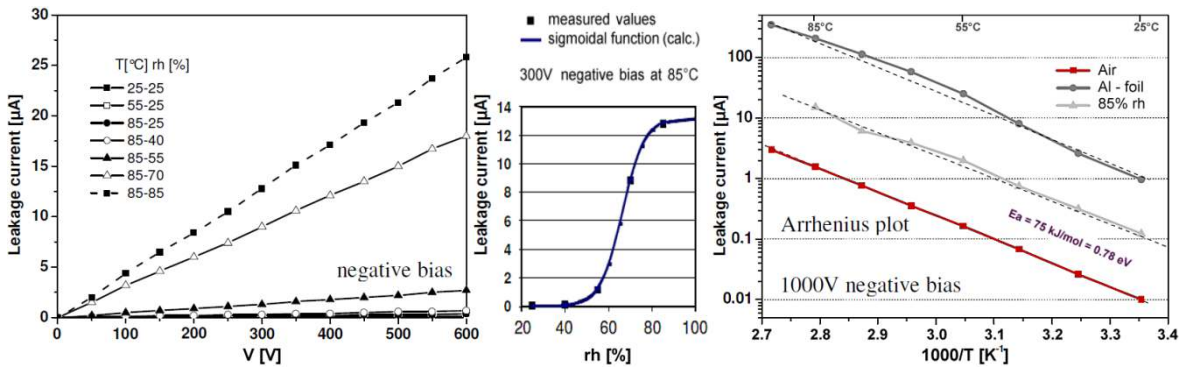
Fig. 6.2.13: Measured values for the leakage current (LC) between cells and module frame. Left side: voltage dependency of LC, with parameters temperature and humidity. Middle: LC as function of the humidity measured (squares) and approximation by a sigmoid function (blue curve). The effect of humidity in the climatic chamber is time dependent. This is due to condensation at the module [Mathiak12]. Right side: Arrhenius plot of LC with three different variants for contacting the module's outer surface: frame only, in (dry) air; front glass and frame additional covered with aluminum foil; frame only contacted, but 85% rel. humidity applied. Modified, from [Hoffmann12].

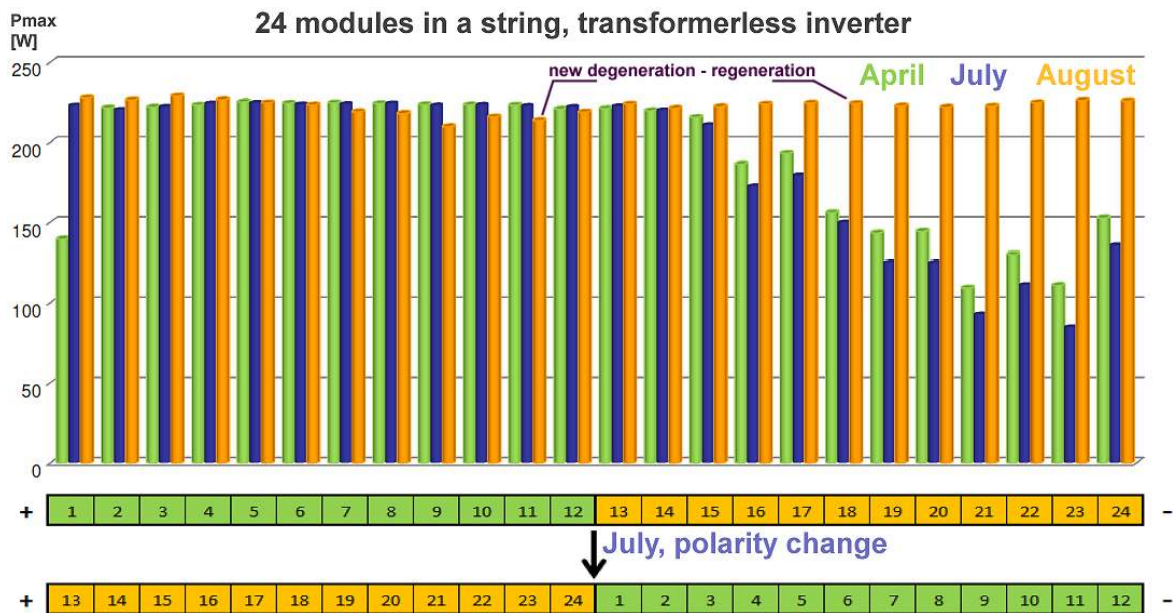
Figure 6.2.14: Measured power for individual PV modules at STC dependent on the module's position in the string. The power losses at negative potential are still increasing until the polarity is changed and recovery to the original Pmax values takes place [Herrmann12].

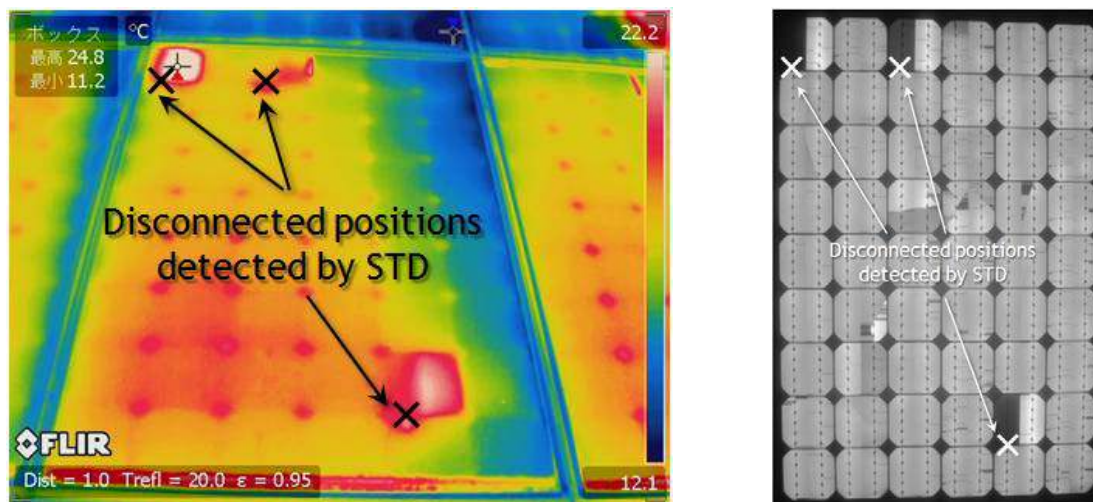
Fig. 6.2.14: Left: An example of disconnected cell interconnections found in the field (IR image). Right: The corresponding EL image of the same PV module.

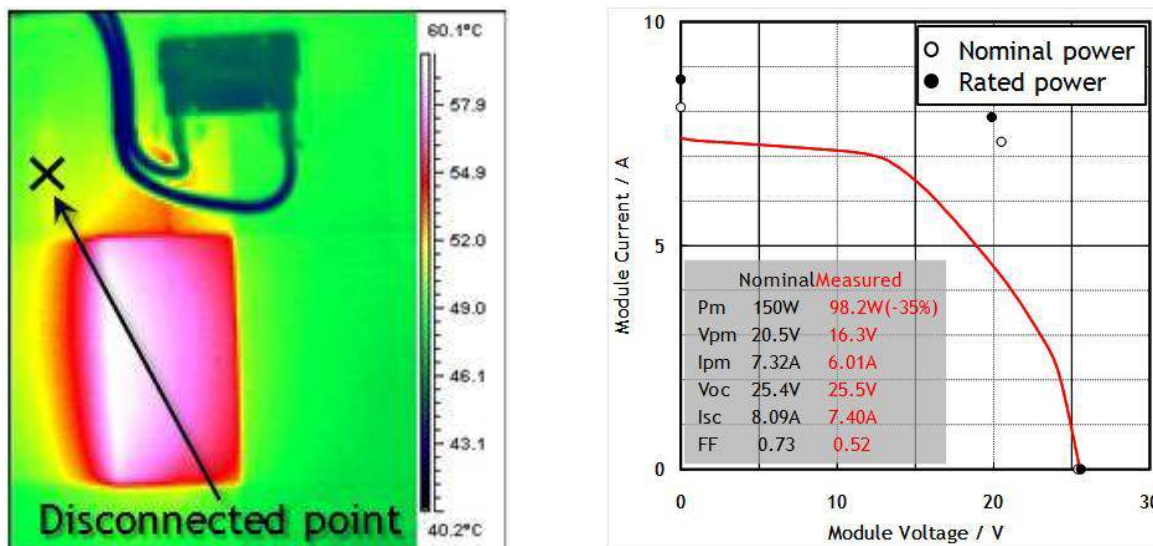
Fig. 6.2.15: Left: an IR image of a PV module where one interconnect ribbon is locally disconnected (“failure stage 1”). Right: I - V curve (indoor STD) of a PV module in which one interconnect ribbon is locally disconnected (“Failure Stage 1”). The Nominal and initial rated I - V curve parameters are plotted into the graph.

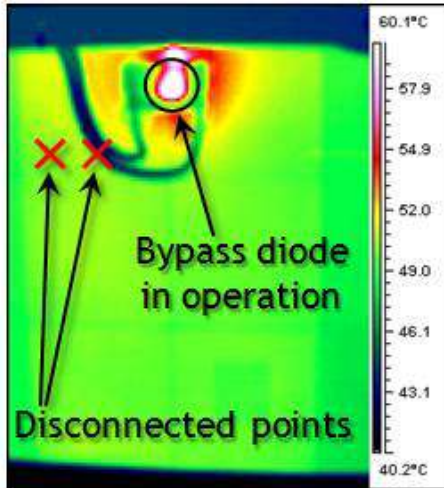
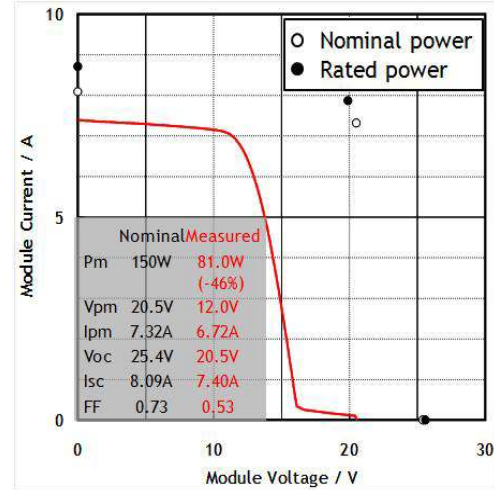
Fig. 6.2.16: Failure stage 2. Left: an IR image of a PV module with two parallel cell interconnect ribbons locally disconnected. Right: I - V curve measurement (indoor STD) of PV module with two parallel cell interconnect ribbons locally disconnected.
