Review of Failures of Photovoltaic Modules

PHOTOVOLTAIC
POWER SYSTEMS
PROGRAMME

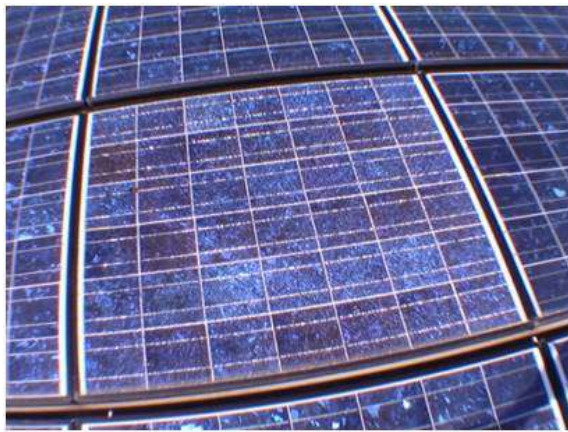
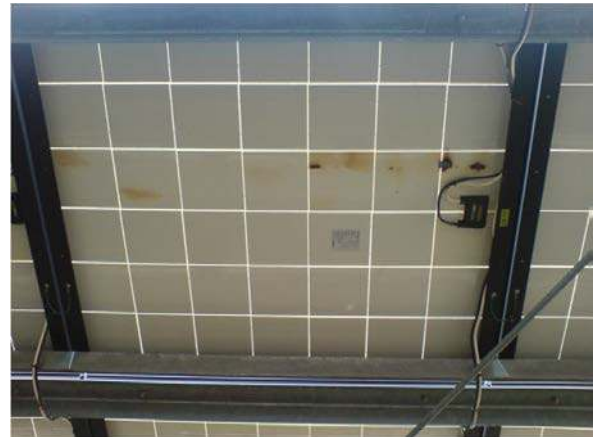
Fig. 6.2.17: Final stage. Left: glass breakage of a PV module caused by broken cell interconnect ribbons. Right: burn marks on the PV module rear side caused by broken cell interconnect ribbons.

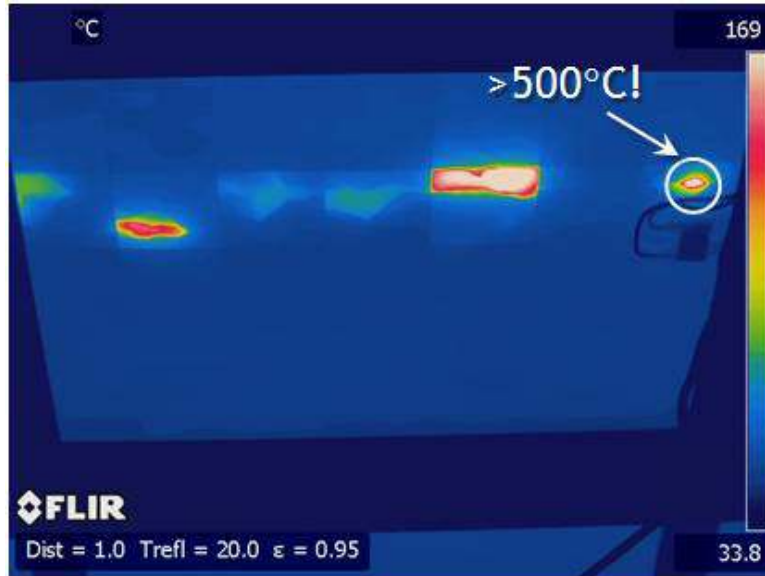
Fig. 6.2.18: An IR image of the “final stage” PV module (observed from rear side).

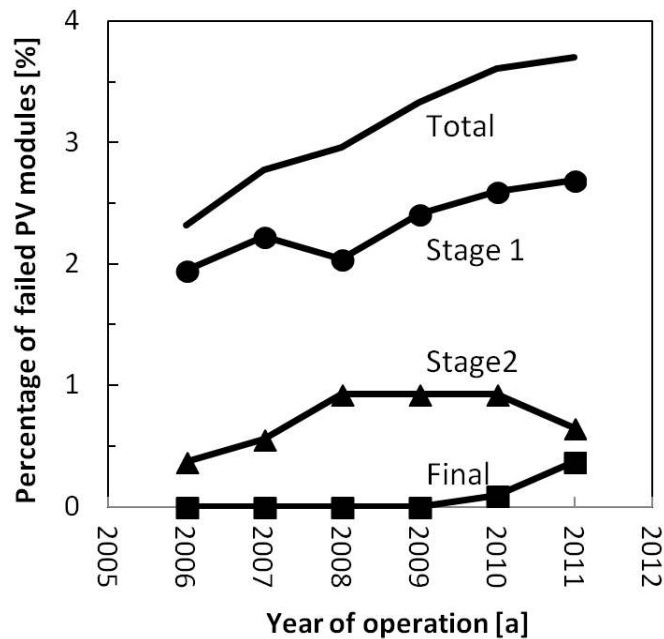
Fig. 6.2.19: Annual trend in number of modules with cell interconnect ribbon failures happening in a PV system. The system consists of 1080 PV modules in total and was built in 2004.

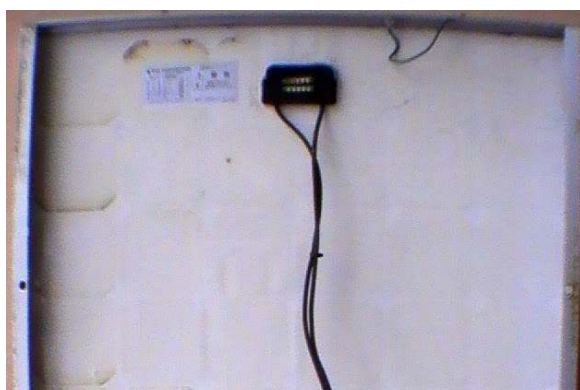
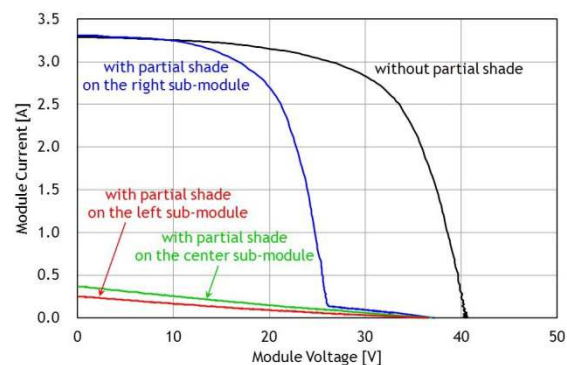
Fig. 6.2.20: A rear side view (left) and a measured I - V characteristic curve (right) of a PV module with burn marks.

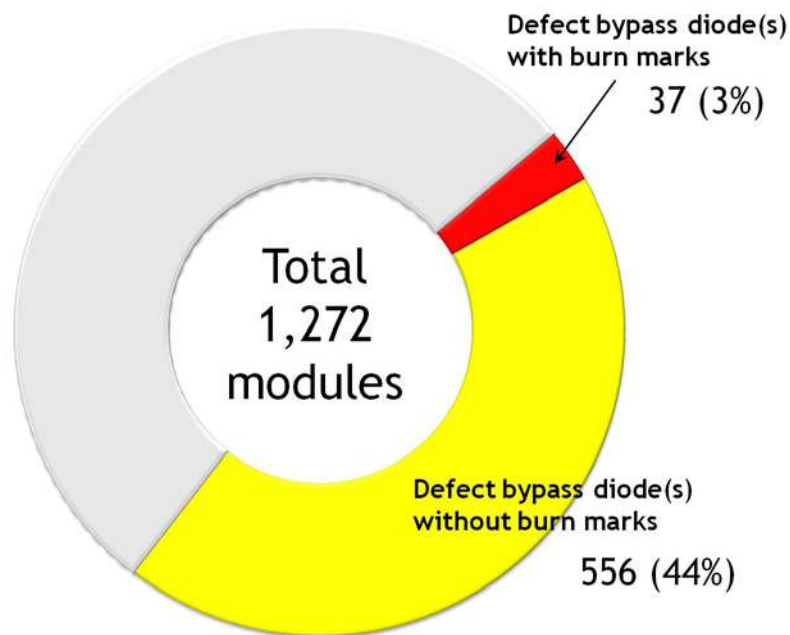
Fig. 6.2.21: A result of bypass diode check for 1272 180 Wp PV modules of one type. The diagram shows the number and percentage of PV modules with one or more defective bypass diodes. The PV modules have been in the field for about four years.

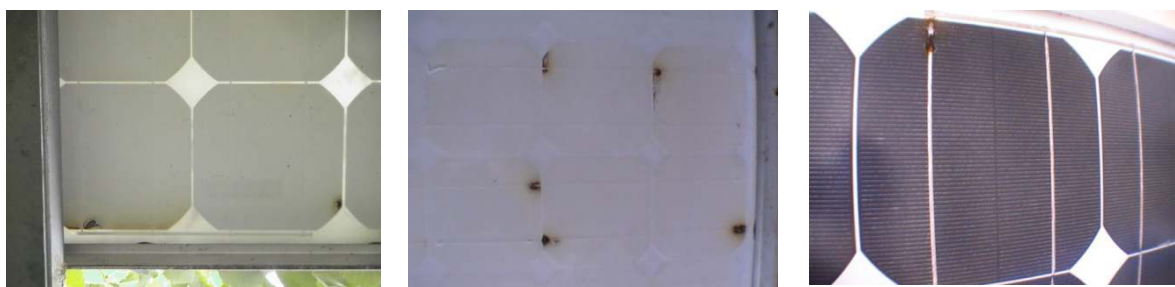
Fig. 6.2.22: Burn marks caused by open-circuit bypass diodes.

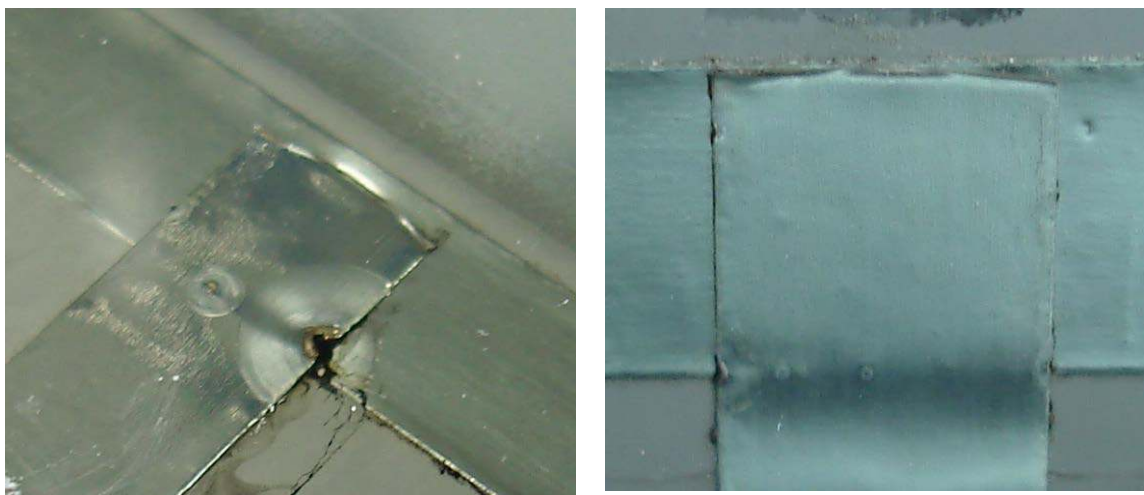
Fig. 6.3.1: Micro arcs which occur if the conductive glue on the string interconnect has an insufficient contact.

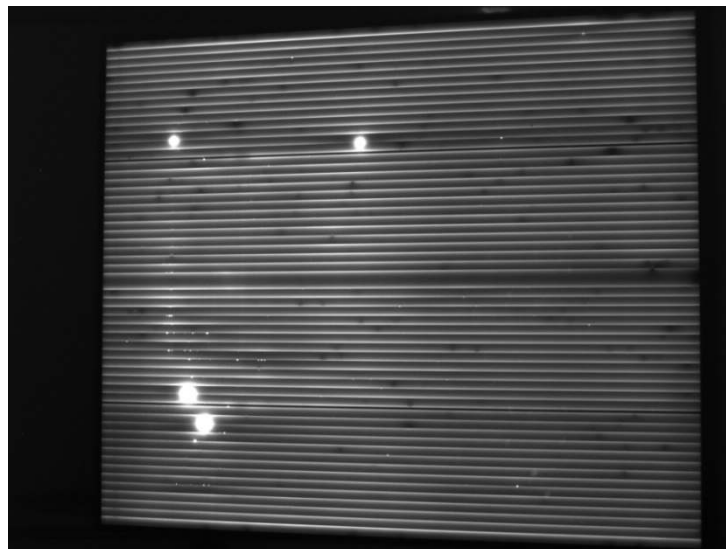
Fig. 6.3.2: Electroluminescence image of an a-Si thin-film module. Dark areas are shunts originating from the production process (type A shunt). Bright spots are severe shunt paths formed by hot-spot operation (type B shunt).

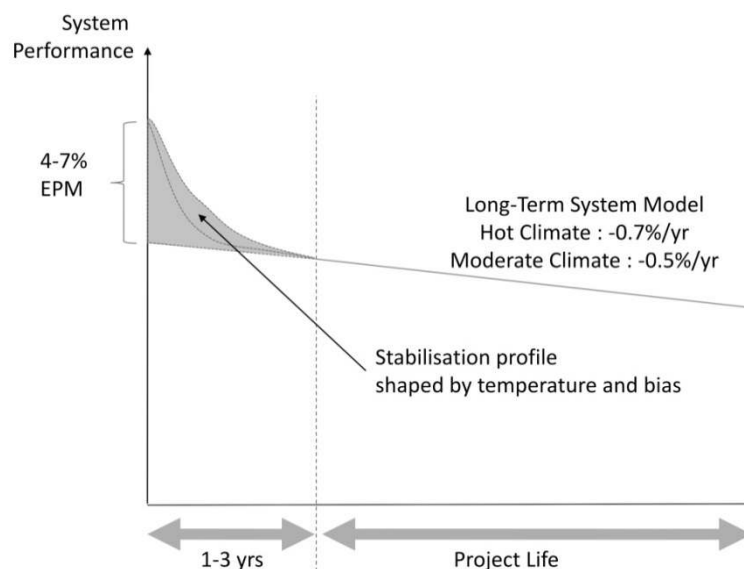
Fig. 6.4.2: Time dependence of degradation caused by Cu diffusion from the back contact into the CdTe absorber [Strevel12, modified]. EPM is the abbreviation for Engineered Performance Margin.

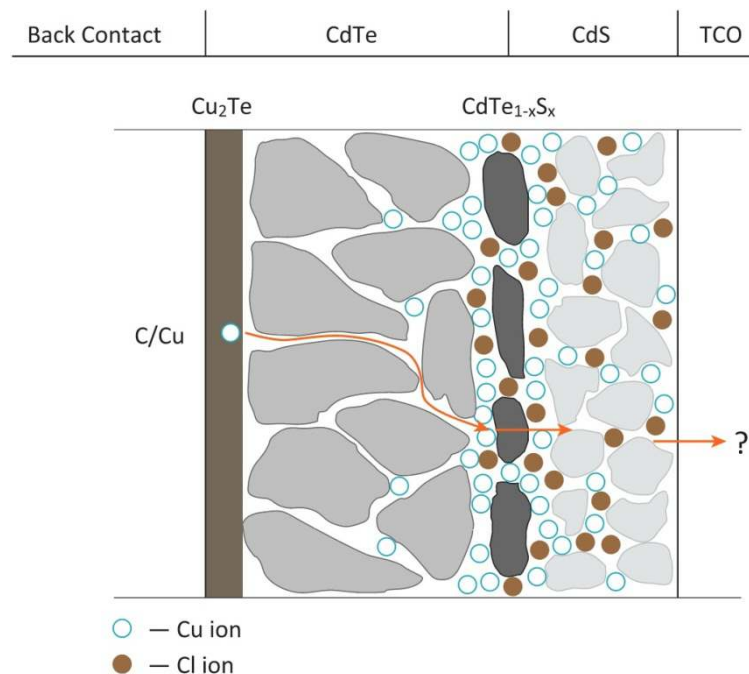
Fig. 6.4.3: Copper migration through a CdTe device [Strevel12].

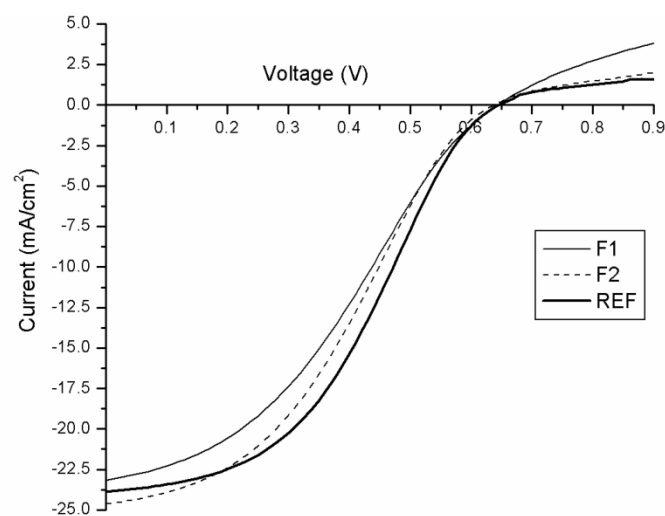
Fig. 6.4.4: Roll-over seen in *I-V* curve of CdTe devices [Carlsson06]. Both field-deployed modules F1 and F2 show a decrease in P_m and FF relative to the reference. The decrease in rollover is more pronounced for module F1.

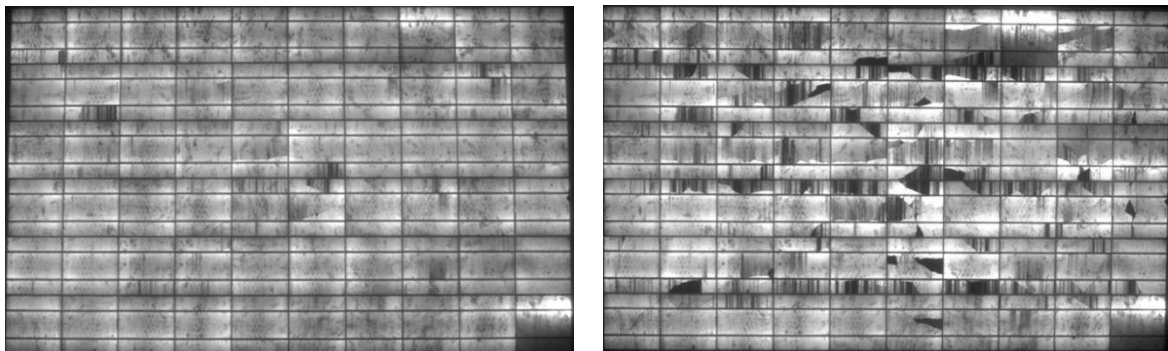
Fig. 7.1.1: Electroluminescence image before (left) and after (right) resonance search.

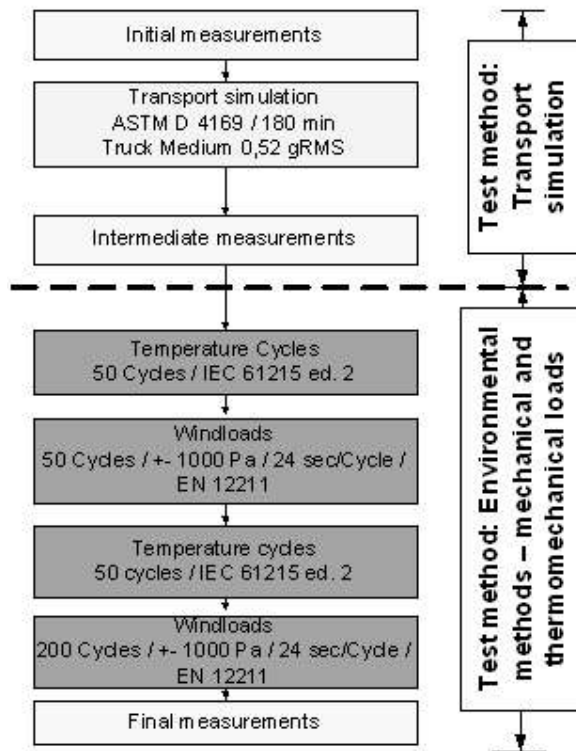
Fig. 7.1.2: Test pattern for combined transport and environmental simulation to determine the longtime behavior of the modules.

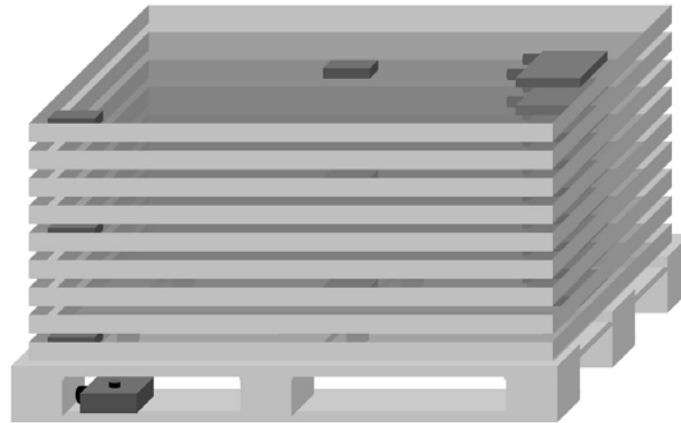
Fig. 7.1.3: The sketch shows the standard positions of the data logger for the acquisition of acceleration data in a PV module transport stack. The standard logger is screwed in the corner of the pallet. Each module in the bottom, in the middle, and in the top position is equipped with two lightweight loggers. They are taped with double sided carpet tape on the module back sheet. On the above-mentioned PV modules one logger is positioned in the module middle and one logger in the module corner. The logger in the module corner is located in the opposite corner of the junction box directly above the lightweight logger.

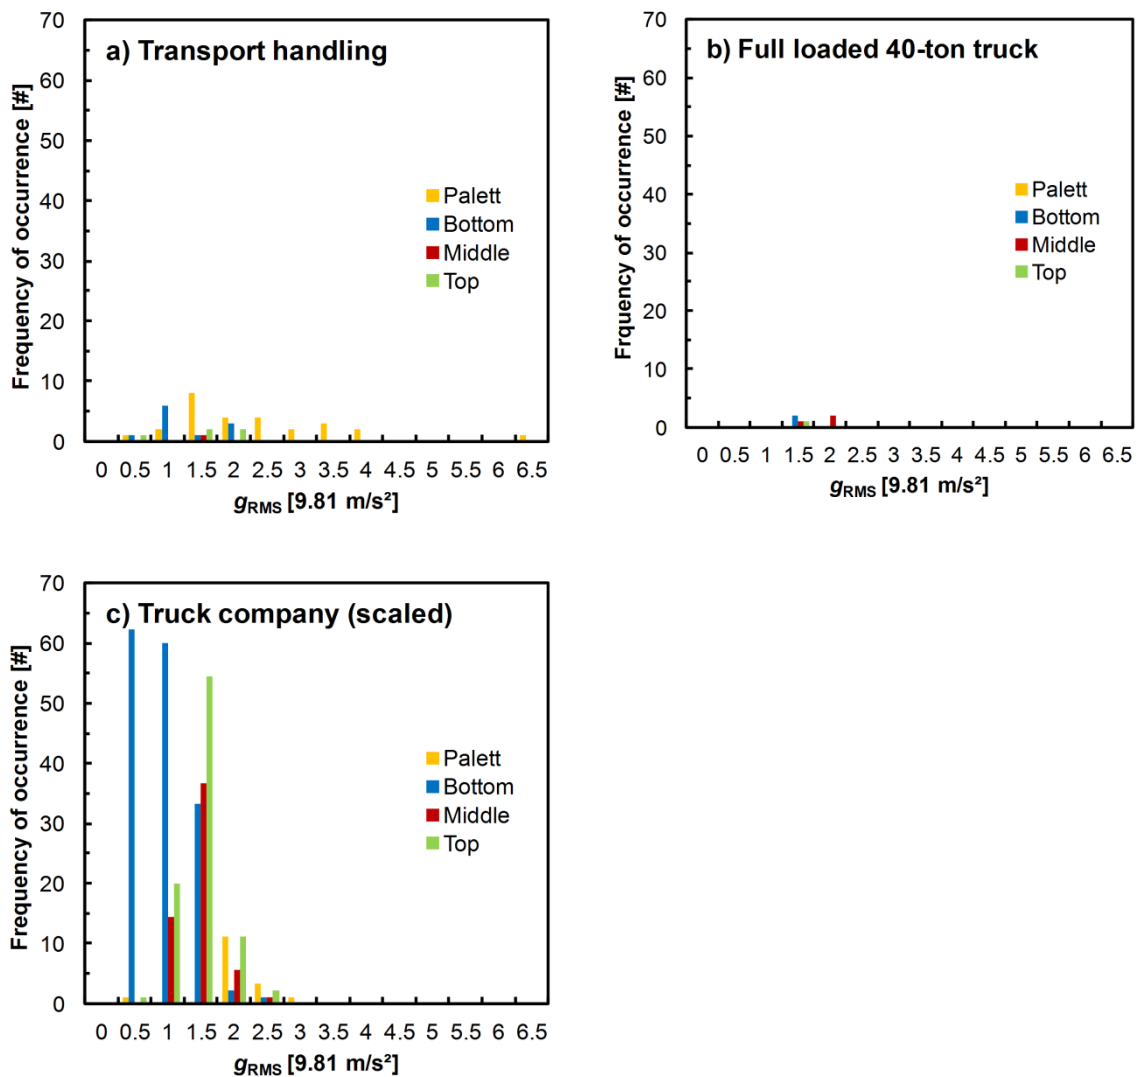
Fig. 7.1.4: Measured shock frequency for a) transport handling, b) transport in a fully loaded 40-ton truck, and c) transport with a truck company driving the same distance. Palett, bottom, middle, and upper indicate the measurement at the module positions in the bottom, middle, and upper part of packaging unit.

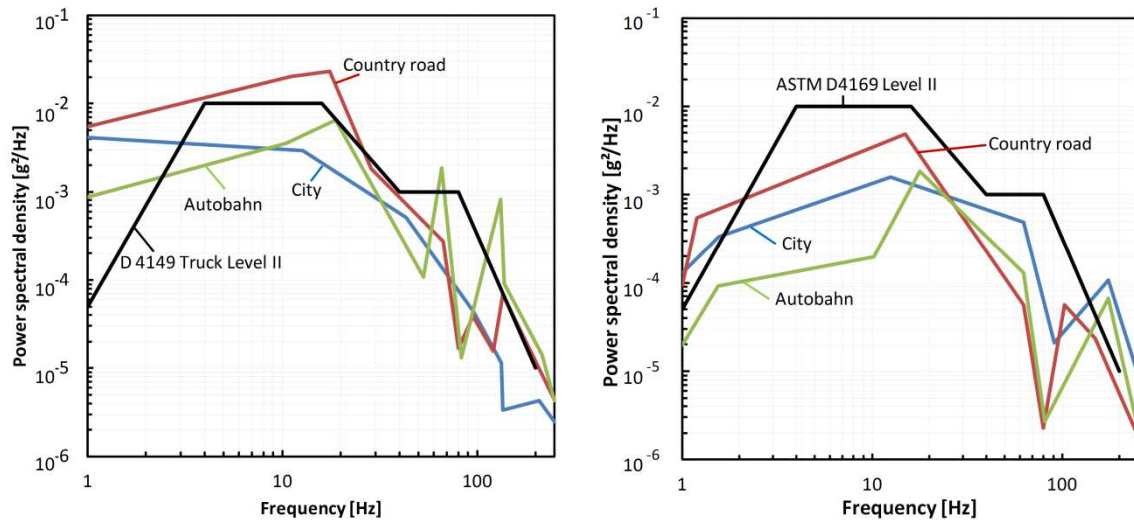
Fig. 7.1.5: Measured reduced PSDs in the corners of PV modules in a transport stack for sunny side down stacked PV modules. Left: Upper PV module in the stack, right: Bottom PV module in the stack. The reduced PSDs are created according to the standard DIN EN 154335 [DIN EN 15433]. The purple and black PSD spectra are similar standard spectra.

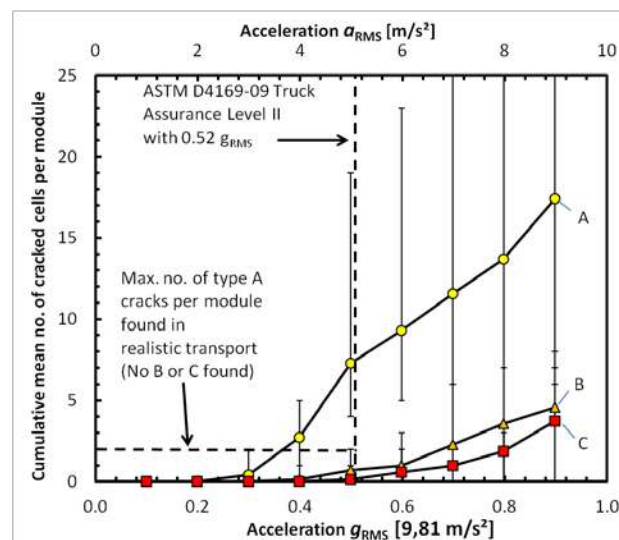
Fig. 7.1.6: The graph shows the cumulative mean number of solar cells with new cracks of type A, B, and C after a 15 min. noise test using the ATSM D4169-09 Truck PSD-spectrum [ASTM1]. The RMS acceleration amplitude a_{RMS} of the PSD-spectrum is varied in this experiment. The error bars show the maximal variance of the set of tested PV modules.

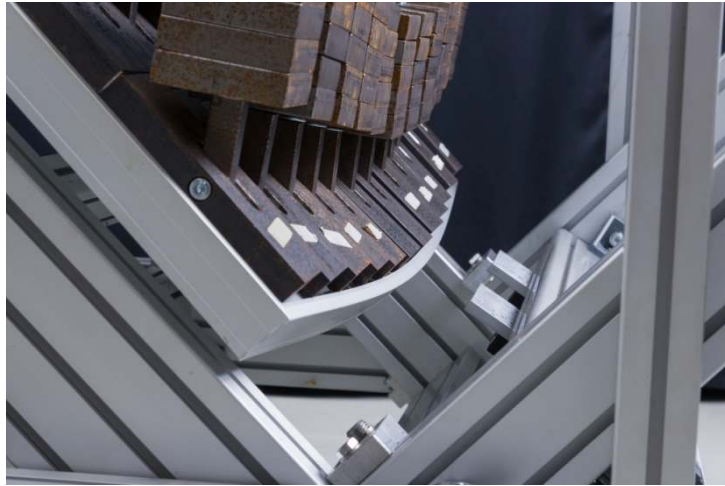
Figure 7.2.1: New test apparatus for snow load testing at TÜV Rheinland 2012: Application of load elements causing the bending of a PV module frame.

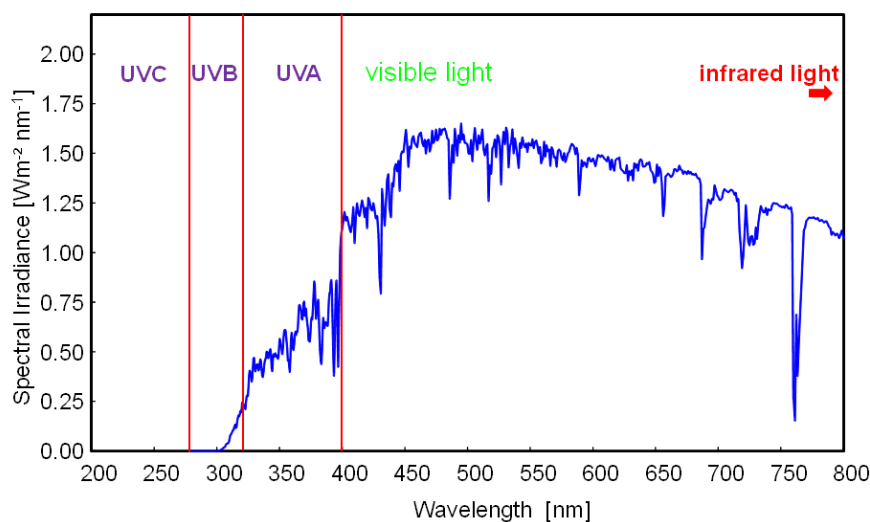
Figure 7.3.1: AM1.5 global reference spectral irradiance distribution. The solar spectrum comprises UV light, visible light, and infrared light.

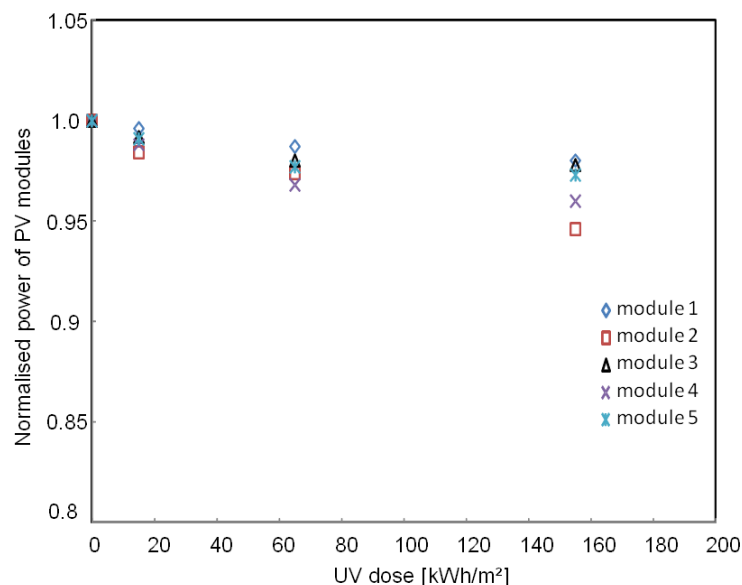
Fig. 7.3.2: The peak power degradation of monocrystalline PV modules after UV irradiation exposure under a simulated UV light source is shown. The module temperature is between 75°C and 85°C.

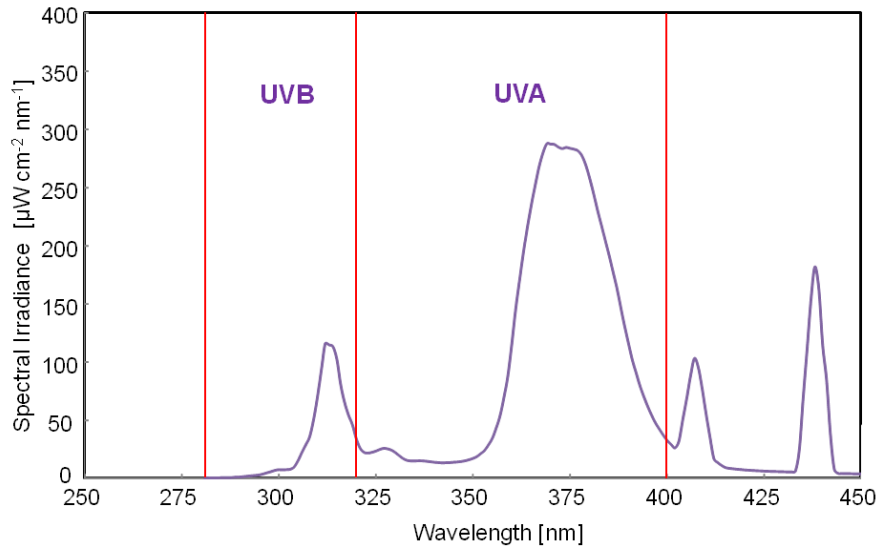
Fig. 7.3.3: The spectral irradiance distribution of a fluorescent lamp used in laboratory is shown. The UVB irradiation (wavelength range between 280 nm and 320 nm) share 9% of the total UV energy.

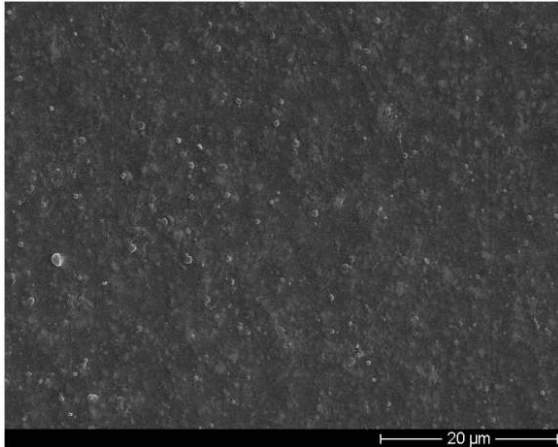
Fig. 7.4.1: Scanning electron microscopic image of a backsheet before ammonia test.

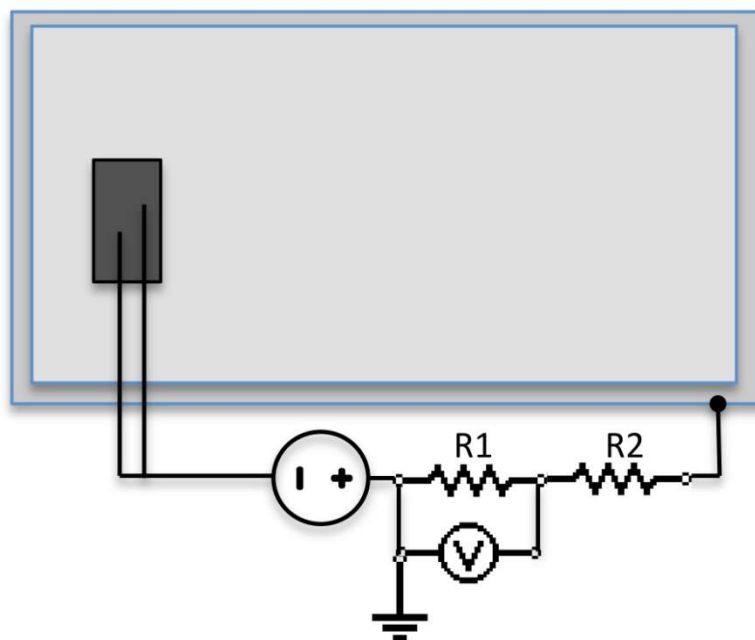
Figure 7.5.1: Application of voltage to the active layer of a PV module via the shorted leads. The leakage current in this example is monitored by a voltmeter across a resistor R1 connected to ground. The voltmeter may be protected from overvoltage by a second resistor R2 [Hacke11]. High voltage power supplies that meter the leakage current may alternatively be used.

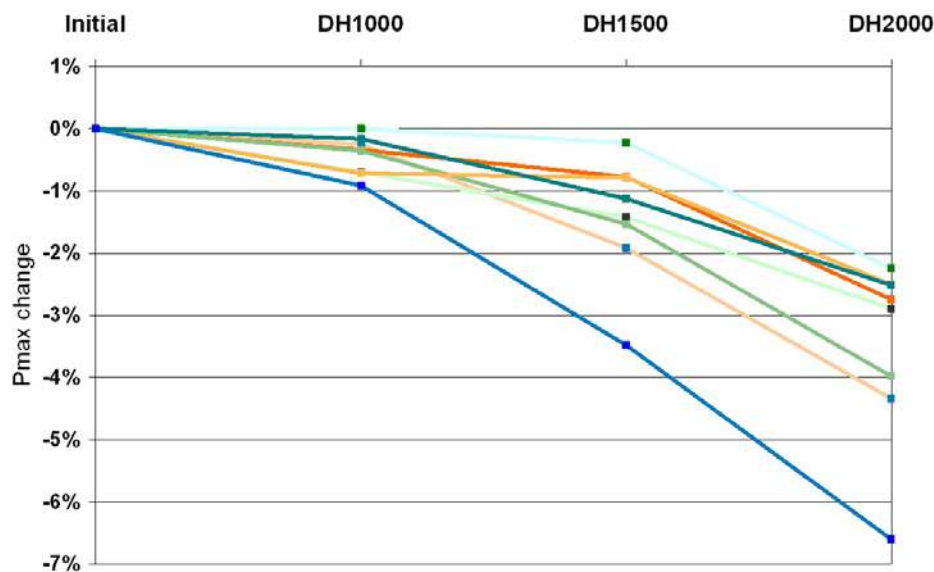
Fig. 7.6.1: Change of output power of 8 PV modules of same type after 1000 h, 1500 h, and 2000 h damp-heat test at 85°C/85%RH [Herrmann11].

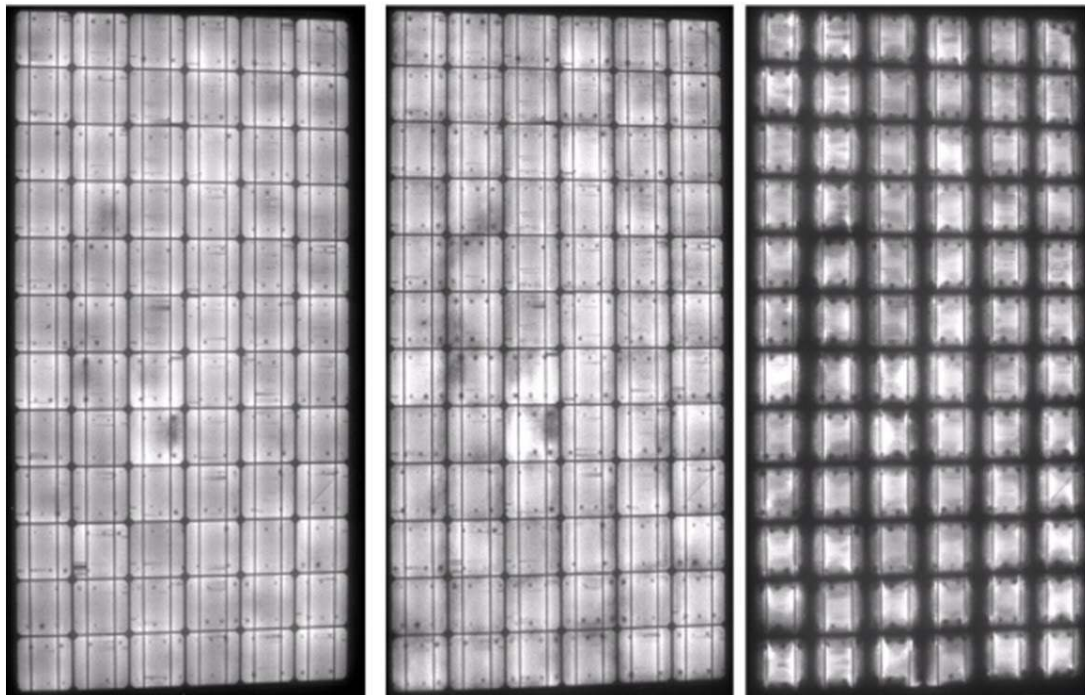
Fig. 7.6.2: Electroluminescence images of a module after 1000 h, 2000 h, 3000 h of damp heat (from left to right) at 85°C/85%RH, featuring -1%, -4%, and -28% degradation of output power, respectively [Herrmann11].

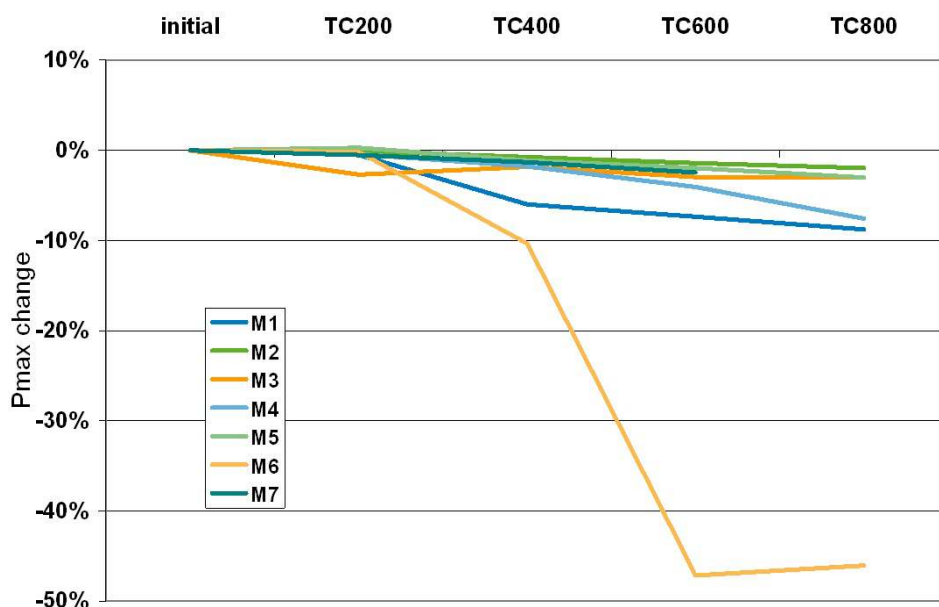
Fig. 7.6.3: Change of power of 7 modules of different types after 200, 400, 600, and 800 temperature cycles [Herrmann11].

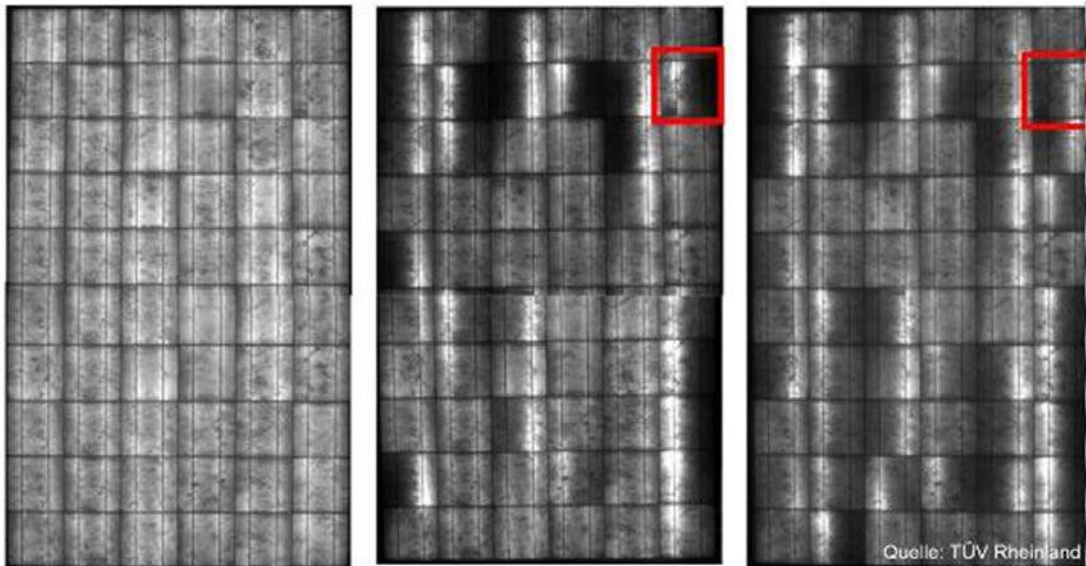
Fig. 7.6.4: Electroluminescence images after 200, 400, and 600 temperature cycles, as described in IEC 61215. Dark areas indicate disconnection of busbars that may not always be permanent, see red markers [Herrmann11].

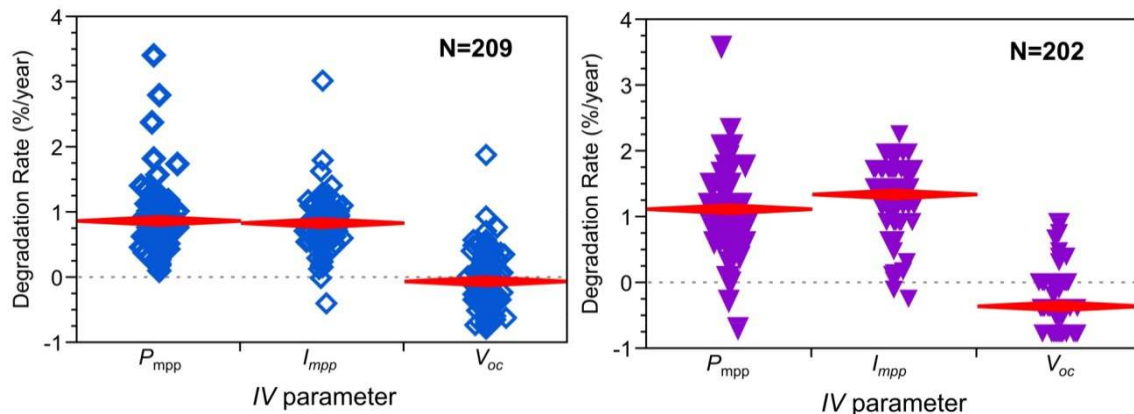
Fig. 8.1: Degradation rates of the maximum-power-point values for power, current and voltage for monocrystallineSi (left), multicrystalline-Si (right). As a guide for the eye, dashed lines indicate no degradation. A negative degradation implies improvement. The symbol N represents the number of PV modules of the statistic [Jordan13].
