Bamboo under the Microscope

By Wolfram Schott

Some observations regarding
Arundinaria amabilis
as a rodmaking material

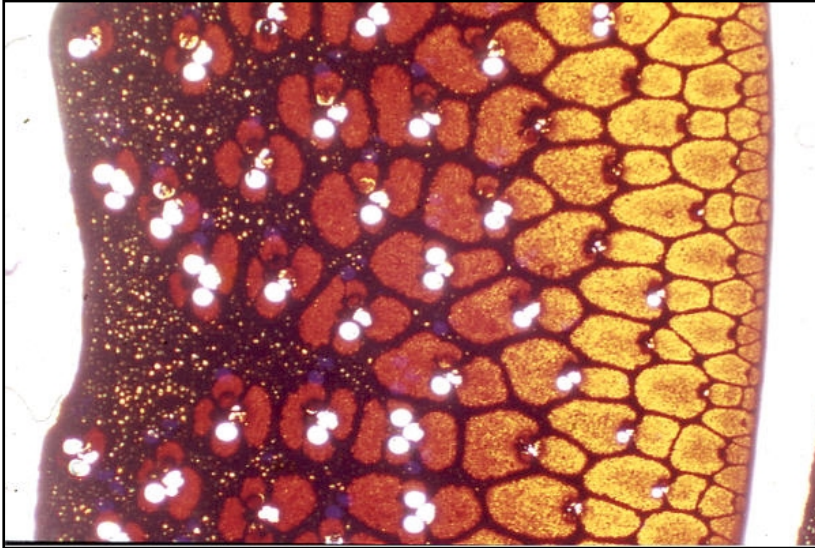
Fig. 11

Long side of picture: 6.6 mm (0.26 in)
Cross section through wall of culm. Heat-treated 10 min at 250 °C (482 °F) in a large laboratory oven. The sample had a size of a few square cm, or about one square inch. The outer third or so of the vascular bundles with thin fibers is dark yellow/orange, to the naked eye this appears dark brown. The inner, coarser fibers have a much darker brown colour. To the naked eye, they appear all but black. In addition, the outermost vascular bundles, right under the skin, are considerably darker than the average outer third. This excessively heated sample is used to demonstrate the ill effects of heating much beyond the removal of water.

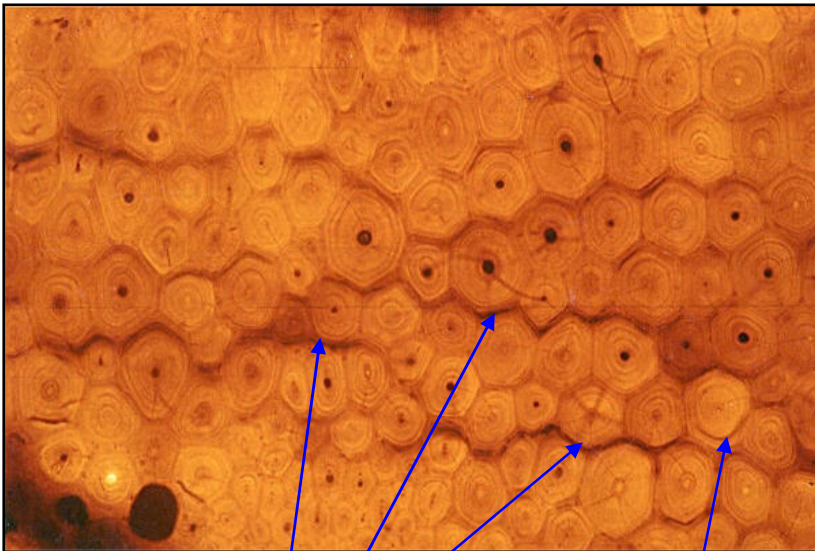
Fig. 12

Long side of picture: 0.32 mm (0.013 in)
A picture taken from the central part of Fig. 12. Desiccation cracks, or fissures, following the walls of the cells have appeared. These split up the vascular bundles into a large number of sub-units. The cells are no longer snugly "glued" to each other. They have shrunk. The intercellular pectin is probably destroyed or cooked off. Some cells show circular cracks even within them, following the secondary walls (cf. Figs. 6 and 7). A bamboo treated such can no longer take up bending loads. The fibers will move along the cracks, shear strength is dramatically reduced.

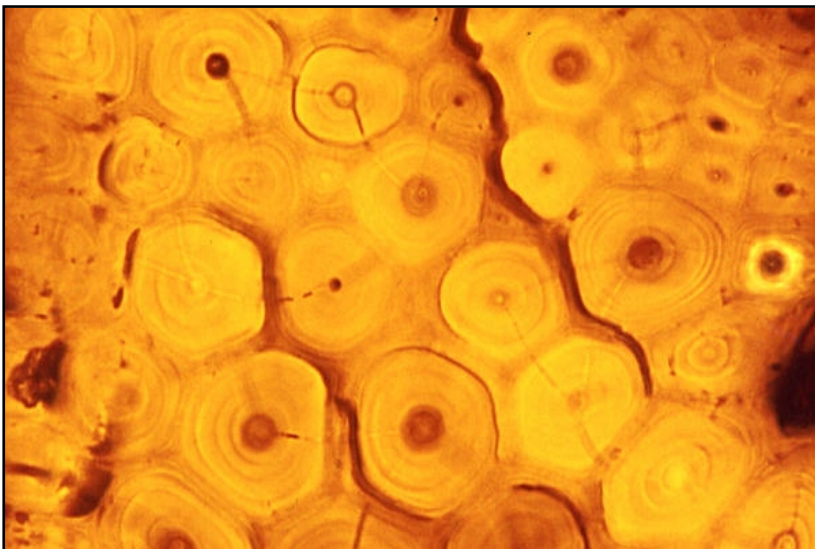
Fig. 13

Long side of picture: 0.23 mm (0.009 in)
A larger magnification of another part of Fig. 11 The "assembly of cells", the vascular bundle, is virtually destroyed: cracks along cell walls, many small cracks within the cells. The "polylamellate wall structure of the fibers" (cf. Fig. 7) seems partly destroyed, possibly due to breaking-up of the lignin-polymers into monomeric units. This sample had contained 6 % water (air-dried) and lost a total of 15 % (by weight) during heat-treating. Compare with Fig. 6.

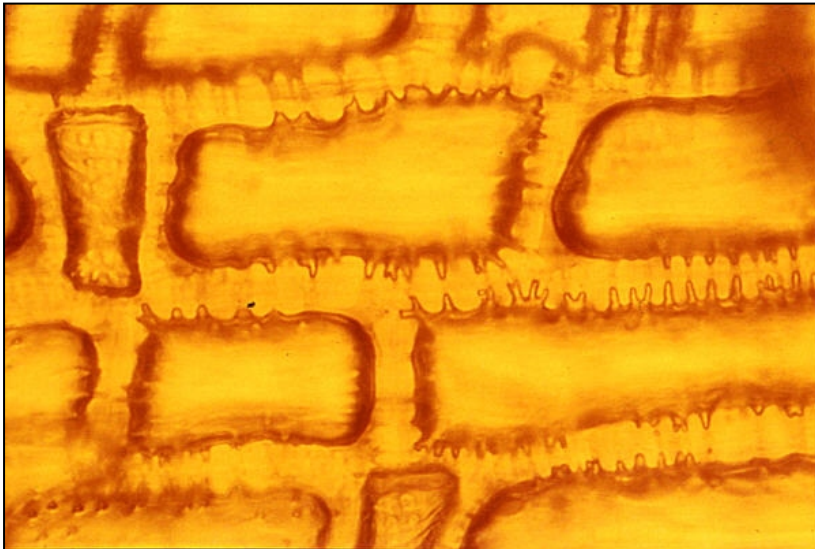
Fig. 15

Long side of picture: 0.23 mm (0.009 in)
 Parenchyma cells ("pith") after heavy heat-treating. The hair-like interconnections ("bridges"), as seen in Fig. 10, seem to have been burned, or scorched, off. Only stumps remain. This is a sample from the inner part of the culm wall.

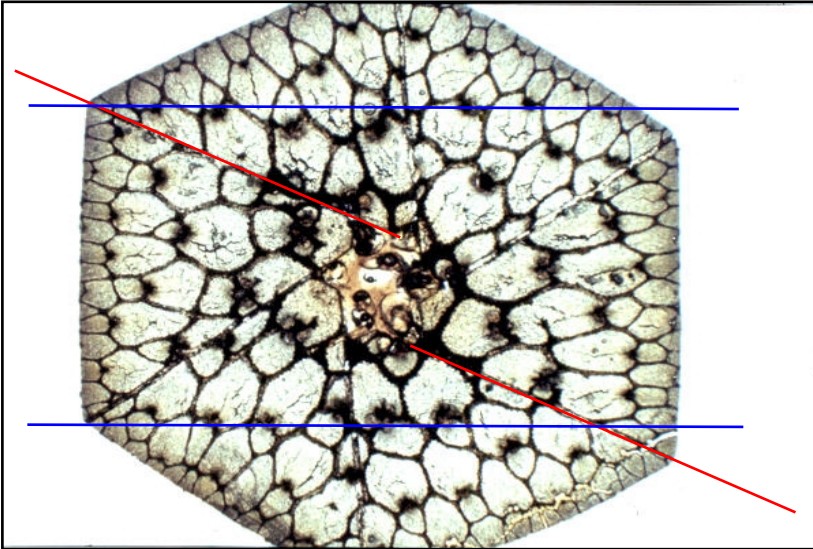
Fig. 19

Long side of picture: 6.6 mm (0.26 in)
 A unique rod, hand planed. Six sided, but not really hexagonal (see blue lines). All six strips are off-shape (no equilateral triangle) by the same amount/angle. How this could be made, repeatedly and with some great degree of precision, I do not know. Maybe the planing form was made this way; more likely, the maker held the plane at an angle, not parallel to the surface of the planing form, with a locked wrist...

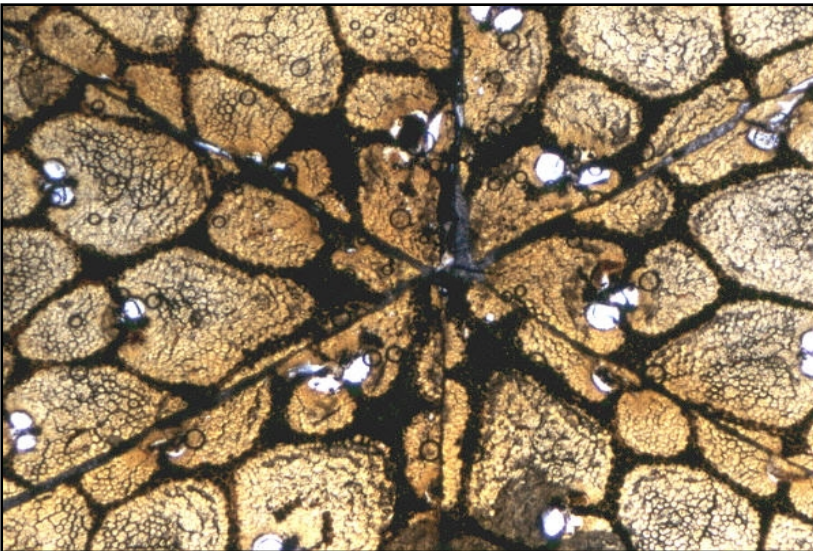
Fig. 20

Long side of picture: 3.2 mm (0.126 in)
 Center of a milled rod. Perfect 60° angles, very thin glue lines. The cutters of the mill were bearing pretty hard on the bamboo, or they needed resharping badly, or they had a wrong cutting edge geometry: Along the inner (milled) surfaces, the cane has been burned to a rather brown colour, due to friction. Very sharp and pointed apices.

This "scorching" of milled strips along their inner surfaces is frequently observed.

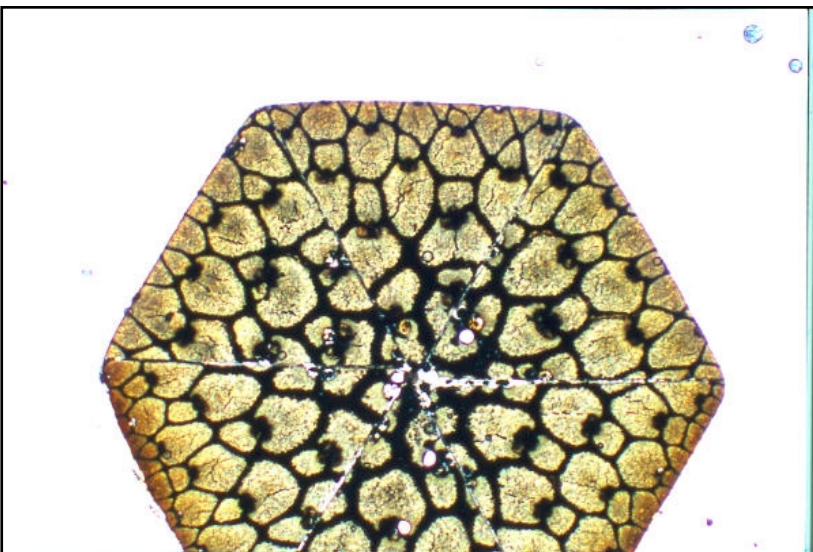
Fig. 21

Long side of picture: 6.6 mm (0.26 in)
 Cross section through tip section of a hand planed rod. The inner apices could have been removed. This is a flamed rod. The outer, or surface, areas of the strips are brown (to the naked eye really dark brown). This is best seen at bottom left and right strips. The high temperature of the flame reaches approx. 0.3 – 0.5 mm (0.012 – 0.019 in) deep into the bamboo. This means for the last 5 or 10 inches or so of the tip that most or the entire tip diameter has been scorched, making it brittle. See Figs. 11 – 13.

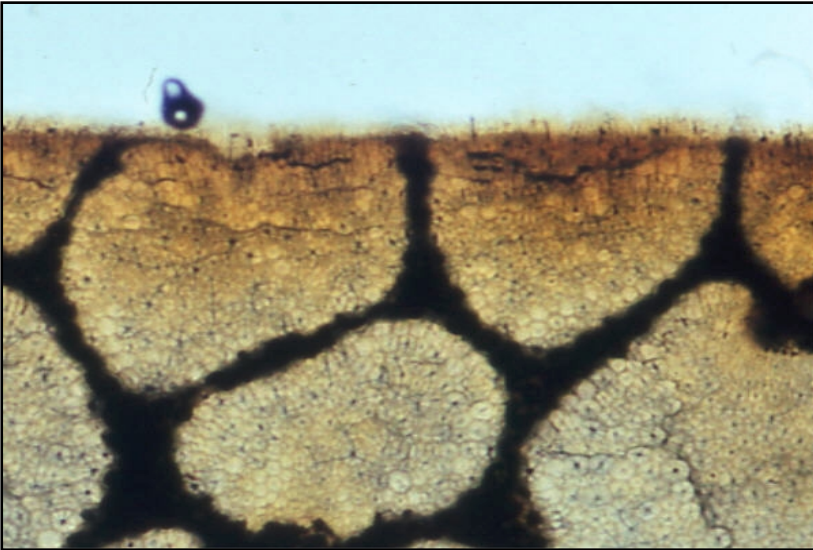
Fig. 22

Long side of picture: 0.41 mm (0.016 in)
 Detailed view from above rod, Fig. 21. Under strong magnification, shrinking-cracks can be observed in the outermost vascular bundles. They run parallel to the surface. The largest cracks right under the surface, where heat was strongest, thinner ones deeper down. The individual cells begin to separate from each other, shear strength is reduced, and it is liable to break. And this is precisely why I got this rod in the first place. It had been stressed and the surface fibers had split into what looked like small brushes in several places.

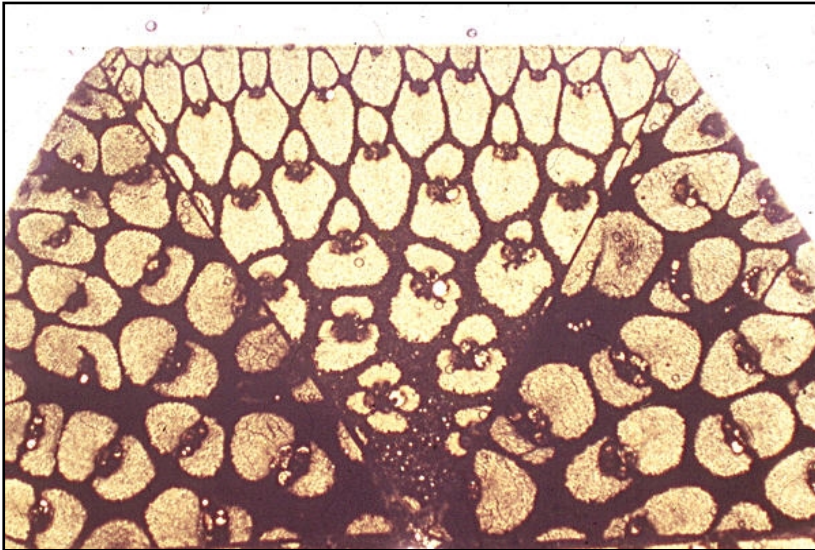
Fig. 25

Long side of picture: 6.6 mm (0.26 in)
 Cross section through butt piece. Milled rod, 60° center angle. This had also the surfaces sanded flat, the glue line at left top is a little off the corner. The two left and right strips are cut through nodes (a 3-and-3 configuration). In the nodes, the vascular bundles are generally coarser, with much parenchyma cells in between. So, if the protruding "hump" of the node is sanded off (not pressed down) to provide for a flat milling surface, one is left with inferior material. As often as not rods break just at these weak node stations, especially at tips.

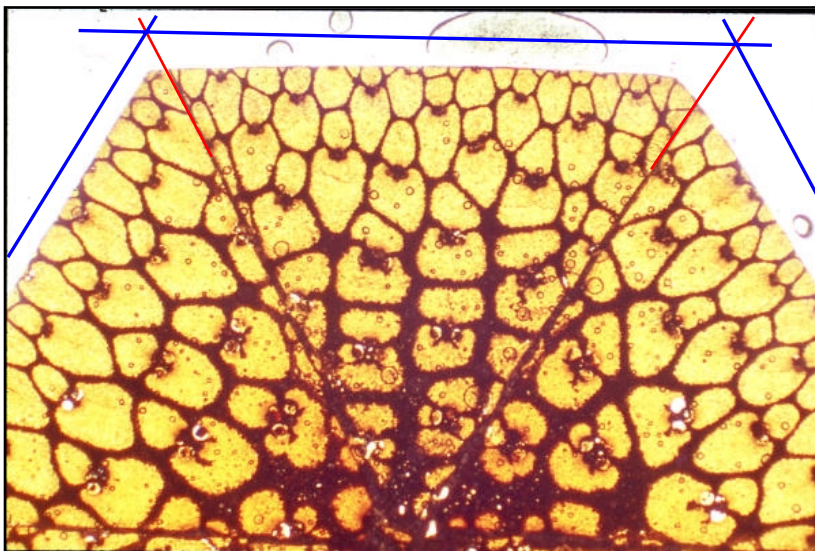
Fig. 26

Long side of picture: 6.6 mm (0.26 in)
 Cross section through butt piece. Milled rod, 60.5 degrees center angle. Another example of rather heavy surface sanding. I have attempted to reconstruct the original outlines by lengthening the glue lines (red) and adding the possible original surface (blue). Compare the last three pictures with respect to geometry, and size/distribution/density of vascular bundles with Fig. 27. Some larger trapped air-bubbles at top, and many tiny ones within the rod section.

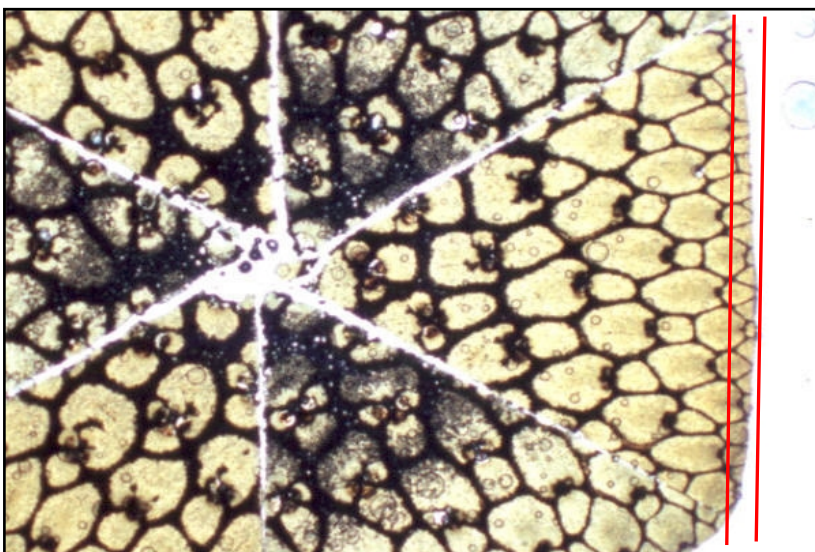
Fig. 27

Long side of picture: 6.6 mm (0.26 in)
 Cross section through butt piece. The strips are milled with 61.5° angle. During glue-up in the binding machine the strips had room enough to rotate a little (clockwise), but they are still symmetrical around the center. Black: three rather bad strips, with inner vascular bundles being destroyed (possibly the result of fungus attack). The outer surface follows the culm-curvature. Had it been sanded or scraped flat, this would have removed a considerable amount of bamboo: 0.25 mm (0.01 in), see red lines. This problem is discussed in "Garrison", page 76.

Remark: Comparing Figs. 24, 25, 26 with Fig. 27, I would rather want to take off the enamel with sandpaper, carefully following the natural curvature of the culm. A true hexagonal shape, with perfectly flat outer surfaces and knife-sharp corners might look very "professional". However, it will also sacrifice a good deal of the most valuable outer powerfibers, especially in butts. Using hand-scrapers or the ubiquitous Stanley 212 scraper carelessly is liable to shave off not only the very thin skin, but also to dig into the topmost vascular bundles rather quickly. Using sandpaper one can actually watch the "uncovering" of the fibers through the "under enamel". Another negative aspect of sharp corners is shown further down, in the chapter on varnish.

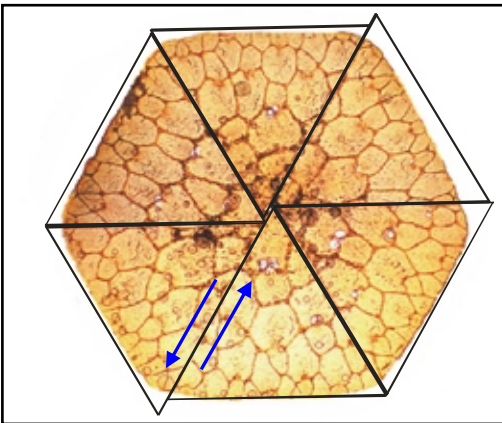
Fig. 32

Using Adobe Photoshop, I have removed the black threads of the guide winding in Fig. 31, plus the guide foot and the varnish. With Coral DRAW, I have constructed six equilateral triangles (with 60° angles) and of equal size. These are placed over the six strips of the rod section. The bottom strip determined the size (height) of the triangles. The result shows the probable original outline of the glued-up strips, provided nothing has been removed from the flat of the bottom strip. It also shows that the two "halves" of the rod section have moved along a glue line in opposite directions, by approximately 0.2 mm (0.008 in). See blue arrows. Sanding off the glue and some powerfibers (most on top right strip), possibly followed by polishing with steel wool (well-rounded corners) prior to varnishing has rectified this mishap ...

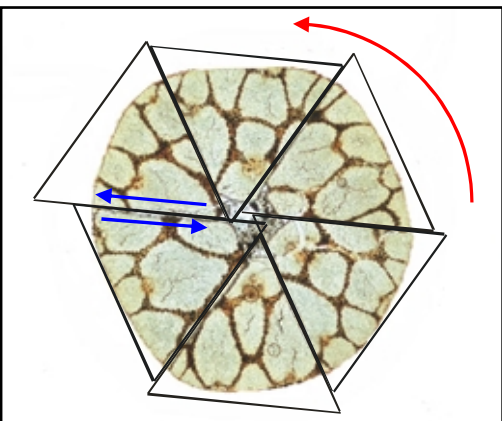
Fig. 34

Again, I have removed the red threads of the intermediate winding. Six equilateral triangles of equal size are placed over the six strips of the rod section. The bottom-left strip determined the size (height) of the triangles. The result shows the probable (minimum) original outline of the glued-up strips, provided nothing has been removed from the flat of the bottom-left strip. It also shows the rotation of the strips, the arrow indicating the direction of the binding thread on the first run through the binder. In addition, a displacement has happened, moving two halves of the rod in opposite directions along a glue line. See blue arrows. The rotation/lateral movement and hence the corners protruding over the flats are the result of too much torque first time through the binder with this delicate tip.

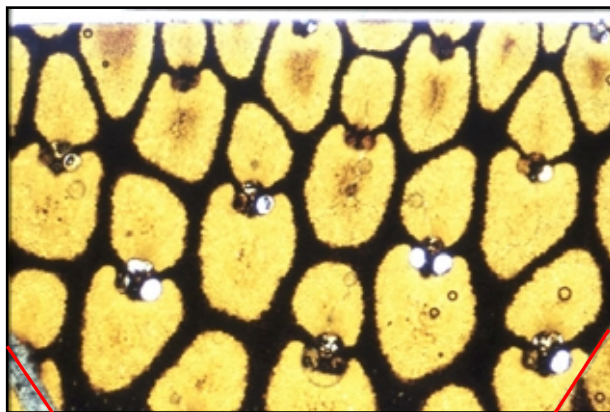
Fig. 40

One strip of a milled rod. Surface (top of picture) heavily sanded or scraped. The vascular bundles are large/coarse and their original position in the culm has been rather deep below the surface. White circles are mayor vessels, the sort that is seen in the inner (left) half of Fig. 1. This strip has 64 % "powerfibers" and 36 % "pith".

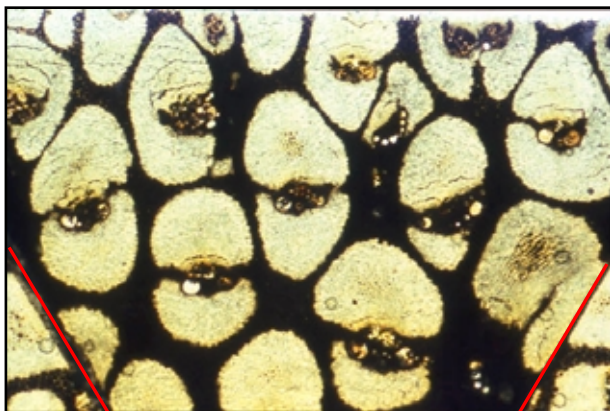
Fig. 41

One strip of a node, milled rod. Surface heavily sanded. Very coarse vascular bundles, typical for nodes. Node not pressed, but sanded flat. Only 60 % "powerfibers", and 40 % "pith" in this strip.

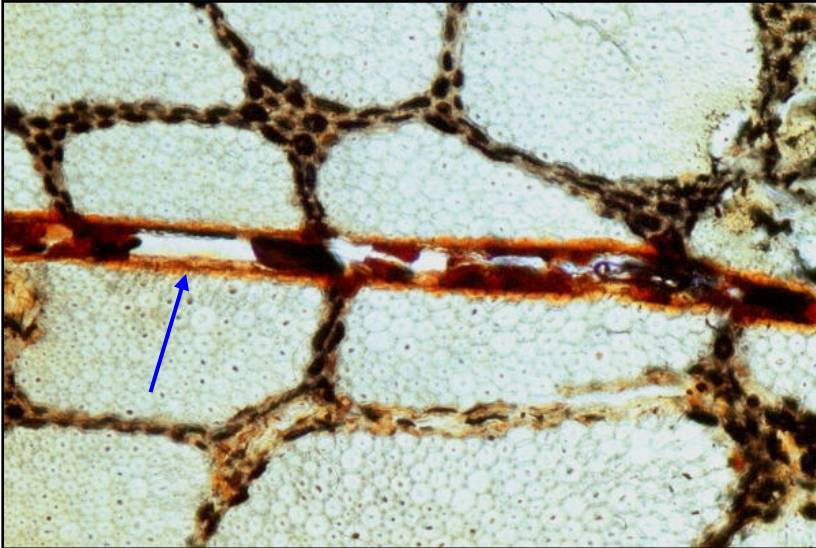
Fig. 46

Long side of picture: 1.3 mm (0.051 in)
 Strongly diluted resorcinol glue. This has not really penetrated any deeper, either. However, it has left open voids, the alcohol having evaporated. Small lumps and crusts of cured glue sit in some places on either side of the joint. Red seams in the fibers (blue arrow) indicate that there once had been glue. Nutshell grains from the glue seem to have prevented a closer fit of the strips, hence a slightly broader glue line (0.05 mm = 0.002 in). Such a defect glue joint is liable to delaminate eventually, since shear-forces cannot be adequately distributed to the bamboo.

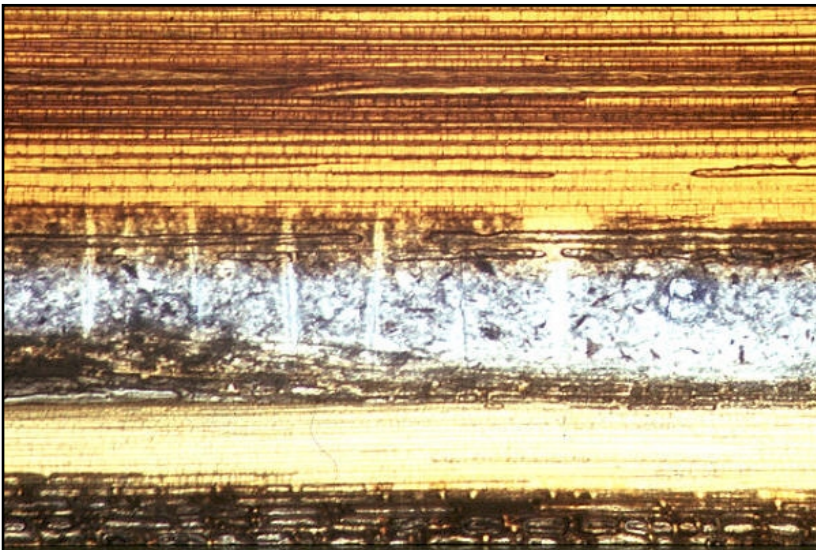
Fig. 47

Long side of picture: 1.3 mm (0.051 in)
 A glue joint prepared parallel to the axis of the rod. Numerous cracks can be seen at short distances from each other. Maybe these developed as shrinking cracks during the curing of the glue (I think it is a melamin-based glue, but I am not sure). Maybe, also, they are the result of the rod's bending back and forth thousands of times, the glue being too brittle to withstand it.

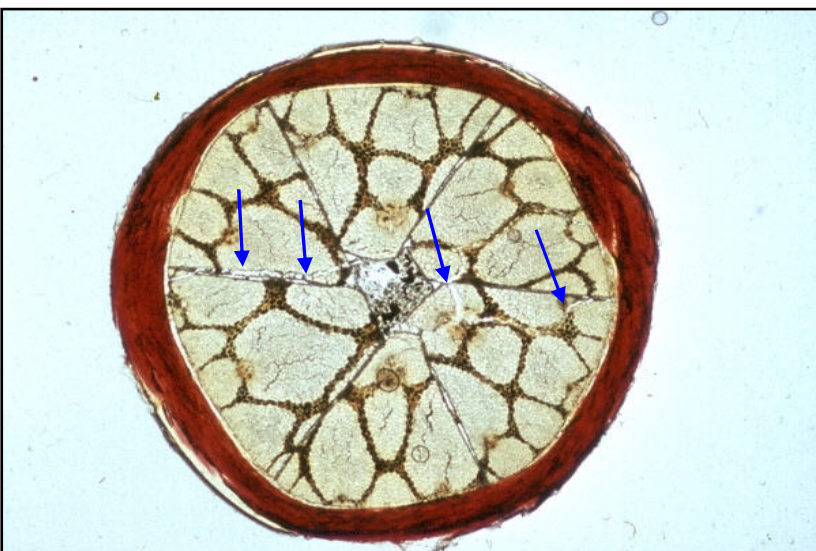
Fig. 48

Long side of picture: 3.2 mm (0.126 in)
 Cross section of milled rod tip. Heavily sanded flats and corners, the rod is more round than hexagonal. Flat-to-flat dimensions of bamboo somewhere between 1.6 and 1.9 mm (0.063 and 0.075 in). Sample prepared through an intermediate winding. The drawn-under ends of the thread located on top right flat. The strips are rotated counter clock-wise around the center. This rod had broken lengthwise in two halves over a distance of some 20 cm, or $\frac{3}{4}$ foot, and was factory repaired (reglued), see arrows. Same photo as Fig. 33.

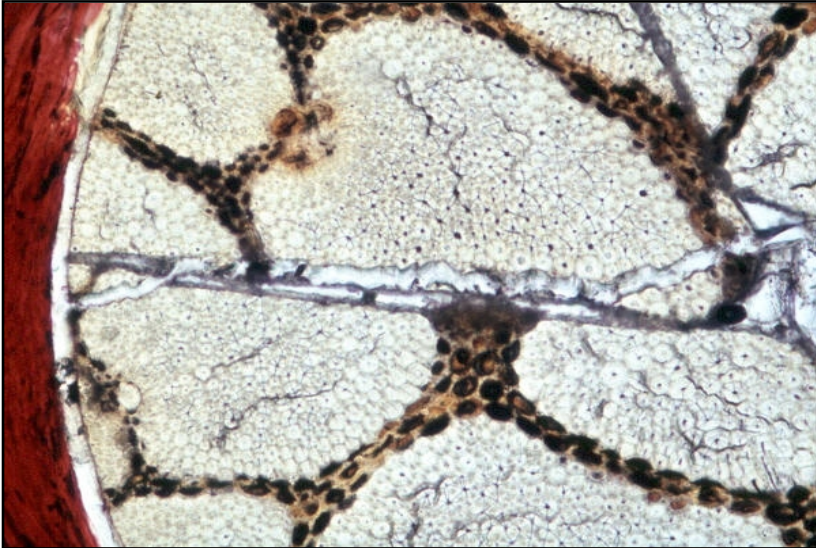
Fig. 49
 Long side of picture: 0.84 mm (0.033 in)
 Photo taken from the left side of Fig. 48, stronger magnification. The break went partly through bamboo (vascular bundles, or "powerfibers"), partly along the initial glue line, continued through the center of the rod (cf. Fig. 48) and again through and along borders of vascular bundles, through parenchyma cells.

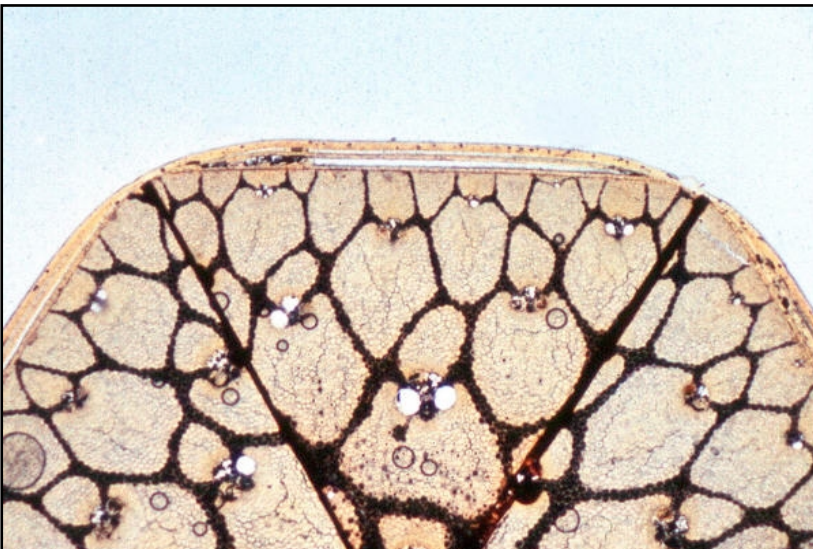
Fig. 50
 Long side of picture: 6.6 mm (0.26 in)
 Cross section of a hand planed rod. Flats are scraped/sanded flat, corners rounded. Resorcinol glue. The rod is dip-varnished three times, using an alkyd-type varnish containing polyurethane, (information given from the maker). The layers have separated, best seen at top flat. Possibly the prescribed open-time of the varnish (waiting-time between two successive coats) had been exceeded.

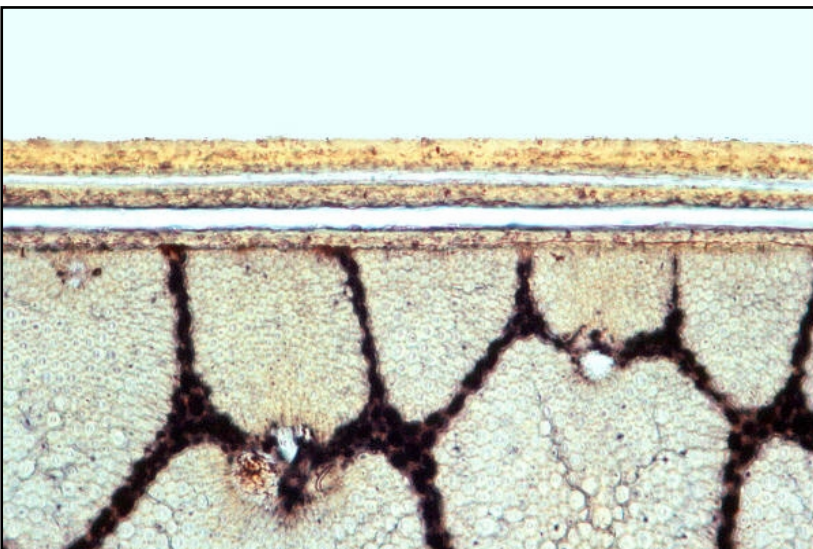
Fig. 51
 Long side of picture: 0.8 mm (0.031 in)
 A closer look. The first layer of varnish adheres to the rod (bamboo), but not the successive two. From top to bottom, I have measured:

Total: 0.115 mm = 0.00451 inches combined varnish+air in the middle of the flat. Three layers of varnish alone: 0.085 mm = 0.00334 in.
