THE NORFOLK RIVERS TRUST
RESTORING NORFOLK'S RIVERS

THE RIVER INGOL

A WATER FRAMEWORK DIRECTIVE LOCAL CATCHMENT PLAN

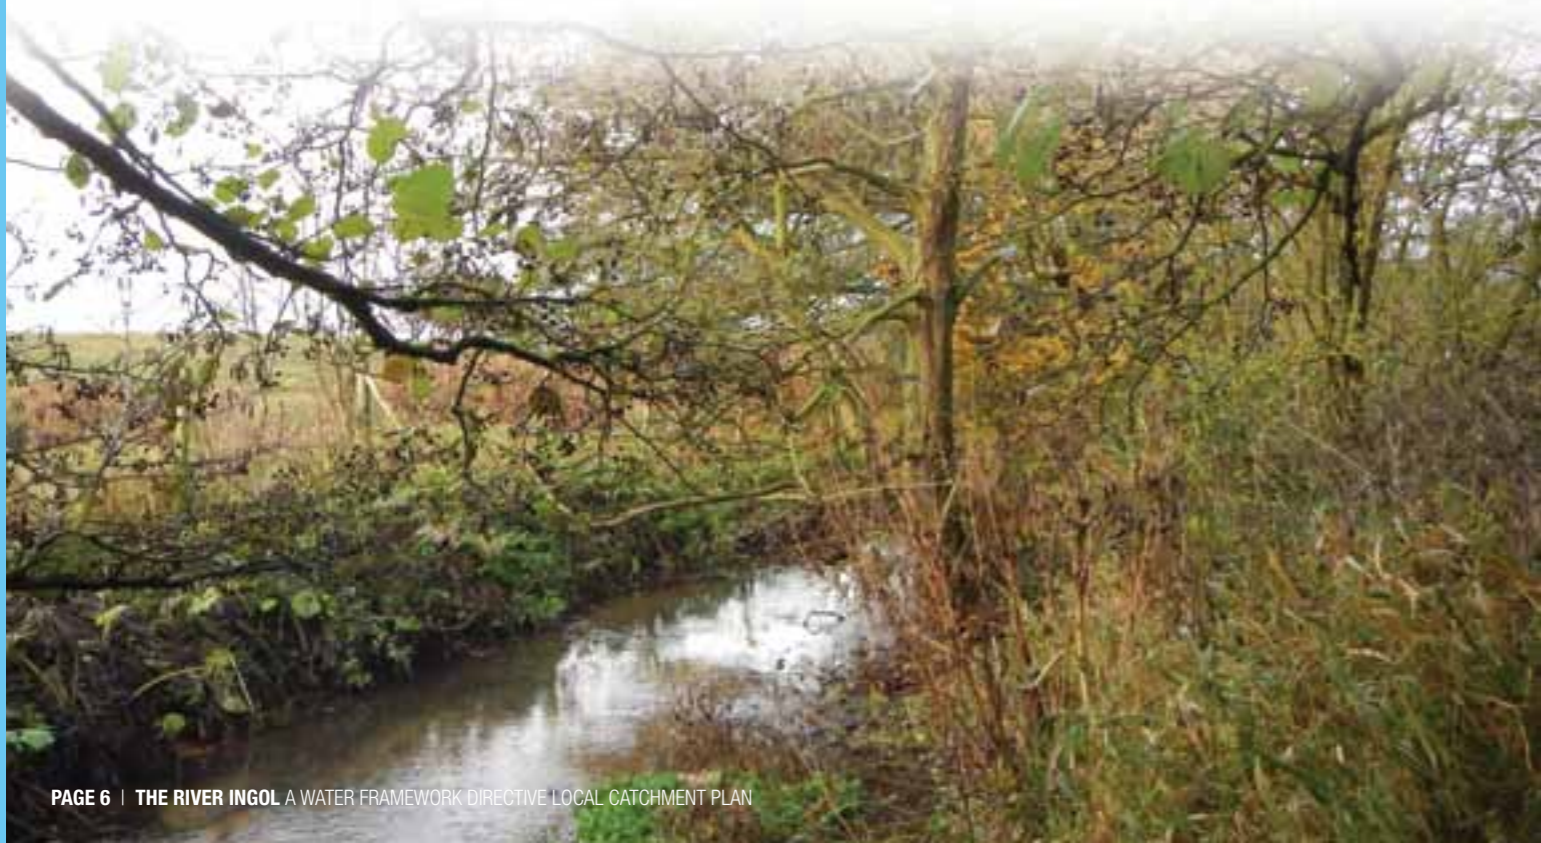
Map 1. Approximate locations of possible restoration options on the river Ingol

Summary of possible restoration options on the river Ingol. These proposals will greatly enhance the water quality and wildlife value of the river. It is stressed that these are subject to landowner consent and are only outline ideas at this stage.

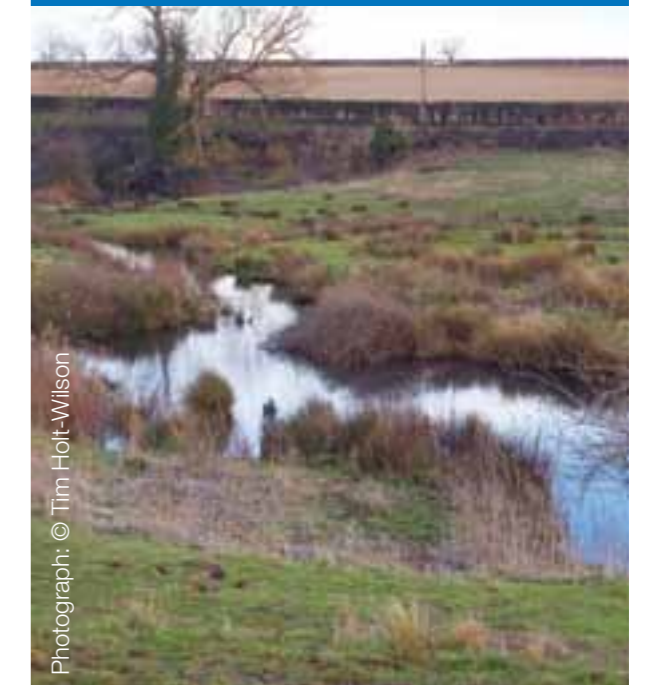
A spring fed pond and wet flushes at Shernborne Hall Meadows. Permeable Lower Chalk bedrock underlies the fields in the background, which are developed on permeable chalky soils.

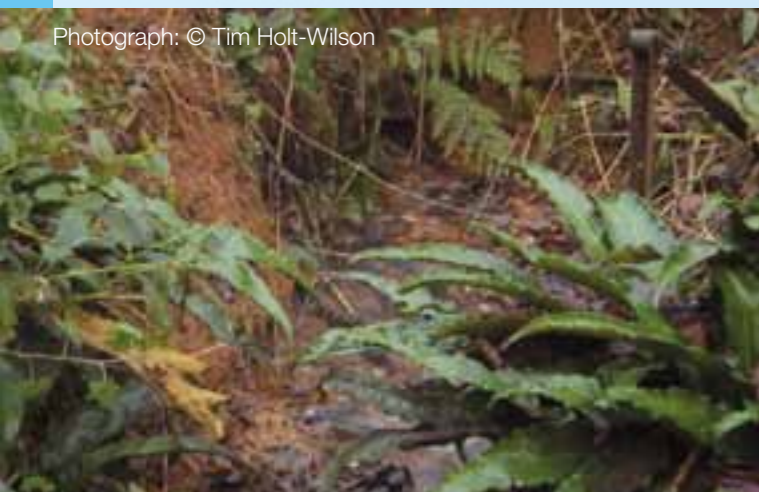
Groundwater emerging from an outcrop of ochre-coloured Carstone in the valley side between Sherborne and Ingoldisthorpe.

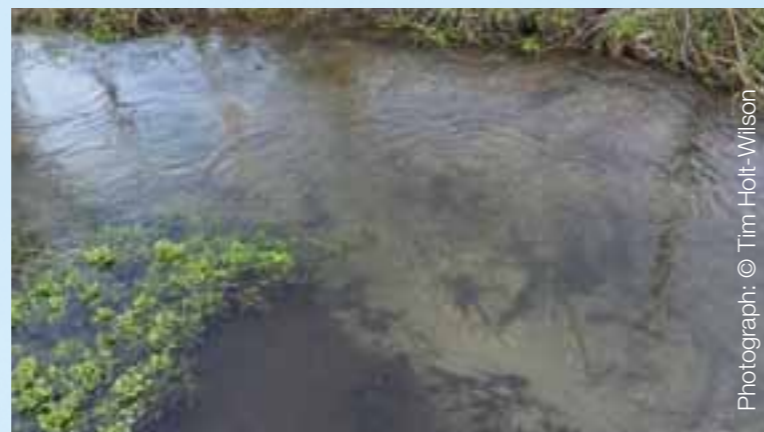
A dissected spread of sandy river terrace or slope-derived deposits occupies the valley floor near St Thomas's Bridge; these supply the river bed with sands and gravels. In-stream vegetation includes watercress.

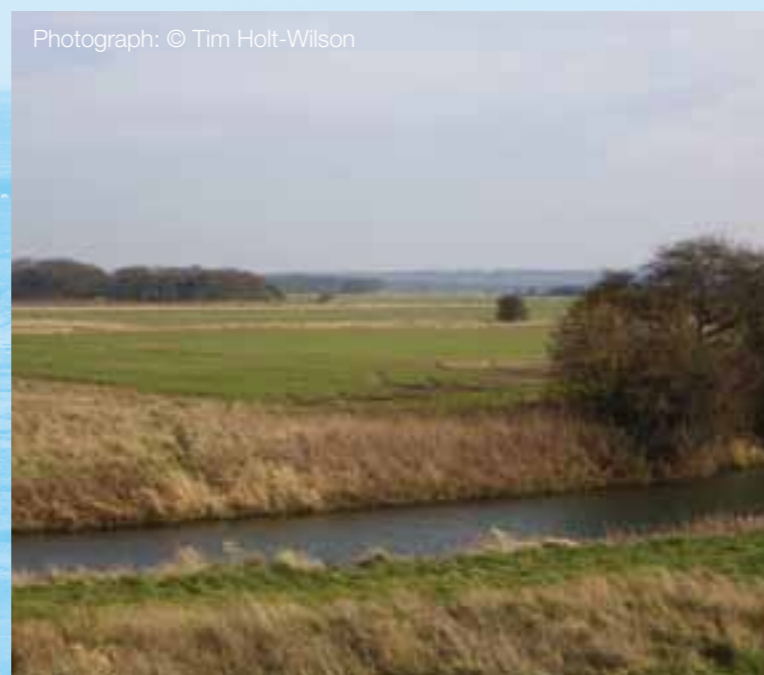
The River Ingol flows through a landscape of former saltmarshes near Shepherd's Port. The land here was reclaimed in 1878.

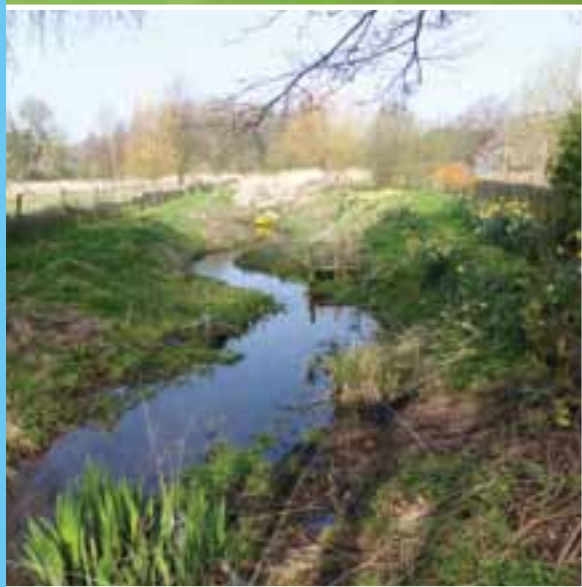
Ten years ago this section of stream was absolutely straight and featureless. Growth of plants and sediment deposition around dead plants has caused a return to a more natural meandering form, which in turn has started to cause pools and riffles to develop. (Photo: Oly van Biervliet, Fox's Beck, Norfolk. With thanks to John Dowland)

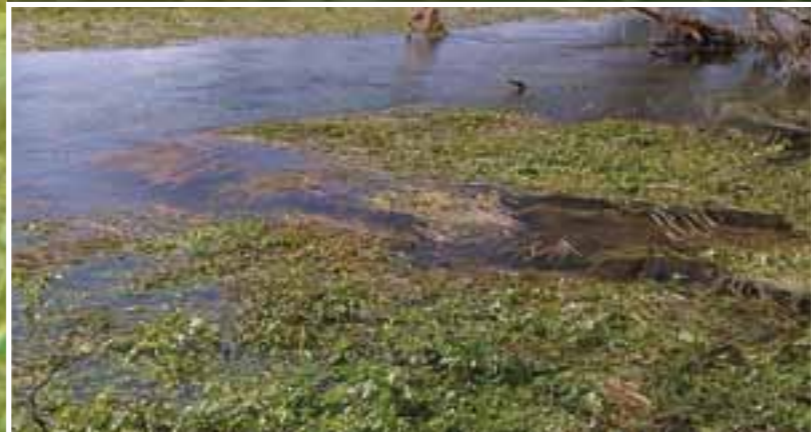
Water plants cause flow variation which also encourages sediment storage and scour.

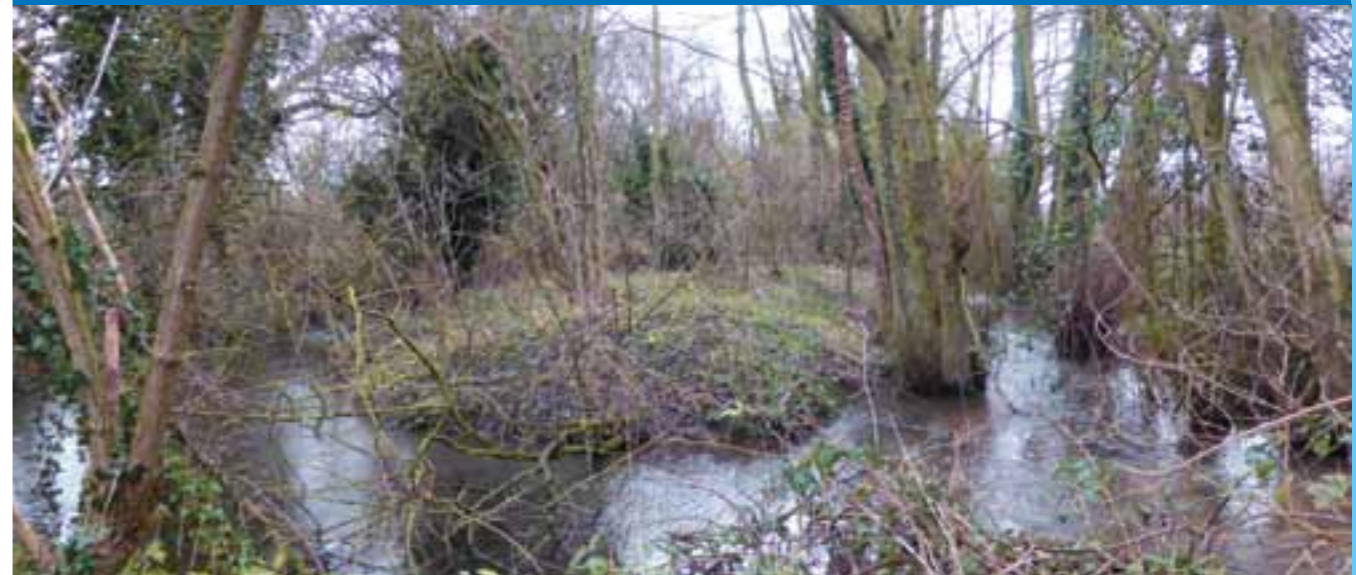
Photo 2. A representative stretch of the upper Ingol.

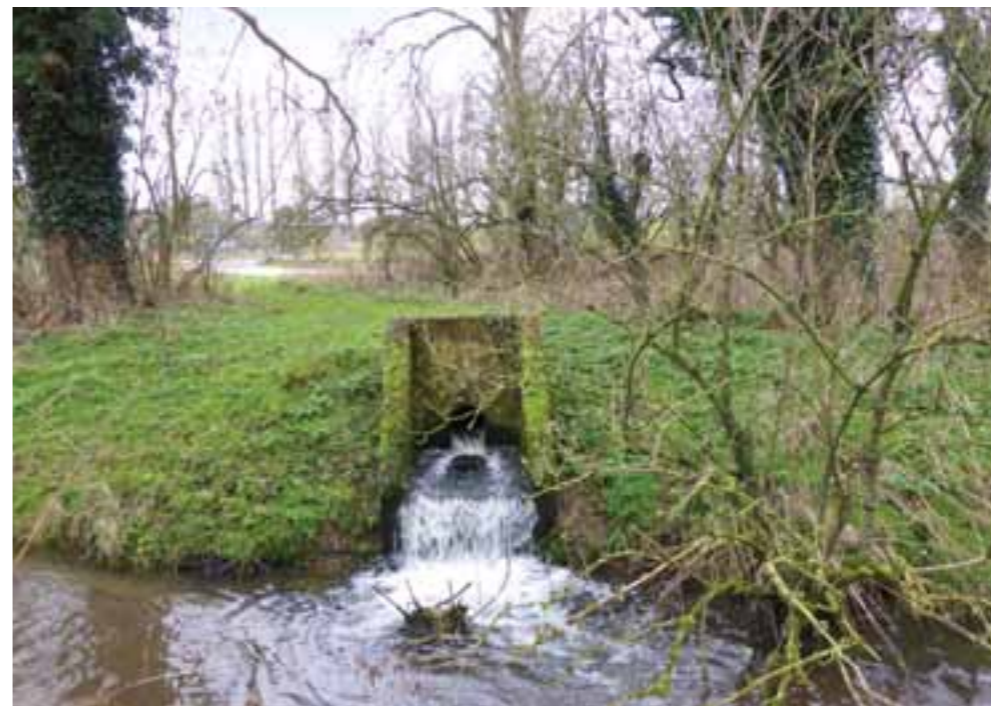
Photo 4. Outfall of Ingoldisthorpe Sewage Treatment Works.

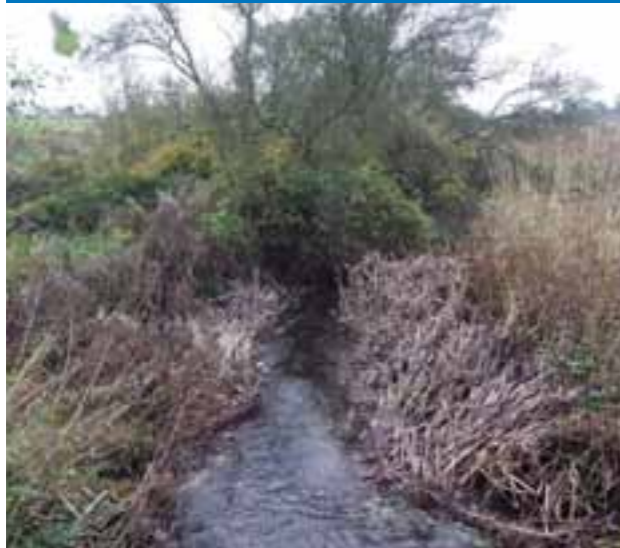
Photo 6. The substrate of the middle section of the Ingol is sandy, with few patches of the gravels which are normally characteristic of chalk streams.

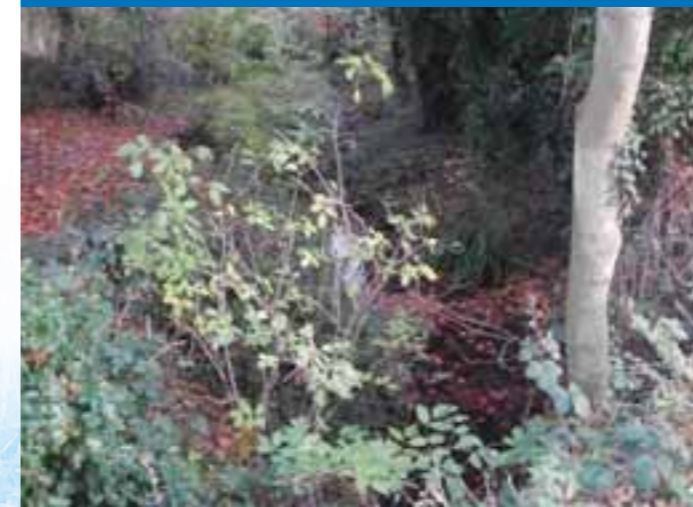
Photo 9. Mill bypass channel has almost no water in it except for during extremely wet conditions.

collapsing banks, which are of concern to residents, and muddy substrate with an accumulation of rubbish probably thrown in from the road bridge over time. The mill is a barrier to fish passage, and no fish apart from eels (which can traverse dry ground) are found upstream of this point. Below the mill, the River Ingol flows more rapidly once more through a section shaded by tree cover. The river channel just above the A149 road bridge provides some of the most important fish habitat in the lower river with dace (*Leuciscus leuciscus*) in particular depending on this section for spawning.

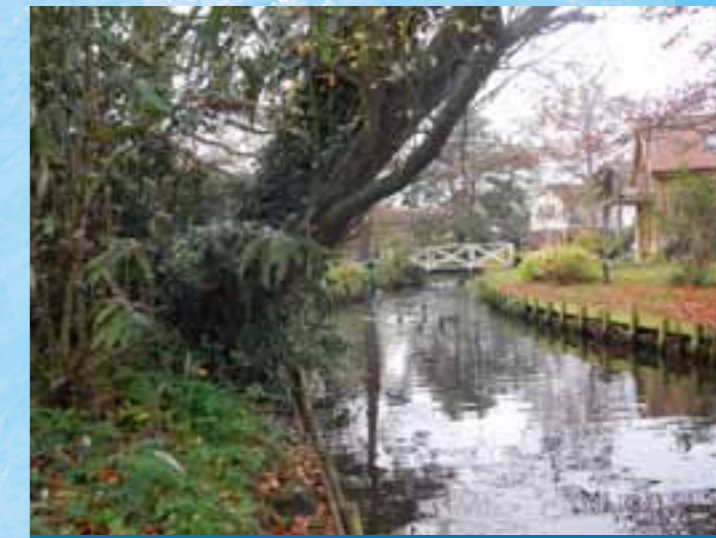
Photo 10. Snettisham Mill Pond.

At the upstream end of this section, the river flows past Ingoldisthorpe through grazed grassland and some arable. The river is sheathed in a buffer of varied vegetation including tree cover alternating with abundant growth of scrubby vegetation and wetland plants. The nature of the stream changes when it crosses the Lynn Road in Snettisham, where it enters the mill pond of Snettisham Watermill and is embanked with a footpath on one side and gardens on the other (Photo 10). The mill pond has

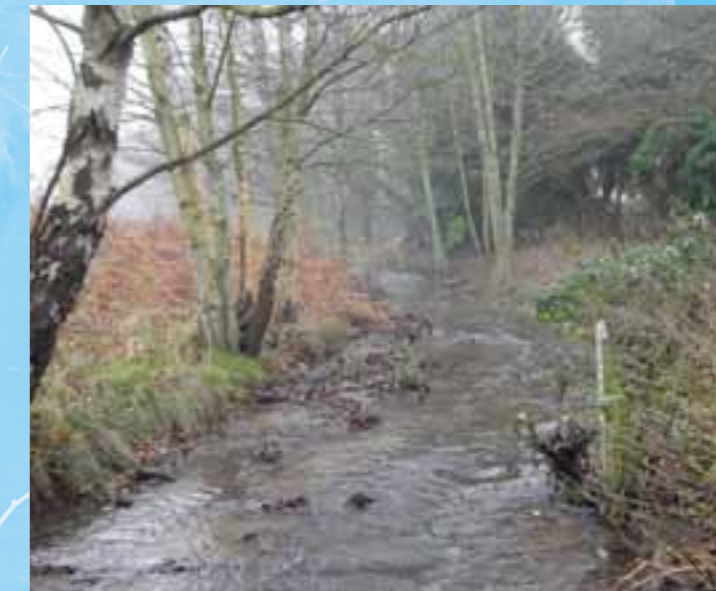
Photo 12. Ingol just above A149 road bridge.

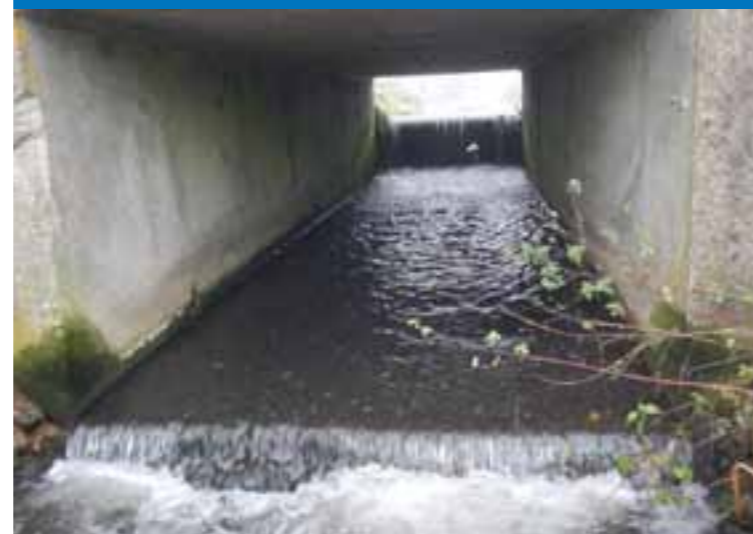
Photo 18. Sluice at tidal outlet.

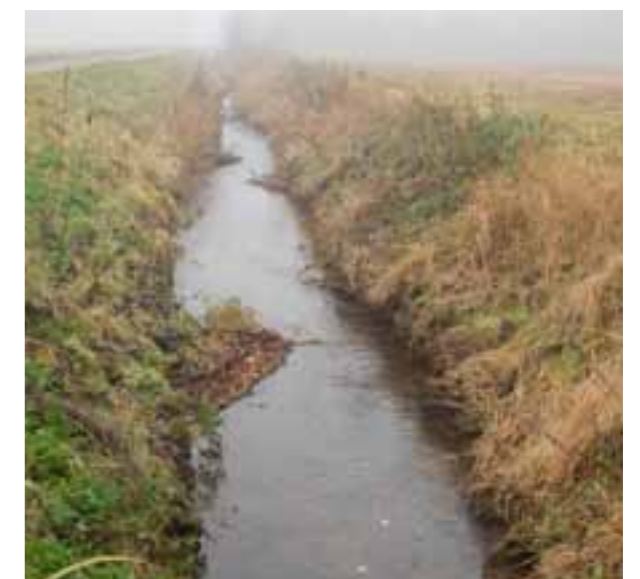
Above the A149 road bridge, the river has some sinuosity and approximates its natural flow path. Below the road, the river is straightened, cut deep below ground level and embanked in several places. A lack of meandering channel, and few trees to provide woody debris means that there is very little habitat variation, and no chance of natural recovery.

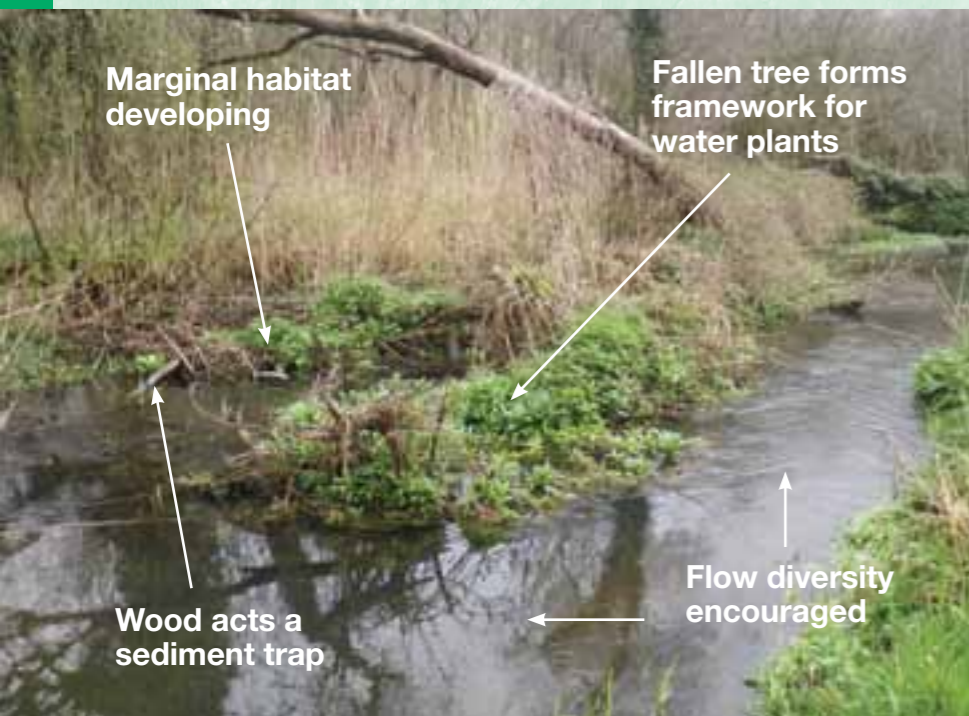
Growing trees have changed this former straightened drainage channel into a river with a more natural structure and in-stream islands (anastomosing channel).

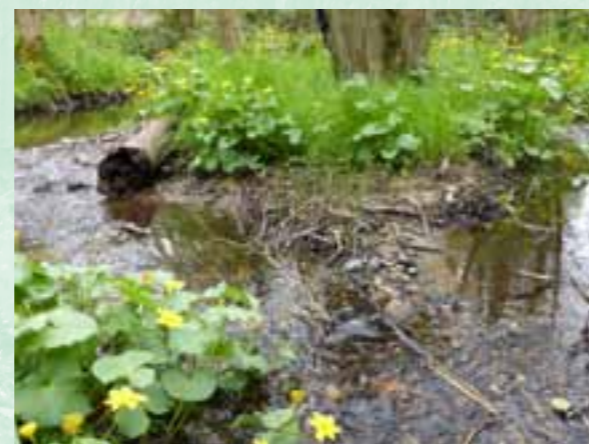
Tree acts as a hard point and has caused a meander to develop.

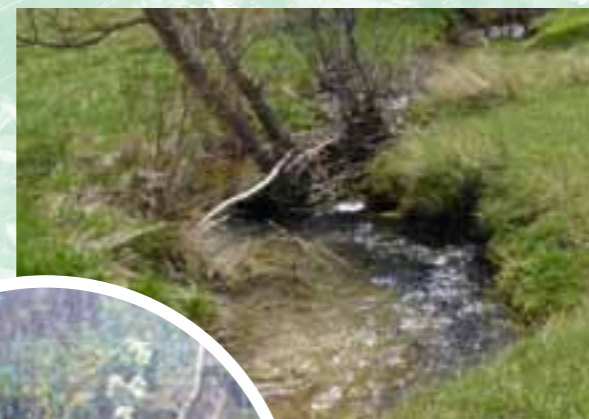
Natural tree fall has several benefits for habitat creation, channel structure and sediment modulation.

Tree acts as a hard point and has caused the development of a pool. Submerged tree roots are also excellent habitat for brown trout.

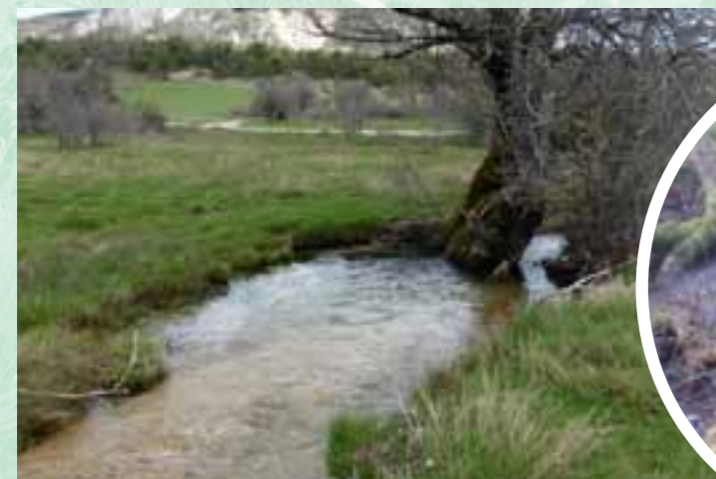
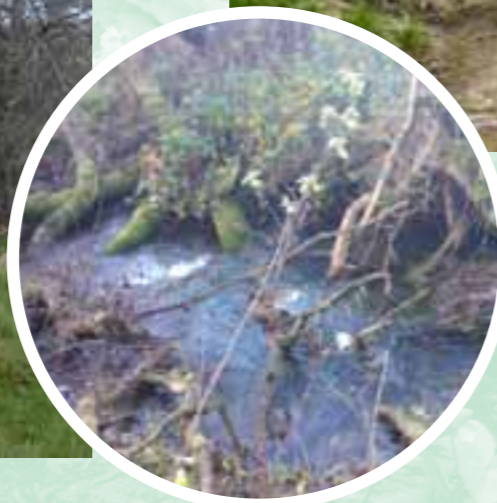
Natural tree fall has caused a great range of microhabitats and greatly increased in-stream surface area for a diversity of river invertebrates.

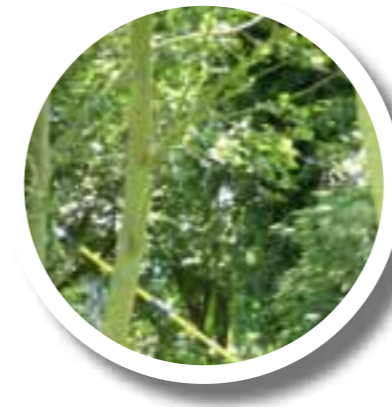
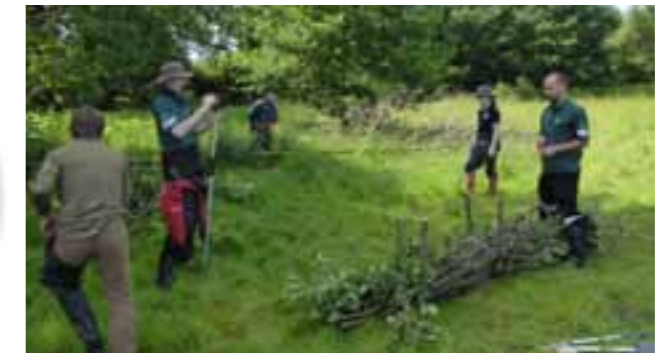
Construction of alder faggots

In this pilot project Norfolk Rivers Trust worked in partnership with the Environment Agency and were helped by volunteers to enhance the habitat of the Ingol at Snettisham. The first stage of this project was undertaken in June 2014, and we have gained permission from the Environment Agency to continue this project in the Autumn.

There were 2 objectives of this project. The first was to enhance the wildlife value for groups such as fish, aquatic birds and insects. A family of ducks has already been seen sheltering in the extra cover! Dace spawning relies on this stretch of the river and will also be enhanced by this project. The second aspect of the project was to use alder faggots (as seen below) to protect banks which were eroding due to unnatural causes (variously unnaturally high flows and water plant removal from banks).

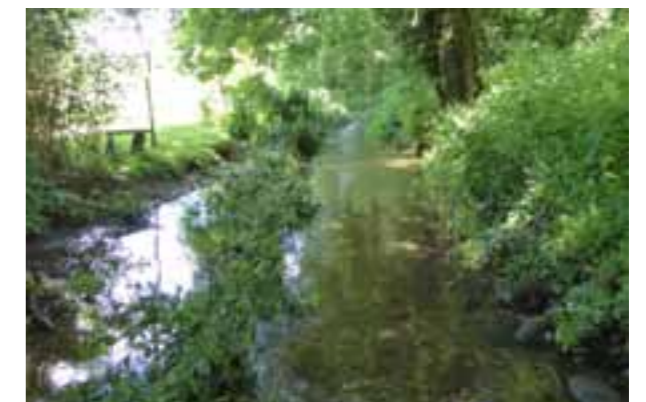
After project – protected banks, flow variation produced which will lead to increased marginal habitat

As seen in the Woody Habitat section, great benefits accrue from woody habitat. Perhaps the greatest of these is that woody habitat can trigger the re-stating of natural river recovery processes which were very much needed in this straightened section of river which had no pools and little flow variation previously to the project.

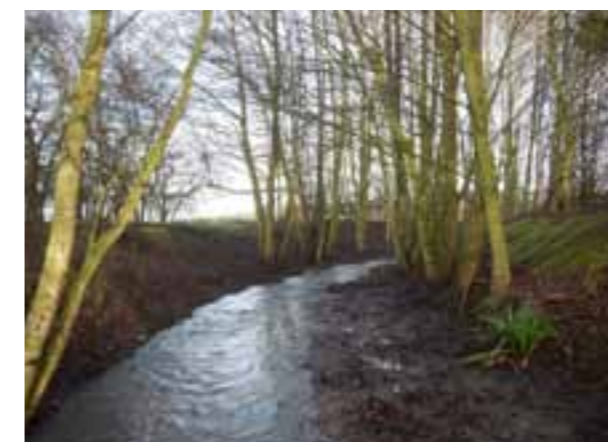
Before project

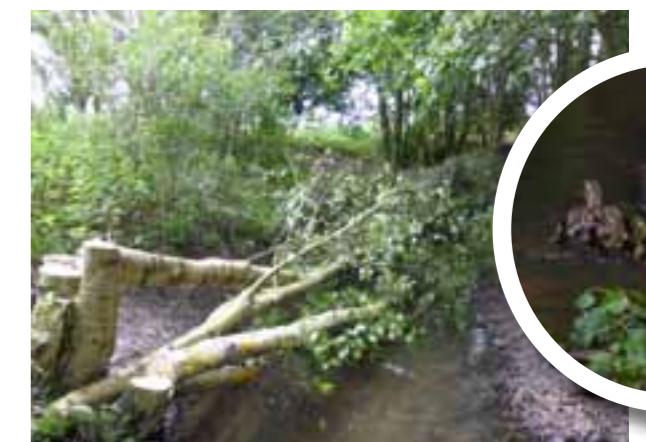
After project - "hinging" of live trees is a good way to ensure stability over time.

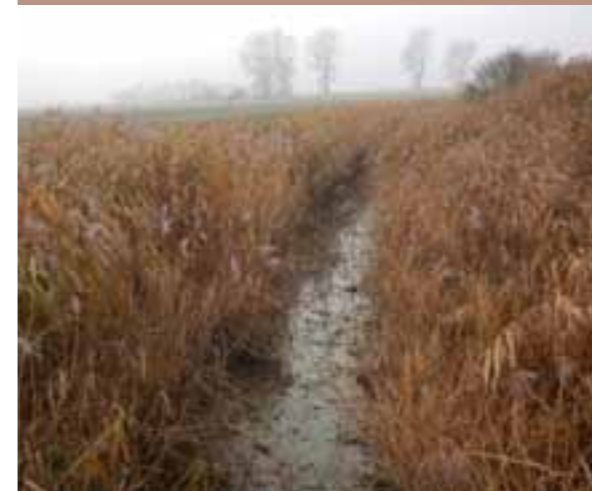
Figure 1. Images showing position of probable position of contemporary course of river is straightened channel. Historic course of the Ingol (from the first series of OS maps which were produced in the late 19th century; image courtesy of Norfolk County Council <http://www.historic-maps.norfolk.gov.uk/mapexplorer/>).

Another solution which might work with natural processes to reduce maintenance and enhance the ecosystem would be a reconnection to the historic channel which is shown in Photo 21. This could clearly have implications for stakeholders and would need to be discussed in detail to determine whether it was acceptable. The historic channel is largely still existing as can be seen in Figures 1 and 2. However, there is a risk that the historic channel would be more exposed to diffuse agricultural pollution because, unlike the perched current channel which flows above the landscape like an aqueduct, the historic channel drains the surrounding farmland. Moreover, the historic channel has very little gradient and was formed under estuarine conditions which are quite different to how the river currently functions due to the one-way sluice at the bottom of the river.

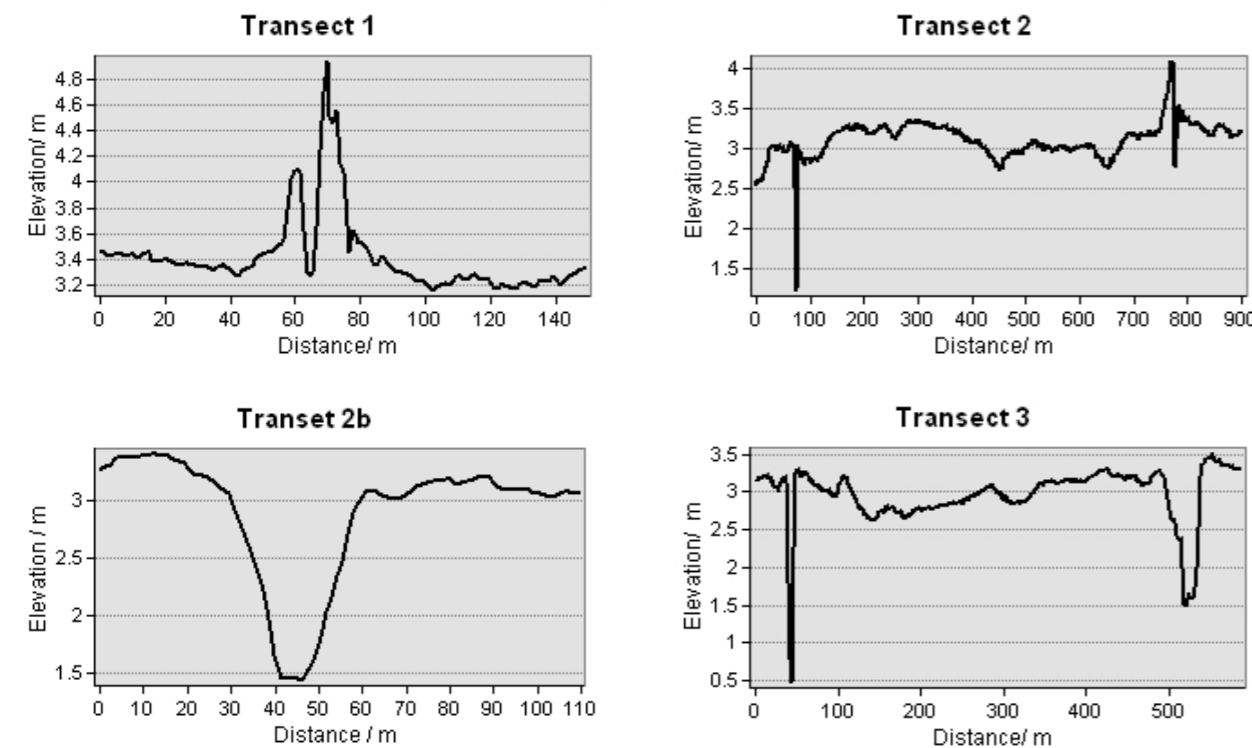
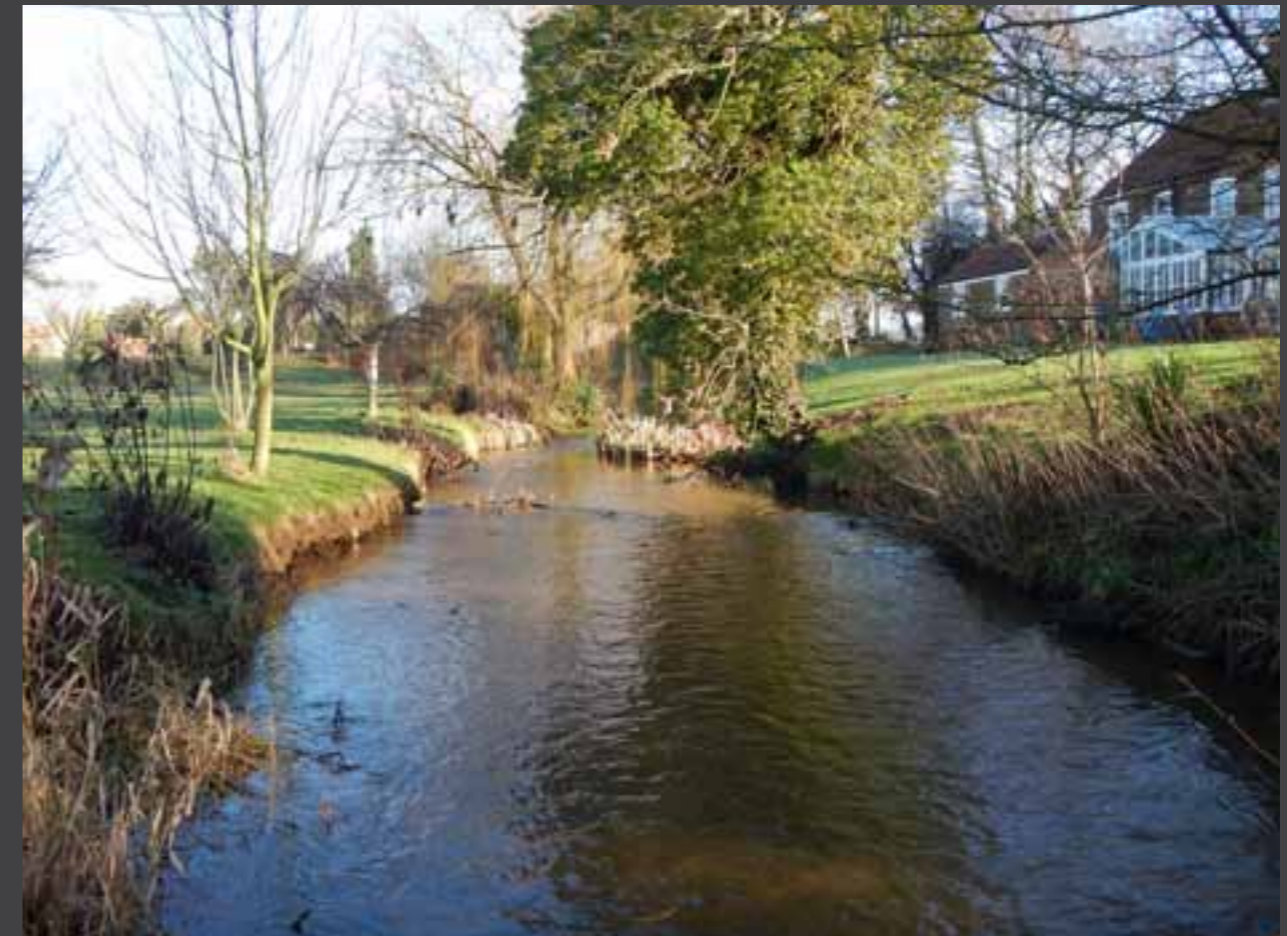
Elevation summary:
 Current channel (transect 1) - 3.3m
 Historic channel (transect 2) - 1.2m

Figure 2. Elevation analysis of current and historic channel of lower Ingol. Green shows higher ground and darker blue shows progressively lower areas. Transects are taken from left to right looking downstream as is standard practice. In summary, the historic channel has a lower channel bed, less steep banks and has a greater capacity to carry water. In its upstream reaches, the current channel is actually perched high in the landscape and kept from flooding by earth banks as shown in Transect 1. Lower level drains pass underneath the river, so it acts almost like to an aqueduct. Much of the historic channel is much wider and lower as shown in Transect 2b. This means that its capacity to carry unusually high flows would be greater. With reference to water quality, it should be noted that the historic channel probably receives more agricultural diffuse pollution than the current channel because the perched current channel does not drain much of the surrounding farmland.
