Ecological Engineering

2014

## 10 years after the largest river restoration project in Northern Europe: Hydromorphological changes on multiple scales in River Skjern

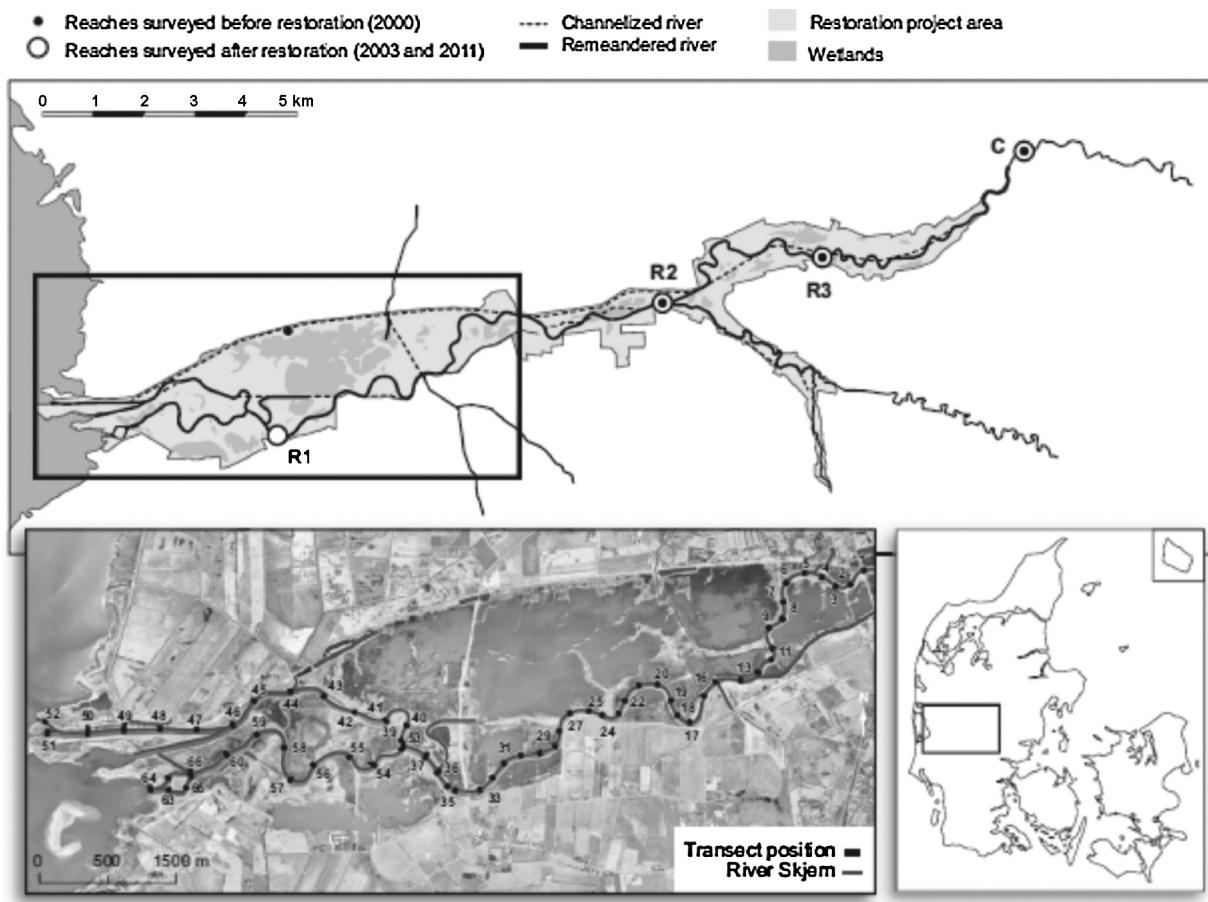
**Fig. 1.** Map showing the study area, study sites for in-stream habitats (R1, R2, R3 and C), and the position of transects used to measure channel stability (1–66).

the restored River Skjern (R1, R2, R3, Fig. 1) based on a comparison with a 300 m long control reach (C, Fig. 1) located upstream of the restoration area (Pedersen et al., 2007b). All four reaches was sampled once before the restoration (2000) and again immediately after the restoration (2003; Pedersen et al., 2007b). After the restoration the location of R2, R3 and C remained at the same location as pre-restoration, while, as a result of the restoration and filling-up of major parts of the channelized river, reach R1 was in 2003 moved from the northern drainage channel to the newly excavated river channel located app. 2 km south (Fig. 1). For this study, we re-sampled these four reaches in 2011 providing data for a long-term evaluation (app. 10 years) of the restoration on in-stream habitats. Identical surveying methods were used in all three years to allow for cross-year comparison, for a detailed description of the methodology, see Pedersen et al. (2007b). In brief, six transects were placed equally spaced along each of the four reaches and each transect was divided into 1 m × 1 m quadrats across the entire width. A GPS was used to exactly identify location of each transect. At each quadrat, depth (to nearest cm), current velocity (at 10 cm above the stream bed), dominating substrates (using seven categories according to the Wentworth-scale (Wentworth, 1922) and macrophyte coverage (%) was recorded. Recording of in-stream variables was done in September 2000, August 2003 and September 2011 and it was aimed to collect data at similar discharge levels. However, the summer 2003 was drier than normal and mean monthly discharge for August 2003 was 12.7 m<sup>3</sup>/s, while mean monthly discharge for September 2000 and September 2011 was 19.4 m<sup>3</sup>/s and 19.1 m<sup>3</sup>/s, respectively.

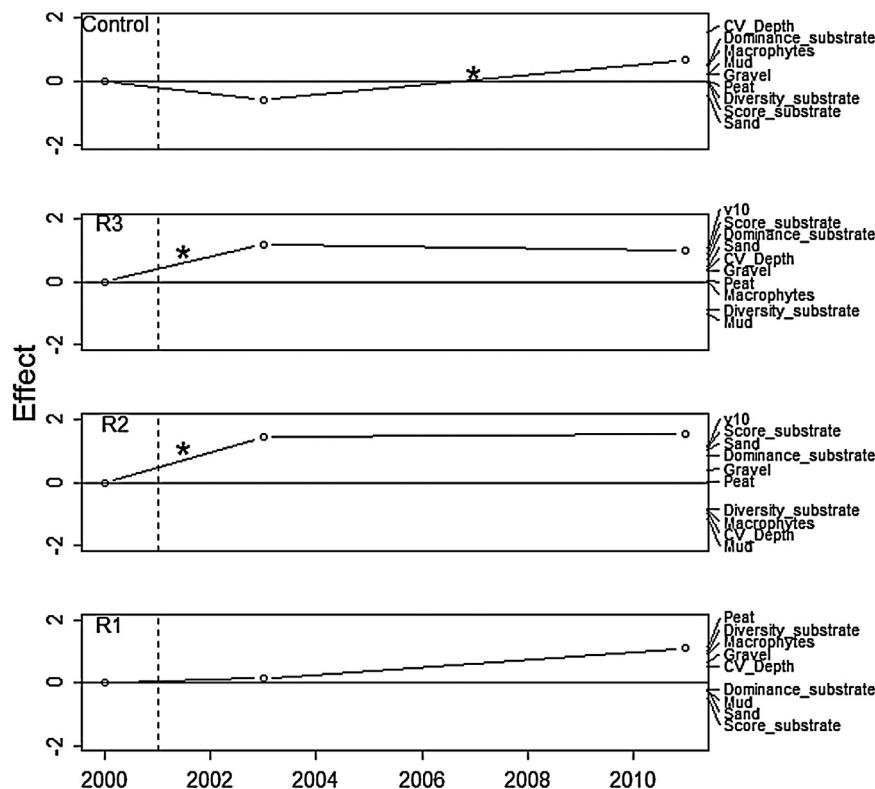
**Fig. 2.** Principal response curve analyses of the development of in-stream habitat parameters in four different sites of the vegetated zone (depths 0–130 cm) of River Skjern: control upstream the restored reaches (R1, R2, R3).

When comparing RDA scores, we found no significant overall change to in-stream habitats in the vegetated zone of the control reach from 2000 to 2003 ( $P=0.493$ ; Fig. 2) however, from 2003 to 2011 there was a significant change ( $P=0.0008$ ; Fig. 2). This change was primarily caused by an increase in CV Depth, indicating more heterogeneous stream profiles with larger variation in depth in

2011 compared to 2003. In the vegetated zone of R3 and R2 the restoration resulted in a significant change to in-stream habitats ( $P=0.022$  and  $P=0.026$ , respectively). In this zone of R3, the restoration resulted in higher current velocities (v10), a coarser substrate (Score\_substrate) although still dominated by sand, a higher coverage of gravel, a reduction in coverage by mud and consequently a lower substrate diversity (Fig. 2). In the vegetated zone of R2, the restoration also resulted in increased current velocities (v10), a coarser substrate (Score\_substrate) although still dominated by sand, a relatively higher coverage of gravel, lower coverage of mud and a lower substrate diversity (Fig. 2). In addition, the analysis showed that the overall significant changes to in-stream habitats of the vegetated zone of R3 were also related to a reduction in macrophyte coverage (Fig. 2).

The observed changes to in-stream habitats in the vegetated zone of R3 and R2 were stable over time showing no change from 2003 to 2011 ( $P=0.906$  and  $P=0.722$ ; Fig. 2). The in-stream habitats of the vegetated zone in the most downstream reach (R1) was not significantly affected by the restoration as only very small changes occurred from 2000 to 2003 (Fig. 2). From 2003 to 2011 there was some development in in-stream habitats but these changes were not significant ( $P=0.897$ ; Fig. 2).

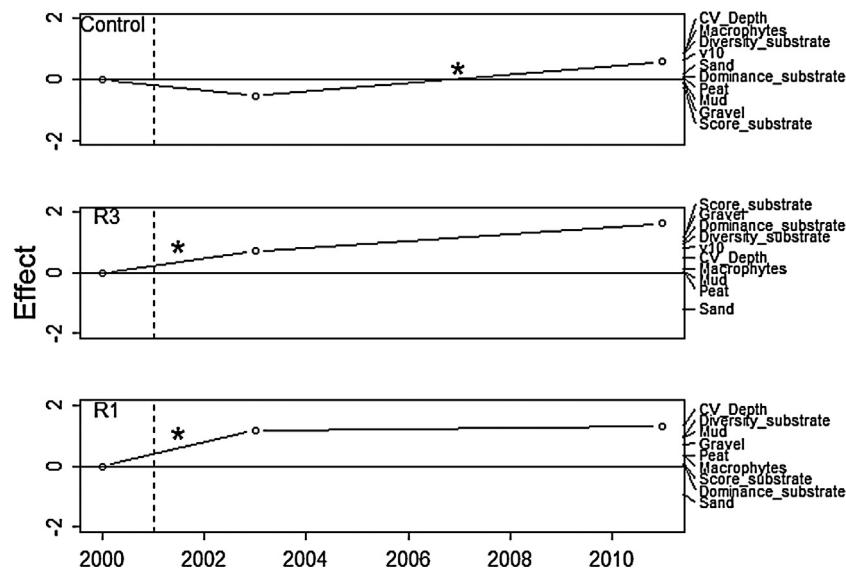
**Fig. 3.** Principal response curve analyses of the development of in-stream habitat parameters in four different sites of the current zone (depths >130 cm) of River Skjern: control upstream the restored reaches (R1, R2, R3).

Similar to the vegetated zone, we found no significant overall change to in-stream habitats in the main current zone of the control reach from 2000 to 2003 ( $P=0.460$ ; Fig. 3) and a small but significant change from 2003 to 2011 ( $P=0.011$ ; Fig. 3). This change was primarily driven by an increase in CV depth, macrophyte coverage and substrate diversity over the period (Fig. 3). In the main current zone of R3 and R1, the restoration resulted in a significant change to in-stream habitats ( $P=0.02$  and  $P=0.011$  respectively; Fig. 3), primarily caused by a higher variation in depth (CV depth) and higher coverage by gravel and consequently a higher substrate score, a higher substrate dominance score and a higher substrate diversity (Fig. 3). As found for the vegetated zone of R3 and R1, the observed changes to in-stream habitats following restoration, stayed stable over time in the main current zone of R3 and R1 ( $P=0.161$  and  $P=0.897$ , respectively; Fig. 3). No analysis was performed for R2 for the main current zone as only very few quadrates had depths over 130 cm.

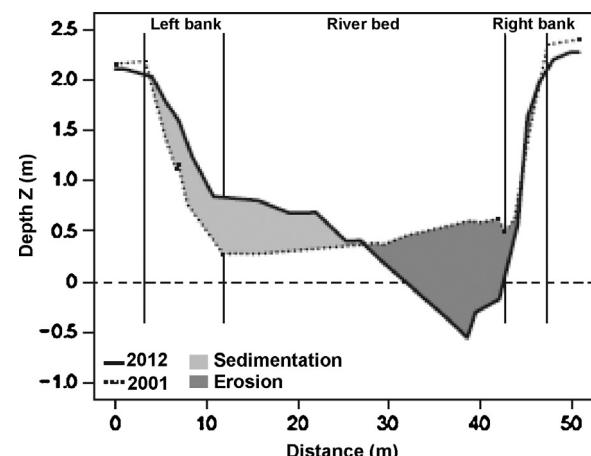
**Fig. 4.** Example of cross-sectional adjustments of the River Skjern between 2001 and 2012.

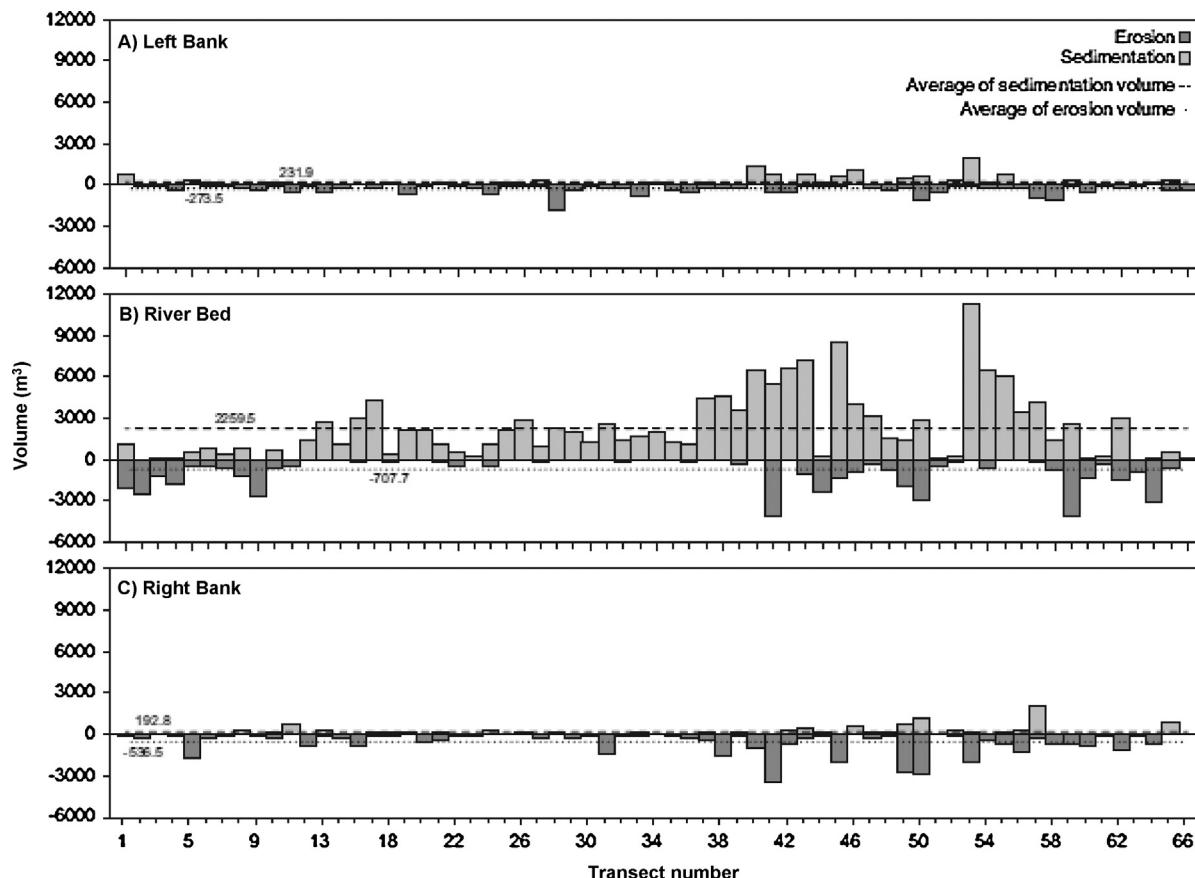
**Fig. 5.** Erosion and sedimentation in the lower 10 km of the restored River Skjern over a 10 year period (2001–2011).

The survey of 65 cross-sectional transects along the lower 10 km of River Skjern in 2001 and again in 2011 revealed marked morphological adjustments through erosion and sedimentation in the newly restored stream channel (Fig. 4). There was large variations in the morphological adjustments among transects during the 10 year period (Fig. 5). Average sedimentation and erosion volume ( $\pm SD$ ) measured at the left bank amounted to  $231 \pm 360 \text{ m}^3$  and  $274 \pm 325 \text{ m}^3$ , respectively, resulting in a net erosion of  $43 \text{ m}^3$  sediment. For the right bank, average sedimentation and erosion volume ( $\pm SD$ ) was  $192 \pm 340 \text{ m}^3$  and  $536 \pm 740 \text{ m}^3$ , respectively, yielding a net erosion of  $344 \text{ m}^3$  sediment. However, the most pronounced morphological changes were observed at the river bed. Average sedimentation ( $\pm SD$ ) for this part of the cross-sectional transects was  $2259 \pm 2333 \text{ m}^3$  sediment and average erosion ( $\pm SD$ ) was  $707 \pm 996 \text{ m}^3$  resulting in a net sedimentation of  $1552 \text{ m}^3$  sediment. Combined, the net balance resulted in a gain of  $1166 \text{ m}^3$

sediment over the 10 years in the restored river channel. The net result is a slightly wider and shallower river in 2011 than in 2001.

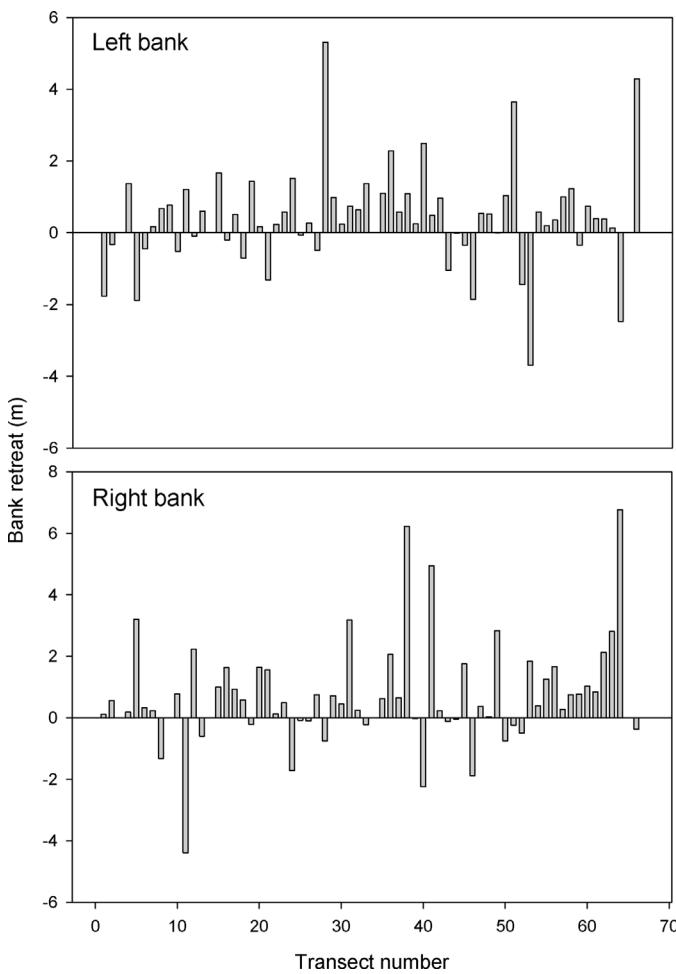
**Fig. 6.** Bank retreat in the lower 10 km of the restored River Skjern over a 10 year period.

There was large variation in bank retreat among transects (Fig. 6) and average bank retreat for left banks was 39 cm and 68 cm for right banks. This corresponds to a forecasted bank retreat of 3.9 m for left banks and 6.8 m for right banks over a 100 years period.
