Wood Canyon Emergent Wetland Project

**City of Aliso Viejo
12 Journey, Suite 100
Aliso Viejo, CA 92656**

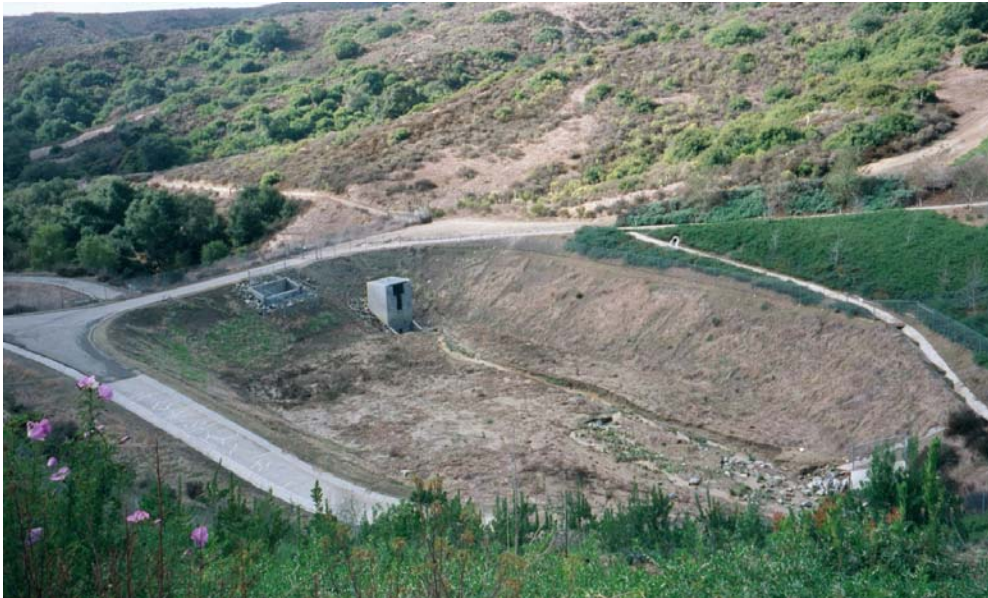
Figure 4: The Wood Canyon Creek at J02P08 – Pre-construction View

- All roads affected by construction activities have been repaired to its pre-project conditions.
- The construction of this wetland site was initiated in September 2005 and completed on December 2005. Figures 3, 4 provide views of the wetland site on pre-construction and current conditions.

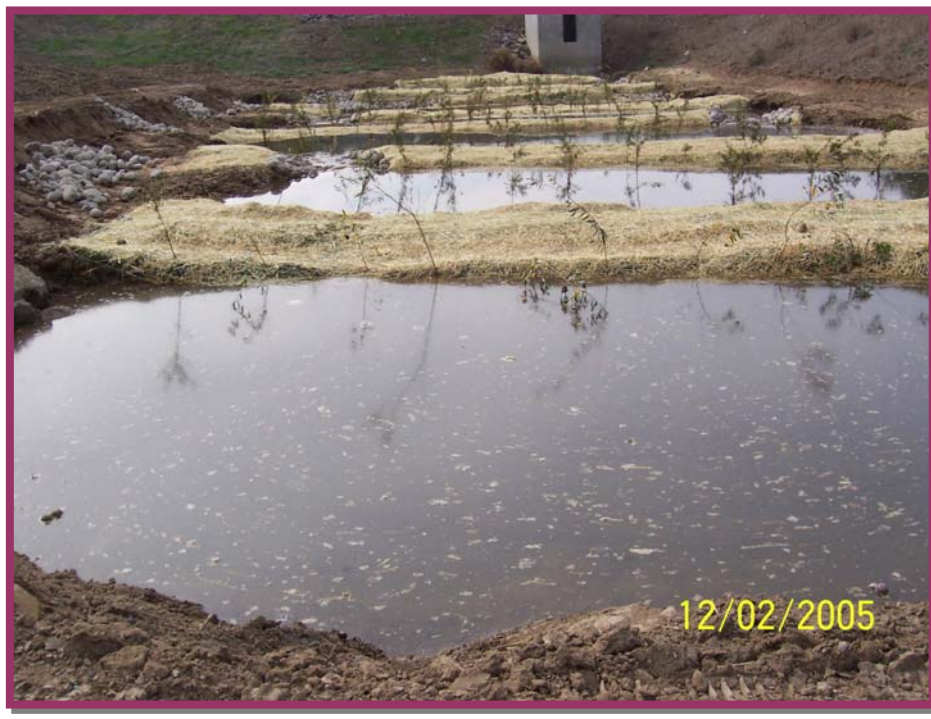
Figure 5: The Wood Canyon Creek at J02P08 – Post-construction View of the Ponds

- Six cascading ponds have been constructed below the flow line of the basin to ensure that the flood control function of the basin is not reduced. The flow is guided to meander and provide the wetland ponds sufficient retention time. Erosion control fabric and cobbles has been used on pond overflows (Figures 3a and 3b).

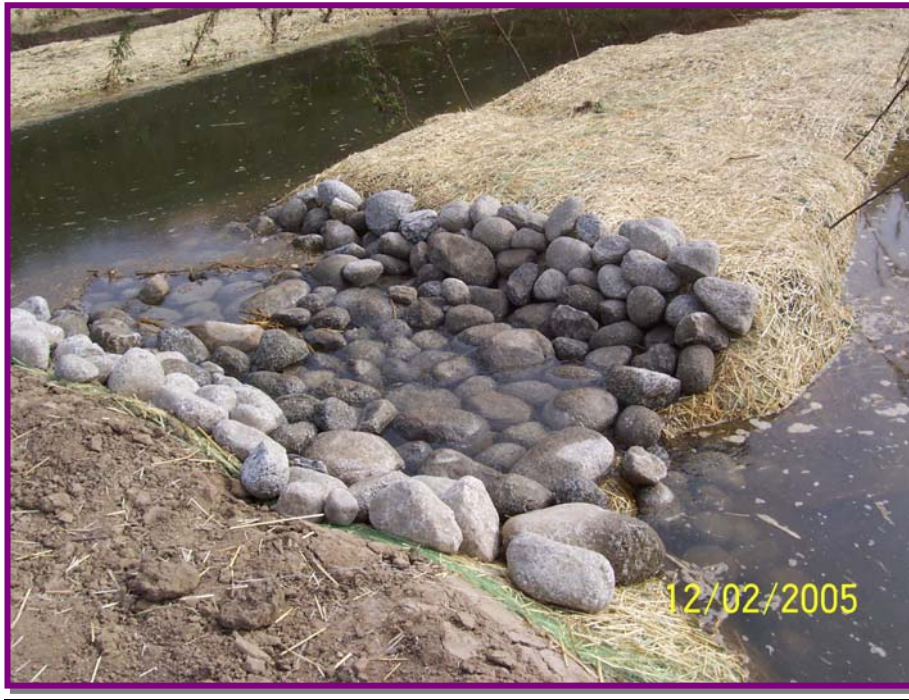
Figure 6: The Wood Canyon Creek at J02P08 – Wetland Inlet

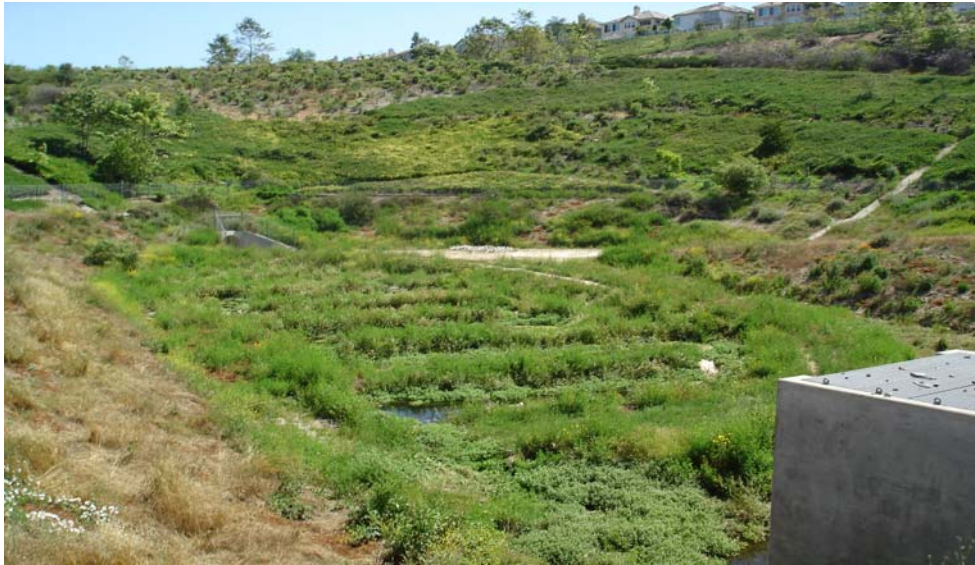
Figure 8: The Wood Canyon Creek at J02P08 – Wetland Site View – Summer 2006

- No erosion was observed at the site during and after the rainy season.
- Water was flowing through the wetland ponds at projected rates.
- All natural and planted vegetations were growing at normal rate (reproduction and density) compared to other natural habitats.
- Frogs, squirrels, birds, butterflies, mosquito fish and other wild species were present at the site.
- Educational brochures describing the importance of a wetlands ecosystem and habitat restoration were posted on a KIOSK at the wetland site. The KIOSK was designed and installed by Aliso Viejo's Boy Scout Troop 700.

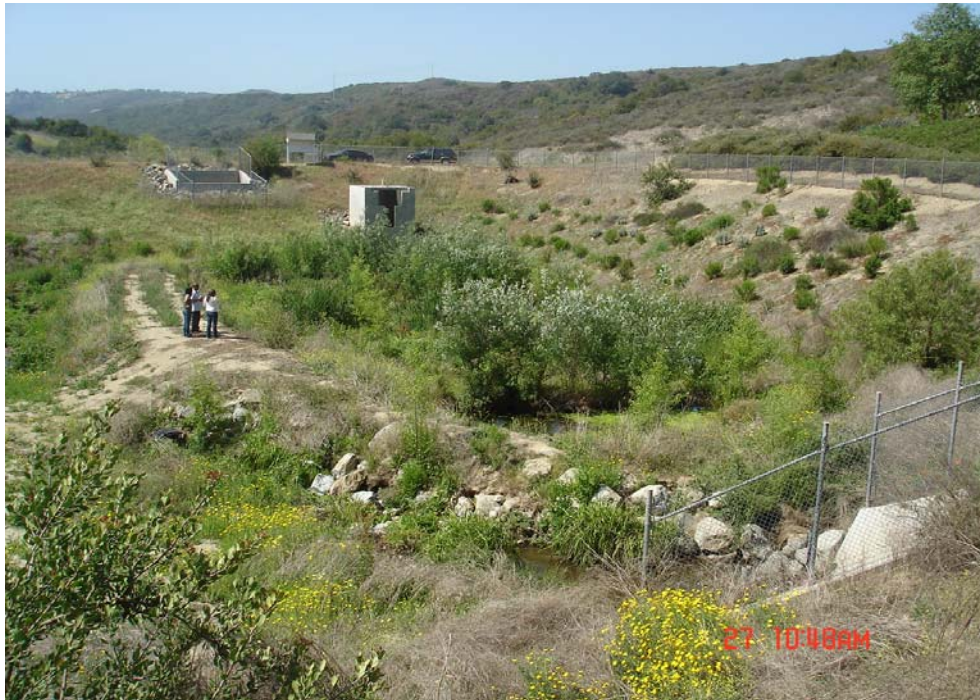
Figure 9: The Wood Canyon Creek at J02P08 – Wetland Site View – Summer 2007

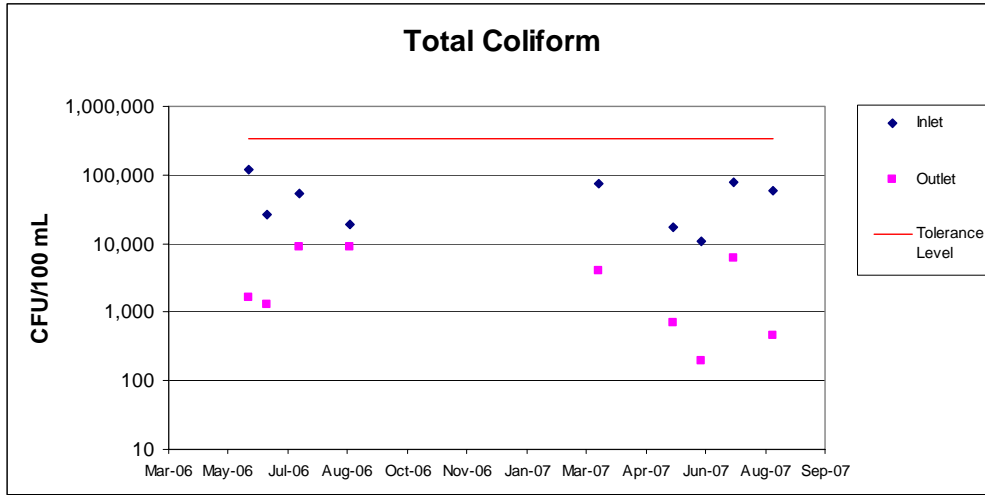
Figure 10: Concentration of Total Coliform

As illustrated in Table 1, concentration of indicator bacteria in water samples collected from the inlet to the wetland ponds ranged from 11,000 CFU/100 mL to 120,000 CFU/100mL for total coliform, 1,700 CFU/100 mL to 18,000 CFU/100 mL for fecal coliform, and 8,600 CFU/100 mL to 72,000 CFU/100 mL for Enterococcus bacteria. These levels are lower than the dry weather Tolerance Intervals reported by the County of Orange in 2006-07 Dry Weather Monitoring Reports.

As the water passed through the wetland ponds, the concentration of indicator bacteria reduced significantly; 1 to 2-logs reduction. The average concentration of the indicator bacteria in the water samples taken from the wetland outlet averaged at 2,583 CFU/100 mL for total coliform, and 419 for Enterococcus bacteria. The level of fecal coliform bacteria dropped to an average of 154 CFU/100 mL, which is lower than REC-1 water quality objective of 200 cfu/100mL. No significant changes in the level of other constituents were observed as the water passes through the wetland.

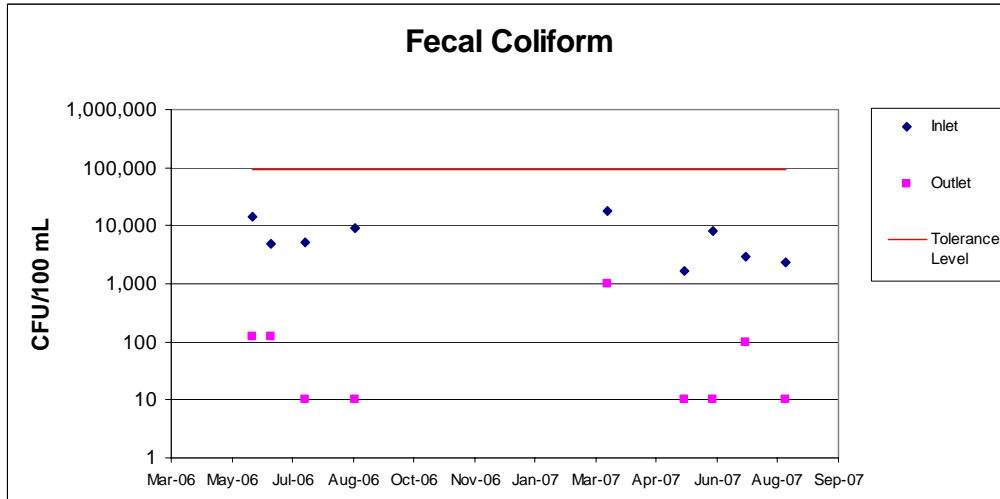
Figure 11: Concentration of Fecal Coliform

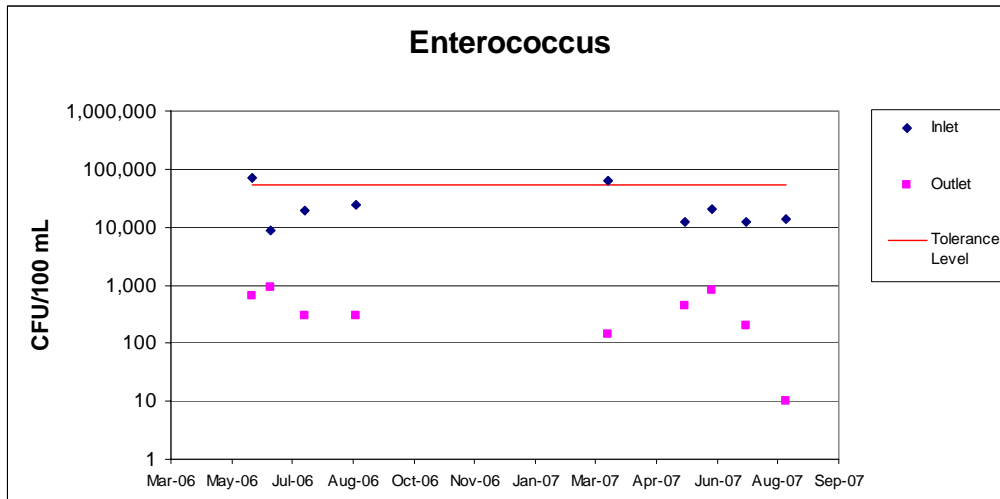
Figure 12. Concentration of Enterococcus Bacteria
