AIRBUS  
TECHNICAL  
DIGEST

NUMBER 7  
JANUARY 1987

## **CATHODE RAY TUBES THEIR EFFECTS ON MAINTENANCE PRACTICES**

## **A310-300 FUEL SYSTEM AND CENTRE OF GRAVITY CONTROL**

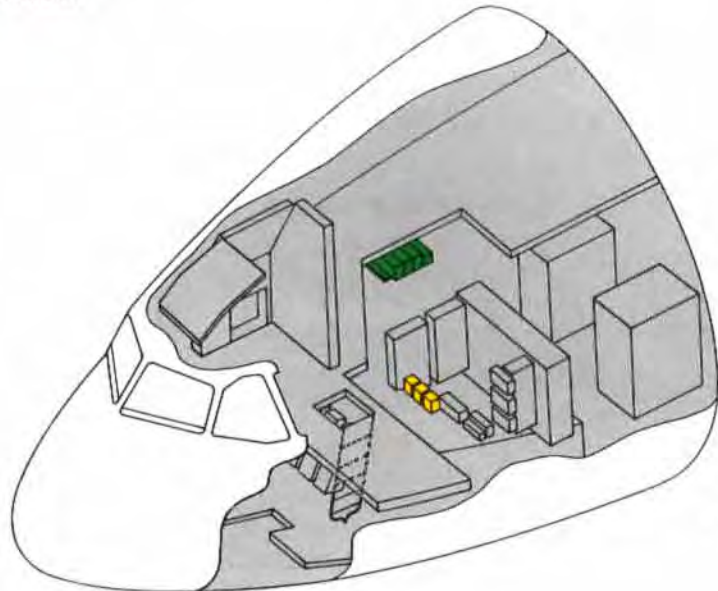
Batteries installation

- Batteries
- Contactor

Application	Technical characteristics
<b>Operation :</b> Forced ventilation	<b>Nominal voltage :</b> 24 volts
<b>Operating Temperature :</b> +50°C to -30°C (+122°F to -22°F)	<b>Rated capacity :</b> 25 Ah at 1 hour rate
<b>Internal resistance :</b> 0.011 Ohm	<b>Connector :</b> complying with MS3509 (ELCON BR 8.1, BAC 110 or equivalent)
<b>Max. instantaneous power :</b> (at +25°C) 15 kW (1150 A-13V)	<b>Electrolyte :</b> Solution of KOH specific gravity 1.24
	<b>Consumable volume of electrolyte :</b> 60 ml
	<b>Dimensions :</b> mm 629 x 150 x 221.5 (inches 24.76 x 5.90 x 8.72)
	<b>Weight :</b> 30 kg ±2% (66.1 lbs ±2%)

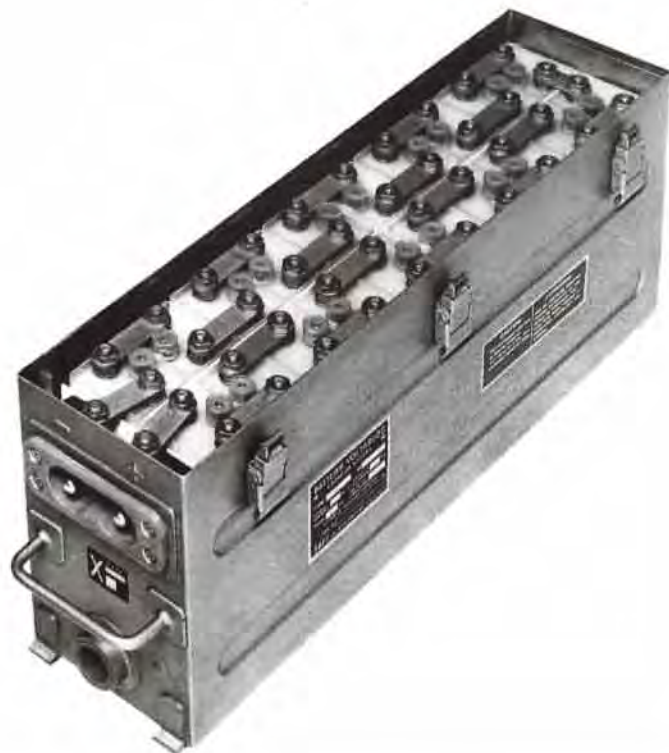
**Figure 2**

The battery of twenty VO 25 KA cells contained in a stainless steel box, is separated into two blocks of ten cells by a transverse divider integral with the box (figure 2). Each block of ten cells is placed in a leakproof insulating liner of silicone elastomer. In each of these blocks, inside the liner, the two rows of five cells are separated by one or more plastic spacers which provide sideways packing. Vertical retention is ensured by means of a piece moulded in silicone elastomer, cemented to the cover and carrying a number of bosses which press against the tops of the cells. Cell interconnection is obtained by rigid nickel-plated copper links and end cells are connected by rigid links to an electrical connector manufactured to MS3509. This connects to the aircraft bus. The casing is fitted with a removable cover retained by six latches, two lifting handles and one ventilation tube on each of the front and rear faces.

SAFT Battery P/N 2520

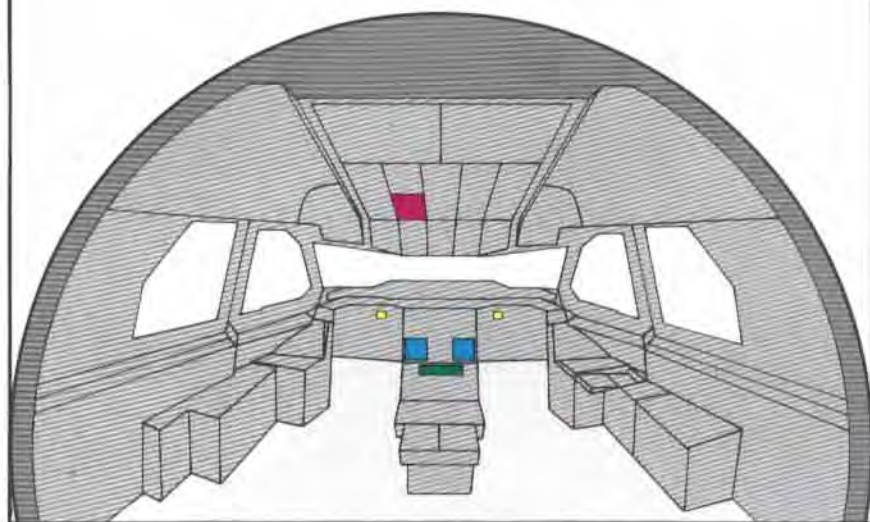
### A310 cockpit - Locations of battery controls and indicators

- Electrical power control
- R/L ECAM display
- Warn light display panel (pre mod)
- Master caution (post mod)

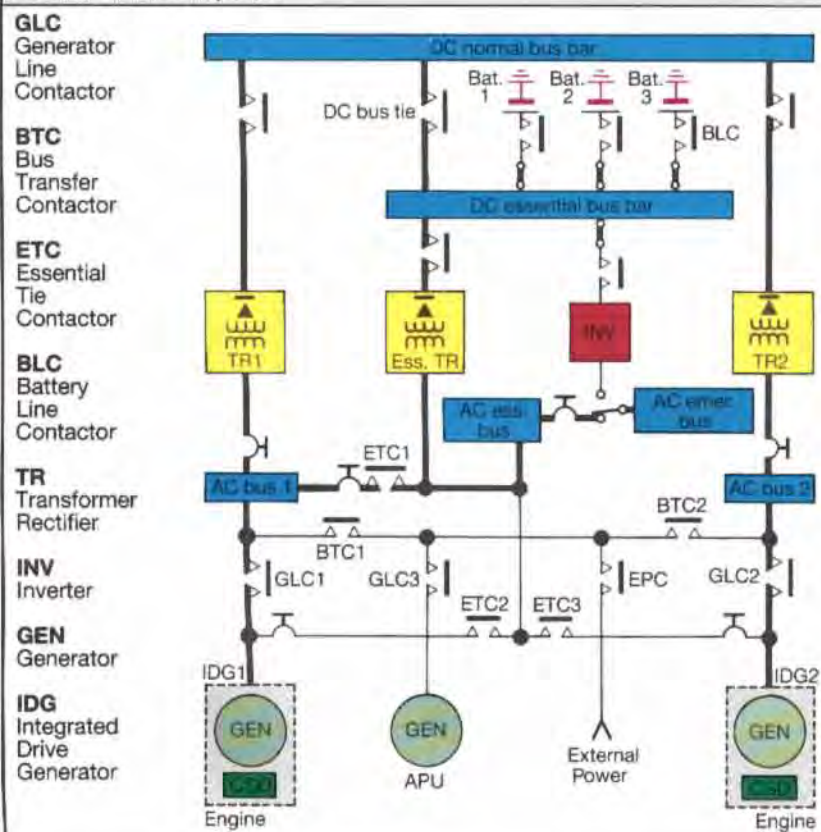
**Figure 3**

The batteries are connected to the aircraft's electrical system (network) shown in figure 3 for :

- starting of the auxiliary power unit (APU),
- supply of on-board DC services, on the ground before the on-board system is on normal supply, and when airborne, in case of fault or failure in the normal supply.

Aircraft electrical system

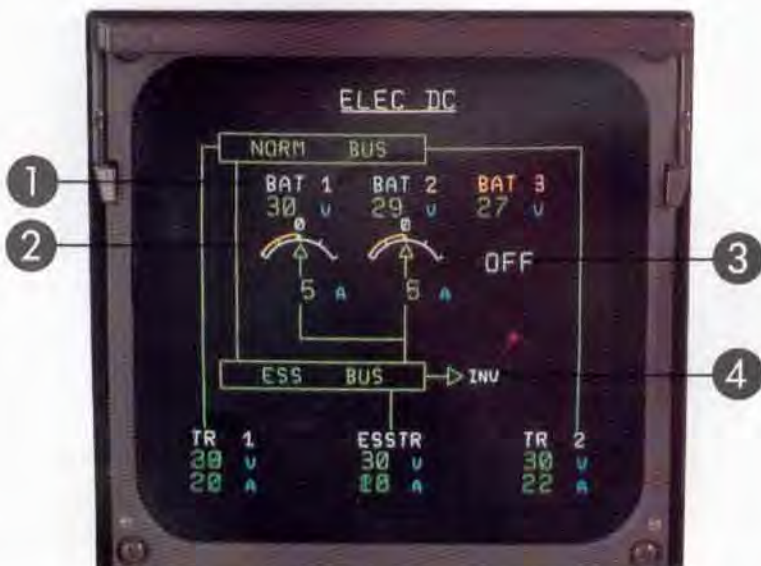
## 3 Battery current digital and analog indications

The indications are green but become amber when the current is  $\leq -5A$ .

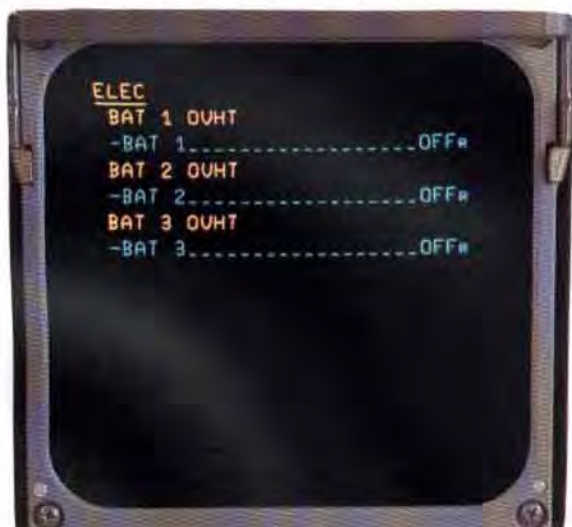
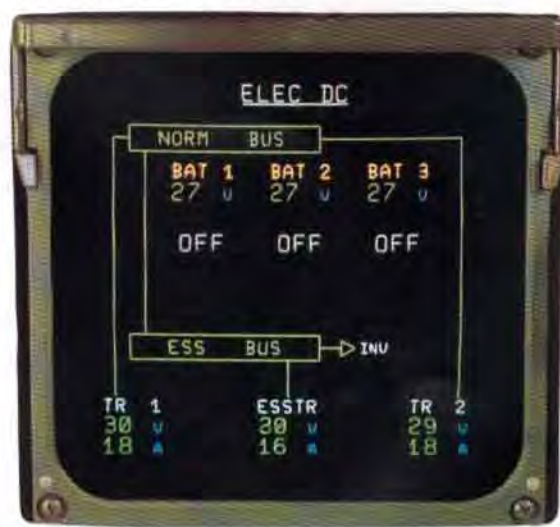
The ELEC system display will come up automatically on the right ECAM provided that no higher priority warning is already displayed on the left ECAM.

The left ECAM display unit shows :

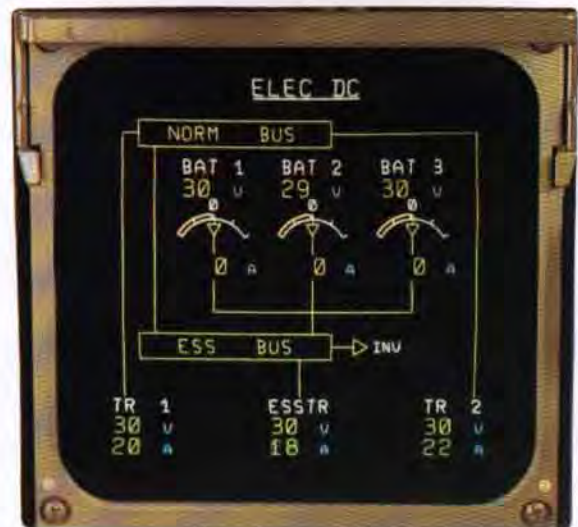
The ON legend in the switch illuminates white. The flowbar in each of the three BAT switches appears in vertical position although the OFF legend remains illuminated.

The ELEC DC system display on the right ECAM shows that the batteries are correctly coupled to the ESS BUS.

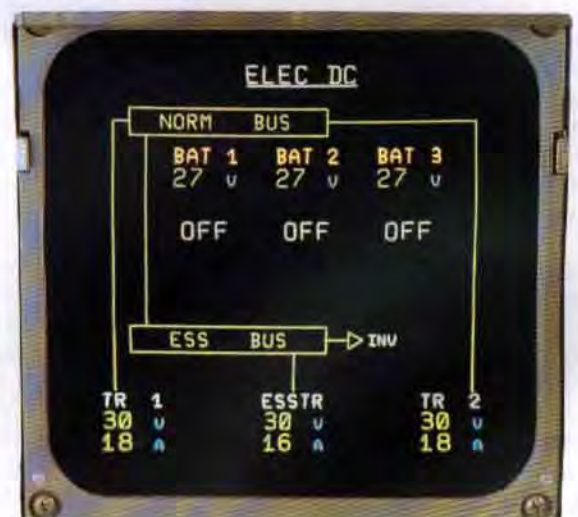
The ON legend is no longer illuminated. The flow bar on each of the three BAT switches disappears and the OFF legend remains illuminated.

The ELEC DC system display on the right ECAM shows that the batteries are uncoupled from the DC ESS BUS.

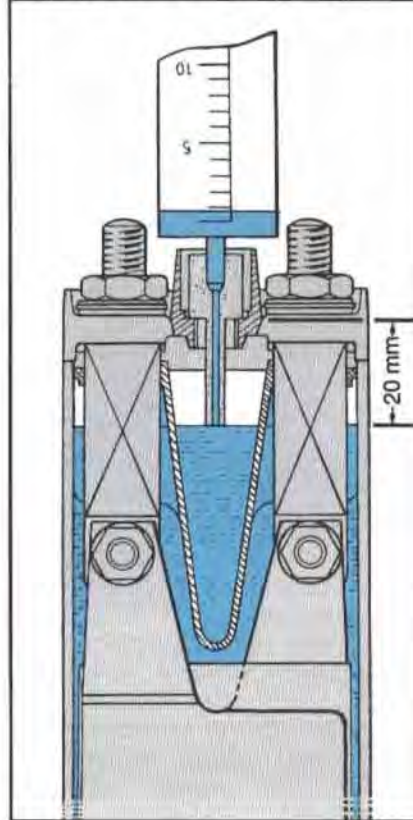
**Figure 4**

Method of topping-up with syringe and calibrated nozzle

By keeping the shoulder of the syringe nozzle in contact with the valve seat and pulling the plunger upwards, one can judge whether the filling is correct.

- Insufficient topping-up will be shown by the plunger drawing up "empty".
- Any excess of liquid will be drawn into the syringe until the level coincides with the end of the nozzle.

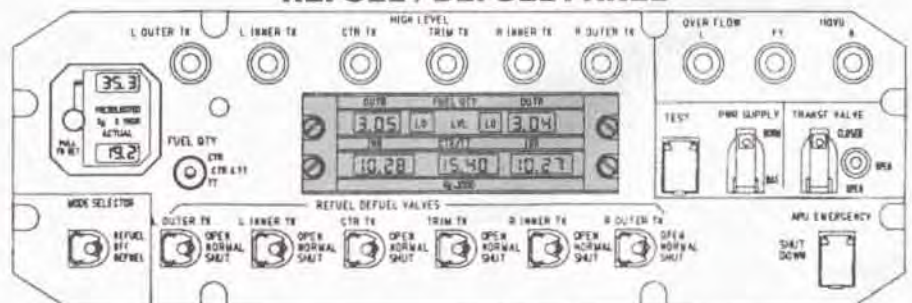
### REFUEL / DEFUEL PANEL

The refuel / defuel control panel is located in the air-conditioning fairing on the lower fuselage close to the leading edge of the right hand wing, within reach of the ground. As an option an additional panel may be located in the maintenance panel on the flight deck.

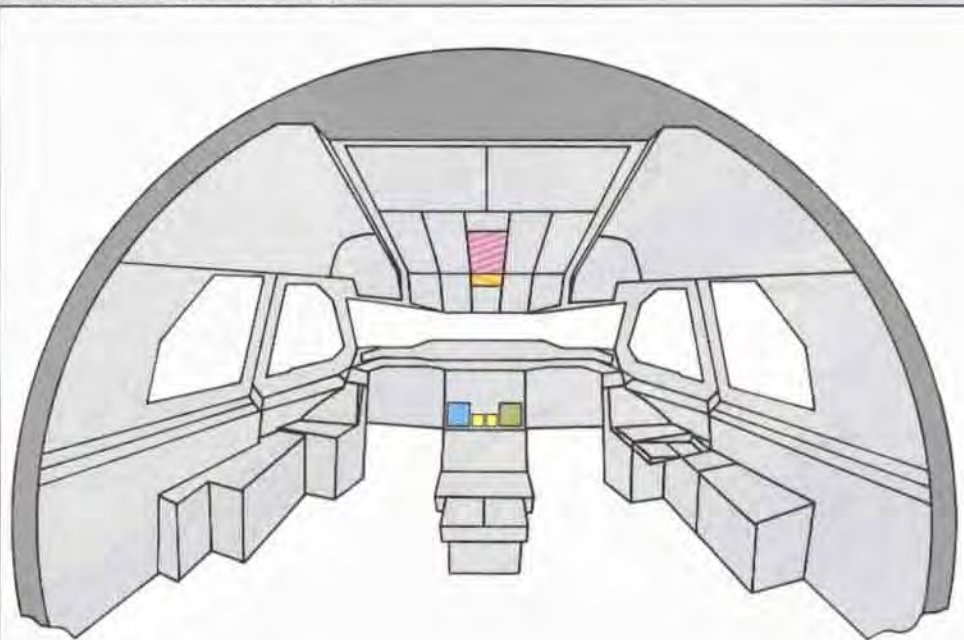
**Figure 2**

Location of control and indications

- Flight crew actions are confined to initiation and termination using the push button controls on the FUEL overhead panel.
- The total quantity of fuel remaining and the quantities remaining in each tank (centre and trim tanks are treated as one) are displayed permanently on the FUEL QTY overhead panel.
- Fuel flow and total fuel used are also shown on two instruments on the centre panel. Warning of low fuel level is totally independent of the fuel quantity indicating system and is displayed on the FUEL QTY overhead panel.
- Total quantity is also shown on the No.1 display unit (DU1).
- The fuel system synoptic diagram is shown on the DU2 fuel system page (a) and fuel flow is shown on the DU2 cruise (CRZ) page (b).

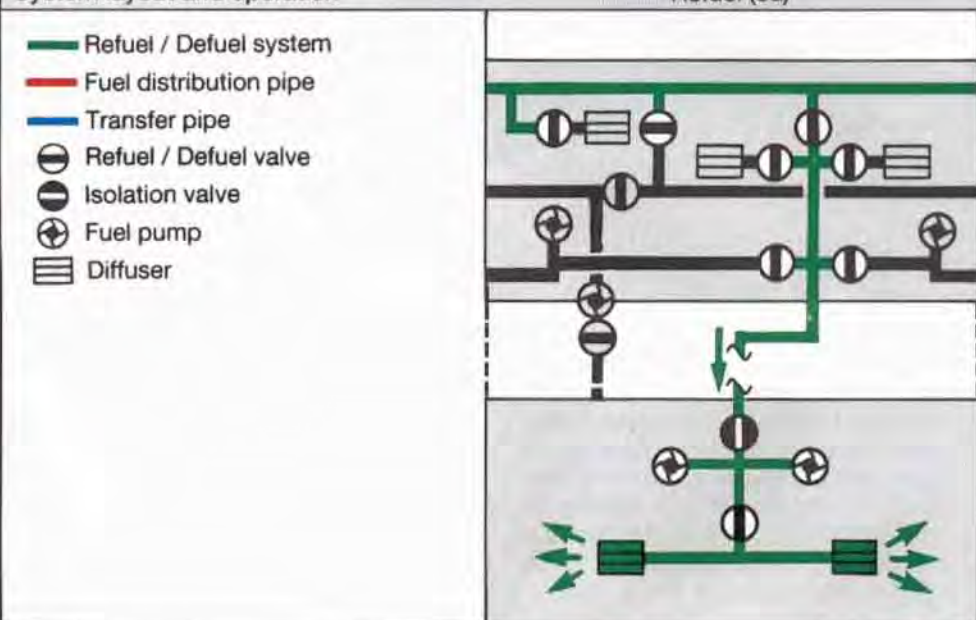
**Figure 3**

System layout and operation

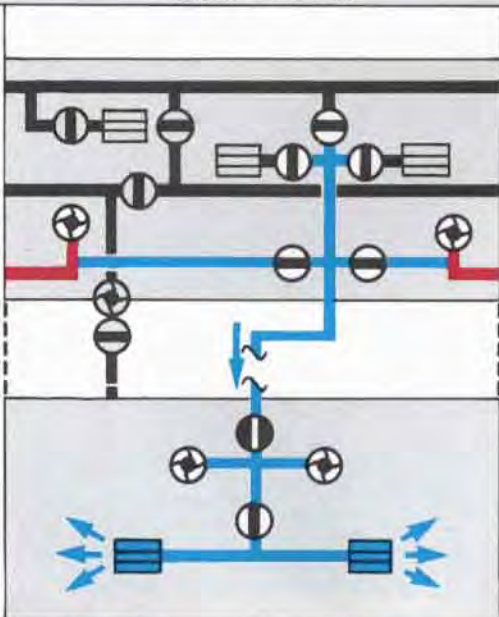
Transfer-Rear (3b)

engine feed systems. When the control valves installed in the centre tank are opened, the fuel pumps provide motive power for rear transfers as well as engine feed, irrespective of which tank is feeding the engines. At this time the trim tank refuel valve is automatically opened (figure 3b).

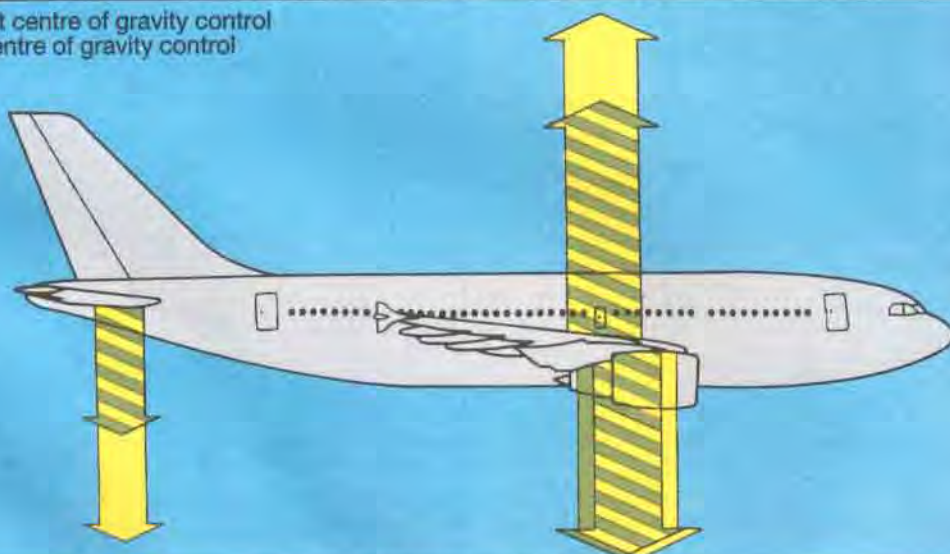
More efficient production of net lift = lower drag + lower fuel burn

- Load without centre of gravity control
- Load with centre of gravity control

Cruise drag reduction of up to 1.5%

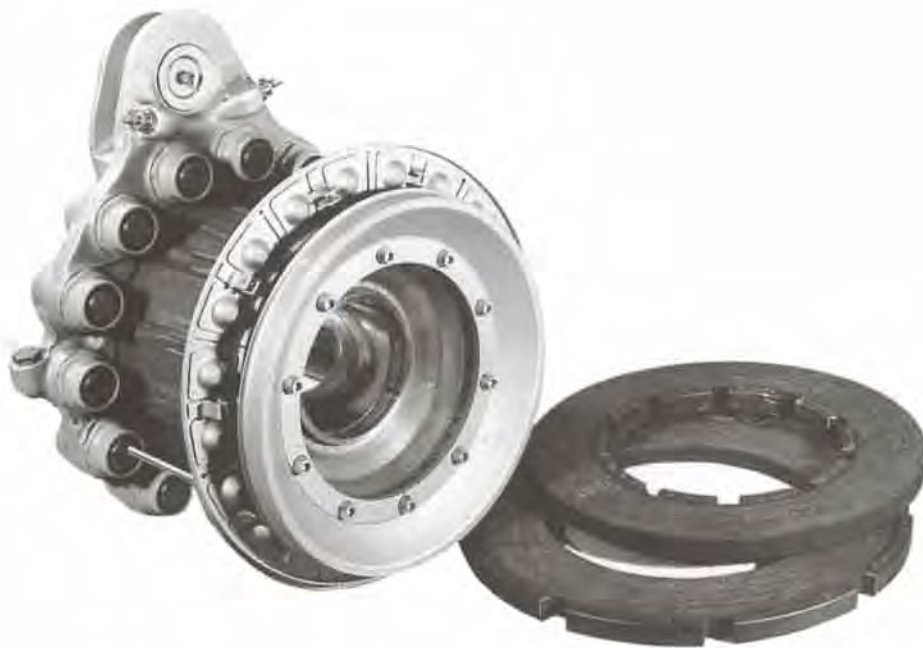
Saving weight has always been a major concern of aircraft manufacturers and it was the case particularly in the 1970s during the development of the supersonic airliner Concorde. That was when carbon brakes for civil airliners were first developed in spite of their high cost. At that time the carbon discs were made of carbonized nylon cloth reinforced by a carbon vapor deposit (CVD). A full decade passed before the carbon brakes became cost effective on subsonic airliners.

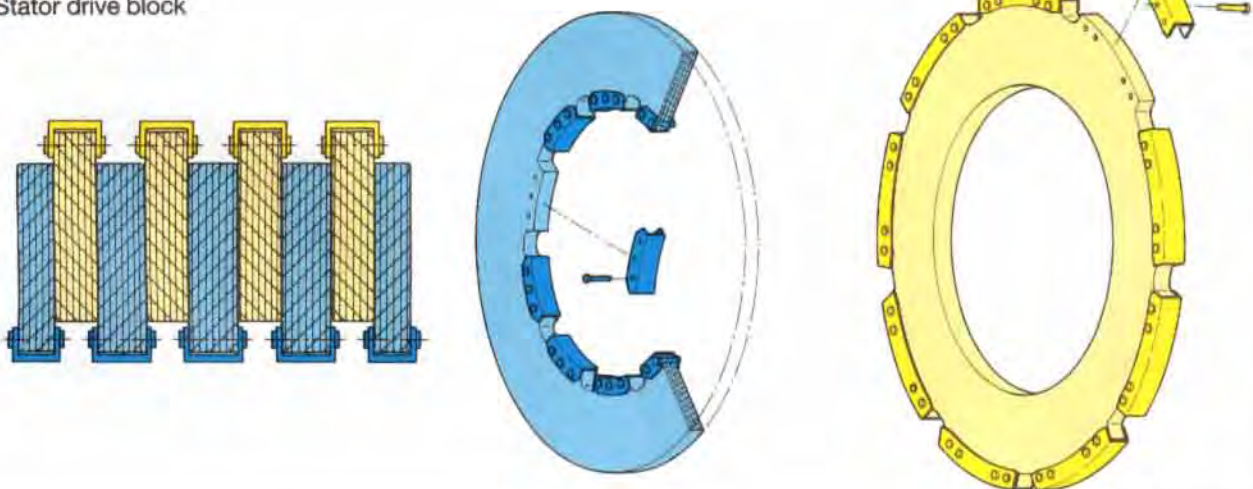
- Rotor
- Rotor drive block
- Stator
- Stator drive block

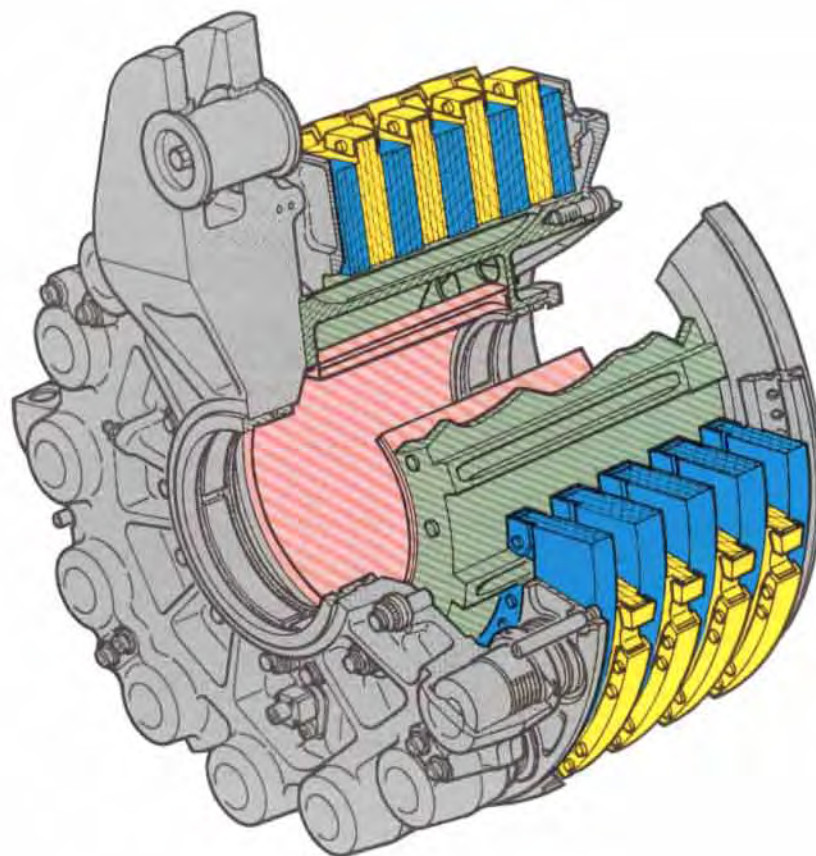
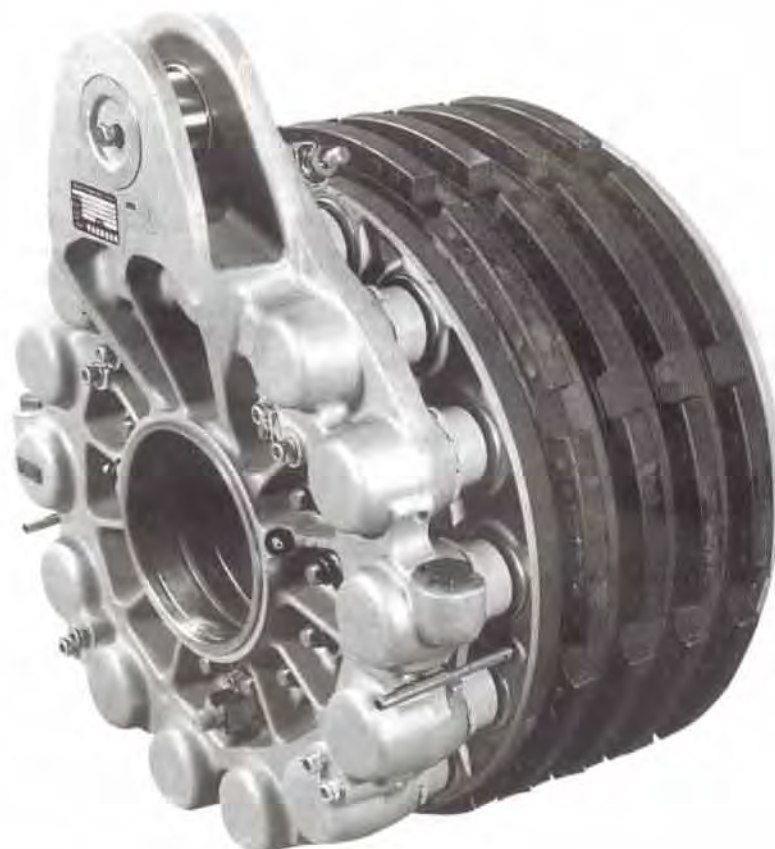
**Figure 4**

A300/A310 carbon brake

- Rotor
- Stator
- Torque tube
- Heatshield

protect the hub and tyre (as is conventional practice with some of the manufacturers of steel brakes), but also to protect the axle and axle equipment (figure 4).

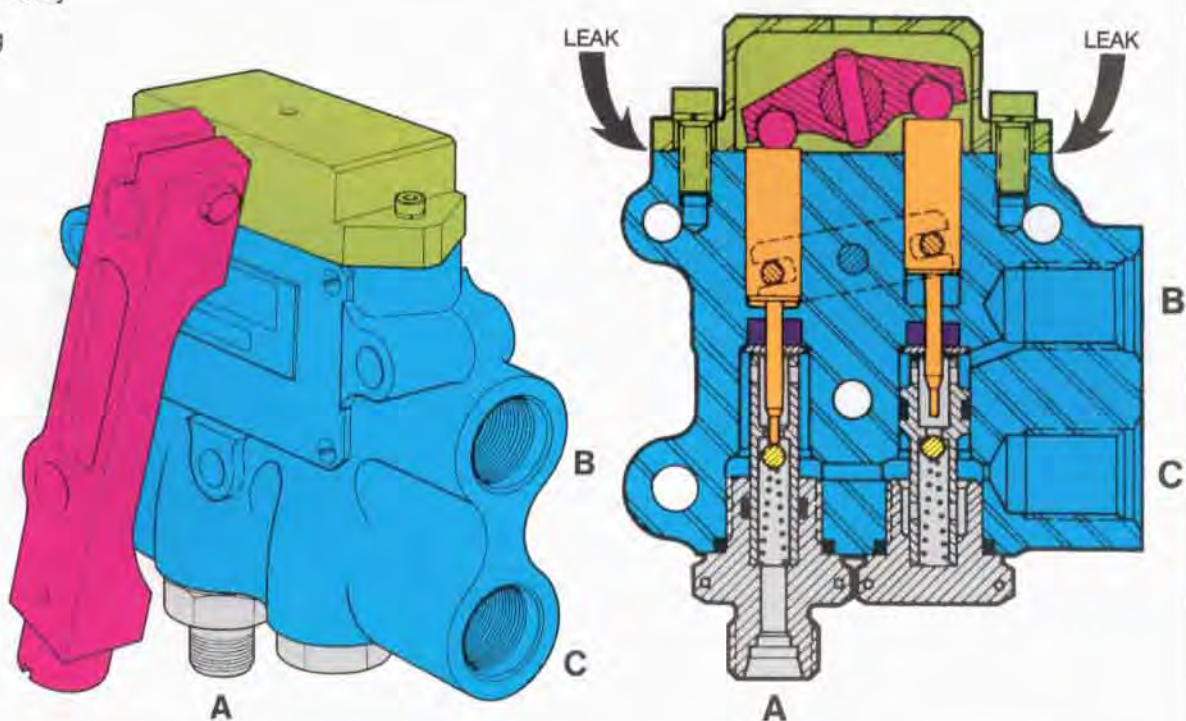
- Swing arm
- Push rod
- Ball valves
- Selector body
- Cover
- Packing

near the sliding rod seals. It cannot escape from there and its permanent contact with the seals is attacking and damaging them. As an improvement Messier issued SB 470-32-565, dated November 1985 describing a

modification designed to avoid accumulation of grease in the cavity. It contains recommendations to delete two covers (not visible on the drawing) on the A300B2, which can be accomplished in-situ, and to

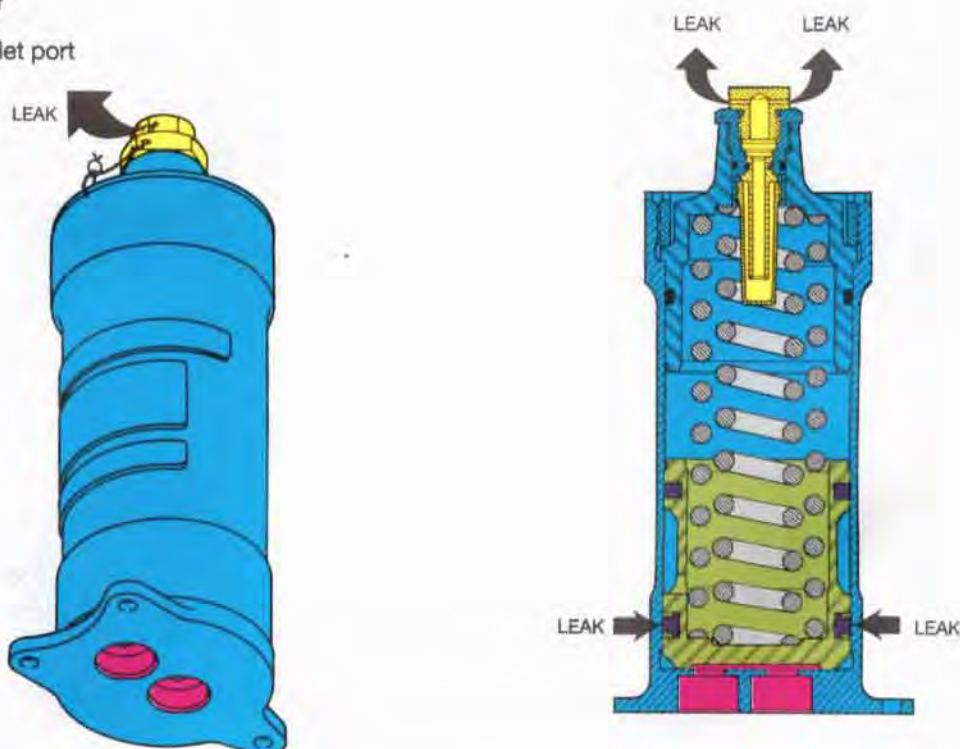
- Accumulator body
- Plug with venthole
- Fluid / air separator
- Packing
- Pressure inlet / outlet port

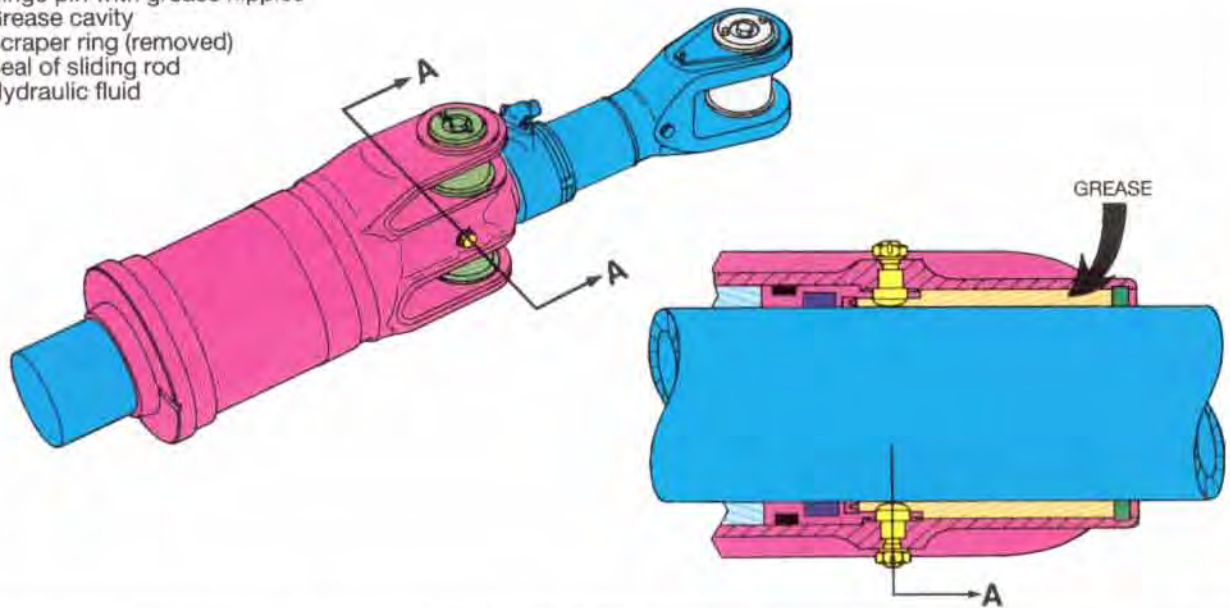
**Figure 3****Main landing gear actuator**

- Sliding rod
- Cylinder
- Hinge pin with grease nipples
- Grease cavity
- Scraper ring (removed)
- Seal of sliding rod
- Hydraulic fluid

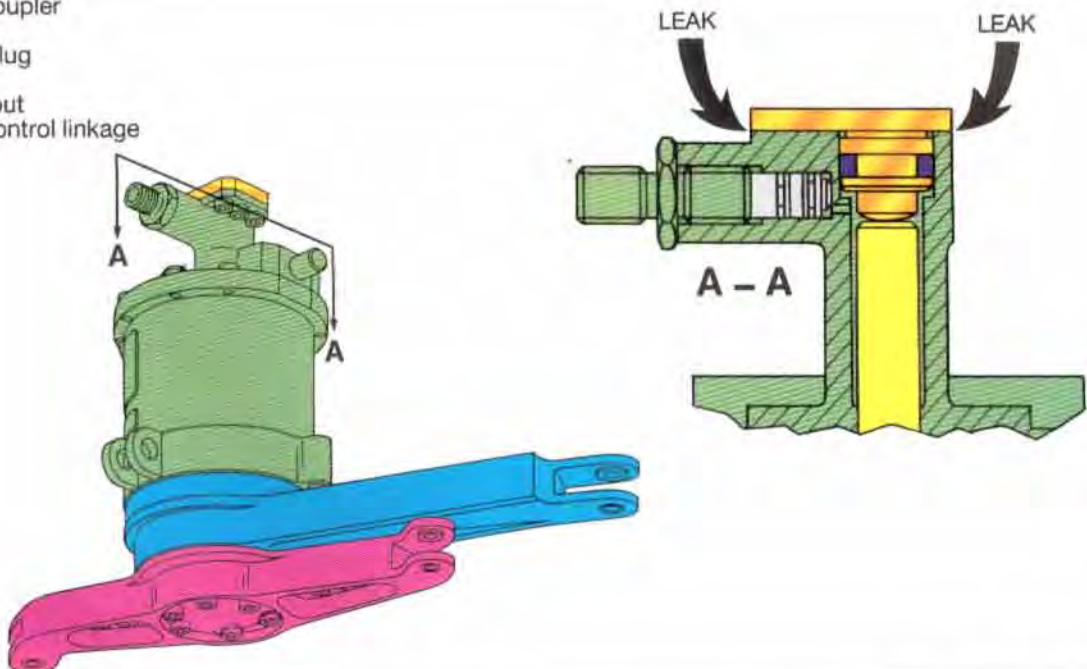
- Steering coupler
- Piston
- Modified plug
- Packing
- Rudder input
- Steering control linkage

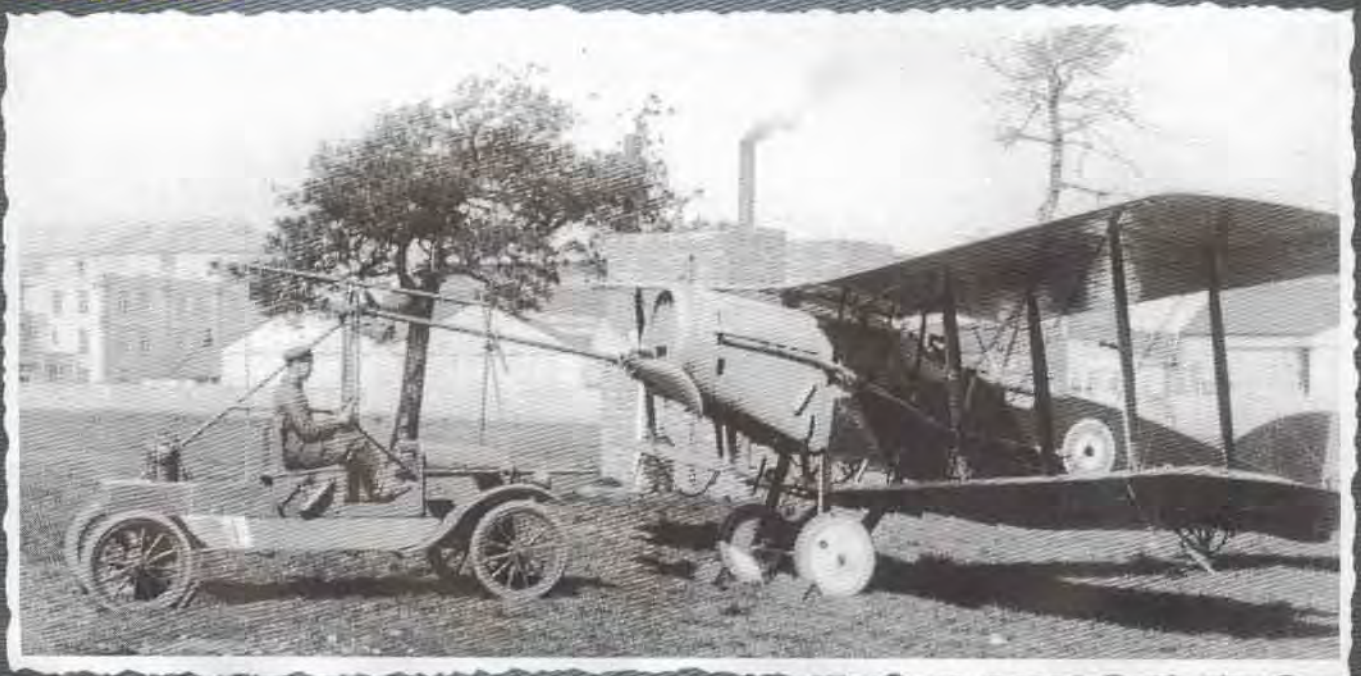
*Bristol Fighter F2B (1918)*

Should battery maintenance present a recurring problem in your organisation, a simple answer may be this piece of standard ground equipment mounted on a motor vehicle, known as a Huck's Starter. This equipment is readily adaptable to turn most aircraft engines !
