## MARINE SAFETY ALERT

Safety Alert 04-23

## **INFLATABLE BOAT SAFETY: DO NOT OVER-PRESSURIZE!**

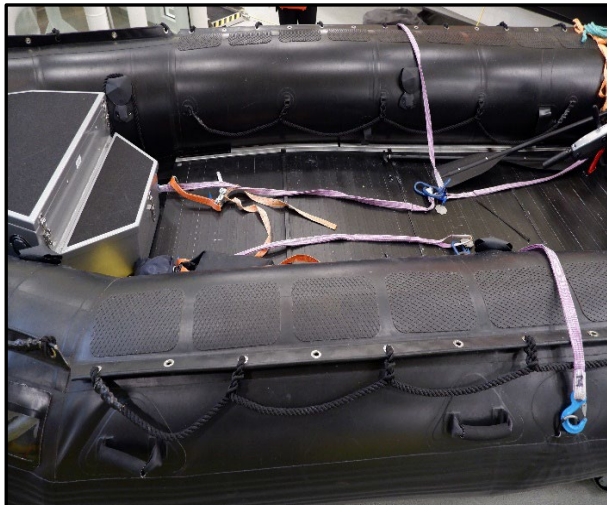
*Figure 1 -Zodiac after bladder failure. Deformation to the deck is visible.*

During a recent investigation of an incident that occurred involving foreign cruise vessel operations in the Antarctic, a U.S. passenger was severely injured due to a Zodiac MILPRO model FC 580/MK5 keel bladder failure while underway on a sightseeing excursion. In calm weather, the keel bladder suddenly ruptured, sending the passenger several feet into the air before landing onto the deck and sustaining serious injuries including a fractured femur. Another passenger was thrown overboard into the freezing water, risking hypothermia.

An investigation has identified that the keel bladder suffered a rupture due to excessive pressure in the tube. The recommended operating pressure by the manufacturer is 3.4 pounds per square inch (p.s.i) or 240 millibar pressure (mb). An on-scene survey of multiple inflatables on board the cruise ship noted pressures up to and exceeding 9 p.s.i. (620 mb) in other keel bladders. The keel bladder is not protected by a safety relief valve, and the manufacturer recommends that they be inflated with a foot pump to reduce the chance of over-pressurization. However, crewmembers were routinely using an air compressor to fill the buoyancy chambers (including the keel tube) prior to the incident. In addition, pressure levels were not being checked using a manometer as recommended by the manufacturer.

The Coast Guard **strongly recommends** that operators of cruise ships and other companies employing inflatable boats:

- Review all manufacturer recommendations for inflatable boat filling and maintenance to verify those procedures are being followed prior to any boat operations including passenger excursions.
- Use manufacturer recommended inflation devices (e.g., a foot pump) and appropriate pressure measurement tools to avoid over-pressurization.
- Verify that company policy addresses manufacturer recommendations and that crews are properly trained before operating and performing maintenance on inflatable boats.
- Contact the manufacturer of your inflatable boats for any additional recommendations and/or training options they may offer.

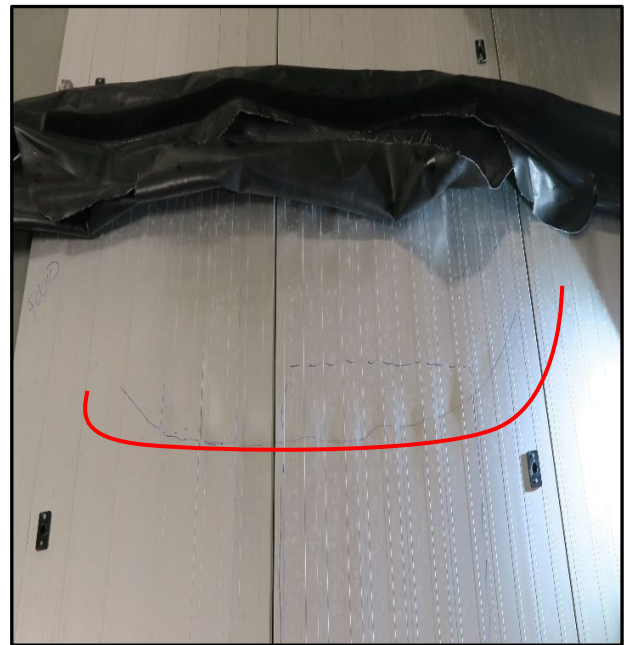
*Figure 2 – Ruptured keel bladder and the view of the underside of the metal hull. The red line has been added to highlight the deformities in the hull metal due to the keel bladder rupture.*
