# UAS Photogrammetry and TLS Technology: A Novel Approach to Predictive Maintenance in Industrial Tank Systems

**Abstract:** This paper explores the integration of terrestrial laser scanning (TLS) and unmanned aerial system (UAS) photogrammetry for the diagnosis and evaluation of deformations in industrial tanks, demonstrating their significant contribution to preventive maintenance. TLS accurately measures distances to the tank's surface, generating detailed 3D point clouds, while UAS photogrammetry captures high-resolution images from various angles and altitudes. By combining TLS and UAS data into comprehensive 3D models, engineers can identify subtle deformations and anticipate structural failures. The study results revealed significant deviations in tank shell verticality and roundness using TLS and notable roof unevenness using UAS. Comparing 3D models before and after corrective measures showed improved structural integrity. This approach enhances safety, optimizes resources, and enables targeted interventions. The findings highlight the potential of TLS and UAS technologies to revolutionize preventive maintenance, offering an efficient, precise, and less intrusive methodol

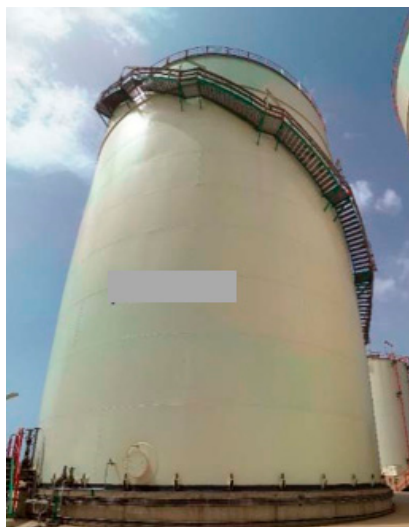
The object of study in this work is a vertical cylindrical carbon steel industrial tank with dimensions of 29,120 mm in diameter and 26,320 mm in height, composed of 11 shell courses, each measuring 2391 mm in height. The tank is designed according to the API 650 standard for fuel storage and has a nominal capacity of 9357 m<sup>3</sup>. Figure 1 shows an exterior view of the studied tank.

**Figure 1.** Exterior view of the vertical storage tank studied in this work.

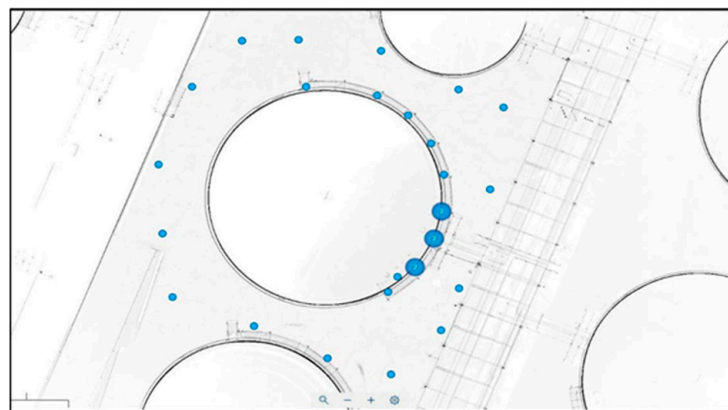
To obtain a detailed three-dimensional model of the storage tank, high-resolution terrestrial laser scanning (TLS) was performed using 28 scanning positions around the tank's external envelope, covering the entire outer surface from the base to the roof. The location of each scan is shown in Figure 2, where the blue points represent the laser positions. The thicker blue points indicate multiple scanning locations in close proximity to each other. In order to capture the most information from the elevated areas of the tank, the TLS was positioned on the helical staircase surrounding the structure.

**Figure 2.** Locations of the 28 laser scans (blue points) around the tank.

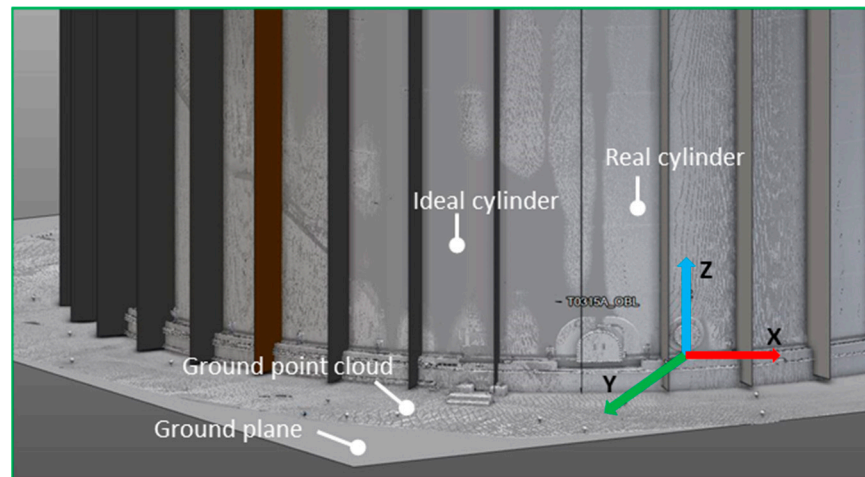
Initially, point clouds in .e57 format are imported and merged to obtain a single comprehensive point cloud representation of the tank. Subsequently, the coordinate axis is positioned at the base of the tank to facilitate the placement of horizontal sections. The ground point cloud, essential for defining the tank's geometry, is then extracted. A plane is created to represent the ground's flatness, and the tank's ideal cylindrical geometry is defined for analysis purposes. Finally, a reference point is established using an easily identifiable feature, such as a manhole on the tank wall, to serve as a reference for vertical sectioning. Figure 3 illustrates the key elements and reference systems used in the BuildIT Construction software for analyzing the tank's geometry based on laser scanner data. Figure 3 showcases the ground point cloud, ground plane, real and ideal cylinders, coordinate system (X, Y, Z), and the clocking point. These elements serve as essential components for defining the tank's base, orientation, and reference geometry.

**Figure 3.** Point cloud, ground plane, ideal cylinder, and reference systems.

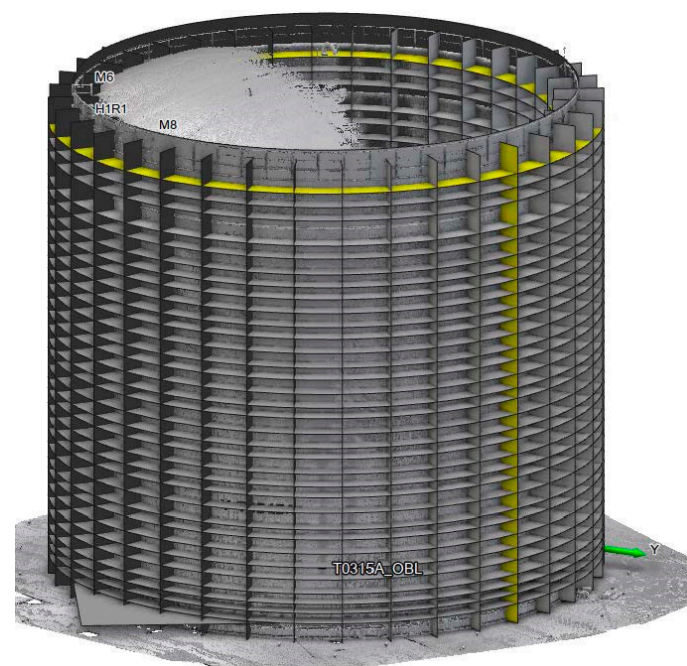
**Figure 4.** Horizontal and vertical sections of the studied tank.

To conduct a detailed analysis of the tank, it was decided to divide it into 36 radial vertical sections, resulting in a separation of 10 degrees between each section. It is important to note that section 1 is located approximately 2 degrees to the left of the 0-degree reference point of the tank's general layout plane.

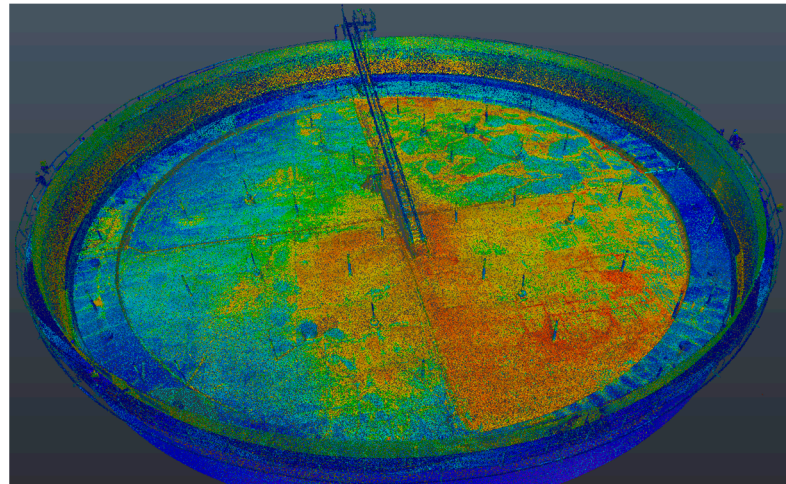
**Figure 5.** Dense point cloud of the tank roof.

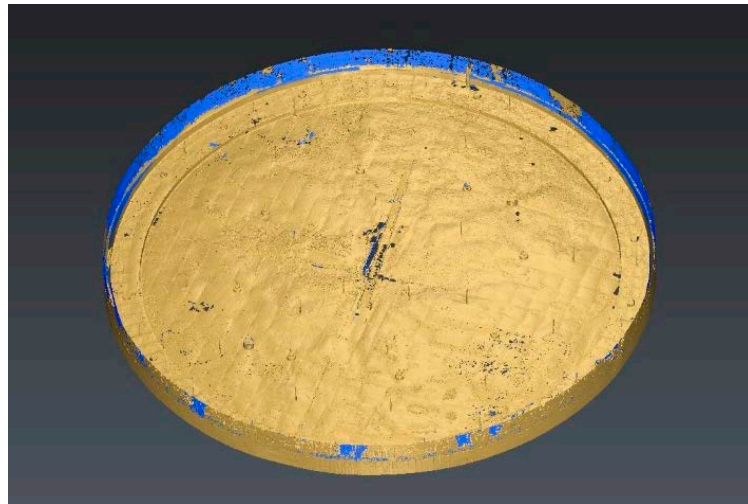
In this study, a high-quality triangular mesh model was generated from a dense point cloud using 3DReshaper software, as illustrated in Figure 6. The input data were obtained from a previous photogrammetric survey and consisted of 21,260,071 points with an average spacing of 0.8 cm.

**Figure 6.** Tank roof mesh model.

A mesh quality analysis was conducted to assess the geometric properties and integrity of the generated mesh. The minimum triangle angle was found to be 15 degrees, while the maximum angle was 120 degrees, indicating a well-structured and balanced triangulation. The average triangle aspect ratio of 1.5 suggests a good proportionality between the triangle edges, with 95% of triangles having an aspect ratio below 2 and 99% below 3, further confirming the mesh's quality.

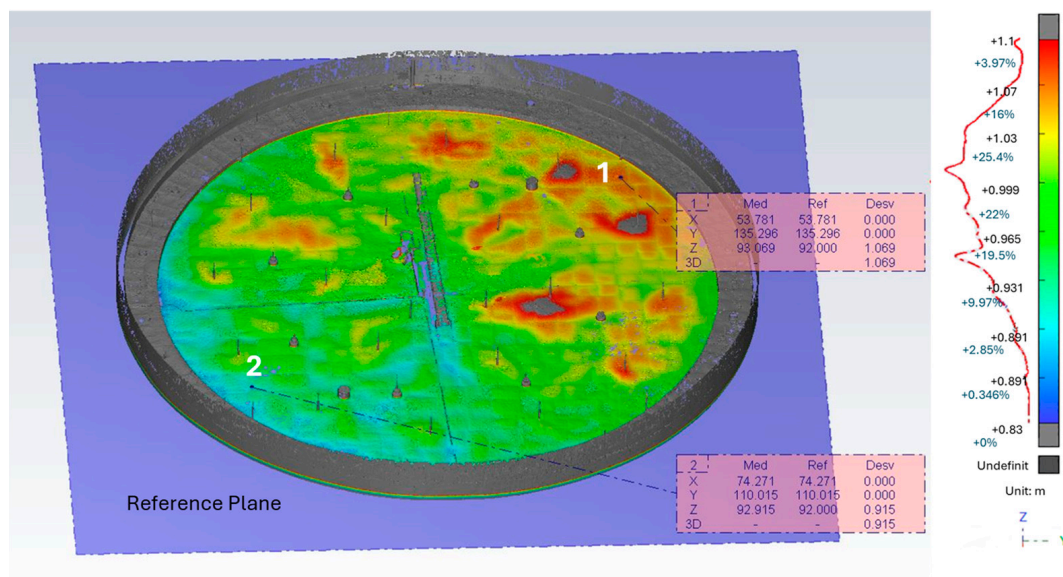
**Figure 7.** Comparison of the mesh with the reference plane.

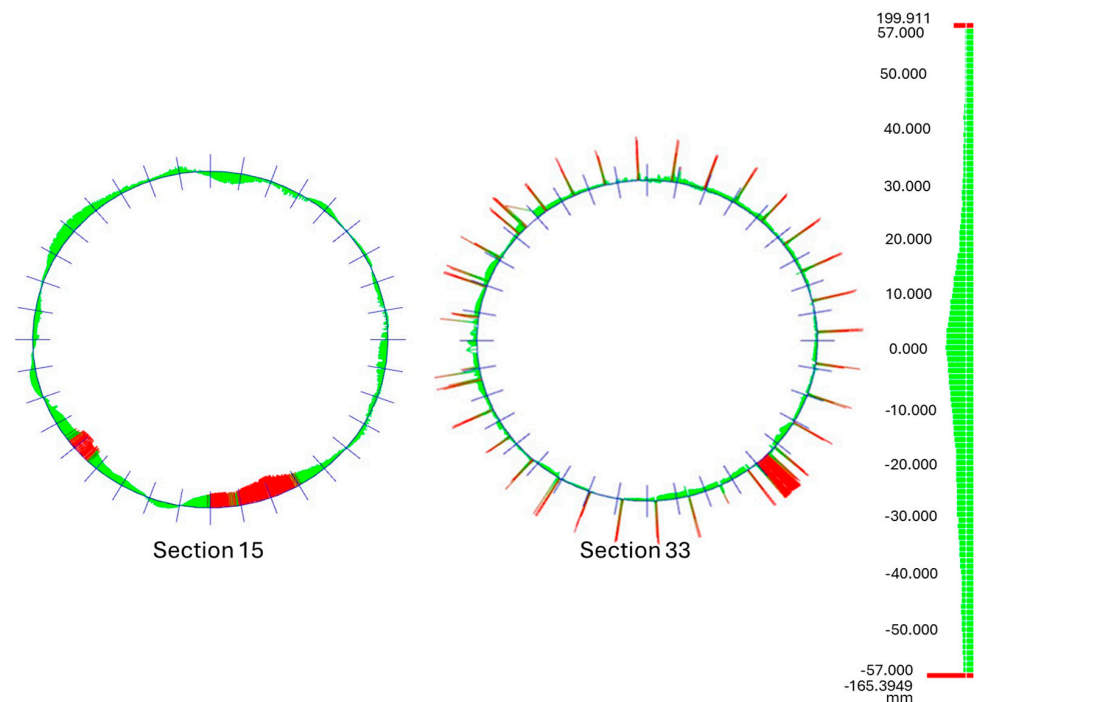
Figure 8 indicates that horizontal section 15 of the tank presents a significant lack of roundness, with a wide variation between the maximum outward and inward deviations (137.803 mm) that is the largest among all the analyzed sections. The graph shows an asymmetric distribution of deviations, with a predominantly negative zone between 0° and 180° and a positive one between 180° and 360°, resulting in an oval shape. This lack of uniform roundness suggests structural problems that could be due to imperfections in construction, uneven loads, ground settlements, welding issues, or damage during operation and which require a detailed investigation to evaluate the underlying causes and determine the necessary corrective measures to ensure the tank's integrity and safety.

**Figure 8.** Roundness study in sections 15 and 33.

In contrast, horizontal section 33 of the tank, which is located near the tank's base, exhibits better roundness compared to the other sections. This section has the smallest variation between its maximum outward and inward deviations (57.312 mm) and a more uniform distribution of deviations along the circumference. Despite the apparent better roundness of section 33 compared to the other sections, the deviations in this section still surpass the previously mentioned allowable limits ( $\pm 19$  mm) set by the API 653 standard.

The results of this analysis reveal the presence of significant deviations in the roundness of several tank sections. These deviations may have implications for the tank's structural integrity and performance. It is essential to conduct further monitoring and a more detailed evaluation of the identified sections to determine the underlying causes of these deviations and to take the necessary corrective measures to ensure the tank's safety and operational efficiency.

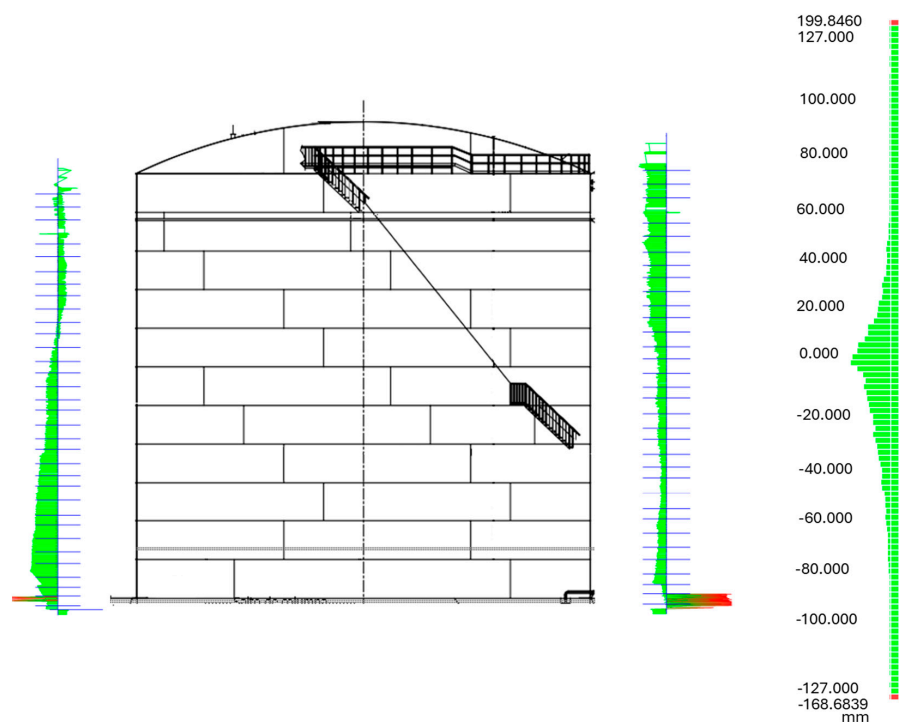
The maximum vertical deviation found in the tank is 82.094 mm, which occurs in the 220° column. This value is within the allowable limit specified by the API 653 standard, which sets a maximum verticality tolerance of 127 mm, as discussed in the applicable regulations section.

Figure 9 indicates a cut of the tank where sections 40 and 220° are shown. The section at 220° of the tank presents the greatest lack of verticality among all the analyzed columns, with a wide variation between maximum outward and inward deviations (110.201 mm).

**Figure 9.** Analysis of verticality in the tank cut from 40 to 200 degrees.

The graph shows an asymmetric distribution of deviations along the tank's height, with a clear tendency towards positive deviations at the top (maximum of 82.094 mm) and less pronounced negative deviations at the bottom (minimum of  $-28.107$  mm). This irregular shape suggests verticality problems that could be due to imperfections in construction, uneven loads, ground settlements, or deformations caused by temperature or pressure changes. It is crucial to evaluate the underlying causes and determine if corrective measures are required to ensure the tank's integrity and safety, considering that the red protrusion at the top corresponds to an instrument and should not be interpreted as an actual deviation of the structure.

Furthermore, the verticality analysis showed that the section at 220° presents the greatest lack of verticality, with a wide variation between the maximum outward and inward deviations of 110.201 mm. Although this deviation falls within the limits allowed by the API 653 standard, it is crucial to investigate the underlying causes and consider corrective measures to prevent the further deterioration of the structure.

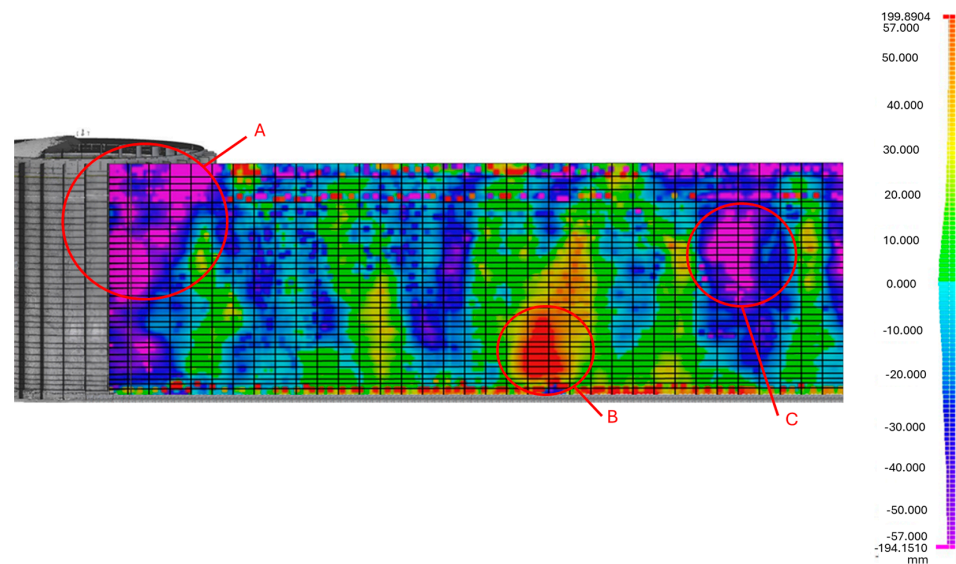
Figure 10 shows a two-dimensional color map representing the unrolled tank walls, allowing for a detailed visualization of the deformations and deviations from verticality across the entire tank surface. This approach provides a comprehensive overview of the tank's structural integrity and facilitates the identification of critical areas that require attention.

**Figure 10.** Analysis results (2D color map) with referenced sections.

The color map employs a scale ranging from dark blue to intense red to indicate the magnitude and direction of the deformations. Cool colors, such as blues and greens, represent negative or inward deviations in the tank, suggesting the presence of dents or areas where the tank wall is below the ideal surface. On the other hand, warm colors, such as yellows, oranges, and reds, indicate positive or outward deviations, implying the existence of protrusions or areas where the tank wall is above the ideal surface.

These local deviations may be associated with problems during the assembly or welding process and require special monitoring to prevent the development of failures due to stress concentration.

When interpreting the color map, it is crucial to consider certain aspects to avoid misinterpretations. Firstly, the data above horizontal section 1 can be disregarded, as it corresponds to the region where the shell plate ends and the upper stiffener ring and handrail support are located. These additional structures may generate variations in the data that do not necessarily represent the actual deformations of the tank wall.

The two-dimensional color map generated from the tank's point cloud allowed for a clear visualization of the deviations across the entire surface. This approach facilitates the identification of critical areas and provides a solid foundation for informed decision making regarding tank maintenance and repair.

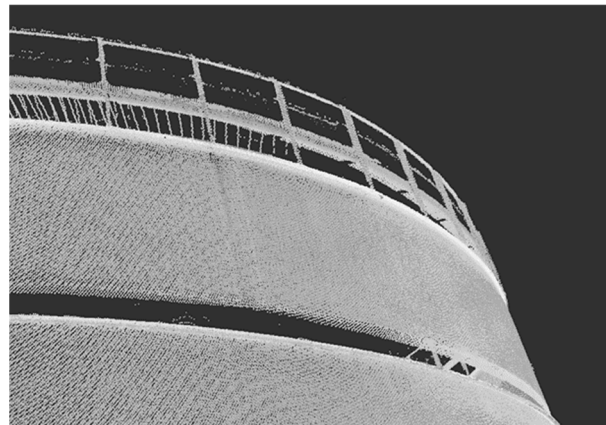
Secondly, at a height of 23,520 mm, there is an intermediate stiffener ring (Figure 11), which may also show data that appears to indicate deformations on the color map. However, it is important to recognize that these variations are attributable to the presence of the ring and should not be interpreted as genuine deformations of the tank wall. These images complement the color map and help contextualize the observed variations in those specific regions of the tank.

**Figure 11.** Intermediate stiffener ring.

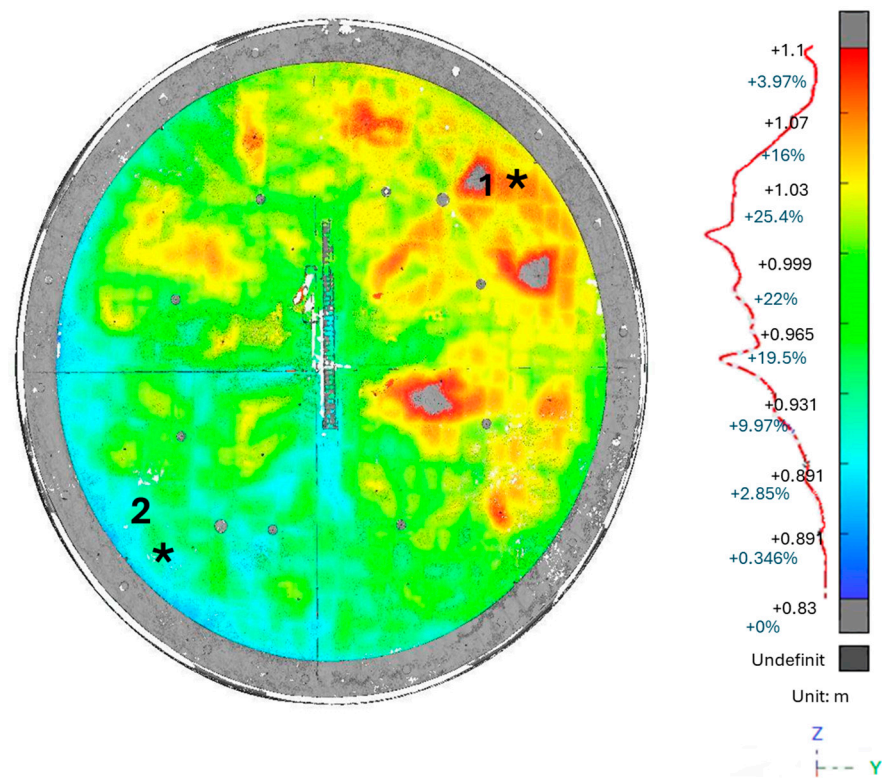
The color distribution is neither uniform nor symmetrical, implying that the roof is not completely flat. Irregular patterns and abrupt color changes are observed, especially near the center and towards the edges of the image, suggesting the existence of unevenness, protrusions, or depressions in certain areas of the surface.

Therefore, the visual analysis of the heat map reveals considerable irregularities in the flatness of the tank roof. The heterogeneous color distribution and the observed unevenness indicate that the surface is not completely flat and has significant height variations. This flatness analysis, based on photogrammetric techniques and visualization through heat maps, provides a valuable tool to evaluate the construction quality and structural integrity of the roof, allowing the identification of areas that may require attention or repairs to ensure optimal and safe performance.

**Figure 12.** Roof flatness in heat map.

A detailed visual inspection and periodic monitoring are recommended to assess their evolution over time and prevent failures due to fatigue or collapse.
