Guidelines for the Assessment of Annex I Priority Petrifying Springs in Ireland

Irish Wildlife Manuals 142

Prepared by the National Parks and Wildlife Service

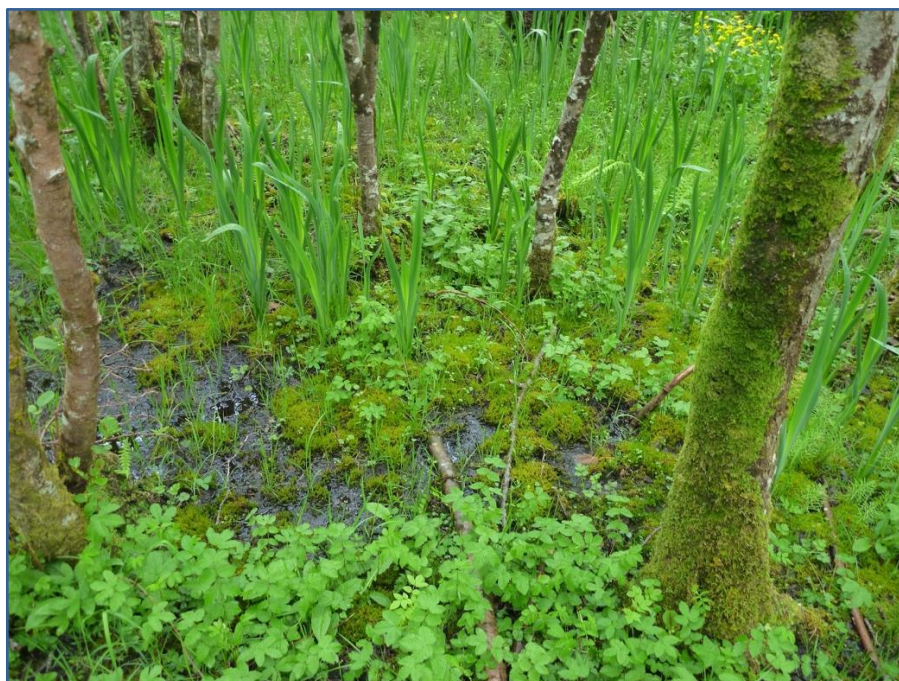
This is a spring that arises in wet woodland and has abundant to locally dominant *Palustriella commutata* (Figure 3). This bryophyte species is typical of highly calcareous water and is a strong positive indicator for *7220. The vegetation present best fits the **Group 4** *Palustriella commutata*-*Agrostis stolonifera* Springheads plant community (Lyons & Kelly, 2017), although it is wooded. This group has variable tufa formation and tufa is sometimes sparse to absent (Lyons & Kelly, 2017). **Group 2** *Palustriella commutata*-*Geranium robertianum* Springheads have similar vegetation and are wooded, but are generally strongly tufa forming and so not a good fit for this spring (Lyons & Kelly, 2017). As there is no tufa formation, Spring A is **not** considered to be an example of *7220 (Table 16). It is however of high ecological value as a ground-water dependent feature and is associated with wet woodland which has affinity to the Annex I priority habitat *Alluvial forests with *Alnus glutinosa* and *Fraxinus excelsior* [*91E0]. It is also located within 1 km of an SAC which has *7220 as a Qualifying Interest and potential hydrogeological connections to the SAC should be considered in any assessment.

Figure 3 *Palustriella commutata* dominated springhead in wet woodland (Spring A). Photograph Joanne Denyer.

Criteria	Value	Comment
No. of positive indicator species (species diversity)	2	Moderate diversity. Minimum of 3 usually required for *7220
Tufa formation	Absent	Some tufa formation required for *7220
Other positive characteristics	Yes	Associated with wet woodland with affinity to 91E0*
Condition assessment	-	Not undertaken, but no obvious impacts
Located within protected site	No	-
Within/adjacent to SAC with *7220 as Qualifying Interest	Yes	<1 km from SAC
*7220 petrifying spring	No	Does not have tufa formation
Conservation score	-	Not example of *7220
National ranking	-	Not example of *7220

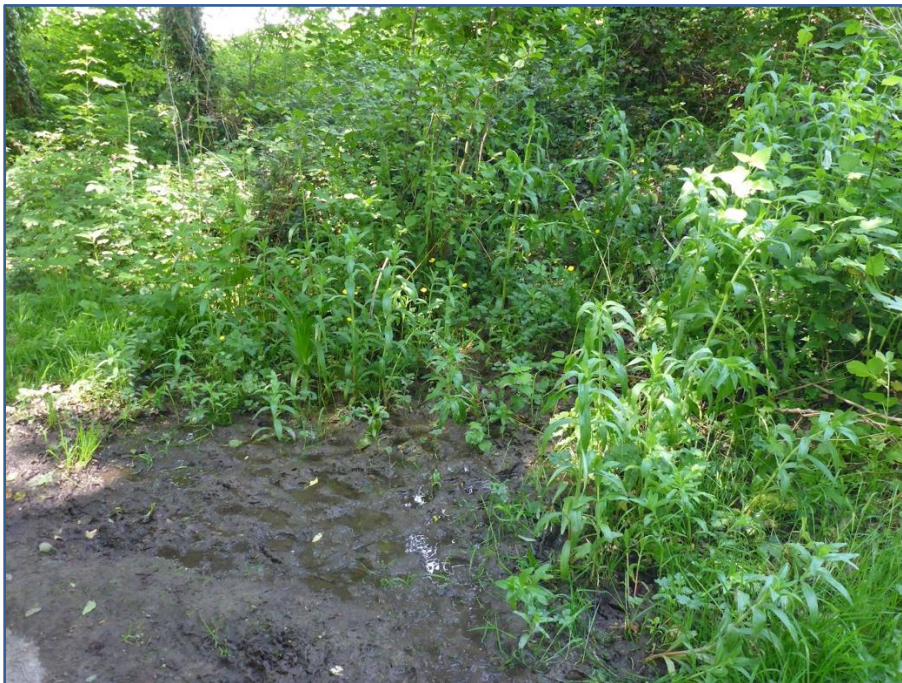
Figure 4 Springhead and seepage (Spring B). Photograph Joanne Denyer.

Criteria	Value	Comment
No. of positive indicator species (species diversity)	Absent	Minimum of 3 usually required for *7220
Tufa formation	Paludal	Patchy paludal (Moderate tufa formation)
Other positive characteristics	Yes	Part of river valley spring complex
Condition assessment	-	Not undertaken, but no obvious impacts
Located within protected site	No	-
Within/adjacent to SAC with *7220 as Qualifying Interest	No	<2 km
*7220 petrifying spring	No	Does not have any positive indicator species
Conservation score	-	Not example of *7220
National ranking	-	Not example of *7220

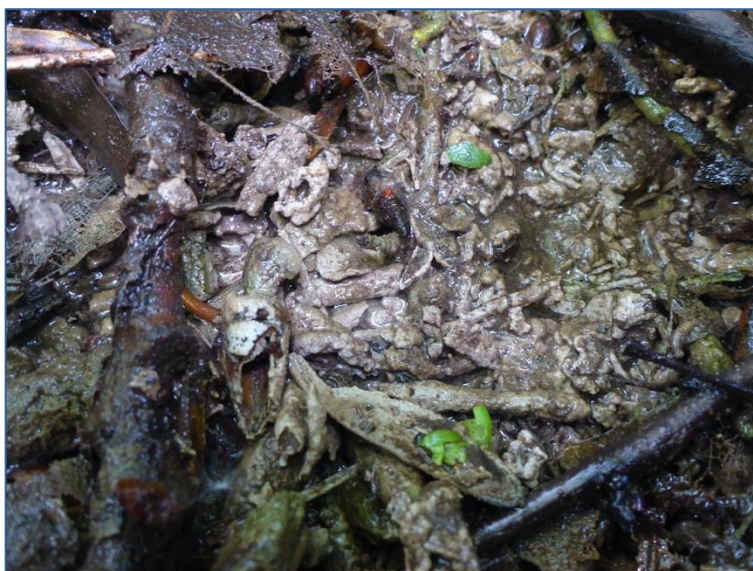
Figure 5 Tufa formation (oncoids and ooids) (Spring B). Photograph Joanne Denyer.

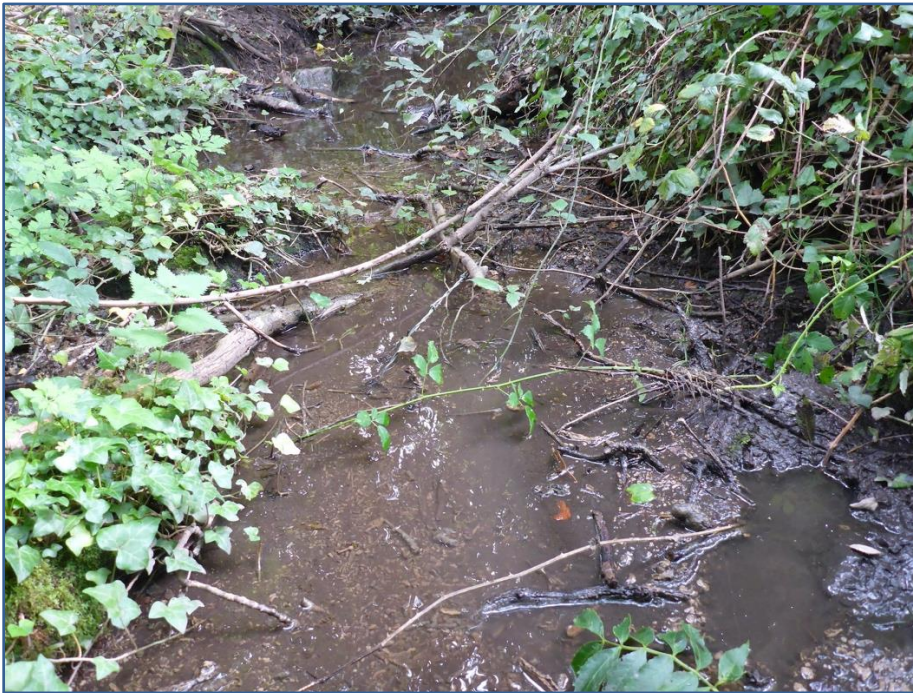
Figure 6 Tufa forming spring within old hedgerow (Spring C). Photograph Joanne Denyer.

Criteria	Value	Comment
No. of positive indicator species (species diversity)	Absent	Minimum of 3 usually required for *7220
Tufa formation	Paludal	Patchy paludal (Moderate tufa formation)
Other positive characteristics	Yes	Part of old hedgerow system
Condition assessment	-	Not undertaken, but no obvious impacts
Located within protected site	No	-
Within/adjacent to SAC with *7220 as Qualifying Interest	No	-
*7220 petrifying spring	No	Does not have any positive indicator species
Conservation score	-	Not example of *7220
National ranking	-	Not example of *7220

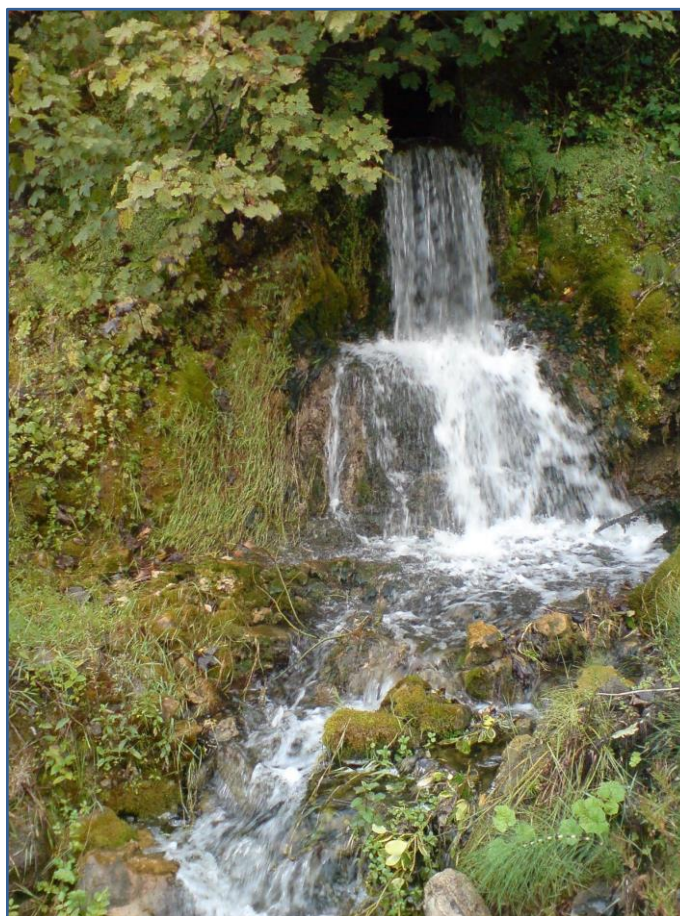
This spring originates from a pipe which flows under a road (Figure 8). As the water emerges from the pipe it forms a waterfall and there is significant tufa cascade formation with a number of positive indicator species (Table 19). The vegetation has most affinity to **Group 4** *Palustriella commutata-Agrostis stolonifera* Springheads vegetation community (Lyons & Kelly, 2017). Although this petrifying spring has a probable artificial origin, it is groundwater fed and fits the criteria for *7220 habitat (Table 19). It has a high national ranking due to high tufa formation and moderate species diversity. When evaluating the ecological value of the site, the artificial origin is irrelevant as the petrifying spring is well developed; but the lack of links to semi-natural habitat may reduce its ecological value. Petrifying springs are well represented in the county

Figure 8 Petrifying spring emerging from pipe under a road (Spring D). Photograph

Criteria	Value	Comment
No. of positive indicator species (species diversity)	7	Moderate diversity
Tufa formation	Cascade	Massive, strongly consolidated deposits (very high tufa formation)
Other positive characteristics	No	-
Condition assessment	-	Not undertaken, but no obvious impacts
Located within protected site	No	-
Within/adjacent to SAC with *7220 as Qualifying Interest	Yes	<1 km
*7220 petrifying spring	Yes	≥3 positive indicator species with tufa formation
Conservation score	5	Estimated as no detailed assessment undertaken
National ranking	High	Artificial origin, but has moderate species diversity and high tufa formation

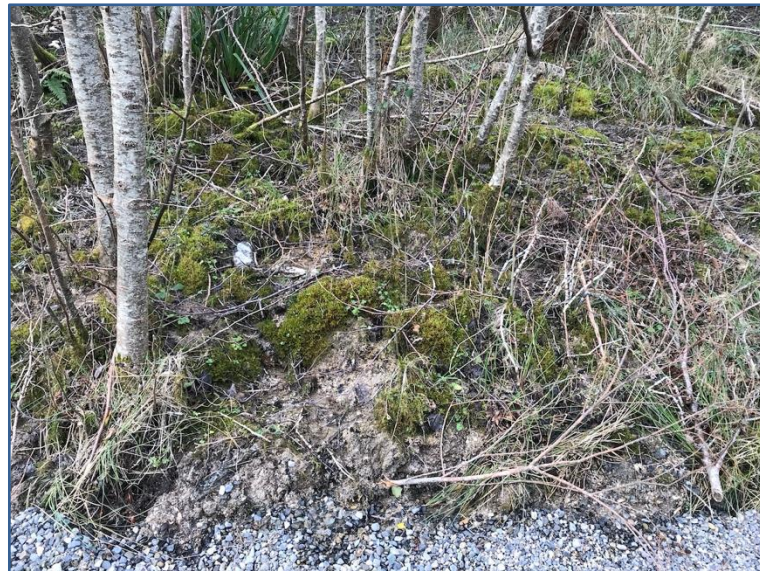
Figure 10 Petrifying spring and seepage area with abundant *Palustriella commutata* and tufa formation, (upstream of Spring E). Photograph Joanne Denyer.

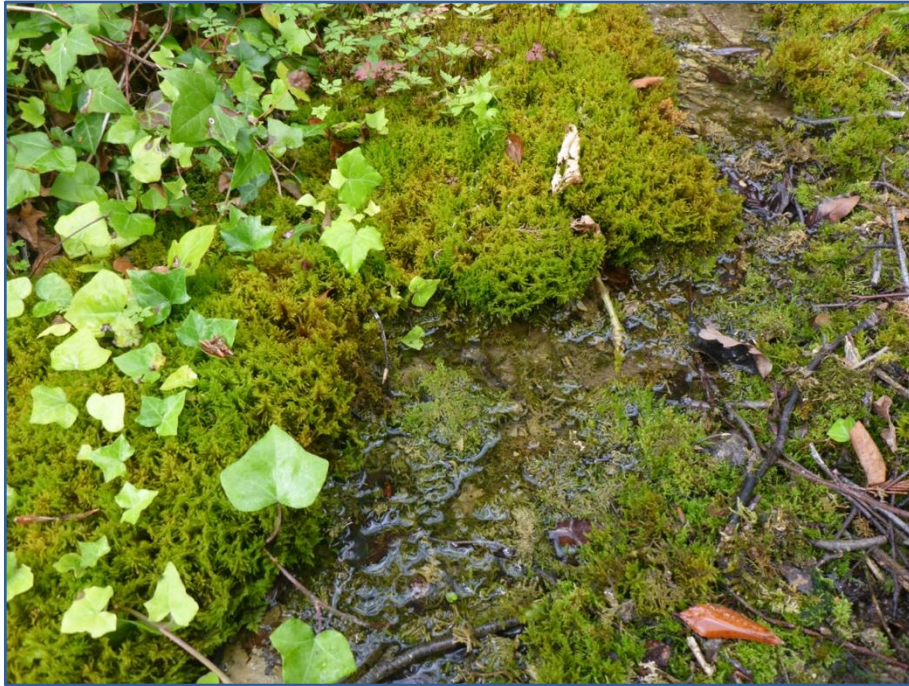
Figure 11 Petrifying spring in garden (Spring F). Photograph Joanne Denyer

Criteria	Value	Comment
No. of positive indicator species (species diversity)	5	Moderate diversity
Tufa formation	Cascade	Smaller consolidated deposits (high tufa formation)
Other positive characteristics	Yes	Part of unusual complex of highly tufa forming springs in residential gardens along a river valley
Condition assessment	Unfavourable-Inadequate	Invasive species locally dominant
Located within protected site	No	-
Within/adjacent to SAC with *7220 as Qualifying Interest	Yes	<3 km from 2 SACs
*7220 petrifying spring	Yes	≥3 positive indicator species with tufa formation
Conservation score	5	Estimated as no detailed assessment undertaken
National ranking	High	Some modification as within a garden setting, but has 3 indicator species and high tufa formation

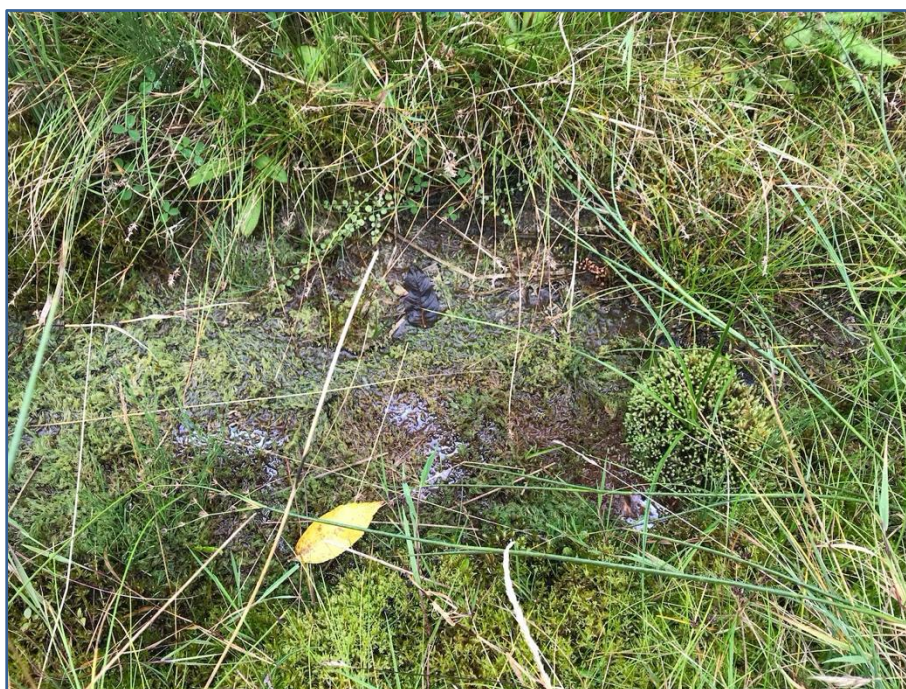
This wet grassland site has a main spring, probably of natural origin, which arises at the top of the field and flows down to a river along the edge of the field. The vegetation within the main spring is an example of **Group 4** *Palustriella commutata-Agrostis stolonifera* Springheads vegetation community (Lyons & Kelly, 2017) and is typical *7220 habitat.

Figure 12 Petrifying spring in drainage channel within wet grassland (Spring G).
Photograph Joanne Denyer

Criteria	Value	Comment
No. of positive indicator species (species diversity)	14	High diversity
Tufa formation	Paludal, cascade, oncoids & ooids	Smaller consolidated deposits or strongly formed paludal tufa (high tufa formation)
Other positive characteristics	Yes	Part of complex of springs within wet grassland, locally grading to fen and associated with a petrifying spring with significant cascade tufa into the adjacent river
Condition assessment	-	No obvious impacts
Located within protected site	No	-
Within/adjacent to SAC with *7220 as Qualifying Interest	Yes	<1 km
*7220 petrifying spring	Yes	≥3 positive indicator species with tufa formation
Conservation score	5	Estimated as no detailed assessment undertaken in this area
National ranking	High	Estimated as no detailed assessment undertaken in this area

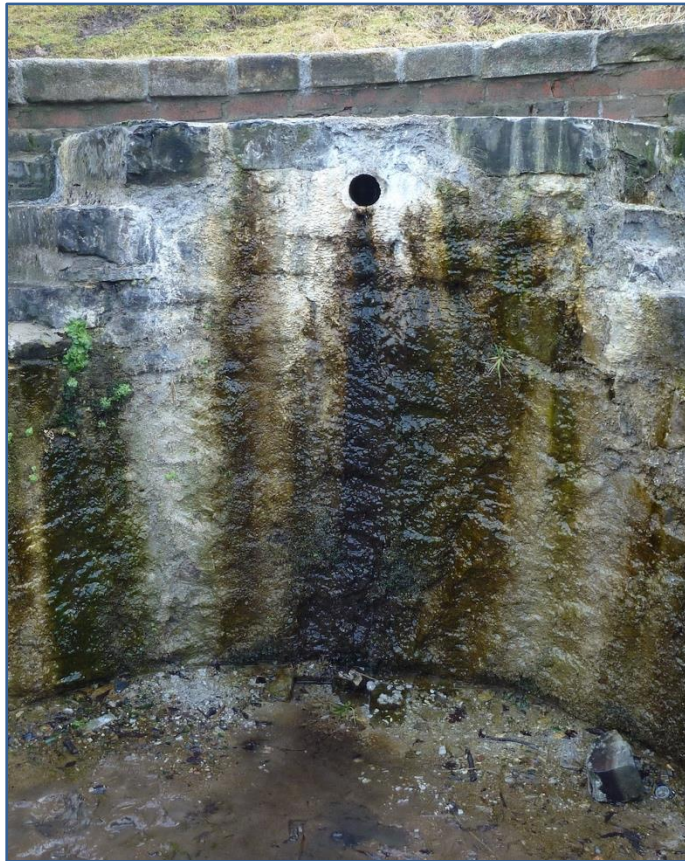
Spring H is located within an SAC for which *7220 is a Qualifying Interest. There is a series of springs in the southern part of the site which arise along a (historically) artificially terraced slope. On one terrace there is a 'Roman Bath' made of brickwork into which a pipe discharges. The flow is small but consistent, as the area below it is usually damp even in summer. In 2011 the stonework near the pipe showed some signs of calcium carbonate precipitation (white staining, Figure 13), but there was no tufa formation or tufa vegetation present. By 2019 (Figure 14), it can be seen that the area below the pipe has developed significant tufa formation and vegetation. At least six positive indicator species are present and it is a good example of *7220 habitat within an SAC (Table 23). The spring is an example of **Group 1** *Eucladium verticillatum-Pellia endiviifolia* Tufa Cascades vegetation community (Lyons & Kelly, 2017). This demonstrates that significant tufa formation and petrifying spring species colonisation can occur in less than 10 years, even on artificial surfaces and that *7220 habitat does not need to be old.

Figure 13 Roman Bath without tufa formation (2011) (Spring H). Photograph Joanne Denyer

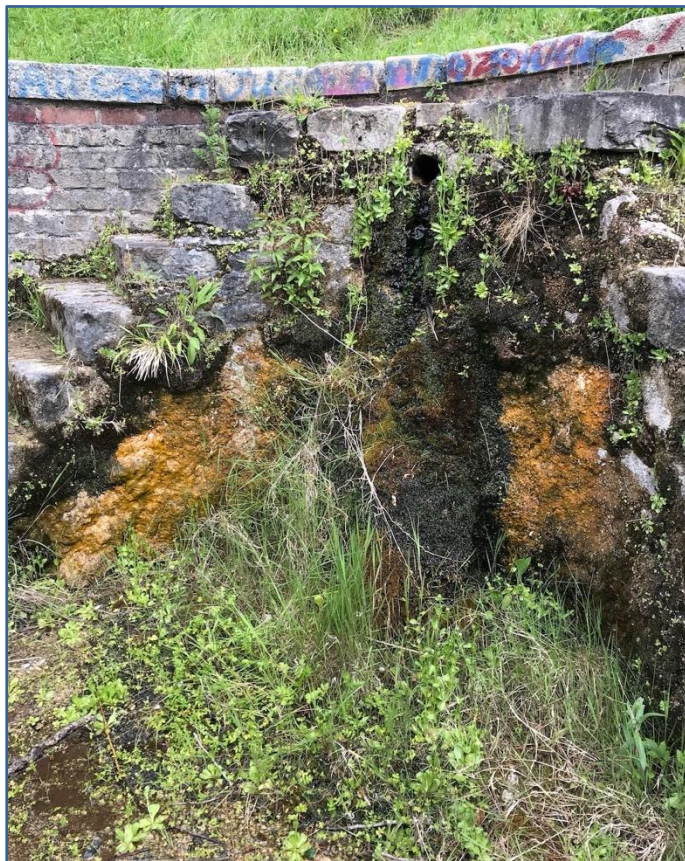
Figure 14 Roman Bath with tufa formation (2019) (Spring H). Photograph Joanne Denyer

Assessment criteria	Value	Comment
No. of positive indicator species (species diversity)	6	Moderate Diversity
Tufa formation	Tufa cascade	Smaller consolidated deposits or strongly formed paludal tufa (high tufa formation)
Other positive characteristics	Yes	Associated with historic/ cultural feature ('Roman Bath')
Condition assessment	-	Not undertaken. No current obvious impacts to spring, but there is litter dumping within the Roman Bath, graffiti and burning of adjacent grassland
Located within protected site	Yes	-
Within/adjacent to SAC with *7220 as Qualifying Interest	Yes	Within SAC
*7220 petrifying spring	Yes	≥3 positive indicator species with tufa formation
Conservation score	6	Estimated as requires full survey to assess
National ranking	High	Estimated as requires full survey to assess

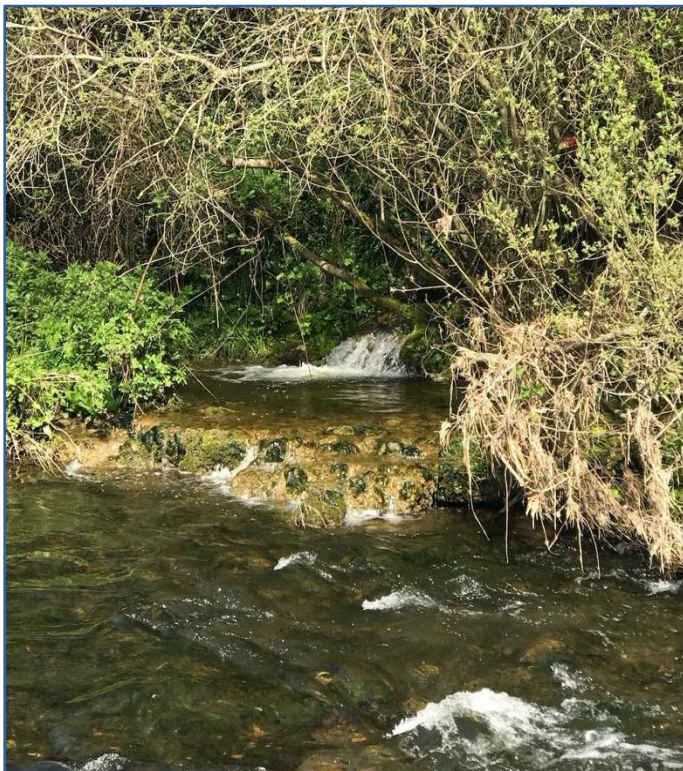
Figure 16 Tufa dam formation where stream (Spring I) joins main river. Photograph Joanne Denyer

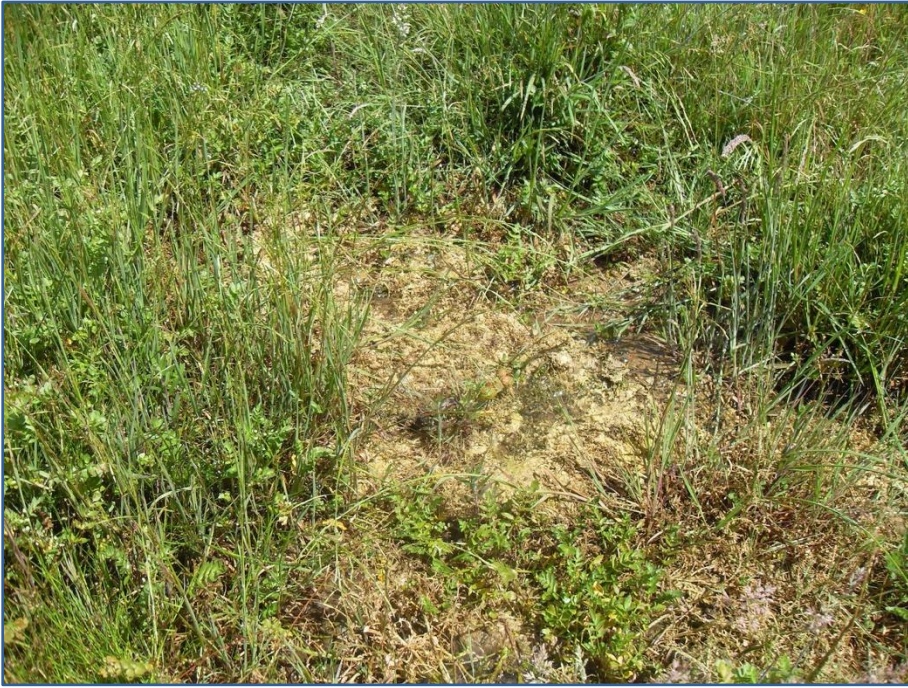
This is a small petrifying spring that arises in an area of wet grassland and scrub within a river valley. It flows down a slope, through an area of marsh and into the river downstream. It is an example of **Group 3** *Brachythecium rivulare-Platyhypridium riparioides* tufaceous streams and flushes vegetation community (Lyons & Kelly, 2017). An initial survey in 2010 found significant tufa formation (Table 25; Figure 17), but only two positive indicator species were recorded. This was due to scrub encroachment and lack of grazing. In 2019, very little tufa formation was present at the springhead, with no positive indicator species recorded (Table 25; Figure 18). However the spring still had good water flow and there was tufa present under the adjacent scrub downstream of the springhead. This further decline in condition is attributed to changes to water quality in the spring catchment area and continuing lack of management at the site. It is considered that with improvement to water quality in the catchment area and suitable site management (scrub clearance and grazing or mowing), the spring vegetation has the potential to recover. Therefore expert judgement was used to classify the spring as *7220, but in unfavourable condition. This finding can be reviewed after any future surveys. The spring is part of a small complex of springs in this area and associated with two Annex I wetland habitats 'Alluvial forests with *Alnus glutinosa* and *Fraxinus excelsior*' [*91E0] and 'Hydrophilous tall herb fringe communities of plains and of the montane to alpine levels' [6430].

Figure 17 Petrifying spring with abundant tufa (2010) (Spring J). Photograph Joanne Denyer

Assessment criteria	Value	Comment
No. of positive indicator species (species diversity)	0 (2019)	2 (2010) = Moderate Diversity. Minimum of 3 usually required for *7220
Tufa formation	Paludal tufa	2019 = patchy paludal tufa (low tufa formation) 2010 = strongly formed paludal tufa (high tufa formation)
Other positive characteristics	Yes	Associated with Annex I wetland habitats 91E0 and 6430
Condition assessment	Unfavourable-Inadequate	Fails on positive and negative indicator species due to vegetation succession and nutrient enrichment
Located within protected site	No	-
Within/adjacent to SAC with *7220 as Qualifying Interest	No	-
*7220 petrifying spring	Yes	Currently no positive indicator species present. Species diversity has declined due to the poor condition of the spring. This is potentially reversible and so expert judgement is used to still assess as *7220.
Conservation score	2	-
National ranking	Low	Usually springs with 'Low' ranking are not considered to be *7220 but expert judgement is used to classify as *7220 (see above).

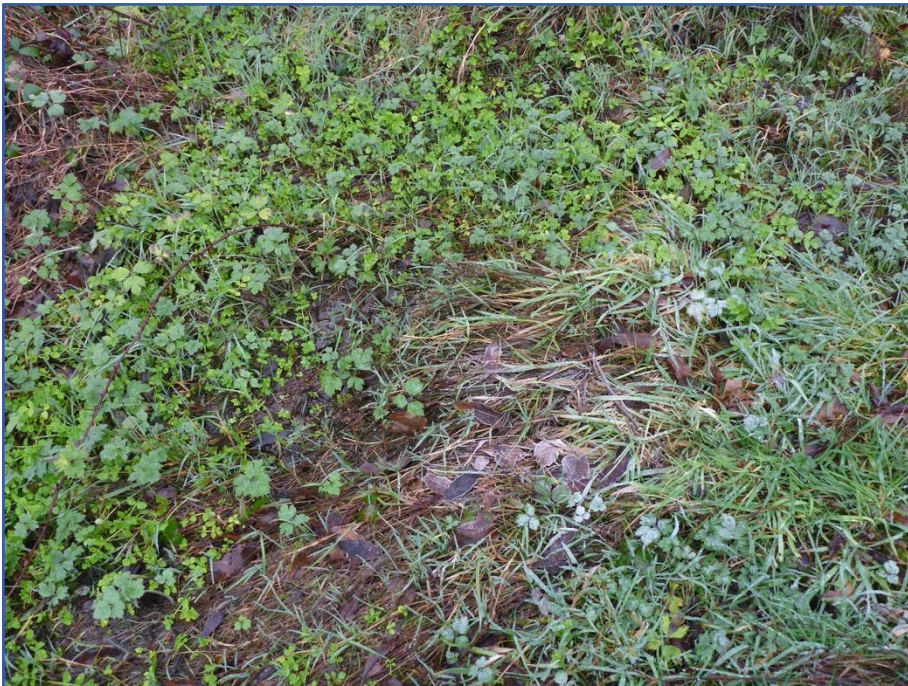
Figure 18 Petrifying spring with little tufa (2019) (Spring J). Photograph Joanne Denyer

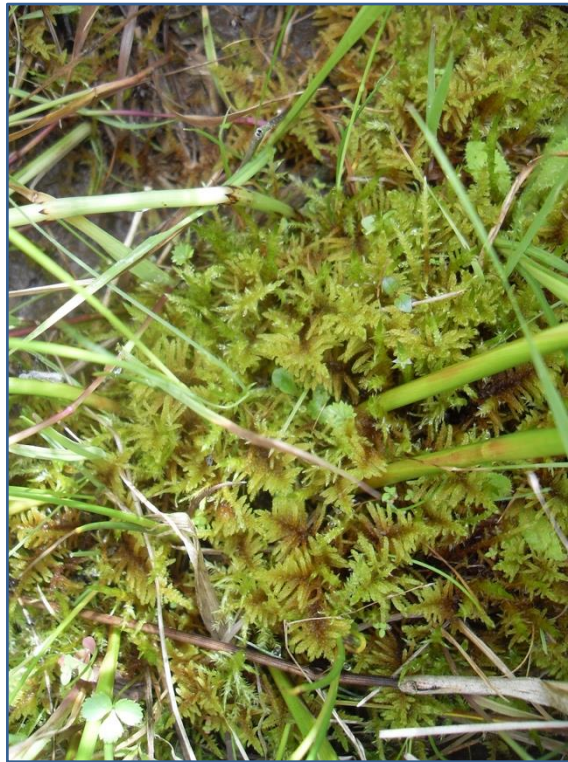
This spring is located on a slope within a river valley. The spring was surveyed in 2010 and found to be an example of *7220 habitat, with six positive indicator species and paludal tufa present (Table 26; Figure 19). It was an example of the **Group 4** *Palustriella commutata*-*Agrostis stolonifera* Springheads vegetation community (Lyons & Kelly, 2017). The spring was accidentally damaged in 2016 with complete removal of the spring vegetation (Figure 20). Groundwater however was still emerging in the area of the former spring. The spring was re-surveyed one year later and petrifying spring vegetation was regenerating and there was some tufa formation present (Table 26; Figure 21). Expert judgement was used to classify the spring as *7220, but in unfavourable condition. The petrifying spring was re-surveyed in 2021, five positive indicator species were recorded and the spring was assessed as being in good condition, five years after the damage occurred (Figure 22). This shows that although the spring vegetation and tufa were damaged, the spring water quality and quantity were not permanently impacted. The spring is part of a complex of springs in this area which adds to its ecological value.

Figure 19 Abundant *Palustriella commutata* in petrifying spring prior to damage (Spring K). Photograph Joanne Denyer

Criteria	Value	Comment
No. of positive indicator species (species diversity)	1 (2017)	6 positive indicators present in 2010; 0 in 2016; 5 in 2021
Tufa formation	Paludal, oncoids & ooids	Sparse tufa (low tufa formation)
Other positive characteristics	Yes	Part of spring complex which contains a very large tufa mound
Condition assessment	Unfavourable-Inadequate	Spring severely disturbed in 2016
Located within protected site	No	-
Within/adjacent to SAC with *7220 as Qualifying Interest	No	-
*7220 petrifying spring	Yes	Fails minimum criteria, but expert opinion used to assess as *7220 as recovering from former disturbance
Conservation score	3	-
National ranking	Moderate	The ranking is increased from low, as it is part of a spring complex

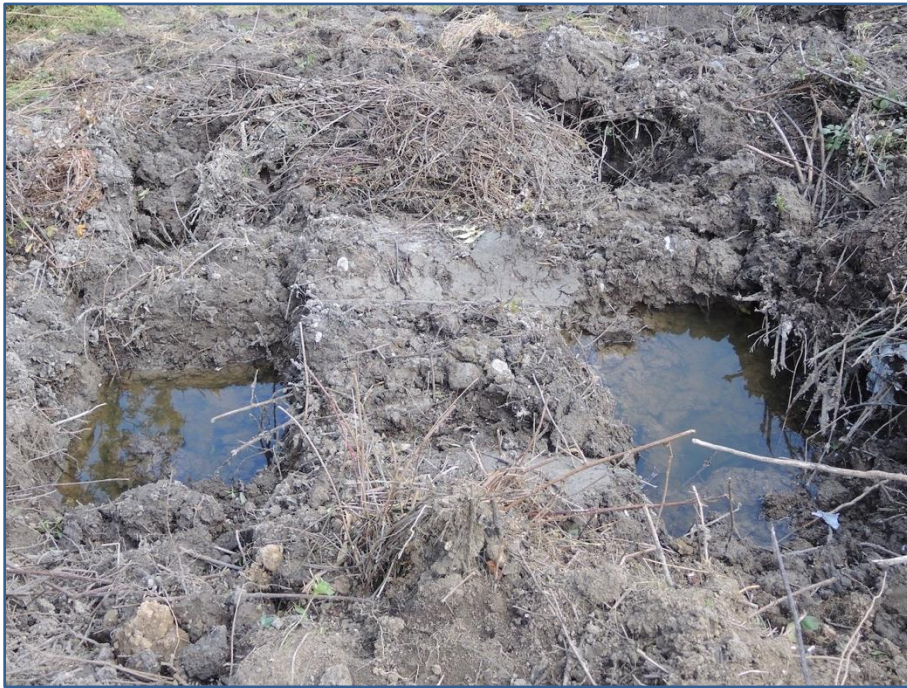
Figure 20 Petrifying spring with no vegetation due to accidental damage (Spring K).
Photograph Joanne Denyer

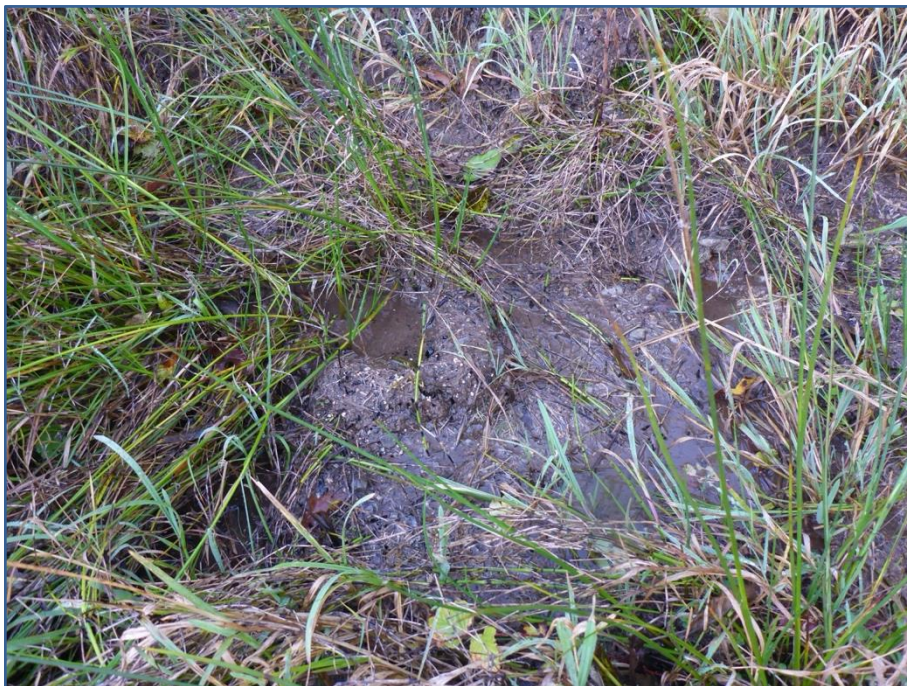
Figure 21 Recovery of Petrifying spring vegetation one year after accidental damage
(Spring K). Photograph Joanne Denyer

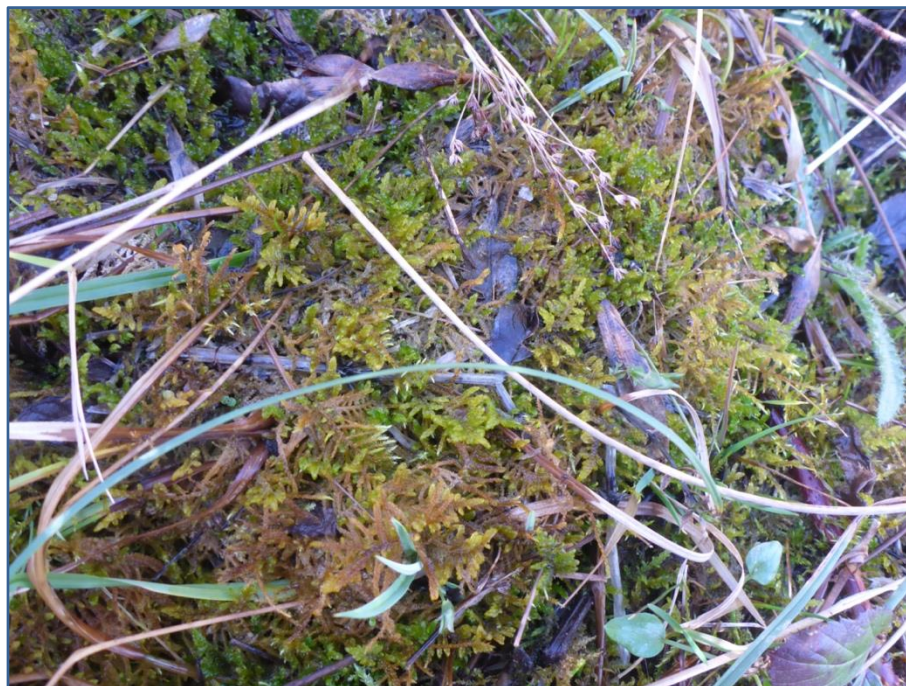
Figure 22 Recovery of Petrifying spring vegetation five years after accidental damage with abundant *Palustriella commutata* (Spring K). Photograph Joanne Denyer

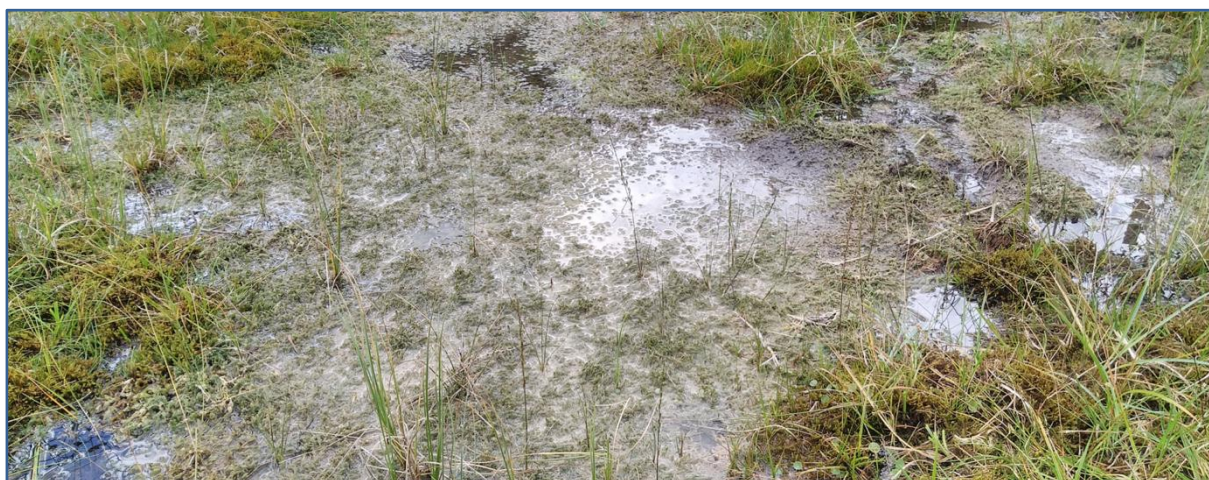
Figure 23 Petrifying spring in lagg zone of bog, dominated by *Chara globularis* (Spring L). Photograph George Smith.

Criteria	Value	Comment
No. of positive indicator species (species diversity)	8	Moderate diversity
Tufa formation	Paludal	Sparse tufa (low tufa formation)
Other positive characteristics	Yes	Occurs in a diverse complex of wetland communities including Annex I habitats 91D0 and 7140
Condition assessment	Favourable	-
Located within protected site	No	-
Within/adjacent to SAC with *7220 as Qualifying Interest	Yes	Within 1 km
*7220 petrifying spring	Yes	≥3 positive indicator species with tufa formation
Conservation score	5	-
National ranking	High	-
