UKRAINE

BORODYANKA CITY, KYIV OBLAST

IMAGERY ANALYSIS: 2 May 2022 PUBLISHED: 14 May 2022 V1

UNOSAT Damage Assessment Overview Map

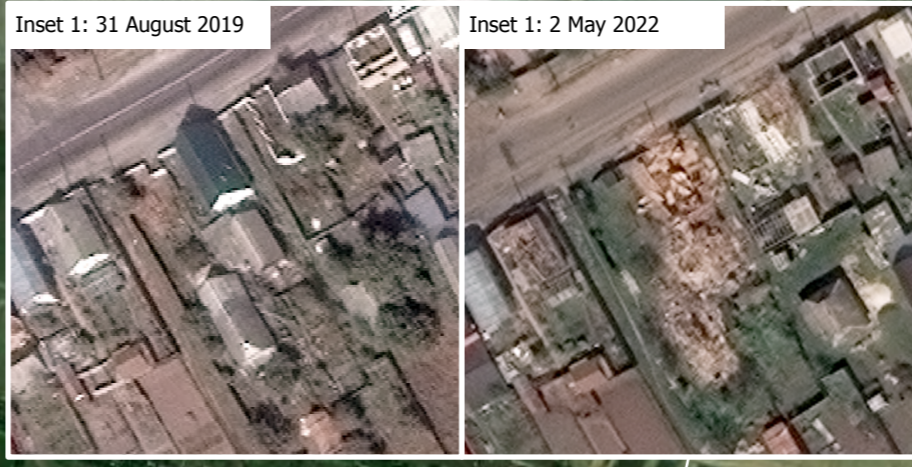
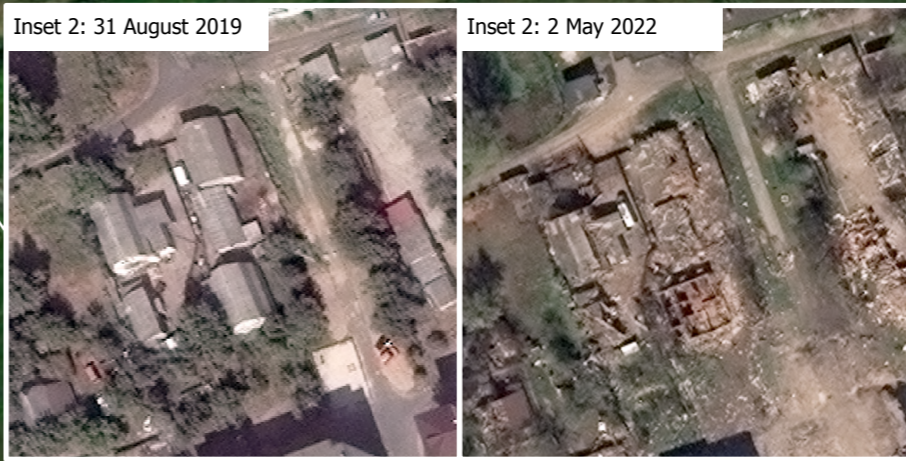
This map illustrates a satellite imagery based building damage assessment in the city of Borodyanka. Based on imagery collected on 2 May 2022, analysis shows that 164 structures sustained damage visible in the satellite imagery. Out of these, 42 are destroyed, 52 severely damaged, 60 moderately damaged and 10 possibly damaged. While no complete count of buildings for Borodyanka is available, an open source dataset which is visibly incomplete indicates at least 1538 structures in the area.

This analysis is based on structures visibly damaged as of 2 May 2022 as seen in marginally degraded satellite imagery affected by light clouds and other limiting factors. This is a preliminary analysis and has not yet been validated in the field. Please send ground feedback to United Nations Satellite Centre (UNOSAT).
