Accident

Aircraft Type and Registration:	AW139, 5N-BOX
No & Type of Engines:	2 Pratt & Whitney Canada PT6C-67C turboshaft engines
Year of Manufacture:	2012 (Serial no: 31386)
Date & Time (UTC):	13 November 2023 at 0958 hrs
Location:	Norwich Airport
Type of Flight:	Commercial Air Transport (Non-Revenue)
Persons on Board:	Crew – 2 Passengers – None
Injuries:	Crew – None Passengers – N/A
Nature of Damage:	Damage to main rotor blade tips
Commander's Licence:	Airline Transport Pilot's Licence
Commander's Age:	35 years
Commander's Flying Experience:	2,600 hours (of which 2,100 were on type) Last 90 days – 200 hours Last 28 days – 80 hours
Information Source:	Aircraft Accident Report Form submitted by the pilot

Synopsis

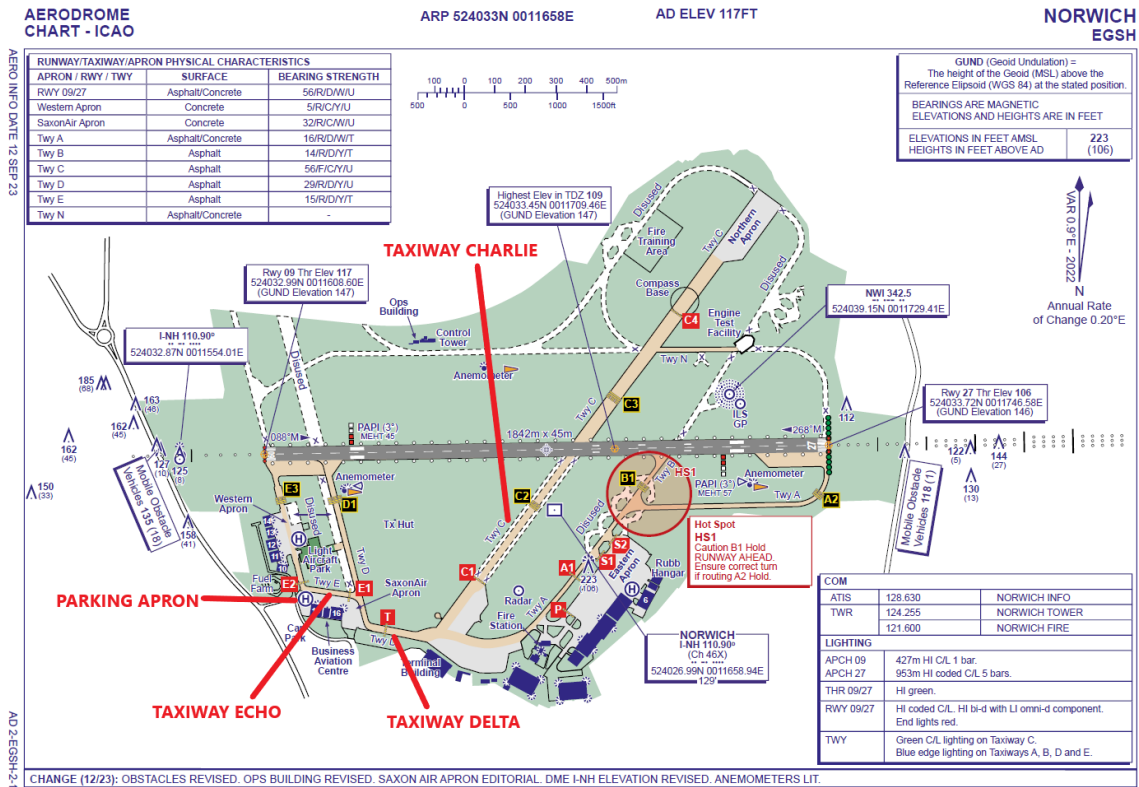
Figure 1
Norwich Airport chart

The helicopter made an approach to Runway 27 and vacated at the intersection with Taxiway Charlie (Figure 1). The helicopter was manoeuvred south down Taxiway Charlie and then turned right to continue via Taxiways Delta and Echo to the parking apron (Figure 1).

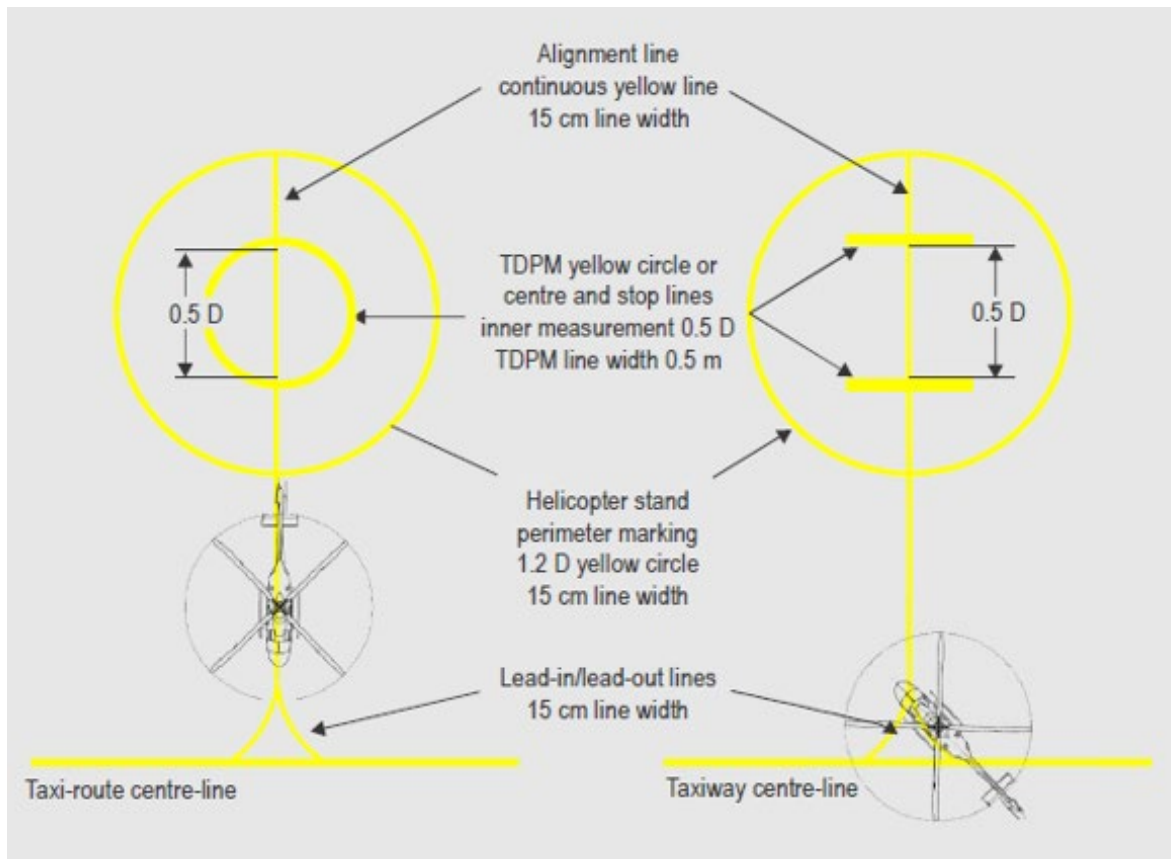
Figure 4

The standards for helicopter parking stand markings are contained in Annex 14 to the Chicago Convention. An extract showing standard marking layouts is at Figure 4.

The stands would be resized for different helicopters in the early part of 2024 and the stand markings would be erased and replaced with new painted surface markings.
