Planning Register - Part 1

Reference Number: 24/00044/LBC

Description of Development: Remove existing floor slab and replace at lower level. Remove and replace existing ceiling at higher level With like for like materials. Remove 2 no. horizontal Roof beams. Service penetration through walls and Roof, opening and reinstatement of a section of Roof to facilitate lifting of distillery equipment. Door removed and to be replaced with louvre screen

Supporting statement to accompany application for listed building consent
For
Nunton Steadings, Isle of Benbecula

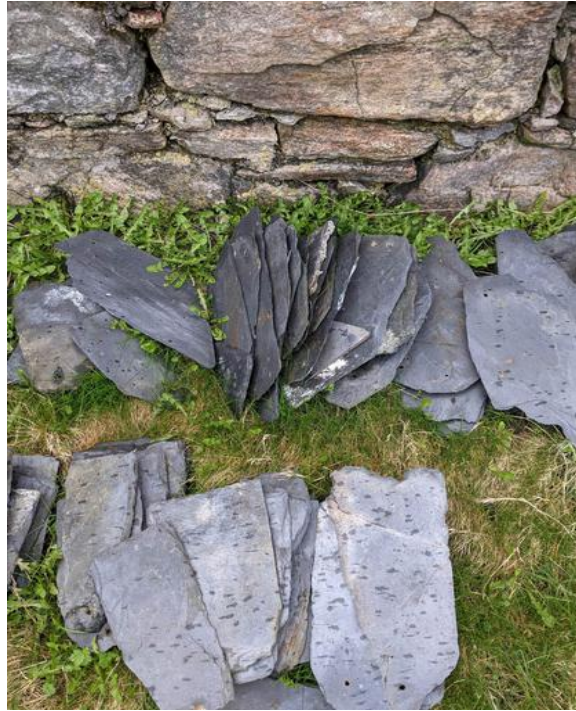
- The traditional slate, laid in diminishing courses has been repaired over time but also the lower rows, nearest the eaves , have been replaced with what is assumed to be Spanish slate at a fixed gauge.

- Generally, however, the roof covering appears to be in a serviceable state of repair, with no significant defects.

Image 8 – Existing Slate roof condition

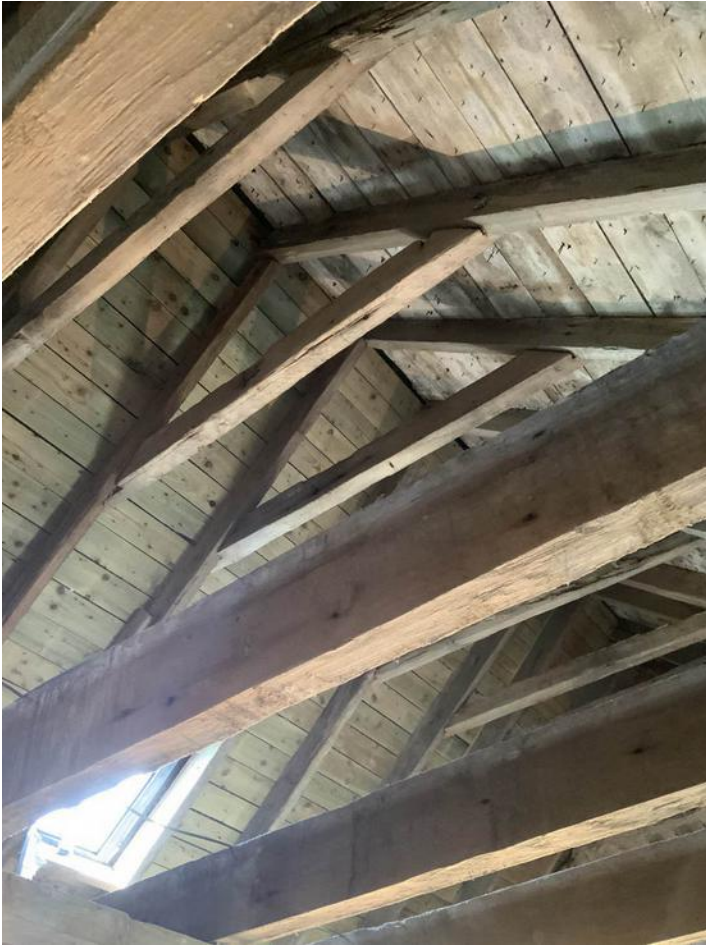
Image 13 – Existing room to become main still room, showing timber lining

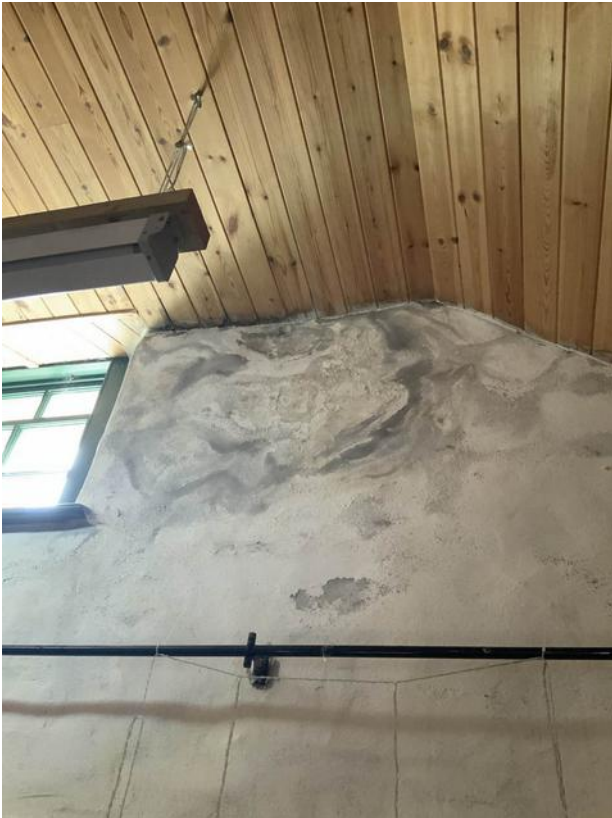
- Exposed timber lintels were examined at several windows.
- There is evidence of wood worm although this is not believed to be an active infestation.
- Exposed wood was observed to be dry with no obvious signs of rot or fungal growth.
- The walls of buildings of this age sometimes incorporate concealed timbers which are at risk of decay and wood beetle (for example, timber lintels and any areas of panelling or dry lined walls).
- All structural timbers will be inspected by a Structural Engineer.
- Any replacement timber will be on a like for like basis.

Image 18 – Example of timber lintel
