REPORT OF  
THE ROYAL COMMISSION  
to inquire into and report upon the  
CAUSE OF THE ACCIDENT  
which occurred to the  
SCAFFOLDING  
on the  
D.I.C. BUILDING  
on 8 MAY 1957

*Presented to the House of Representatives  
by Command of His Excellency*

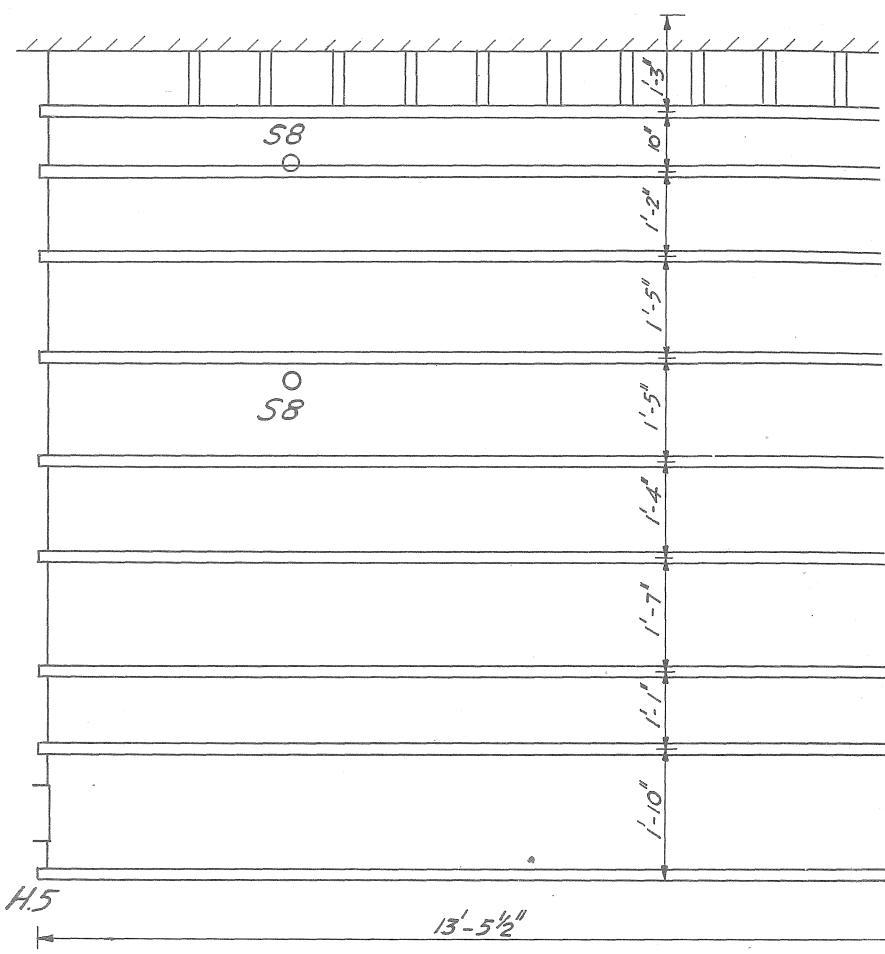
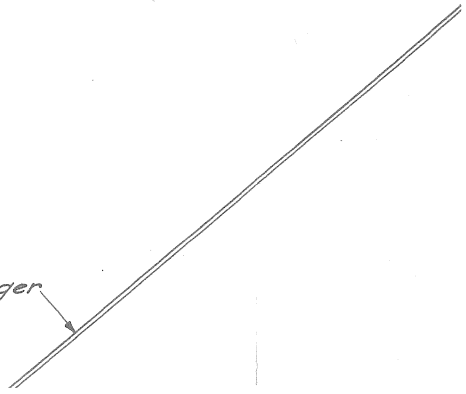
**PART PLAN OF VERANDA,**  
 SCALE:  $\frac{1}{2}'' = 1'-0''$

42. At the same time we cannot escape the conclusion that the overload had caused some elastic deflection or other yielding of the oregon joists of the verandah, and that this movement may have aggravated the conditions which we think led to the collapse. On the other hand we do not accept the theory that the oregon joists carrying the main load of the scaffolding collapsed by being pushed down past the flanges of the rolled steel joists which supported them, or that a standard of the scaffold punctured the verandah. We believe that the scaffolding itself was in a highly unstable condition, and that the first major failure was the buckling of the heavily loaded and poorly restrained standards. This allowed the crumbling framework of the scaffolding to drop down, subjecting the hangers supporting the steel joists of the verandah to impact which in turn caused the wrought-iron bolts connecting the hangers to the verandah joists to fail. Three panels of the verandah then collapsed to the pavement.

43. We find nothing in the behaviour of the verandah which is inconsistent with its original design and construction; in other words it was adequate in strength to carry any loading which it would normally have been expected to carry. Its condition at the time of collapse was, for all reasonable and practical purposes, sound.
