Bamboo under the Microscope

By Wolfram Schott

Some observations regarding
Arundinaria amabilis
as a rodmaking material

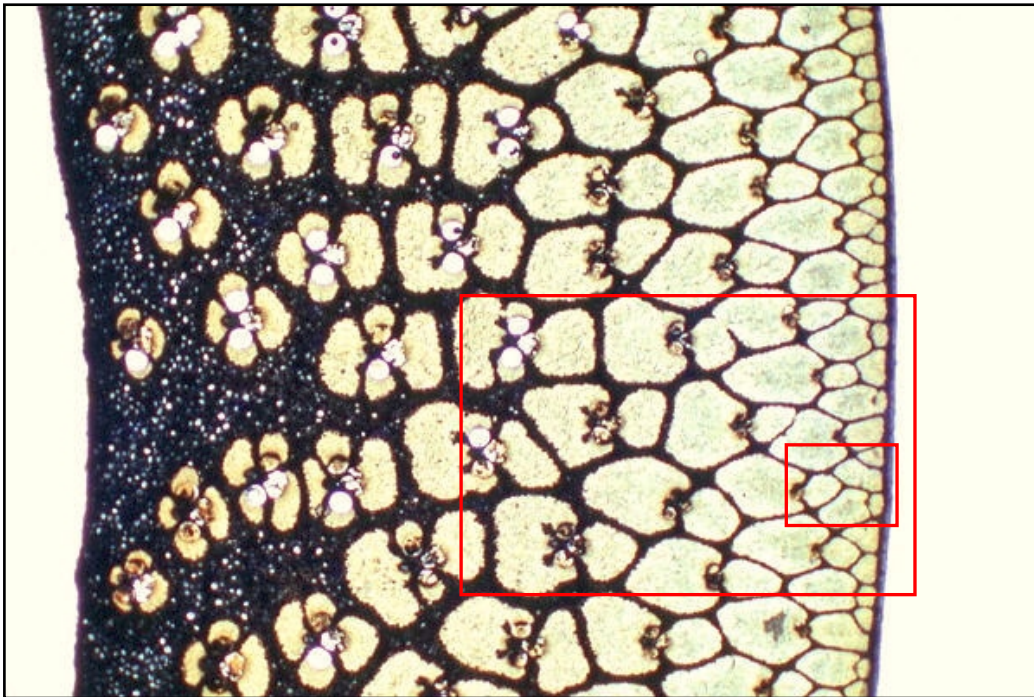
Fig. 1
Long side of picture: 6.6 mm (0.26 in)
 Cross section through wall of culm. Yellow: "powerfibers", black "pith". The fibers conduct the light, which is coming from underneath, much like glass-fibers, appearing bright (yellow). The "pith" cells reflect the light back down and appear dark. This is opposed to what the naked eye sees: light falling onto the long-ish powerfibers from above will disappear "down into the depth", the fibers appearing dark brown. "Pith"

cells will reflect the light, appearing white or buff-coloured. The "power fibers" are actually what is called vascular bundles, consisting of thousands of individual cells each, tightly packed together. The black areas represent the "pith", or basic tissue, between the vascular bundles which is botanically called parenchyma and is built up of elongated cells, which become more and more roundish towards the inner part of the culm (at left). White round holes in the left half of the section are large vessels (metaxylem), which serve as water conducting pipes. Red rectangles show approximate positions of Figs. 2 and 3.

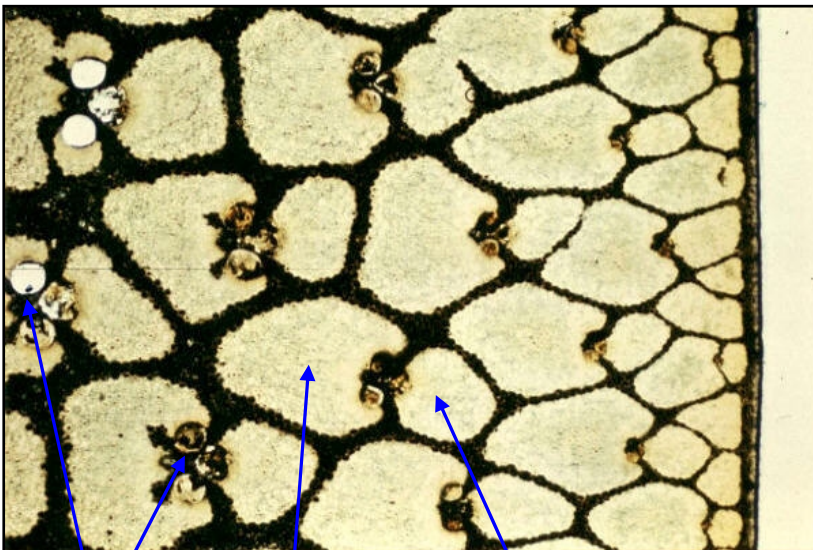
Fig. 2
Long side of picture: 3.2 mm (0.126 in)
 More details can be seen: the "powerfibers", or vascular bundles, are grouped in pairs (phloem and xylem) on either side of a set of vessels. They are smallest near the outside of the culm, where also the surrounding basic tissue is very narrow. The relation between vascular bundles and basic tissue is, dependent of the quality of the culm, something like 50/50%. This sample (Fig.1) was measured to 56% "powerfibers". The outer half of the culm consists of 75% "powerfibers". This is the part of a culm which is usually used for rod making.

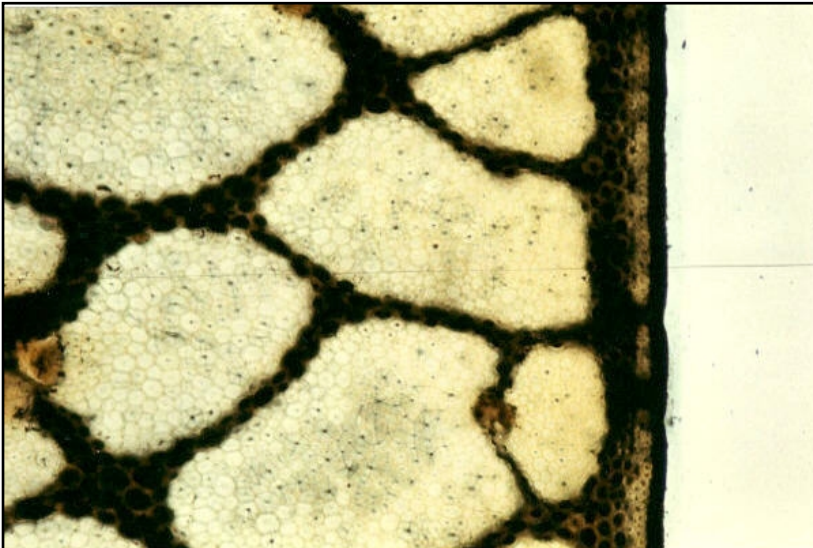
Fig. 3

Long side of picture: 1.3 mm (0.051 in)
 Fine structures within the vascular bundles become visible. These are tightly packed cells. The skin can be subdivided into a black outermost layer (epidermis), followed by a light (yellowish-brown) layer, and another, somewhat thicker, black layer (cortex).

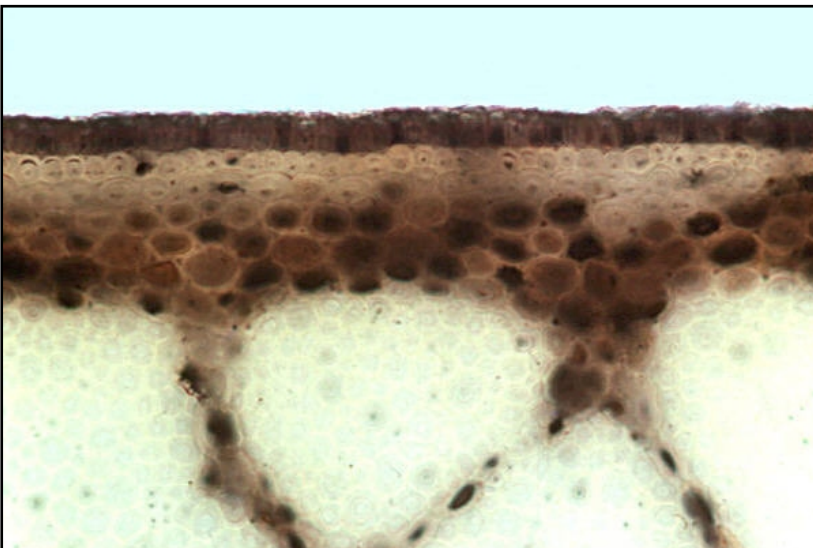
Fig. 4

Long side of picture: 0.23 mm (0.009 in)
 Skin, or rind, in detail. The outermost layer is a one-cell-thick layer of 0.015 mm (0.00059 in), the rod maker's "enamel". Next comes a tan layer of even smaller cells, which is 0.025 mm (0.00098 in) thick, and finally a layer of coarser, dark brown/black cells, which is 0.03 mm (0.00118 in) thick. The last two layers are also called "under-enamel" by some rod makers. Sum total is 0.07 mm (0.00275 in). All of this must be carefully removed to expose the vascular bundles. But nothing more. The yellow vascular bundles are over exposed (too bright), to properly capture the dark skin structure.

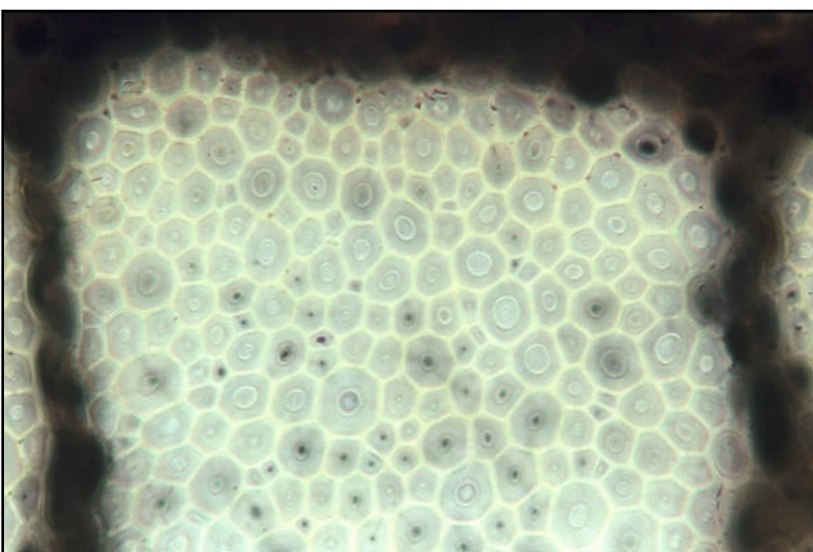
Fig. 5

Long side of picture: 0.23 mm (0.009 in)
 A vascular bundle from just under the skin. The individual cells are clearly visible. Their average diameter is approx. 0.01 mm (0.0004 in) with some smaller ones, possibly tapering ends of cells, and a few larger ones. Taking this average diameter of 0.01 mm (0.0004 in), this means a density of $100 \times 100 = 10000 \text{ cells/mm}^2$, or 1 million cells/cm², or 6.45 million cells/inch². An impressive number indeed. They show polygonal outlines, most of them hexagonal. At very high magnifications, internal structures, like concentric rings, can be detected.

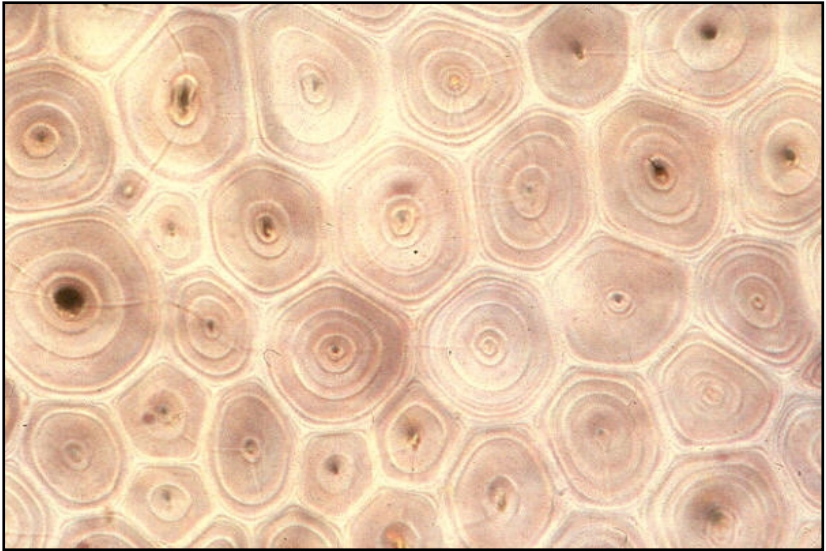
Fig. 6
 Long side of picture: 0.23 mm (0.009 in)
 Part of a vascular bundle from about the center of a wall (cf. Fig.1). Here the individual cells are much larger/coarser. Their diameters are two or three times as large as those in Fig. 5. The internal, or ultrastructure, is sharper visible, due to manipulation with the microscope. It shows the below described "polylamellate secondary walls". Visible also the yellow pectin, the bonding agent between the cells, and the lumen, or cell cavity, in the center of the cells. The shape and distribution of the cells reminds me much of a honeycomb.

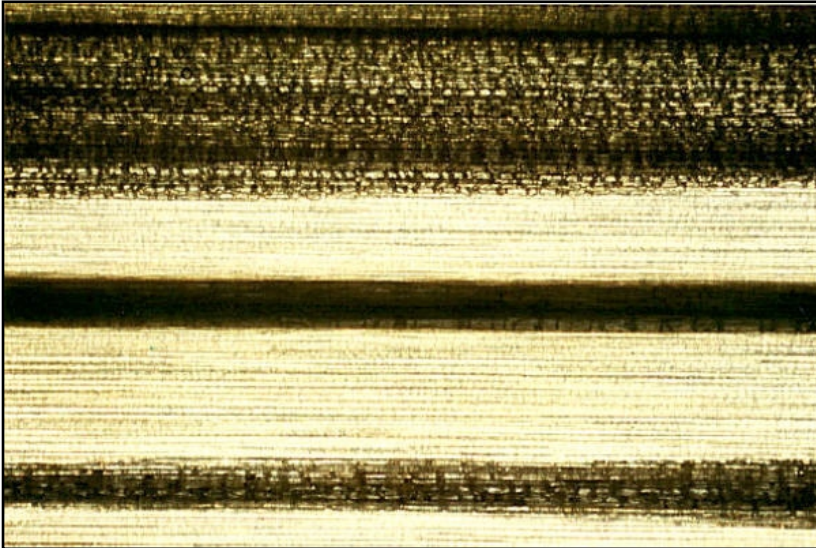
Fig. 8

Long side of picture: 1.3 mm (0.051 in)
 Longitudinal cut through bamboo. Yellow: vascular bundles, with the individual long fibers (cells) clearly visible. Black and somewhat transparent the rod maker's "pith" (parenchyma). These are short, elongated cells of 0.03 to 0.05 mm (0.0012 to 0.002 in) diameter and two to four times that length.

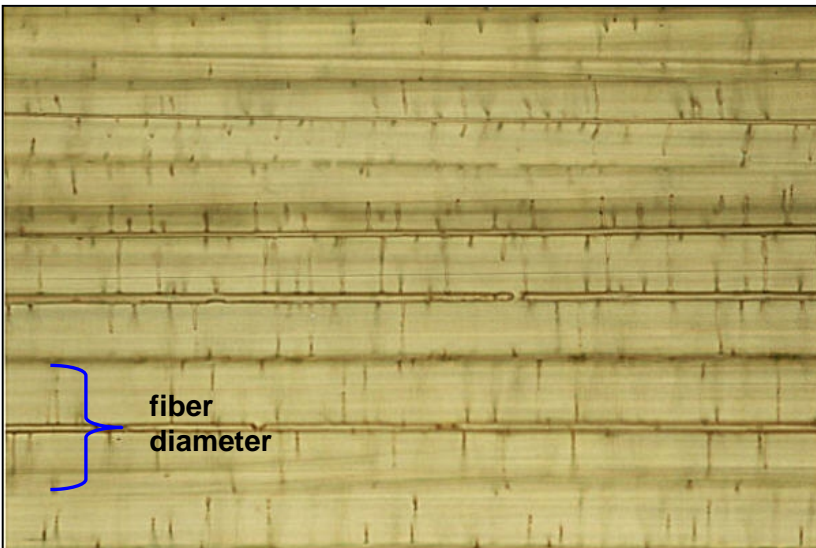
Fig. 9

Long side of picture: 0.23 mm (0.009 in)
 A few fibers, or cells, seen longitudinally. The center of the cells is easily recognised by its lumen, or cell cavity. From this lumen, radial structures, much like branches in a tree, reach perpendicular into the cell body. At close scrutinising of Fig. 6, one can faintly see some of these structures. The outer walls are not so easily seen in this picture, as several cells lie on top of each other, blurring the image somewhat.

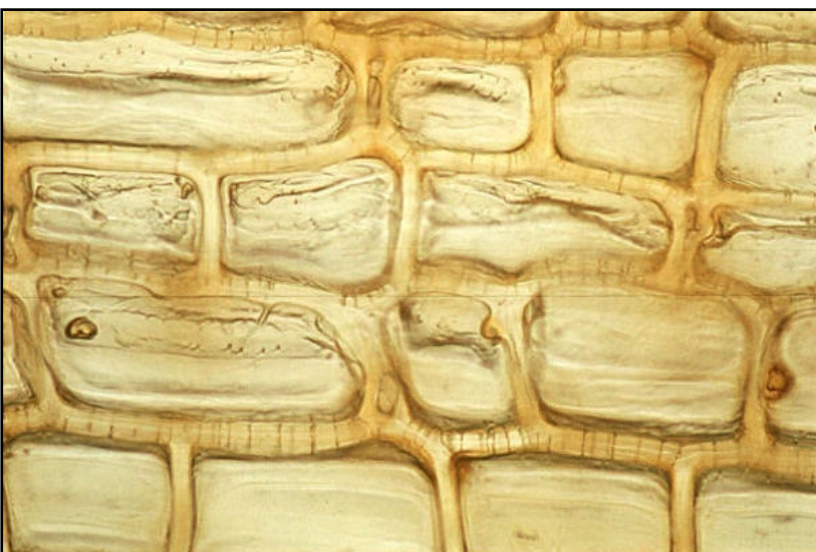
Fig. 10

Long side of picture: 0.23 mm (0.009 in)
 Parenchyma cells in strong magnification. They seem to "swim" in a yellowish matrix, which actually is the embedding epoxy, and are connected with each other and held at distance by tiny hair-like "bridges". These cover all sides of the cells, of course (here the top ones are ground off). Obviously, such short cells contribute nothing to the bending strength of either culm or rod, opposed to the above very long fibers (like a chain versus a rod). Maybe they serve as some sort of "shock absorber", both in the plant and in the fishing rod.

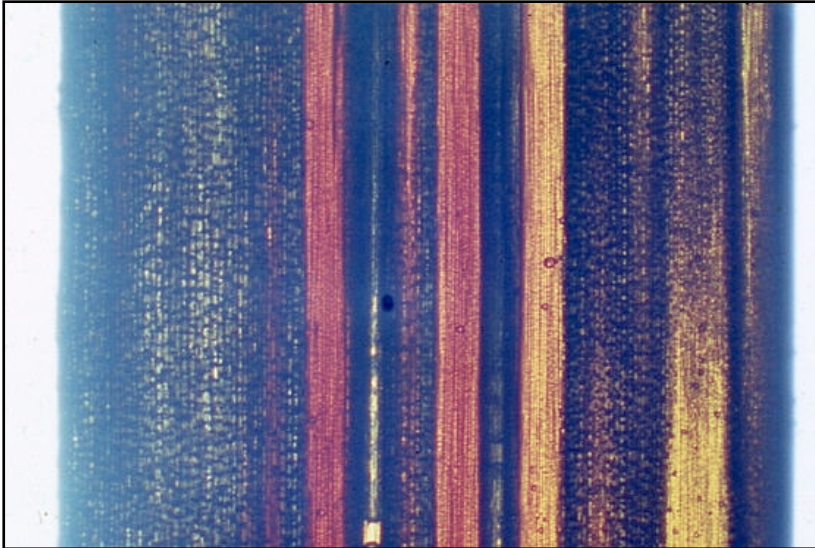
Fig. 14

Long side of picture: 6.6 mm (0.26 in)
 Longitudinal cut through wall of culm. Also in this view the outer vascular bundles (at right) are less brown than the inner ones (at left), cf. Fig. 11. Black "pith" overlying parts of some vascular bundles, especially the two rightmost ones, due to the cross-section not being perfectly parallel to the direction of the fibers. Strong light had to be used to penetrate the dark brown fibers perpendicular to their orientation. This is why the left side of the image is a bit blurred due to stray light.

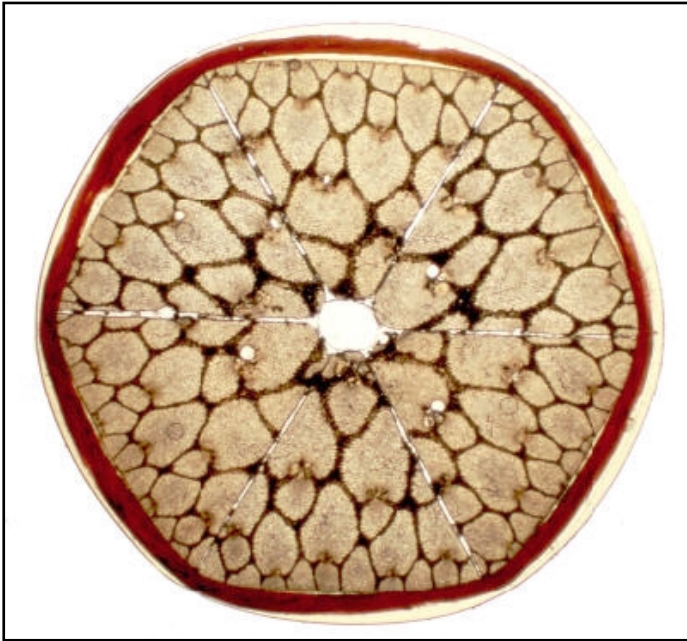
Fig. 16

Cross section from the tip joint of a rod. Flat-to-flat diameter (bamboo) 3.9 mm (0.153 in). The strips are milled to 60°, the centers, or apexes, are rounded, leaving a tiny hole in the center. Thin and even glue-lines. The outer flats are slightly rounded, following the curvature of the culm. The overall outside geometry shows a slight "off-hexagon" with the flats not exactly parallel to each other (see top versus bottom flat), which indicates some surface sanding. The strips show small vascular bundles, little more than the rind, or skin, is removed. This sample is a cut through an intermediate winding (red). On the left upper flat, the drawn-under threads of the invisible knot are seen. Between the bamboo surface and the thread a thin layer of varnish: the rod blank was varnished prior to winding. A good example of a commercially produced rod.

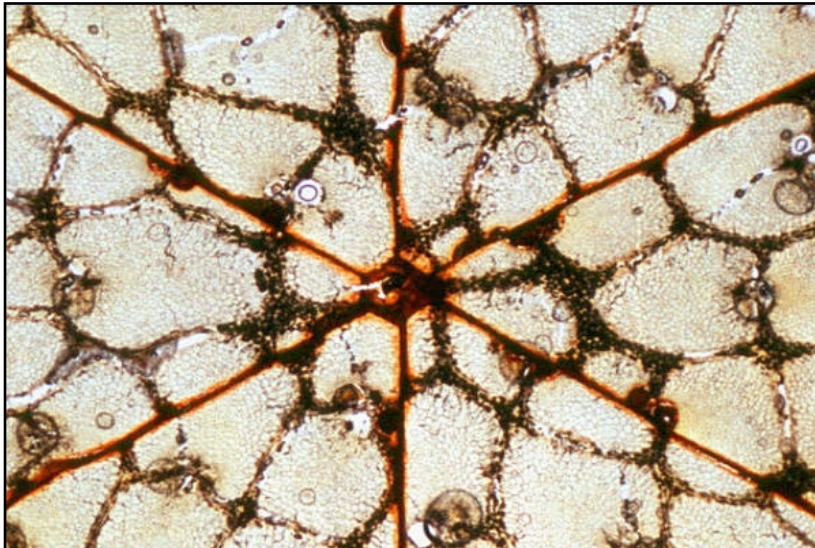
Fig. 17

Long side of picture: 3.2 mm (0.126 in)
Center of a rod, butt joint. This is a hand-planed rod. Perfectly planed strips, precise 60° angles. The innermost tip (apex) has been planed off. Red resorcinol glue is used, diluted with alcohol. The glue penetrates slightly into the fibers, making for a good hold.

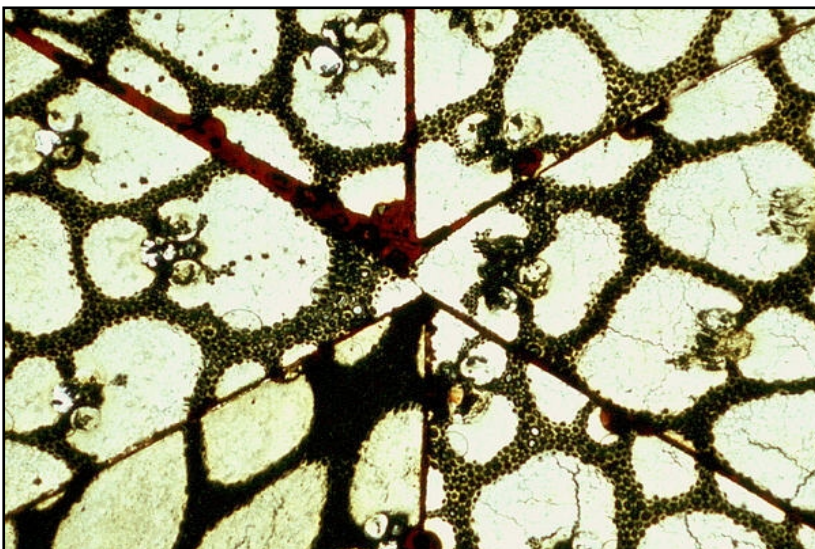
Fig. 18

Long side of picture: 3.2 mm (0.126 in)
Center of a rod, butt joint. Another hand-planed rod. Perfectly planed strips, precise 60° angle. The inner apexes are **not** planed (or sanded) off. The result is seen: the two horizontal strips (left and right) overlap each other, wedging the top-left one outwards, hence a thicker glue line. The whole center is disturbed, with uneven glue lines as another result. The outside geometry of this rod will be asymmetrical, with the three pairs of flats producing different values when measured. Resorcinol glue, undiluted.

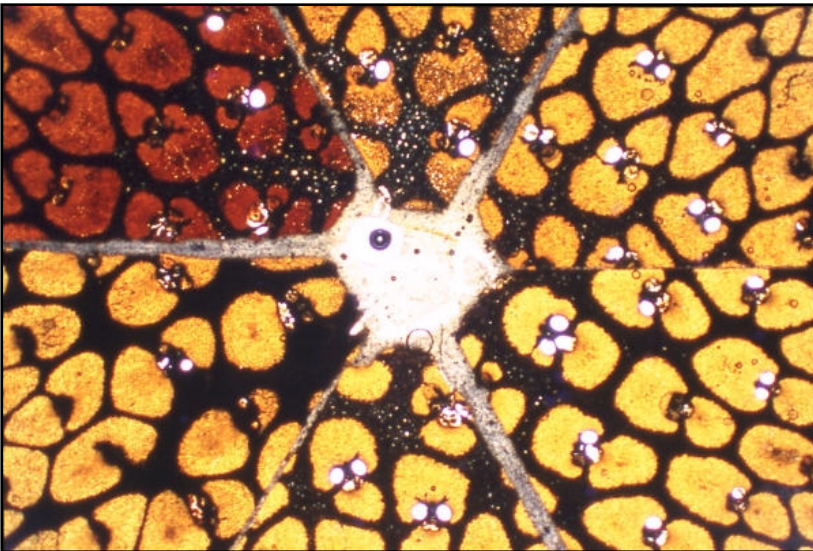
Fig. 23

Long side of picture: 6.6 mm (0.26 in)
 Rod center, about middle of butt. This is an impregnated rod, milled. Three different colours can be distinguished. Top left: dark brown. Top, top right and bottom left: medium brown/orange. Bottom and bottom right: dark yellow. This indicates three different batches of strips, each treated separately with somewhat variable results. Center angle 62 degrees, apexes trimmed off. Glue lines near center 0.3 – 0.6 mm (0.0118 - 0.0236 in) wide. Rather coarse vascular bundles, with much parenchyma in between.

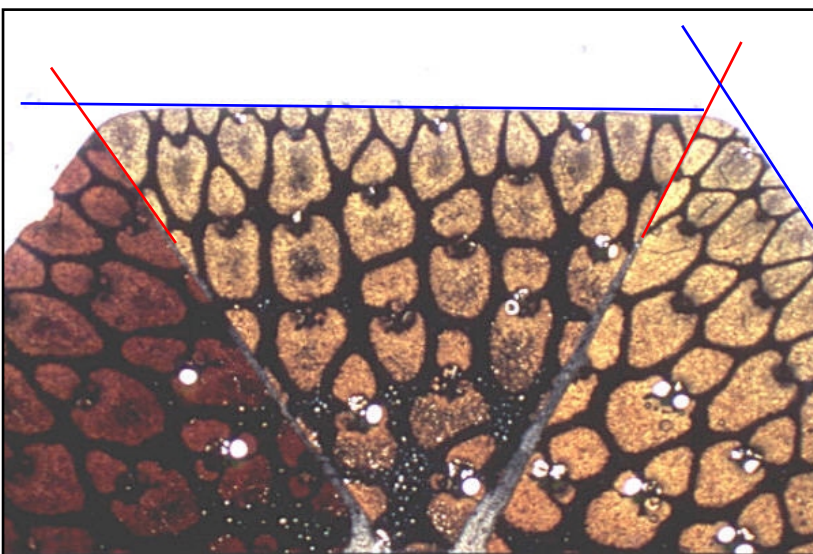
Fig. 24

Long side of picture: 6.6 mm (0.26 in)
 Same rod as Fig. 23, top half. Surfaces have been sanded flat and polished, corners rounded. Glue lines not ending at the corners (see red lines). The vascular bundles are rather large near the outside of the rod, indicating that a good deal of the best material has been removed. Compare with Fig. 1 or Fig. 2. The rod appears much darker to the naked eye than the sections might suggest. The strip at top left is almost black, the others dark brown.

Remark: Comparing Figs. 24, 25, 26 with Fig. 27, I would rather want to take off the enamel with sandpaper, carefully following the natural curvature of the culm. A true hexagonal shape, with perfectly flat outer surfaces and knife-sharp corners might look very "professional". However, it will also sacrifice a good deal of the most valuable outer powerfibers, especially in butts. Using hand-scrapers or the ubiquitous Stanley 212 scraper carelessly is liable to shave off not only the very thin skin, but also to dig into the topmost vascular bundles rather quickly. Using sandpaper one can actually watch the "uncovering" of the fibers through the "under enamel". Another negative aspect of sharp corners is shown further down, in the chapter on varnish.

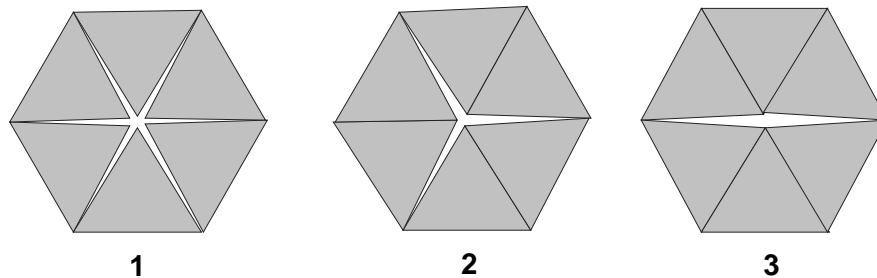
Fig. 28

No. 1 is the most symmetrical one, and all pairs of flats are parallel to each other. No. 2 is also symmetrical around the center, but the three pairs of flats are not parallel to each other. No. 3 is symmetrical to a horizontal plane only, not to the center.

Fig. 27 is an example of No.1, and Fig. 23 is an example of No. 2. I have never observed No. 3.

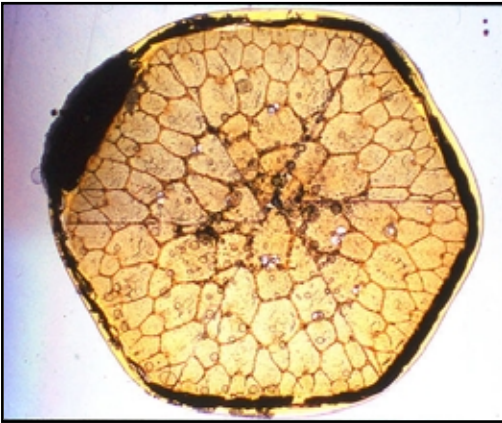
Fig. 31

Cross section of milled rod, tip section. Flat-to-flat dimensions of bamboo 4.0 mm (0.157 in). Center angle 60°. Very thin glue lines. A cross cut through a guide winding (black thread). Guide foot at top left flat. A hand varnished rod.

Using Adobe Photoshop, I have removed the black threads of the guide winding in Fig. 31, plus the guide foot and the varnish. With Coral DRAW, I have constructed six equilateral triangles (with 60° angles) and of equal size. These are placed over the six strips of the rod section. The bottom strip determined the size (height) of the triangles. The result shows the probable original outline of the glued-up strips, provided nothing has been removed from the flat of the bottom strip. It also shows that the two "halves" of the rod section have moved along a glue line in opposite directions, by approximately 0.2 mm (0.008 in). See blue arrows. Sanding off the glue and some powerfibers (most on top right strip), possibly followed by polishing with steel wool (well-rounded corners) prior to varnishing has rectified this mishap ...

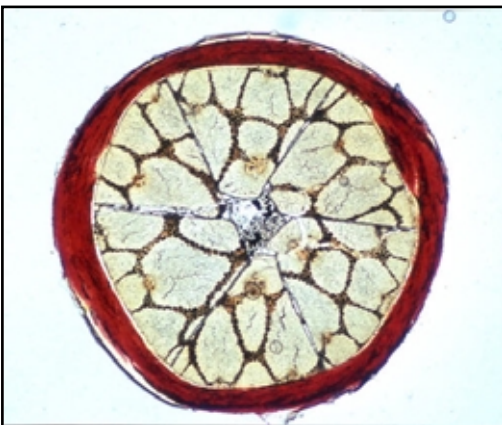
Fig. 33

Cross section of milled rod tip. Heavily sanded flats and corners, the rod is more round than hexagonal. Flat-to-flat dimensions of bamboo somewhere between 1.6 and 1.9 mm (0.063 and 0.075 in). Sample prepared through an intermediate winding. The drawn-under ends of the thread located on top right flat. The strips are rotated counter clock-wise around the center.

Long side of picture: 3.2 mm (0.126 in)
 Cross section of milled rod tip. Heavily sanded flats and corners, the rod is more round than hexagonal. Flat-to-flat dimensions of bamboo somewhere between 1.6 and 1.9 mm (0.063 and 0.075 in). Sample prepared through an intermediate winding. The drawn-under ends of the thread located on top right flat. The strips are rotated counter clock-wise around the center. This rod had broken lengthwise in two halves over a distance of some 20 cm, or $\frac{3}{4}$ foot, and was factory repaired (reglued), see arrows. Same photo as Fig. 33.

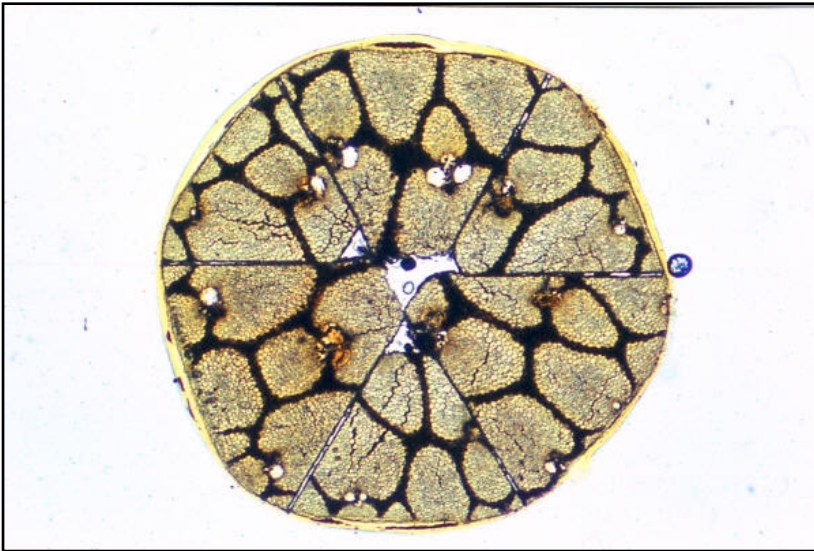
Fig. 35

Long side of picture: 3.2 mm (0.126 in)
 A cross section through the tip of a milled rod. Flat-to-flat dimensions approximately 1.9 mm (0.075 in). Center angles 60 degrees, apexes trimmed. All six flats sanded to various degrees, corners rounded. Why every other strip is deeper than its neighbour, I do not know. Maybe it is intended, maybe just an accidental mismatch, with three strips taken, as a mistake, from the "wrong heap". This is a 3-and-3 strip, and node, rod. Thin varnish (yellow), mostly on the flats, and very little on the corners.

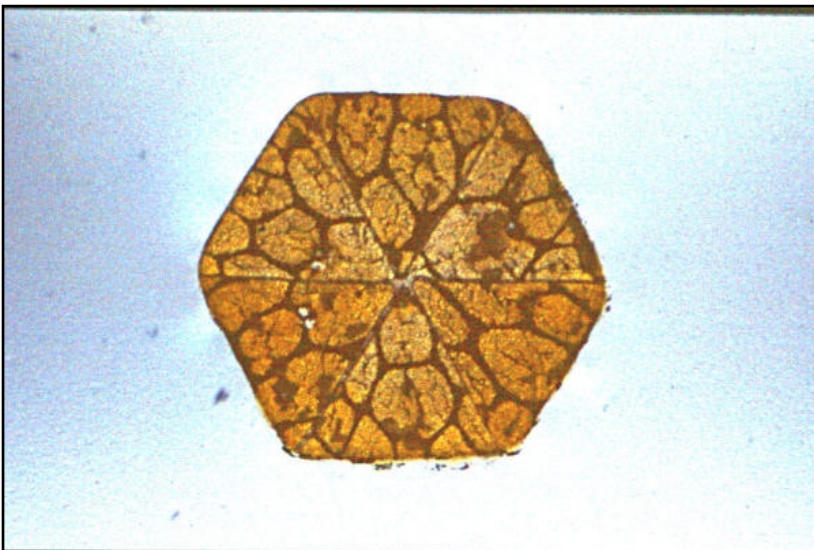
Fig. 36

Long side of picture: 3.2 mm (0.126 in)
 Cross-section through leeway cut-off from the tip of a 7' # 3 rod, milled. Flat-to-flat dimensions 1.46 mm (0.0574 in), very symmetrical. A three-and-three strip configuration (3 taken from one culm, and 3 from another). The top, bottom-left and bottom-right strips have a darker colour than the remaining other three. Not a very sharp photo, but I included it to demonstrate perfect milling and gluing, even down to such delicate dimensions. Hand planing can achieve the same precision, of course, and usually does so. However, mind your vascular bundles. There are not many left in such a tip.

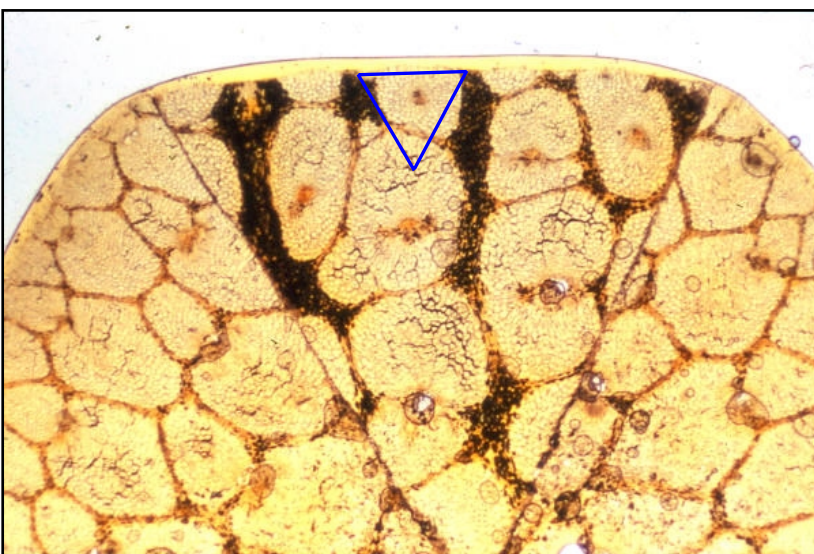
Fig. 37

Long side of picture: 6.6 mm (0.26 in)
 Cross section through milled rod, 60°, varnished, and cut through node. Few and large vascular bundles, with much parenchyma; compare with the two other strips.
 In blue, to scale, a triangle of 0.7 mm (0.027 in) depth (cf. Fig. 36). It may contain next to no, or one half, or even one whole, vascular bundle of inferior quality (cf. Figs. 1, 5 and 6). Three such nodes in one position will produce a very weak area indeed. I have seen several rods that broke, within the last 10 to 15 inches or so, of the tip, in such node stations.

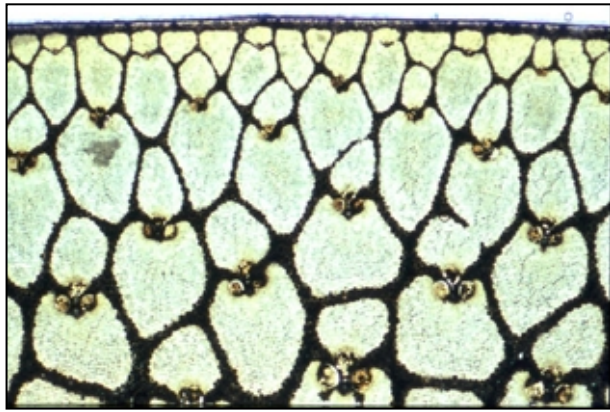
Fig. 38

A cross section through the outer third or so of a culm. Skin on top of picture. This is an average culm, and the area of this picture contains 75 % vascular bundles, or "powerfibers", and 25 % parenchyma, or "pith".

The amount and size of vascular bundles in finished rods can, and does, change considerably, depending on the care the strips have received. This affects the strength of the rod, of course.

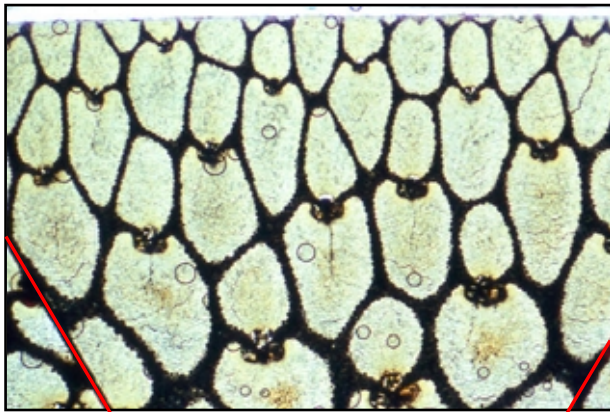
Fig. 39

One strip of a hand planed rod. The glue lines are indicated in red near bottom left and right corner. On top of picture, the surface of the strip. (In all 3 Figs. 39-41). An ever so slight rounding is seen, following the natural curvature of the culm. Little more than the skin has been removed. Compare size and distribution of vascular bundles with Fig. 34. This (whole) strip has 74 % "powerfibers" and 26 % "pith".

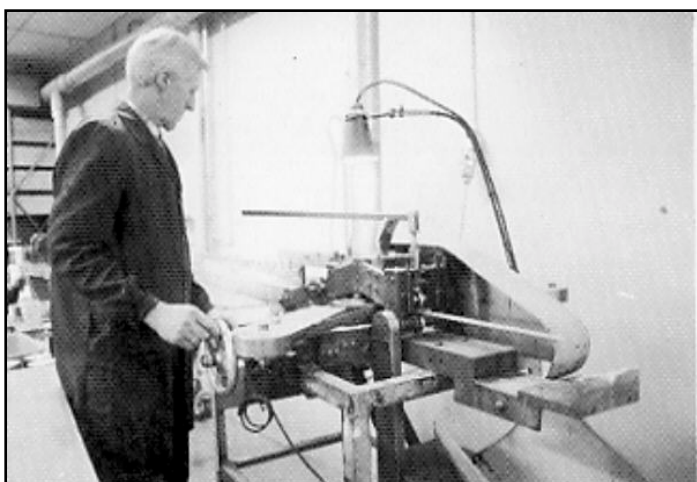
Fig. 42

Two opposing sides of a glued up rod section are simultaneously cleaned with double belt sanders. Both skin, glue and binding thread are taken off. The hand wheel controls the "gap" between the two belts, while the rod passes through, moved by a transport mechanism. Much skill is needed to follow the taper, repeatedly in three successive runs, especially with tips ...

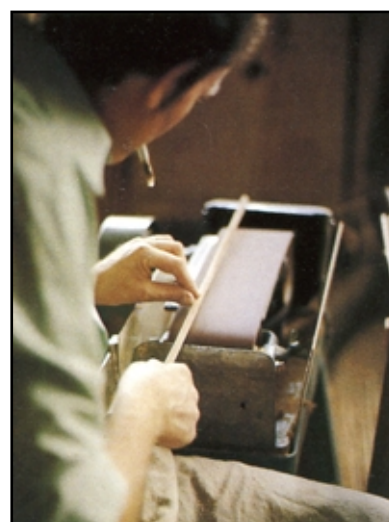
Fig. 43

Another belt sander in action, cleaning the surfaces of a rod blank.

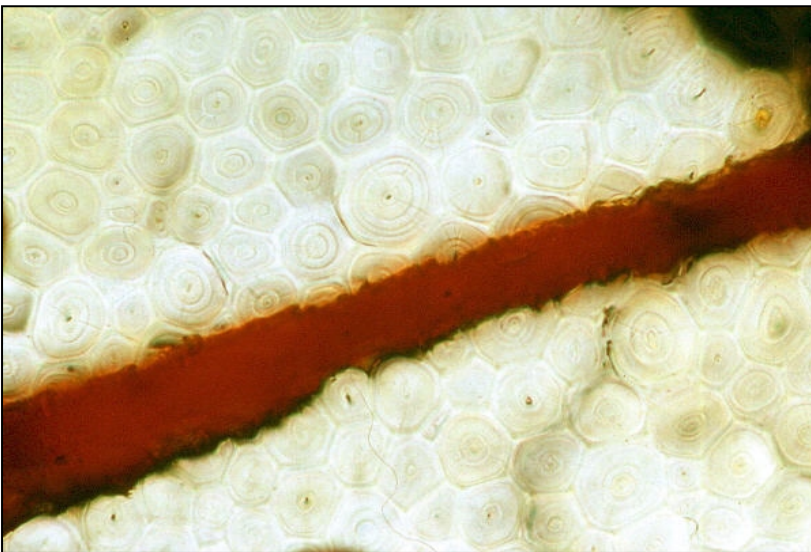
Fig. 44

Long side of picture: 0.23 mm (0.009 in)
A glue-line under high magnification. The fibers (cells), which have a diameter of . 0.01 mm (0.0004 in) to 0.02 mm (0.0008 in), are cut lengthwise, halving many. This needs a sharp iron. Resorcinol glue is used here, undiluted. Thickness of glue-line is approximately 0.02 mm (0.0008 in). The glue has not penetrated into the fibers.

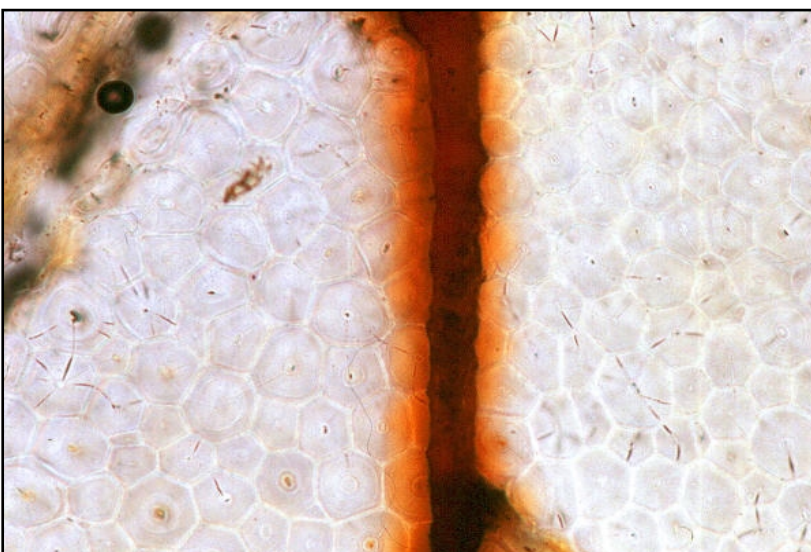
Fig. 45

Long side of picture: 0.23 mm (0.009 in)
Moderately diluted resorcinol glue. This has penetrated into the fibers, giving a better hold for the glue. Thickness of glue-line 0.01 mm (0.0004 in). About an equal penetration into the fibers has taken place.

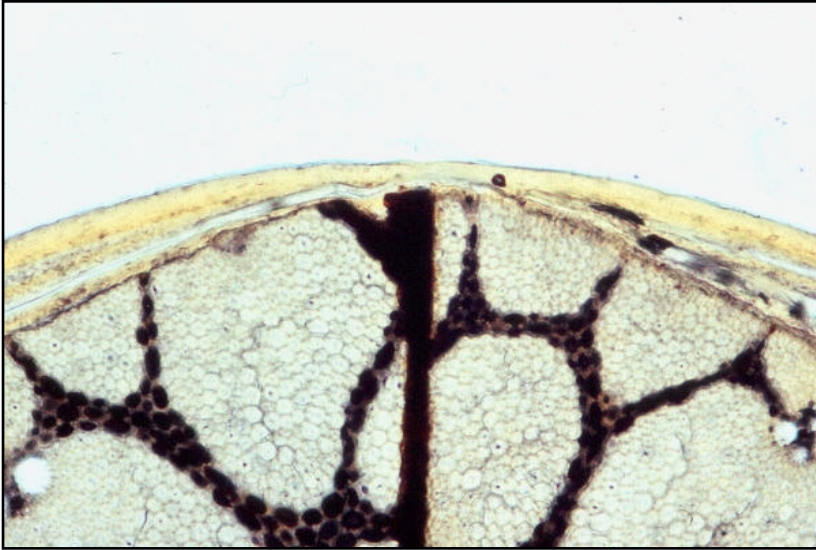
Fig. 52

Long side of picture: 0.8 mm (0.031 in)
 A higher magnification of the top left corner of Fig. 50. In spite of three layers of varnish, the resulting thickness is only 0.018 mm (0.0007 in). The varnish has built up on the flats, due to surface tension. Another three dippings would have produced a round rod, without contributing considerably more varnish to the corners. And here the corners had been rounded! Had the corners been knife-sharp, even less (or no) varnish would have been deposited there.
 In between the right side layers, some debris has been deposited during preparation of the sample.

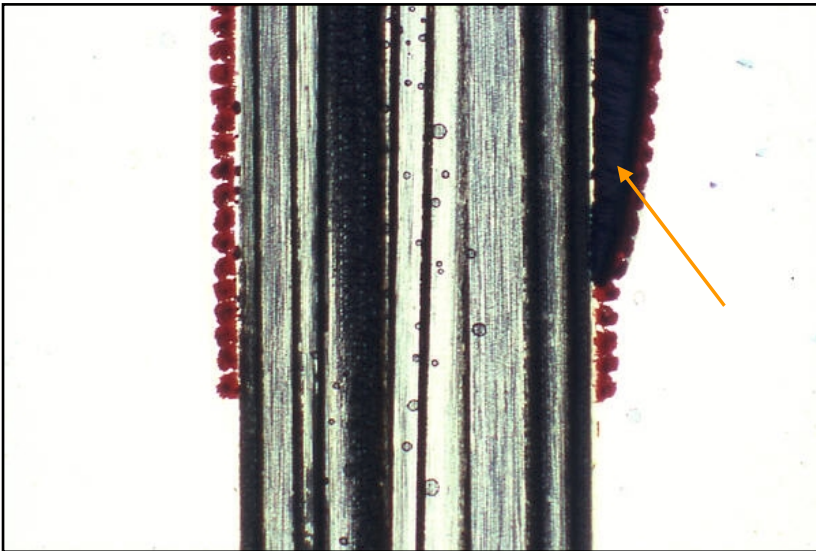
Fig. 53

Long side of picture: 6.6 mm (0.26 in)
 Longitudinal cut through a guide winding. The black guide foot is on the right side (steel, not transparent, of course, see arrow). Under the foot, a thin layer of varnish, also on the opposite side, under the red winding threads (nylon in this case). The varnish is not really visible in this picture, due to strong light having been used. Many trapped air bubbles along the center of the section.

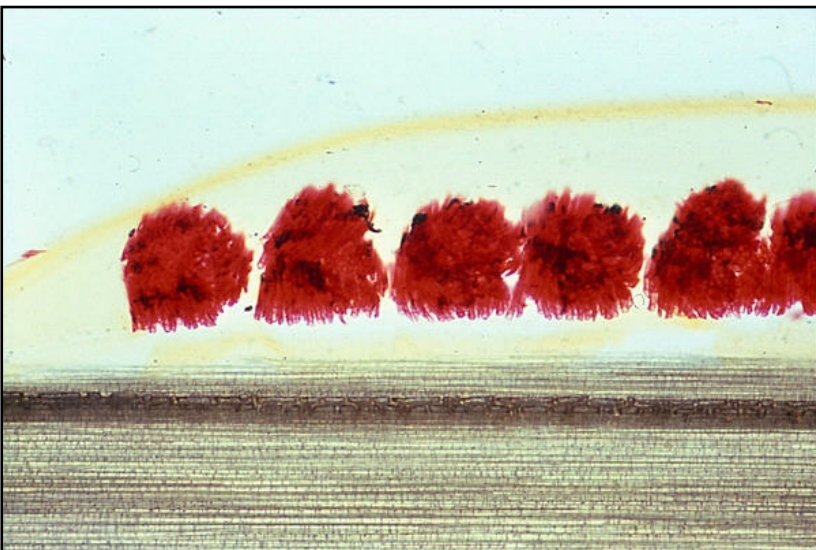
Fig. 54

Long side of picture: 1.3 mm (0.051 in)
 Here the varnish becomes visible (partly crossed polarizer/analyzer in the microscope). Clearly visible a yellow layer of varnish under the threads, which appear to be floating above the surface of the bamboo, and varnish between and above the threads.

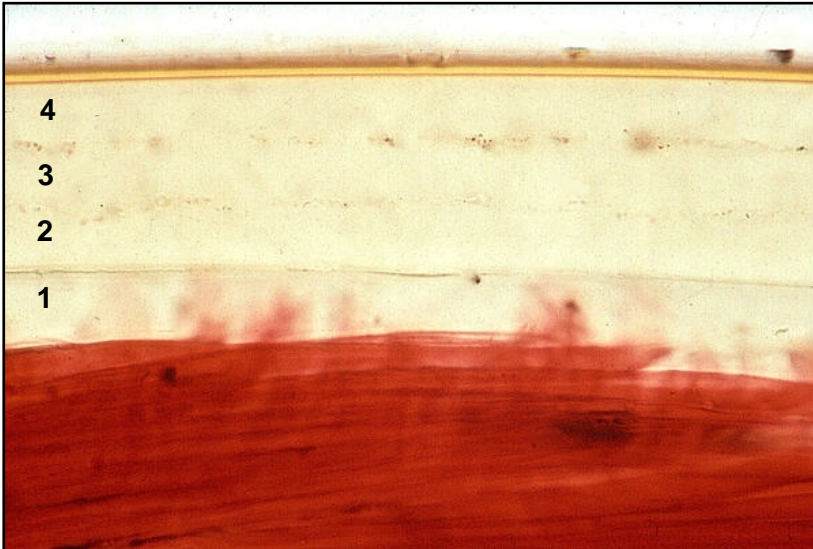
Fig. 55

Long side of picture: 0.32 mm (0.012 in)
 Cross section through guide winding. The individual fibers of the thread are visible. Further four layers of varnish, with a good bond between each other. Bottom layer (1) belongs to the soaking of the windings prior to varnishing the whole rod. It has a slightly lighter colour. Maybe a different varnish was used for priming. The whole story is: 1. the blank has been varnished. 2. The guides have been wrapped on and soaked/filled with varnish. 3. The rod has been varnished three times (2, 3, 4). The topmost dark yellow line is due to light refraction between varnish and embedding epoxy and is an optical artifact.

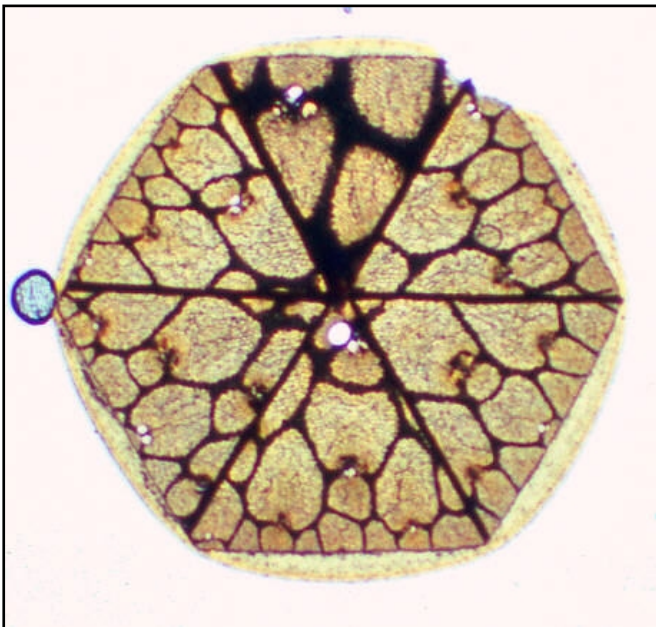
Fig. 56

Cross section through tip section of a hand planed rod, with Garrison-type node placement. Perfect 60° strips. Flat-to-flat dimensions of bamboo 2.82 mm (0.111 in). All three of them.

A small chip has broken off from the right top corner during preparation of the sample. Trapped air bubble at left.
