**PRELIMINARY GEOTECHNICAL EVALUATION
REHABILITATION OF THE
EAST ALISO CREEK EMERGENCY SEWER (REACES)
MOULTON NIGUEL WATER DISTRICT
LAGUNA NIGUEL, CALIFORNIA
MNWD JOB #2002059**

May 9, 2003
Project No. 202426002

Subject: Geotechnical Evaluation
Rehabilitation of the East Aliso Creek Emergency Sewer
Moulton Niguel Water District
Laguna Niguel, California
MNWD Job # 2002059

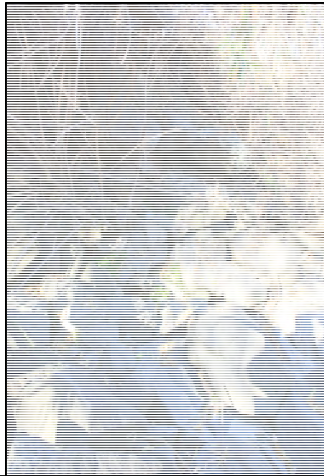
34
Oversteep / Undercut Riprap
 (looking u/s) Emergency rock placement?
 Near-vertical rock on bank. Stable toe.
 Geotechnically stable bank?

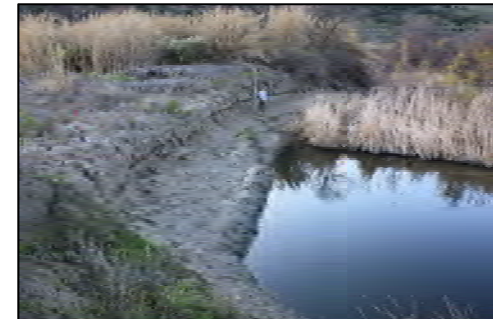
32
Probable Future Incision
 (looking d/s toward bend) Active erosion in chute (red shovel). Bend persists since pre-1930. Clay in toe of bank reduces rate of erosion/migration.

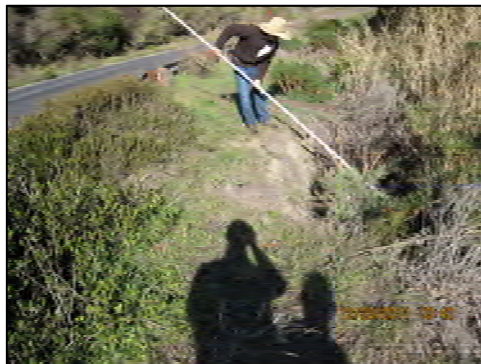
31
Flow Impingement, Narrow Setback
 Active flow impingement above elevation of riprap revetment along bank. Narrow setback. Also concentrated runoff down the bank.

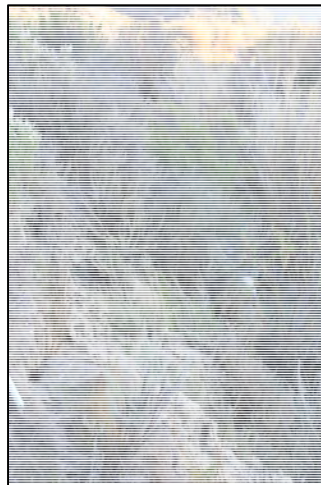
30
Flow Impingement
 (looking d/s) Flood flows in Aliso Creek erode bank material upstream of existing riprap revetment.

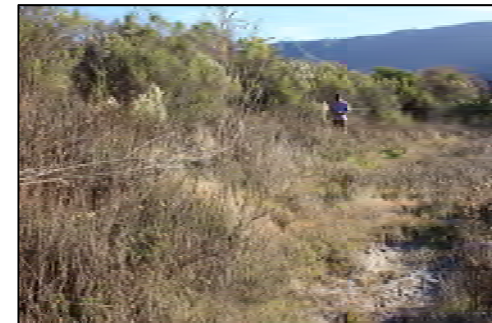
29
Stable Bank
 Downstream view of left bank, 2.5H:1V bank slope. Woody shrubs established across bank, stable toe along high flow chute.

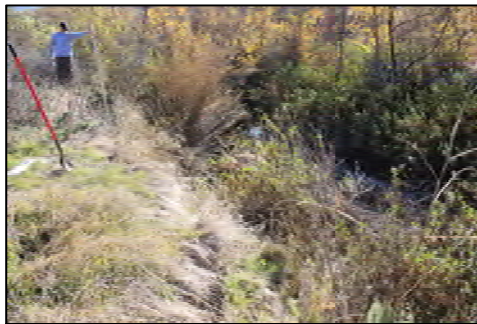
27
Concentrated Runoff

(looking d/s) Concentrated runoff from upland areas enters Aliso Creek by spilling across the bank, causing erosion.

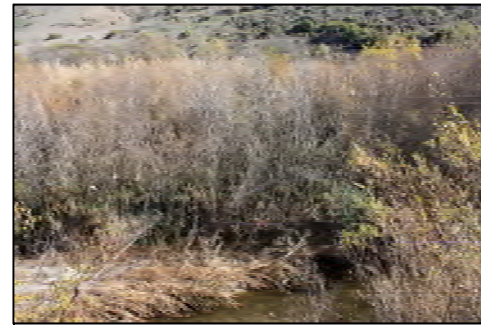
26
Stable Bank

Landward view of inset floodplain with dense growth of tree-willows and sycamores. Approximately 100-foot buffer to toe of bank.

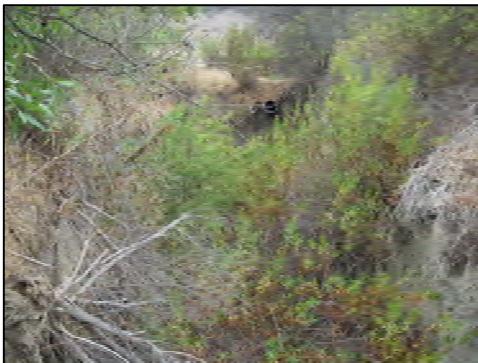
25
Tributary Crossing

Landward view up tributary channel incised 20 feet. Incision "checked" by culvert; road embankment and proposed alignment is geotechnically unstable.

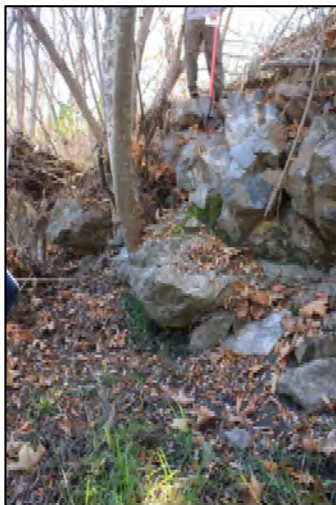
24
Oversteep Riprap

(looking d/s) Emergency rock placement? Near-vertical rock on bank. Geotechnically stable bank? Established trees and depositional berm minimize fluvial energy applied on the bank.

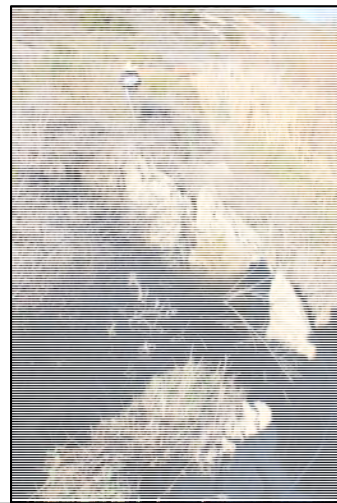
23
Slumping

(looking u/s) Slumping of full bank height into Aliso Creek.

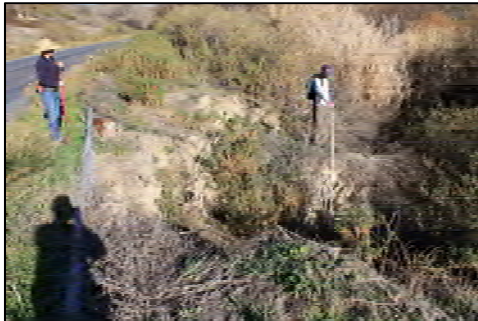
22
Concentrated Runoff

(looking u/s) Wood Canyon overflow down AMWA Road enters Aliso Creek by spilling down the bank. A headcut is propagating up the flowpath toward the proposed alignment.

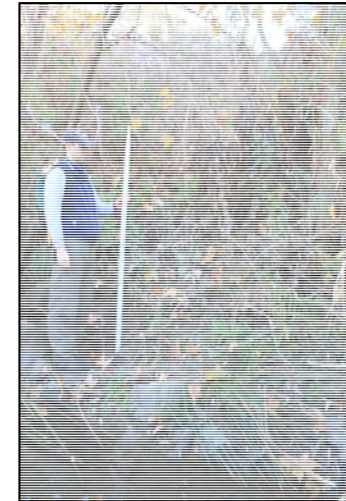
20
Stable Bank

Landward view of depositional berm and vegetation along toe of riprap revetment. Stable bank angle. Sycamore and tree-willows along toe.

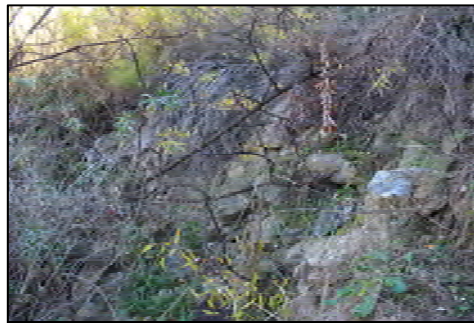
18
Slumping

(looking u/s) Slumping bank displaces riprap along upper bank; lower bank stabilized by depositional berm.

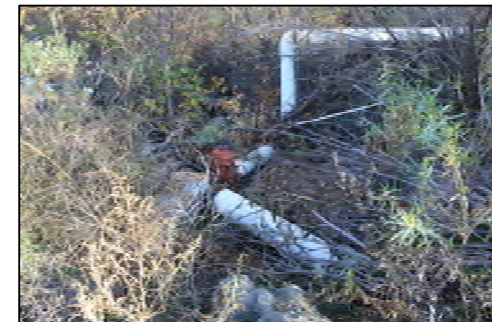
17
Wood Canyon

Riverward view of area scoured by flows overtopping AMWA Road crossing.

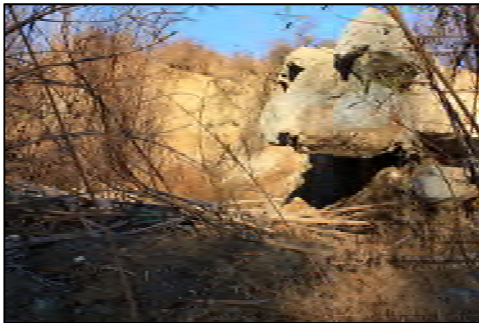
14
Undercut Riprap
Threatening ACWHEP diversion structure.

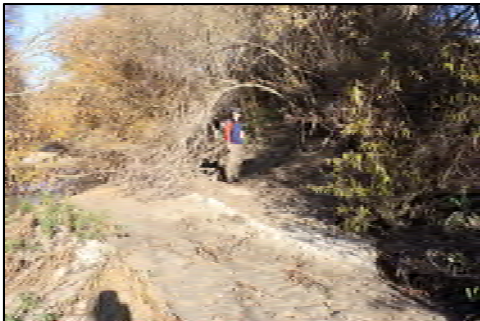
11
Stable Bank
(looking u/s) Stability promoted by 6-foot high, vegetated, depositional berm along toe of bank. Floodplain connected, stable bank angle.

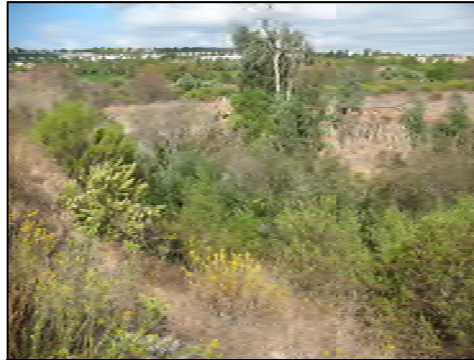
3
Flow Impingement

Riverward view of bend in Sulphur Creek where flood flows directly impinge on bank slope.

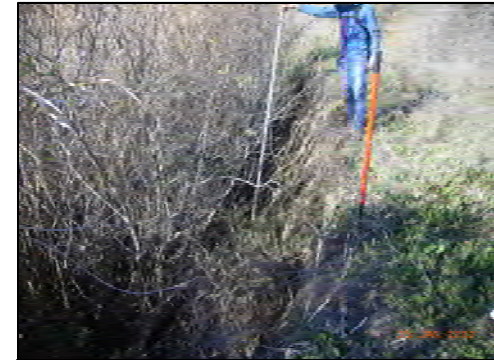
2
Upper Bank Geotechnical Instability

(looking u/s) Lower bank stabilized by dense woody vegetation; upper bank will continue to erode to achieve a stable bank angle.

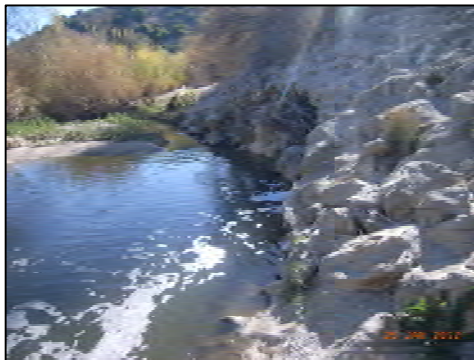
1
Undercut Grouted Riprap

Likely due to scour over bridge drop; grout prevents rock from conforming to scour hole.
