South Orange County Wastewater Authority

Lower Aliso Creek Erosion Assessment

County of Orange, California

April 2012

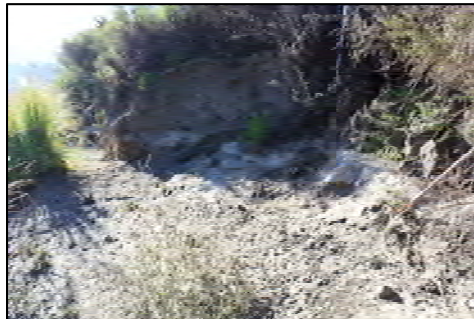
33
Oversteep Bank, Narrow Setback
 (looking d/s) Potential for continued fluvial erosion. Bank not geotechnically stable. Top of unstable bank within 15 feet of AMWA Road.

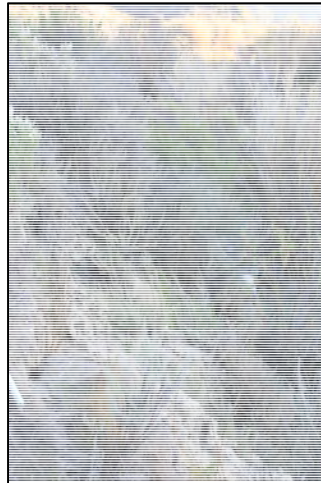
30
Flow Impingement
 (looking d/s) Flood flows in Aliso Creek erode bank material upstream of existing riprap revetment.

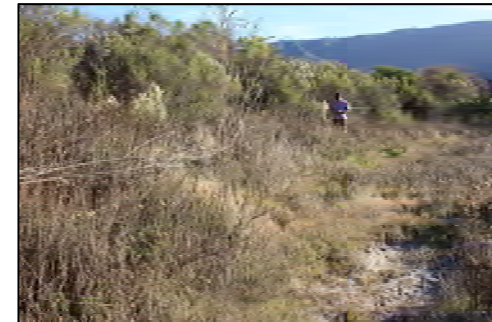
29
Stable Bank
 Downstream view of left bank, 2.5H:1V bank slope. Woody shrubs established across bank, stable toe along high flow chute.

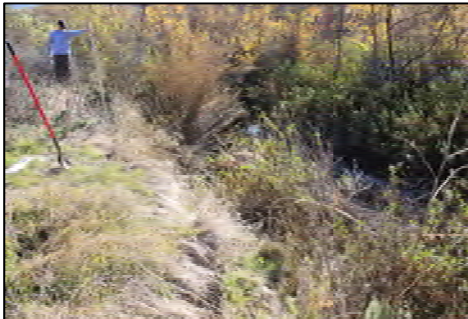
27
Concentrated Runoff

(looking d/s) Concentrated runoff from upland areas enters Aliso Creek by spilling across the bank, causing erosion.

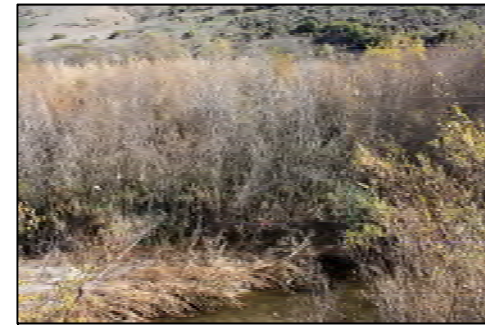
26
Stable Bank

Landward view of inset floodplain with dense growth of tree-willows and sycamores. Approximately 100-foot buffer to toe of bank.

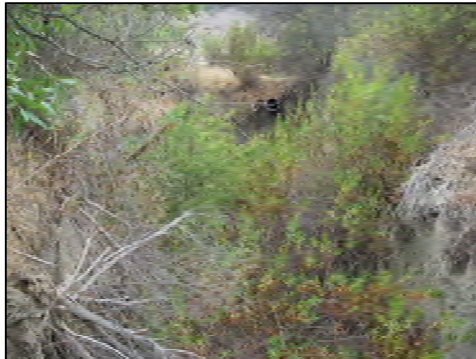
25
Tributary Crossing

Landward view up tributary channel incised 20 feet. Incision "checked" by culvert; road embankment and proposed alignment is geotechnically unstable.

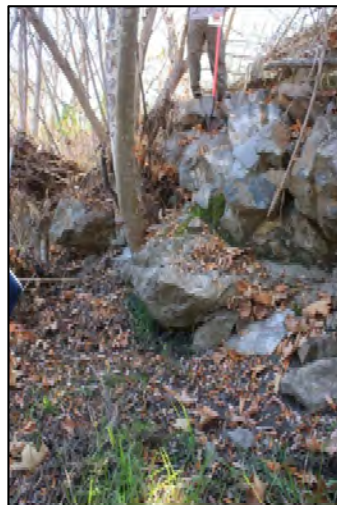
24
Oversteep Riprap

(looking d/s) Emergency rock placement? Near-vertical rock on bank. Geotechnically stable bank? Established trees and depositional berm minimize fluvial energy applied on the bank.

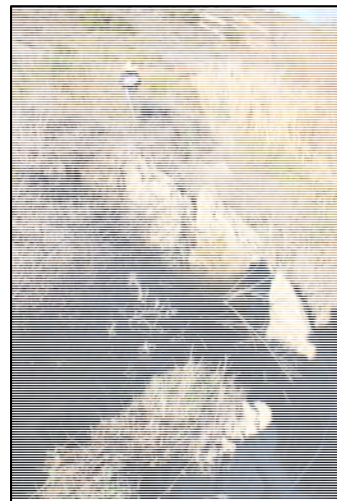
23
Slumping

(looking u/s) Slumping of full bank height into Aliso Creek.

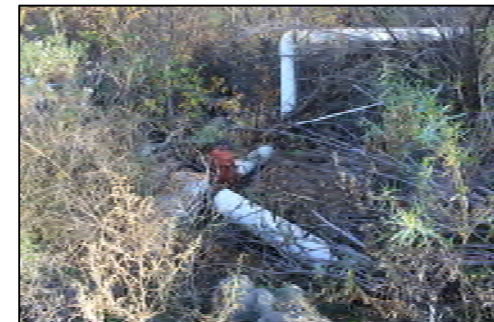
17
Wood Canyon

Riverward view of area scoured by flows overtopping AMWA Road crossing.

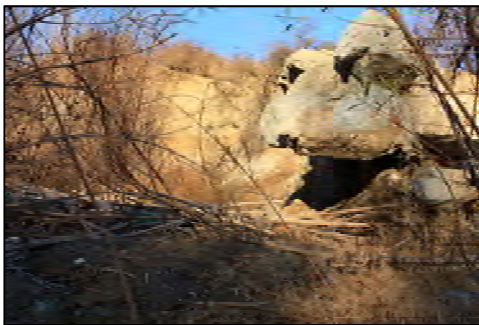
14
Undercut Riprap
Threatening ACWHEP diversion structure.
